# Public Service Commission State of North Dakota

## INSPECTION REPORT

DATE OF INSPECTION: September 29, 2010  
TYPE OF INSPECTION: Partial  
PERMITTEE - MINE: Coteau Properties Company - Freedom Mine  
PERMITS INSPECTED: NACT-8102, NACT-8203, NACT-8401, NACT-8503, NACT-8601,  
NACT-9001, NACT-9101, NACT-9501, NACT-0201, NACT-0401  
PERSON ACCOMPANYING INSPECTOR: Terence Schmidt  
INSPECTION CONDITIONS: The inspection was conducted between 10:00 a.m. and 5:30  
p.m., CDT. Skies were clear. The temperature was near 50°  
F but rose to 70° F. Access was unrestricted.

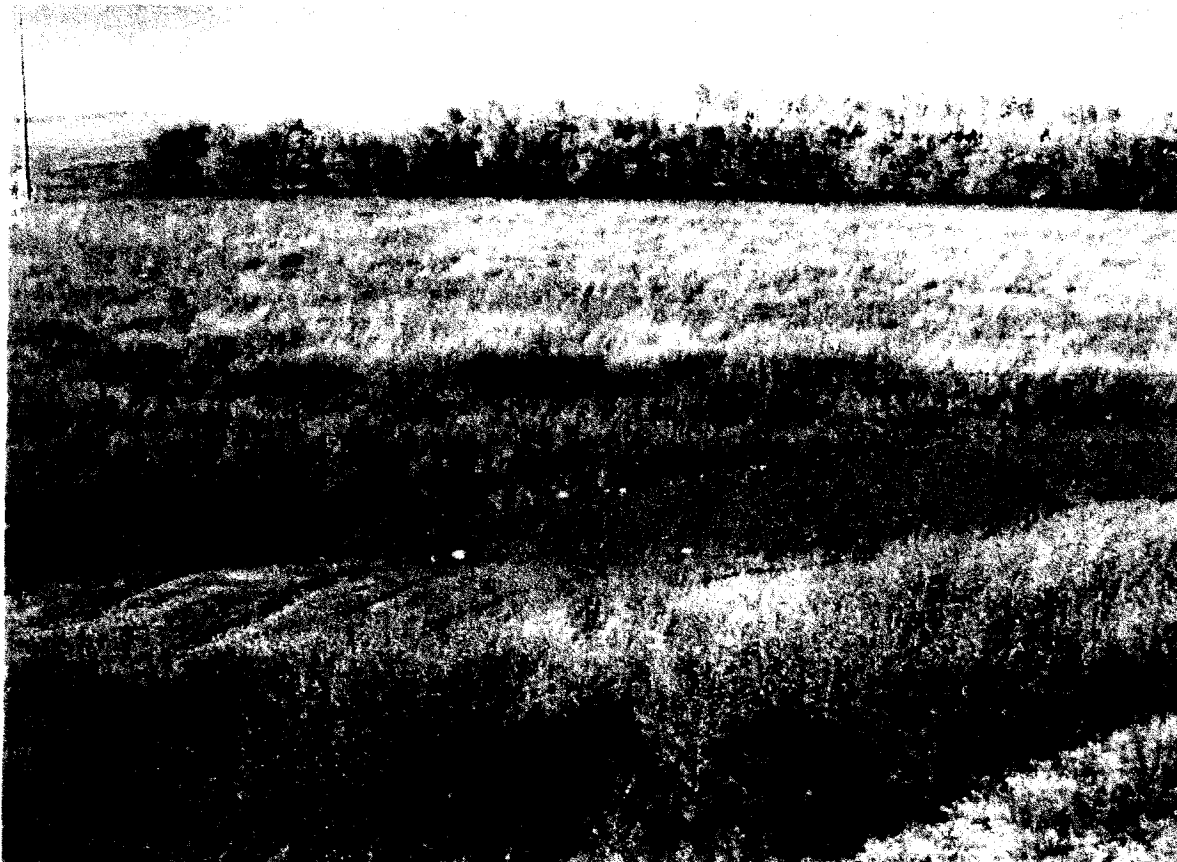
The conveyor haul road was also traversed during the inspection. An area of concern was noted on the downstream side of the culvert in the SE¼ of Section 18, Permits NACT-8102 and NACT-8203, during the September 2, 2010, inspection. The September 2<sup>nd</sup> inspection stated "Vegetated overburden as well as the subsoil respread edge, acting as a sump, was collecting sediment prior to the water flowing down a reclaimed drainageway. However, with sediment build-up, the vegetation no longer effectively filters the sediment in the runoff. It was suggested that silt fences and/or an excavated sump be installed." The inspector was following up on the area to see if the necessary measures from the September 2<sup>nd</sup> report had been implemented on the downstream (south) side of the haul road. The upstream (north) side of the haul road was also viewed during this inspection. Upon inspection, it was apparent that sediment had also filled the north haul road ditch and had been deposited on upstream reclaimed lands. See attached photo 1. Based on these observations, a follow-up inspection was conducted on September 30, 2010, by Mr. Berg and Mr. Moos.

Photo 1. Looking north from conveyor haul road in the SE<sup>1</sup>/<sub>4</sub> of Section 18, Permits NACT-8102 and NACT-8203.
