INSPECTION REPORT

DATE OF INSPECTION: September 30, 2010

PERMITTEE - MINE: Coteau Properties Company - Freedom Mine

PERMITS INSPECTED: NACT-8102, NACT-8203, NACT-8601, NACT- 9001, NACT-9501,

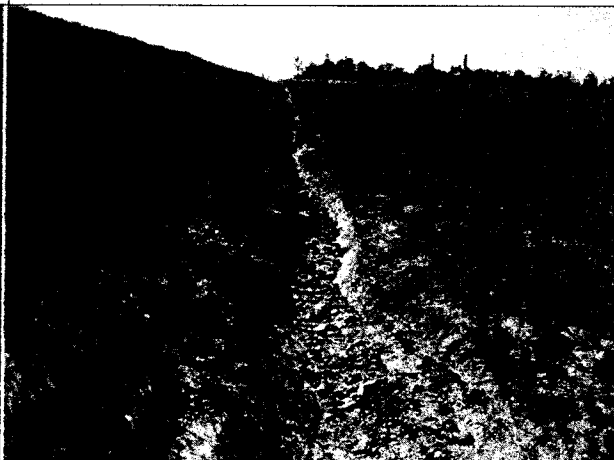
Photo 2: Looking SW on the north side of haul road.

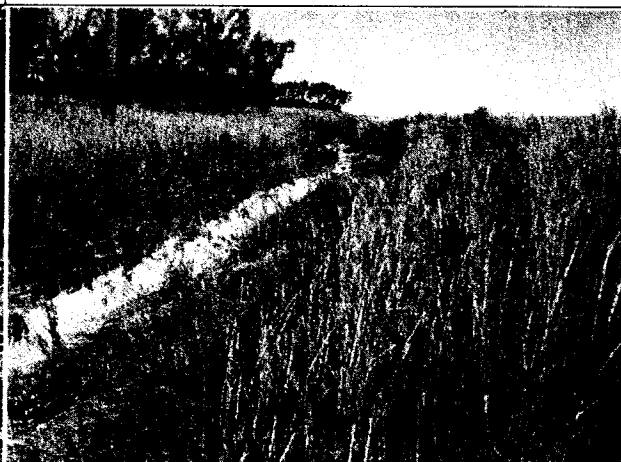
Photo 4: Looking NE along north side of haul road.

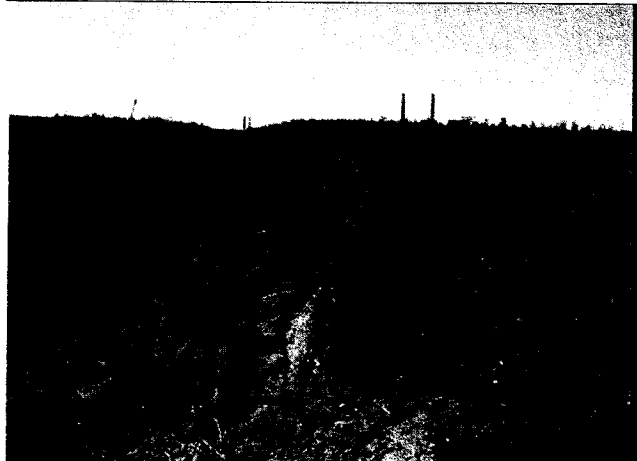
Photo 5: Looking SE down ditch on the north side of the haul road.

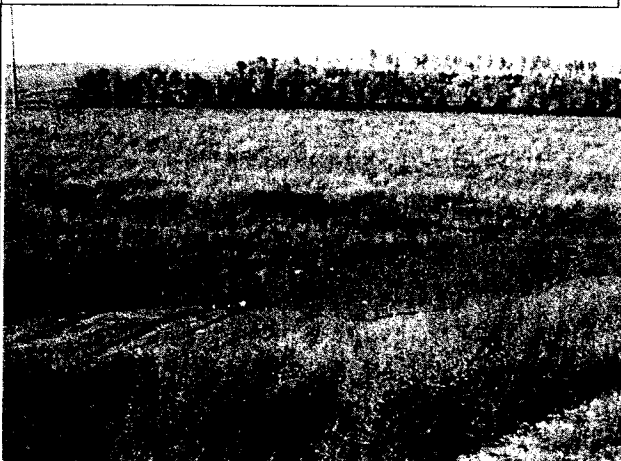
Photo 6: Sediment deposition along north side of haul road on reclaimed lands.
