**RE: Tree and Shrub Survival Report for ND PSC Case No. PU-10-630 (Plains All American Pipeline, L.P. Bakken North Pipeline)**

## **Tree and Shrub Survival Report for the Bakken North Pipeline Project, Williams County, North Dakota**

**ND PSC Case No. PU-10-630**

September 2017

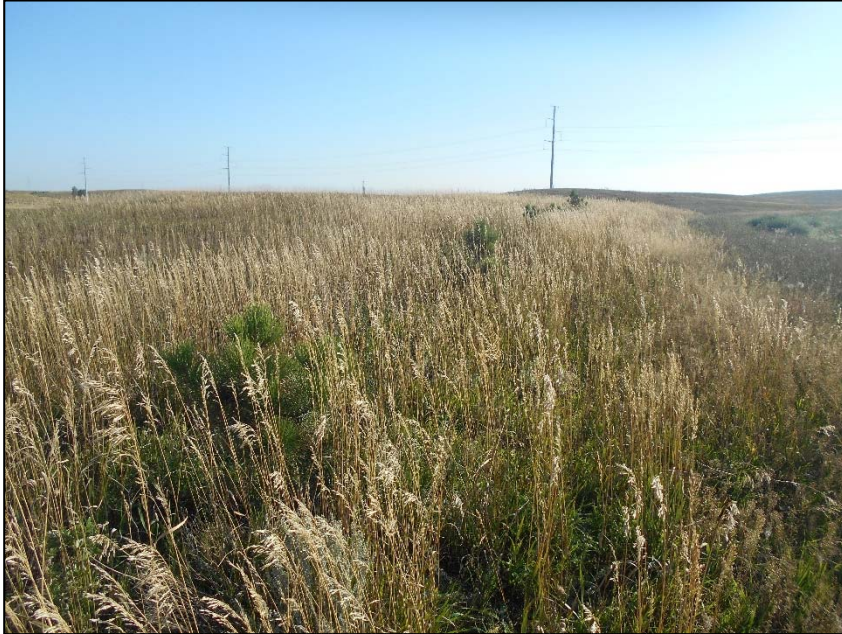
The plantings for each landowner were revisited on September 8, 2017 (Figures 1 and 2). Replanted trees were in fair condition overall; however, the fabric weed barrier was often damaged or overgrown with vegetation, making it difficult to observe some of the smaller tree and shrub plants. The chokecherry replants located in SW Section 10, Township 154 North, Range 102 West were not found; however, because no indication of the presence of these replants was observed it was not assumed that the saplings had died. Overall conifer and shrub species fared better than large deciduous species; and several shrub species had higher numbers of individuals than last year. New sapling growth or surveyor error (i.e., surrounding vegetation caused plants to be missed; plants were counted previously as dead; etc.) are possible reasons for the increase in shrubs from year 2 to year 3. Trees or shrubs which had any portion of living plant material were considered alive. Of the 1,031 trees that were replanted in the fall of 2014 and spring of 2015, 391 were alive during the September 2017 survey (Appendix A). Since the number of trees originally planted greatly exceeded the 2:1 planting requirement, the current survival rate is above the required 75% (294 trees) at 99.7%.

**Figure 1. Ponderosa pine row located on Bradley and Marilyn Olson property, facing north (photo taken September 8, 2017).**

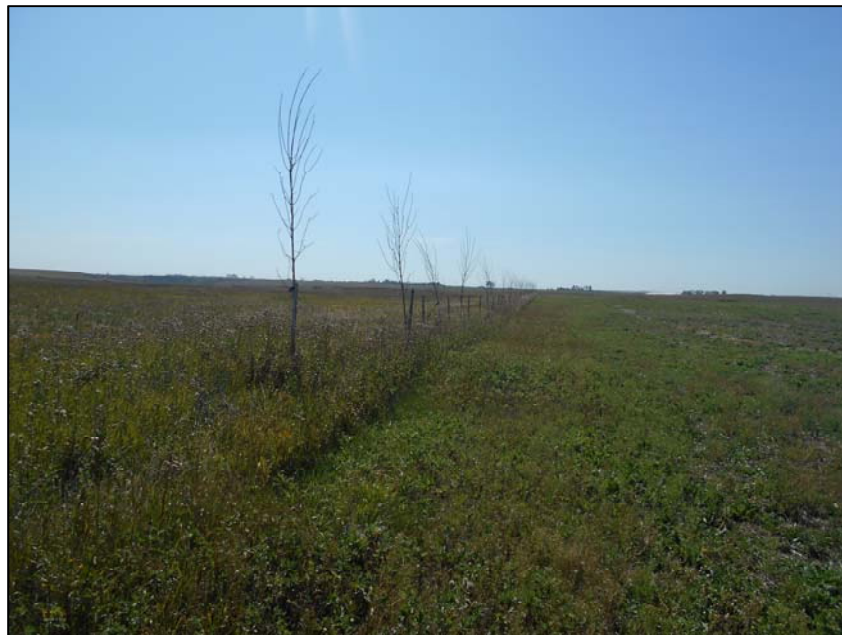
**Figure 2. Green ash row located on Bradley and Marilyn Olson property, facing west (photo taken September 8, 2017).**
