**Post Construction Inspection Report
PU-10-637
Rangeland Colt Pipeline**

169 **PU-10-637** Filed: 10/29/2013 Pages: 8
Rangeland Colt Pipeline interim inspection report

Rangeland Pipeline, LLC

Post Construction Inspection Report

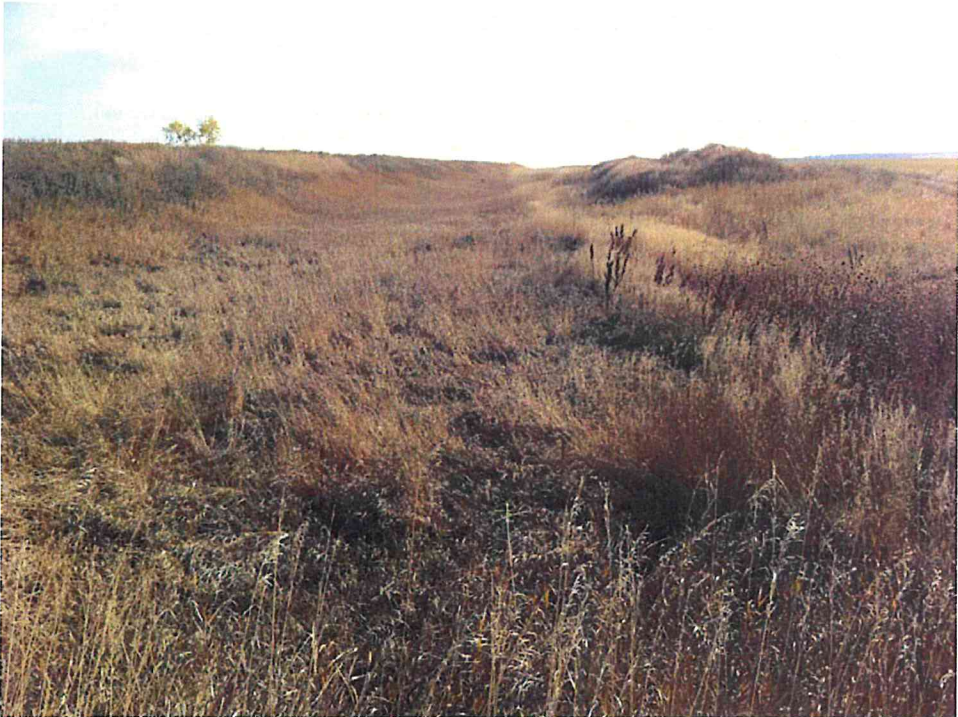
At the time of the inspection, re-contouring and reseeded had been completed and re-vegetation along the route was nearly completed. (Appendix 1, Photos 1, 2). Where landowners had planted crops over the pipeline, re-vegetation varied from being partially completed (Appendix 1, Photo 3) to nearly completely reclaimed (Appendix 1, Photo 4). Re-vegetation is of paramount concern to prevent erosion, especially around steep slopes (Appendix 1, Photo 5).

Photo 1 – Nearly complete re-vegetation

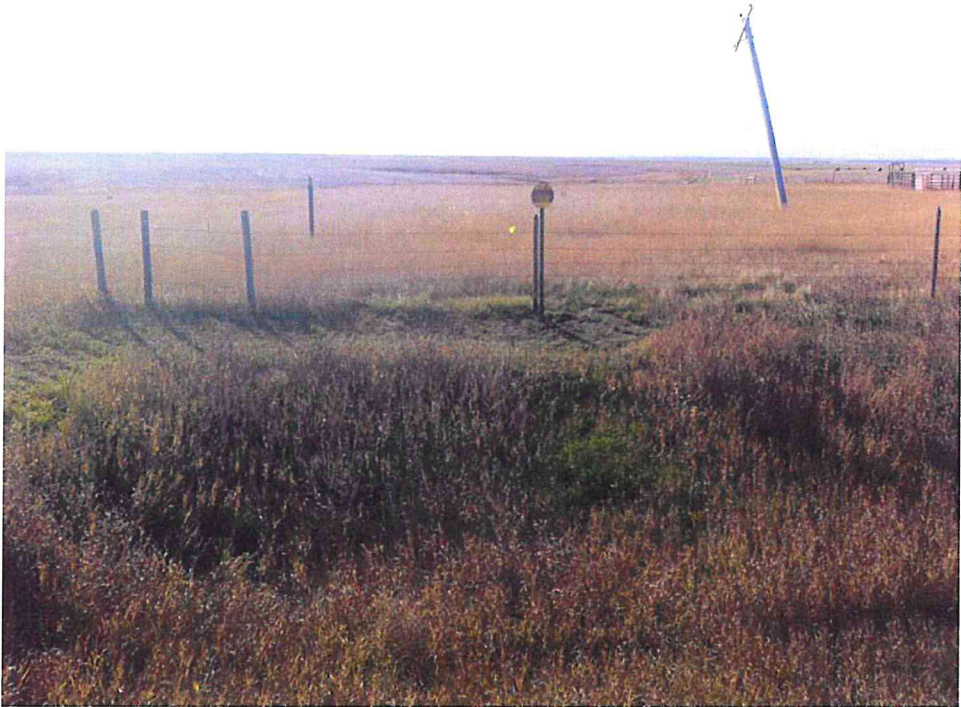
Photo 2 – Nearly complete re-vegetation

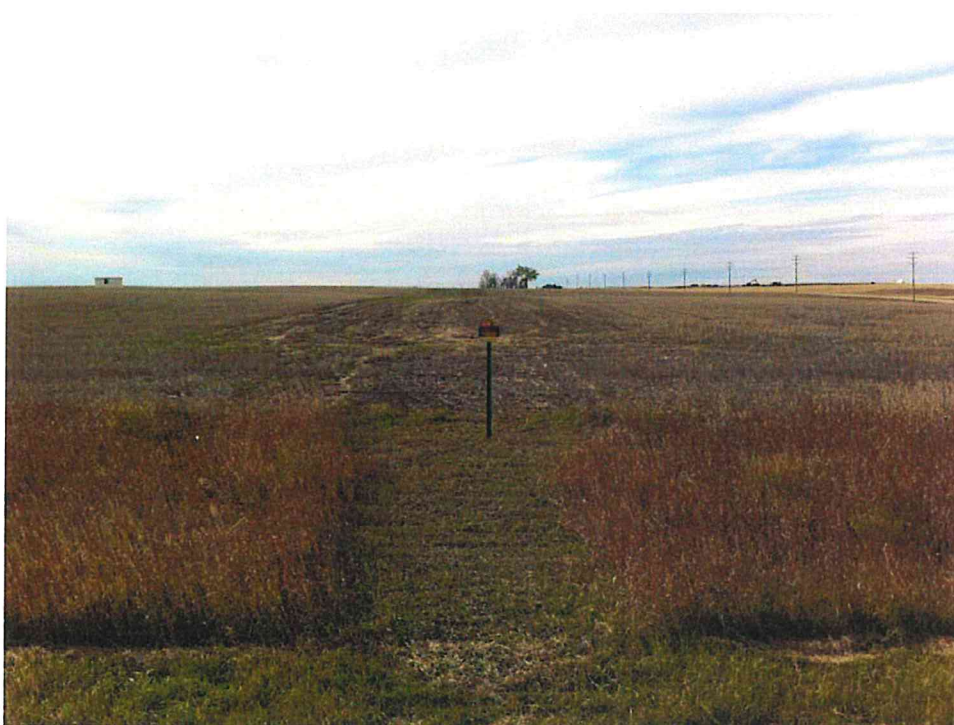
Photo 3 – Partially complete re-vegetation in cropland

Projects of this type typically are subject to PSC stipulations to monitor re-vegetation and restoration by October 1st for 3 years following completion of construction. In other areas, if reseeded is still unsuccessful after 3 years, additional topsoil may be necessary for vegetation to colonize the area. However given the whole of the Project of focus in this assessment, the re-vegetation of the area exceeded the 70% criteria. The transmission facility has been constructed in compliance with the siting laws and rules and applicable Commission orders.

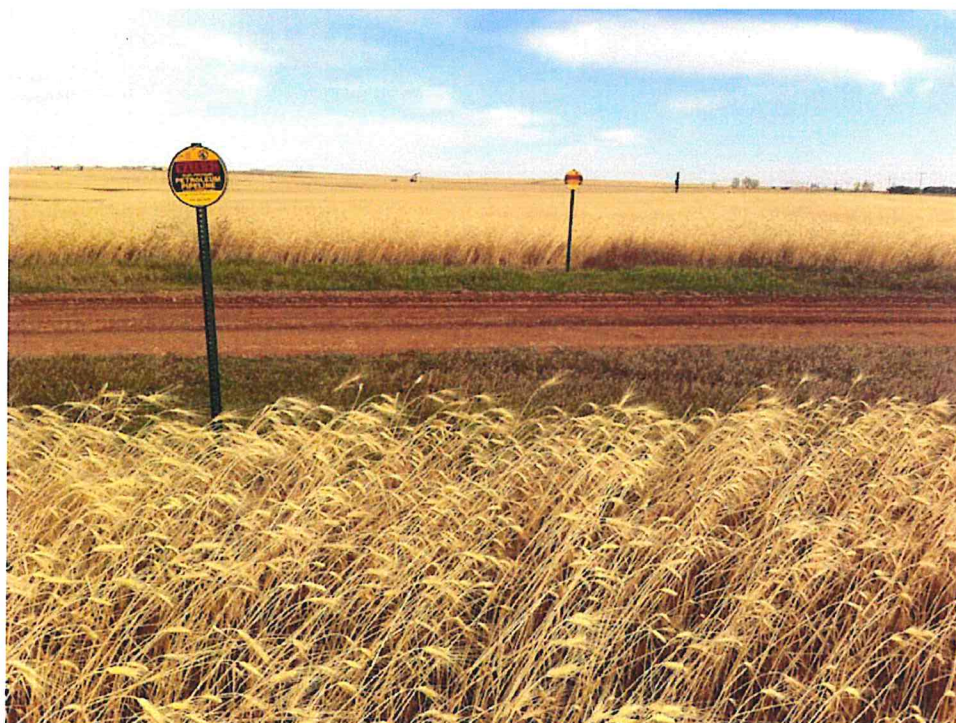
Photo 4 – Nearly complete re-vegetation in cropland

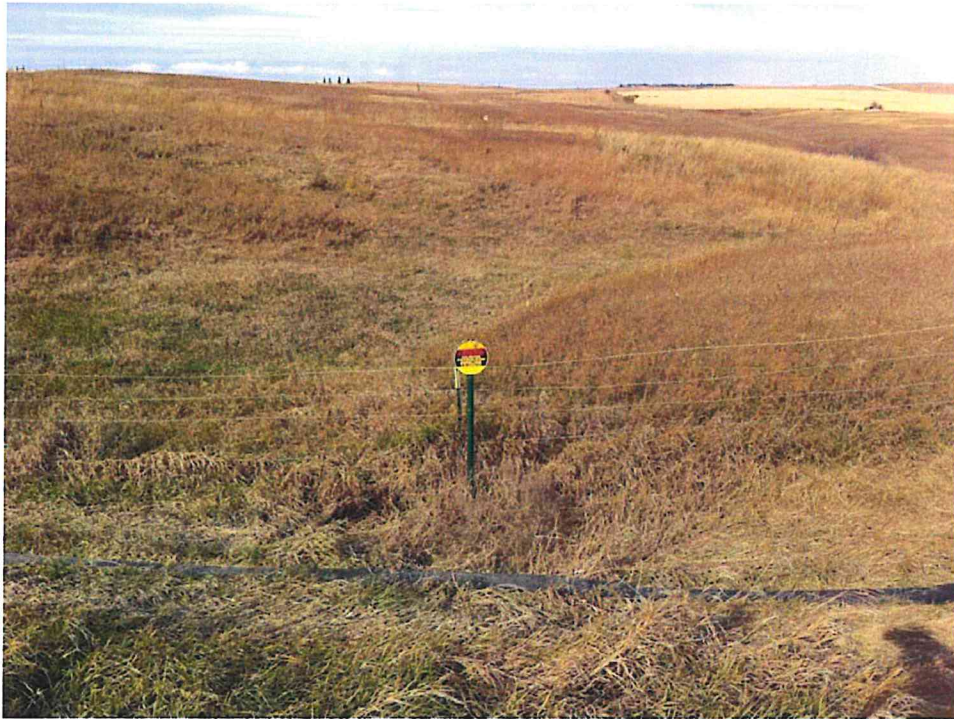
Photo 5 – Steep sloped area of erosion concern
