This letter is in follow-up to our field inspection of pending bond release applications No. 7 and 8 to Permit BCGH-8204. We noted several features that will need to be repaired prior to this office recommending final bond release approval. These features are identified on Figures 1 and 2. As previously discussed, repair of the subsidence feature(s) over the Teuber Mine will not be necessary. In addition, the leafy spurge and Canada thistle located on the hayland in the NE 1/4 of Section 27 must be sprayed with an effective herbicide prior to final bond release approval. During the inspection it was recommended that the feature ponding water on the reclaimed cropland in Section 32 be reshaped to provide positive drainage.

INSPECTION REPORT

PERMITTEE - MINE: Basin Cooperative Services - Glenharold Mine

PERMIT INSPECTED: BCGH-8204

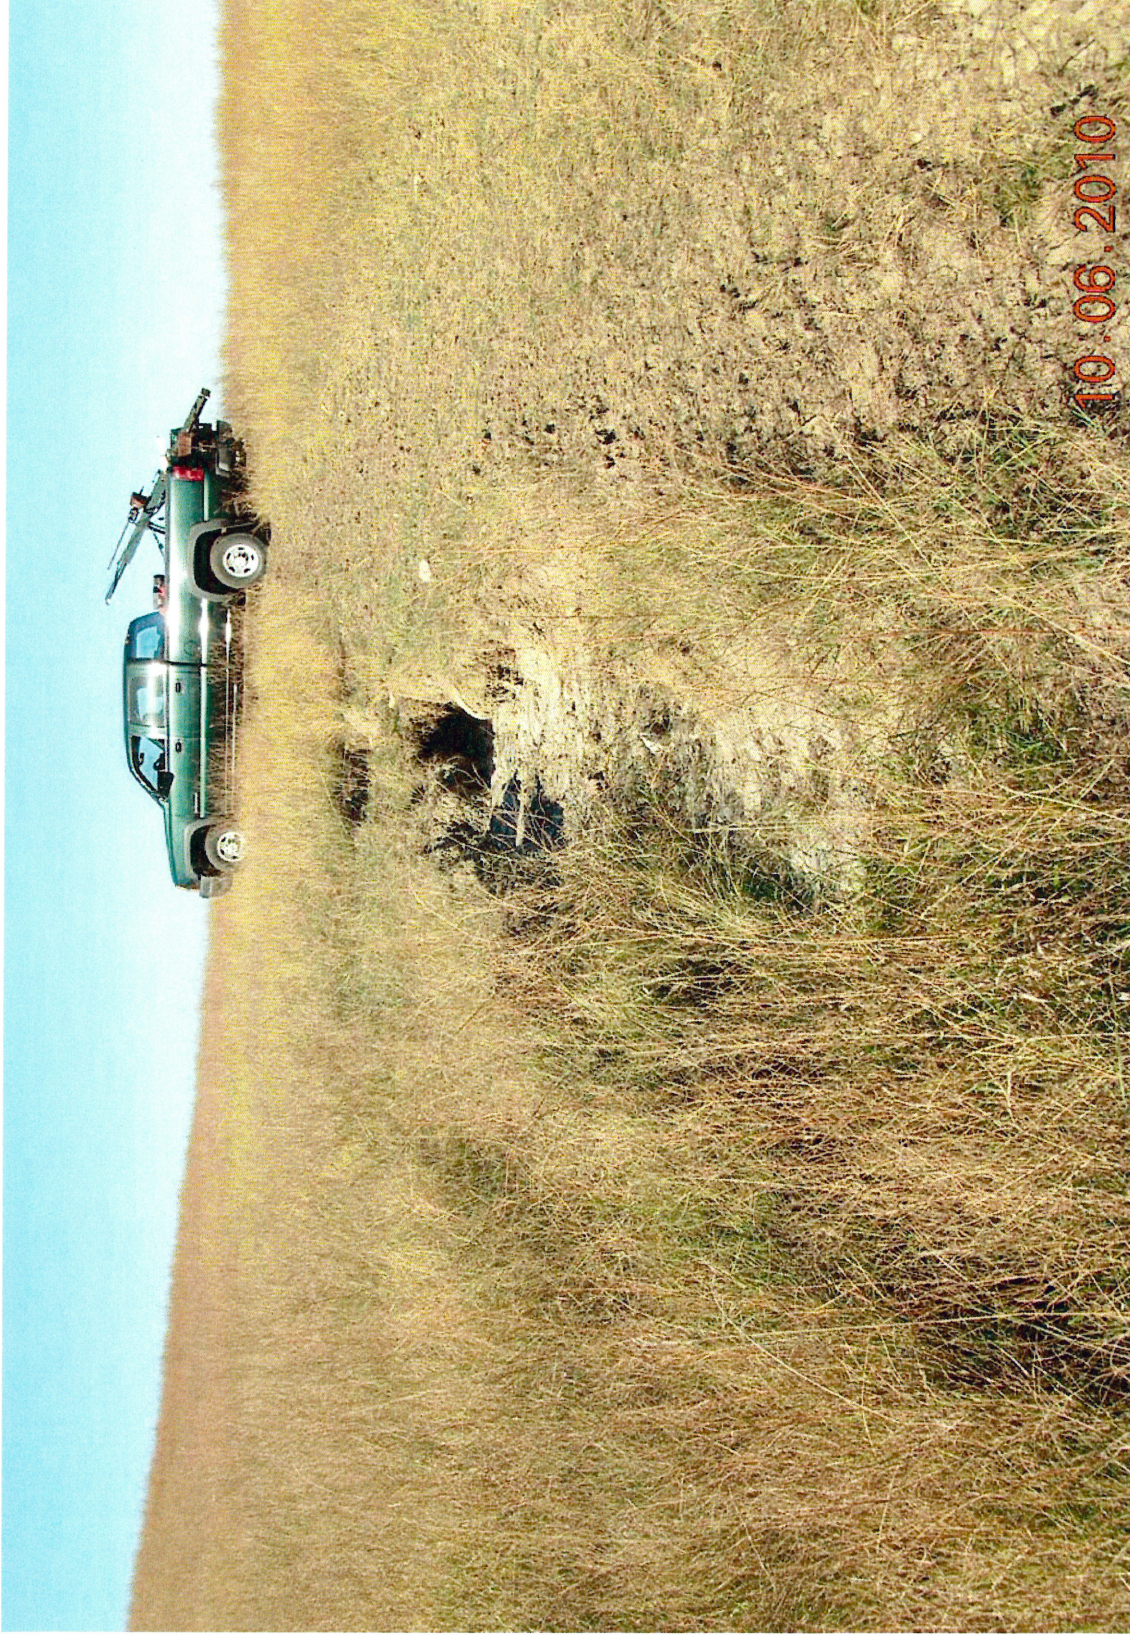
1. Erosion in a drainageway in the SE $\frac{1}{4}$ of the NE $\frac{1}{4}$ of the SE $\frac{1}{4}$ of Section 5 (Tract 5) about midway between soil probe numbers 15 and 16 as pictured in Figure 4;

Figure 4. Erosion in a drainageway in the SE¹/₄ of the NE¹/₄ of Section 5 (Tract 5) about midway between soil probe numbers 15 and 16.

Several erosion or instability features were observed during the inspections. These features should be inspected by Basin Cooperative Services and repaired as necessary in 2011. Repair of some of these features may not be necessary depending on their location, for example if they are located on pre-law or early law areas and the SPGM respread requirements for the particular area. They are described as follows in relation to section, tract, or soil probe numbers:

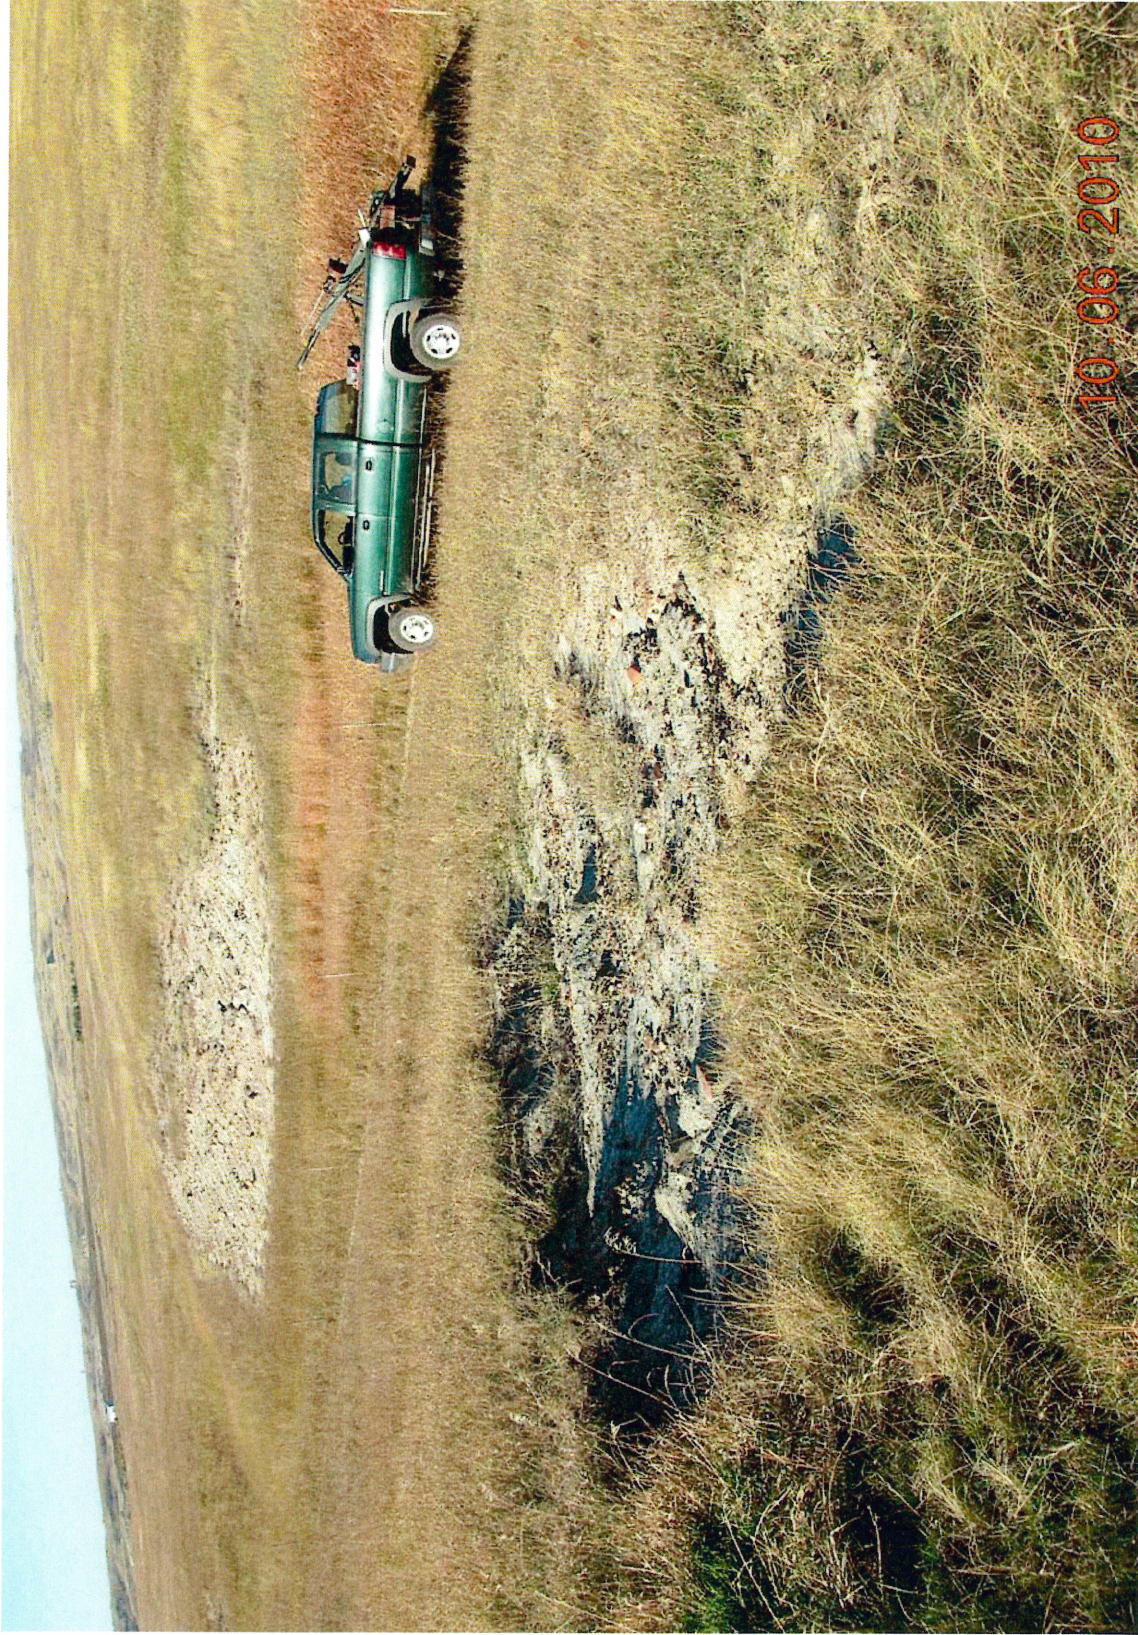
2. Erosion south of the fence line near the center of the NE $\frac{1}{4}$ of the SE $\frac{1}{4}$ of Section 5 (Tract 5) about 450 feet northeast of soil probe number 17 as pictured in Figure 5;

Figure 5. Erosion south of the fence line near the center of the NE¼ of Section 5 (Tract 5) about 450 feet northeast of soil probe number 17.

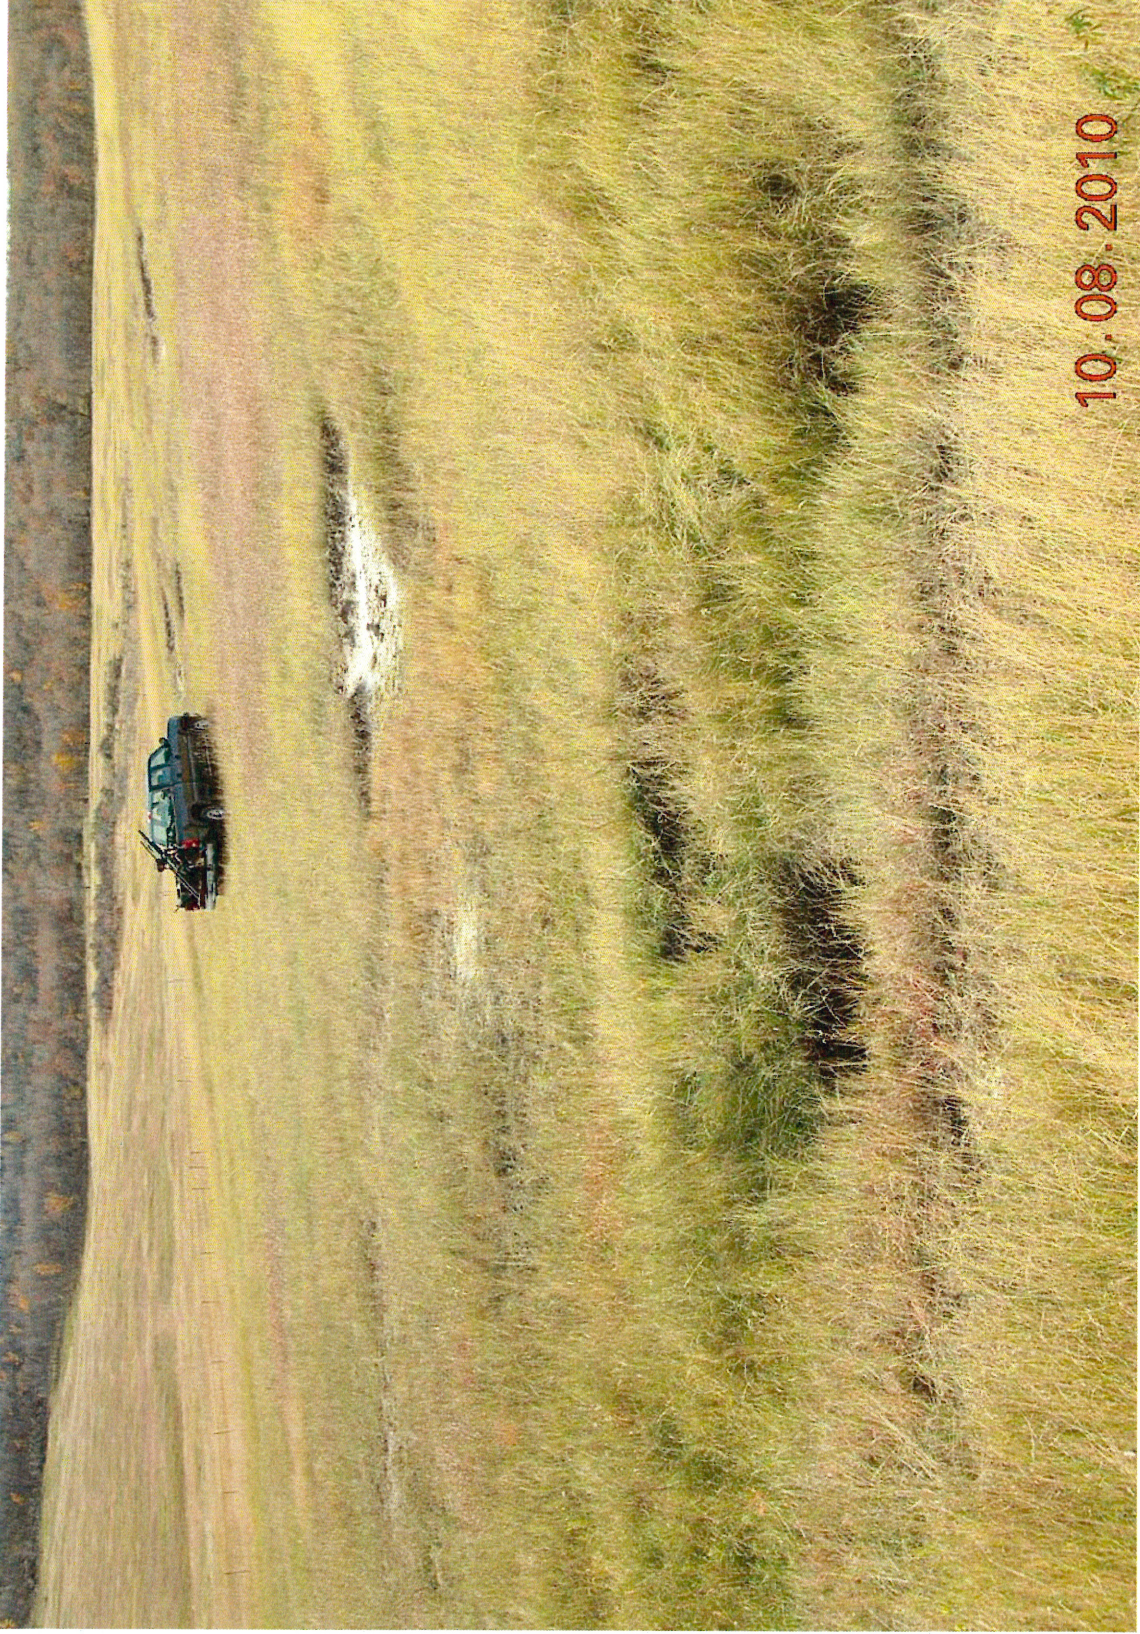
3. Erosion and piping near the permit boundary in the SE $\frac{1}{4}$ of the SE $\frac{1}{4}$ of the SW $\frac{1}{4}$ and the SW $\frac{1}{4}$ of the SW $\frac{1}{4}$ of the SE $\frac{1}{4}$ of Section 31 (Tract 4C) south-southeast of soil probe number 51 as pictured in Figure 6;

Figure 6. Erosion and piping near the permit boundary in the SE $\frac{1}{4}$ of the SE $\frac{1}{4}$ and the SW $\frac{1}{4}$ of the SW $\frac{1}{4}$ of the SE $\frac{1}{4}$ of Section 31 (Tract 4C) south-southeast of soil probe number 51.

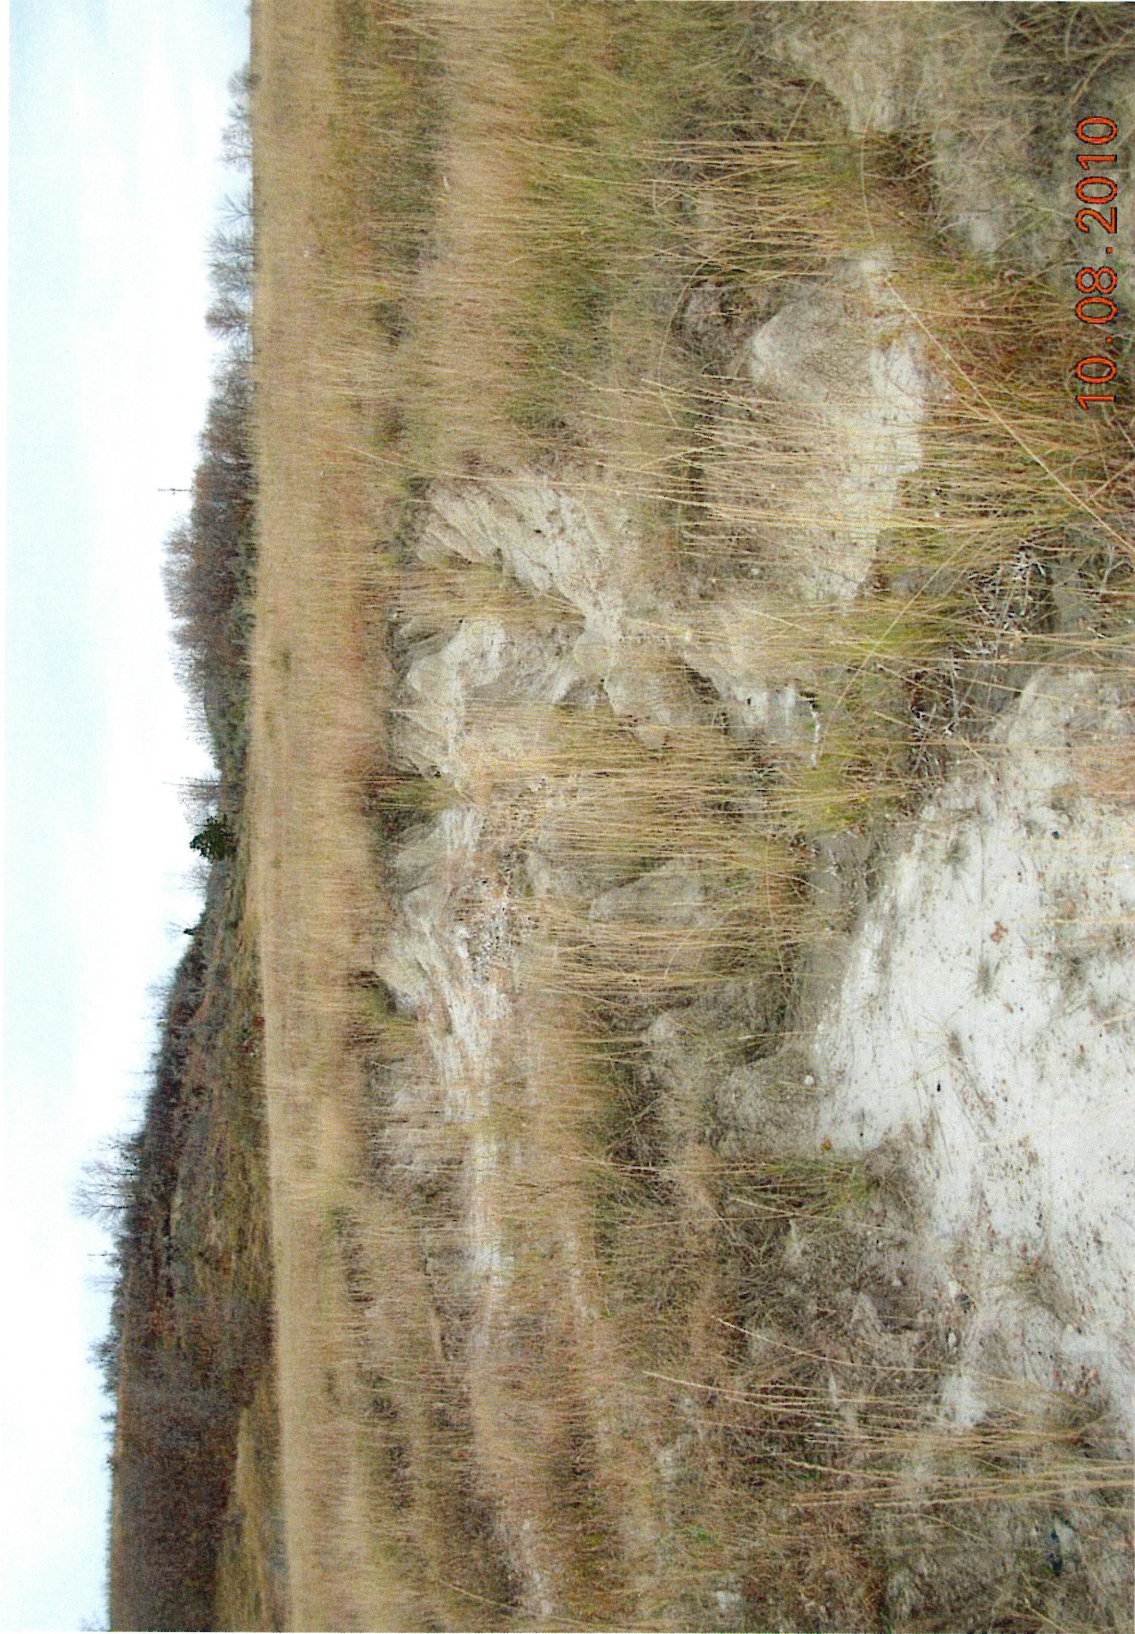
4. Erosion and piping west of Pond 1 in the N $\frac{1}{2}$ of the NW $\frac{1}{4}$ of the SW $\frac{1}{4}$ of Section 31 (Tract 4C) south of soil probe number 55 as pictured in Figure 7;

Figure 7. Erosion and piping west of Pond 1 in the N $\frac{1}{2}$ of the NW $\frac{1}{4}$ of Section 31 (Tract 4C) south of soil probe number 55.

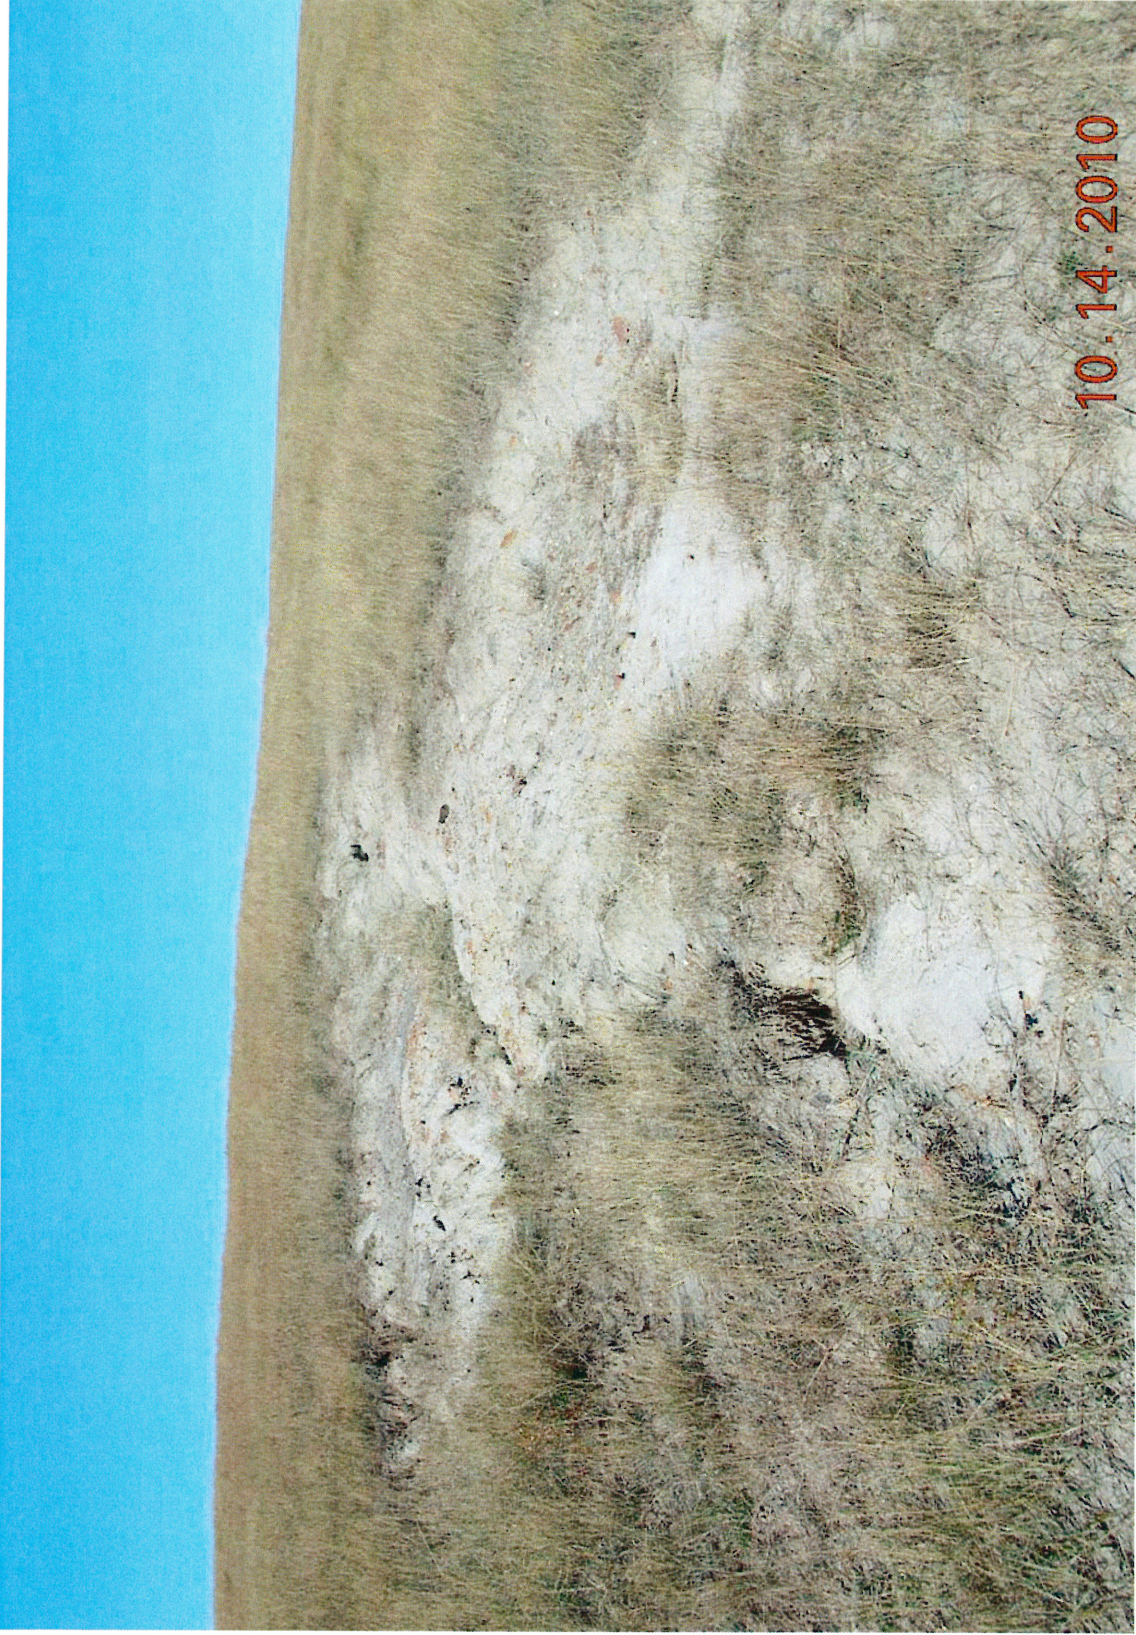
7. Erosion on the hillside in the in the SW $\frac{1}{4}$ of the NW $\frac{1}{4}$ of the NE $\frac{1}{4}$ of Section 31 (Tract 4C) west of Pond 31-3H near soil probe number 64 as pictured in Figure 8;

Figure 8. Erosion on the hillside in the in the SW¹/₄ of the NW¹/₄ of Section 31 (Tract 4C) west of Pond 31-3H near soil probe number 64.

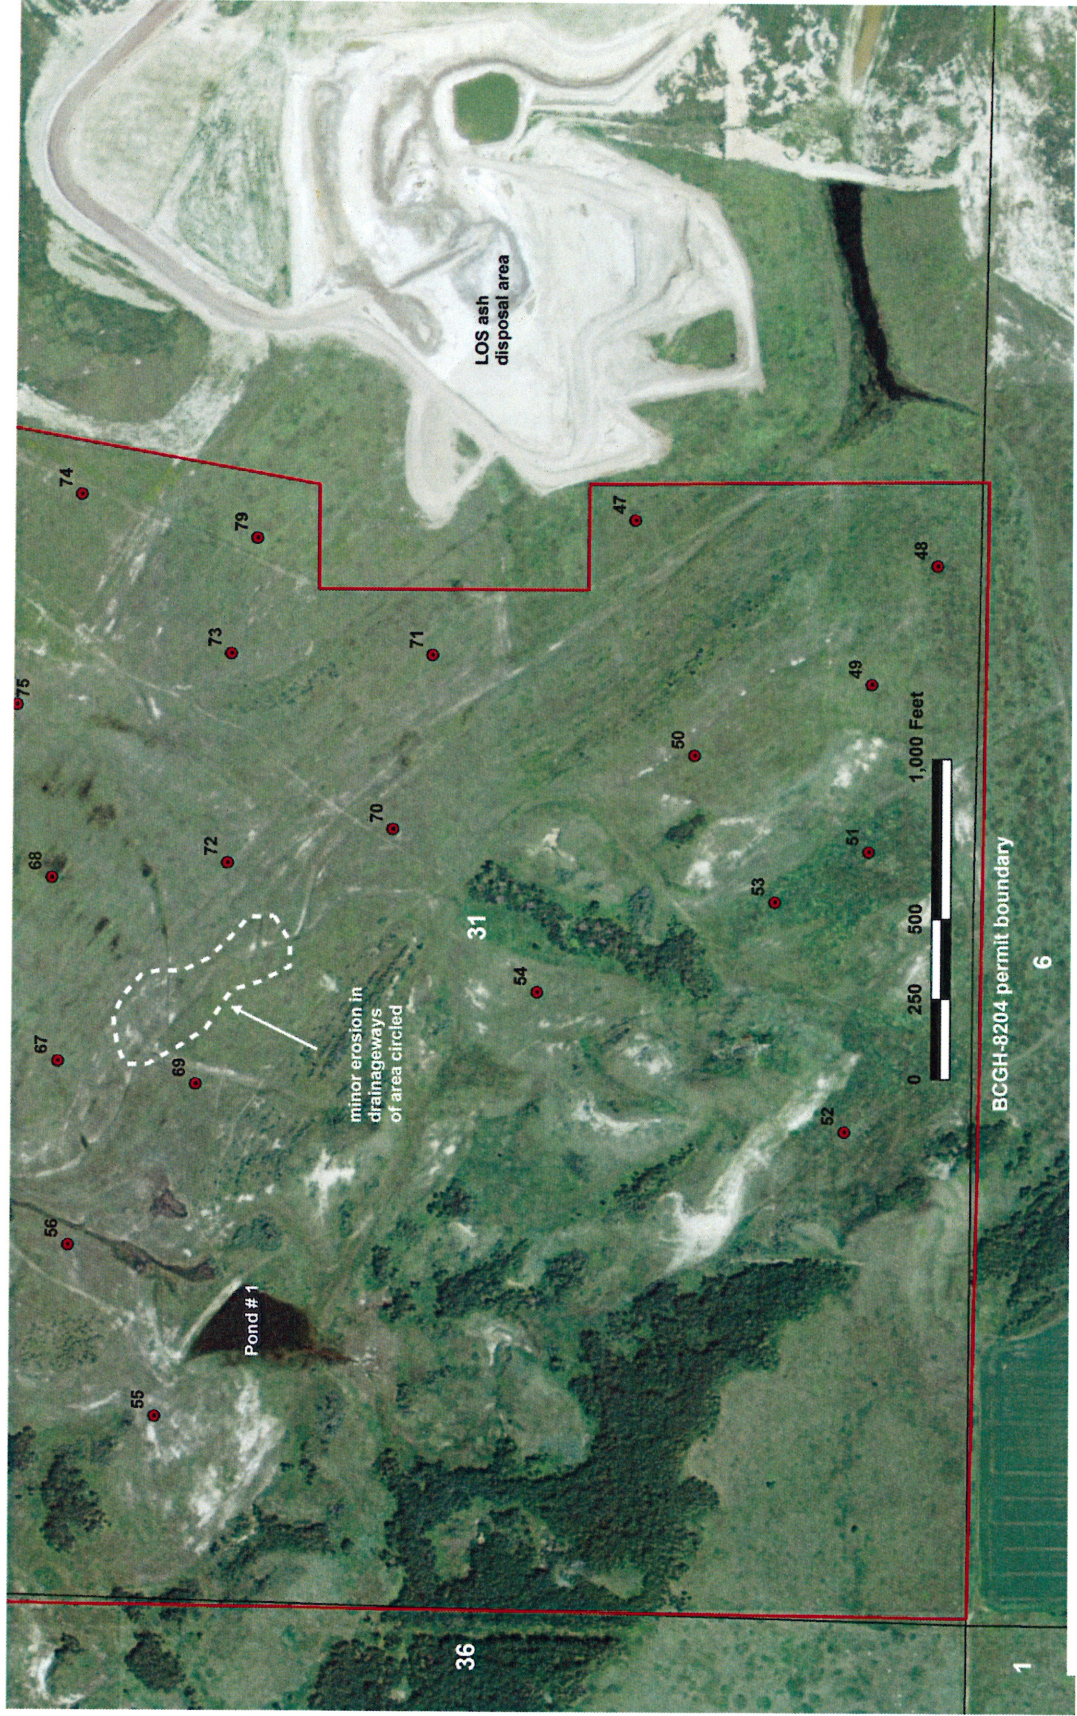
8. Minor erosion in several drainageways near the center of Section 31 (Tract 4C) near soil probe numbers 69 and 72 as outlined on Figure 9;
9. Erosion and piping in the W $\frac{1}{2}$ of the E $\frac{1}{2}$ of Section 31 (Tract 4C) about midway between soil probe numbers 73 and 74 and also nearby and southeast of soil probe number 74 (no photographs); and,

Figure 9. Minor erosion in several drainageways near the center of Section 31 (Tract 4C) near soil probe numbers 69 and 72.

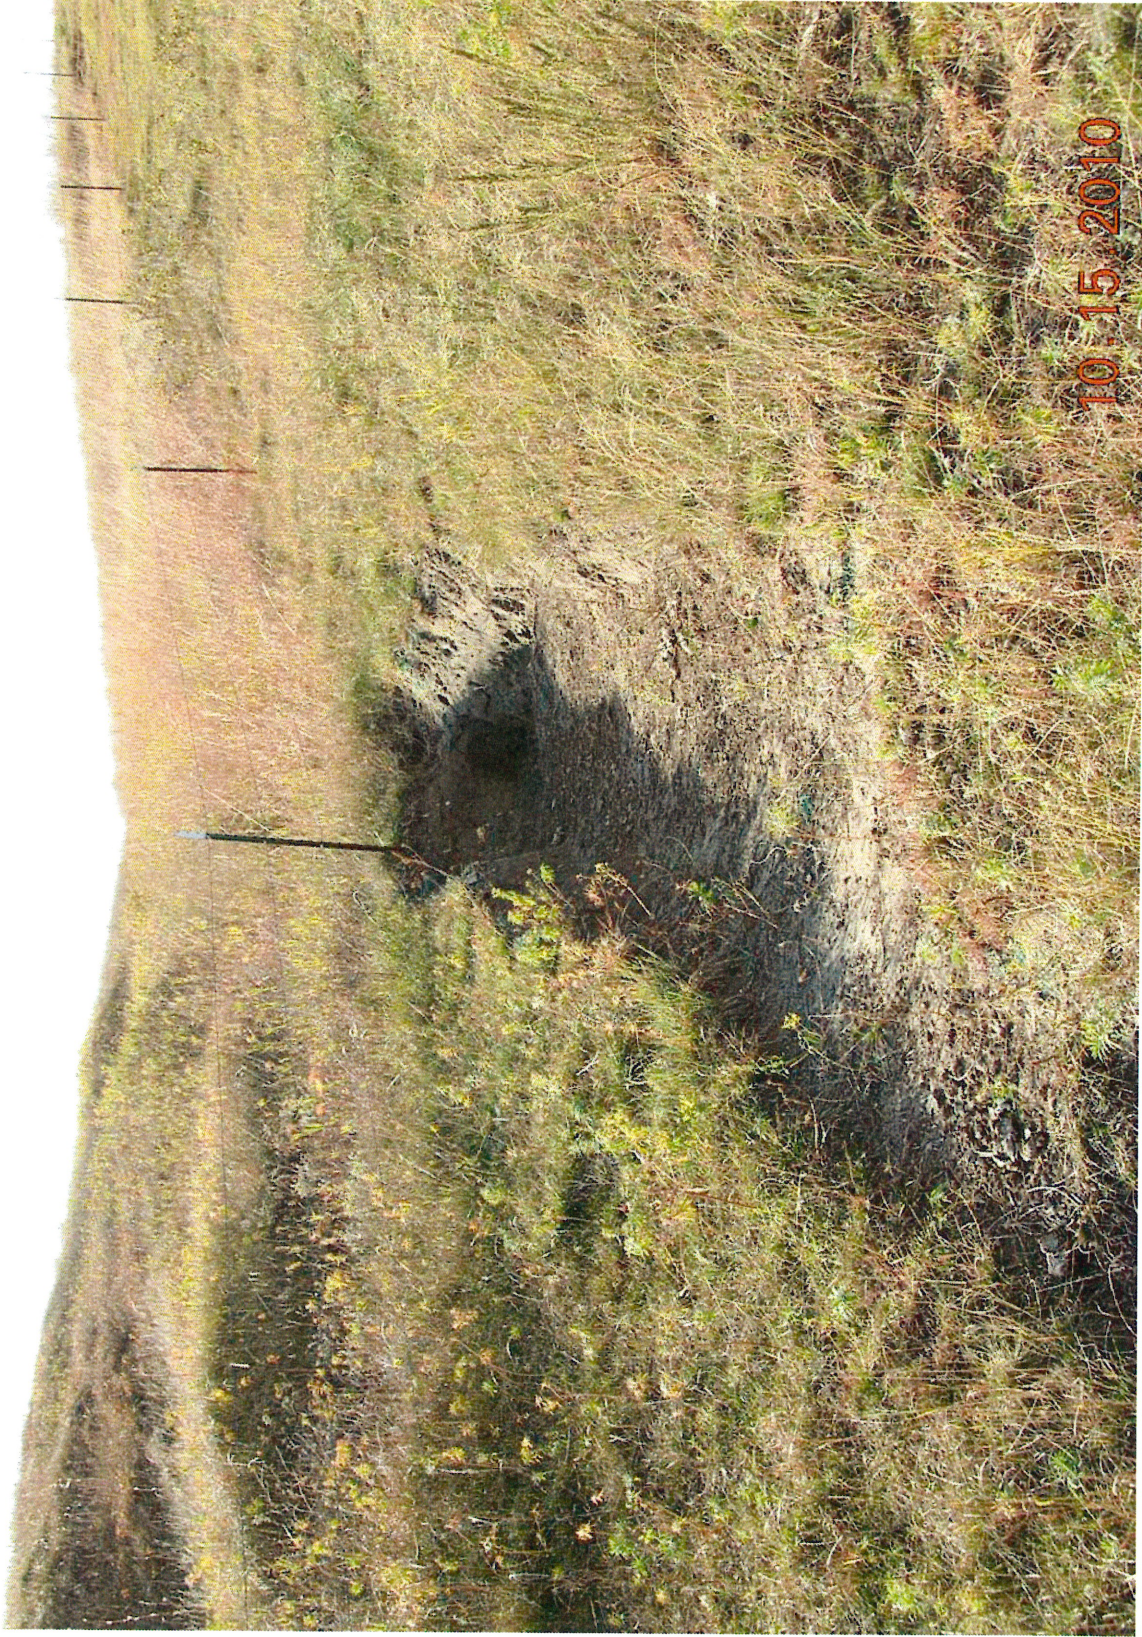
10. Erosion in a drainageway in the SE $\frac{1}{4}$ of the NW $\frac{1}{4}$ of the SW $\frac{1}{4}$ of Section 18 (Tract 1C) at the mine disturbance boundary about 200 feet northeast of soil probe number 88 as pictured in Figure 10.

Figure 10. Erosion in a drainageway in the SE $\frac{1}{4}$ of the NW $\frac{1}{4}$ of Section 18 (Tract 1C) at the mine disturbance boundary about 200 feet northeast of soil probe number 88.
