# **Bison II Wind Project Post-Construction Inspection Report PU-11-57**

## **NORTH DAKOTA PUBLIC SERVICE COMMISSION**

## **WENCK ASSOCIATES, INC.**

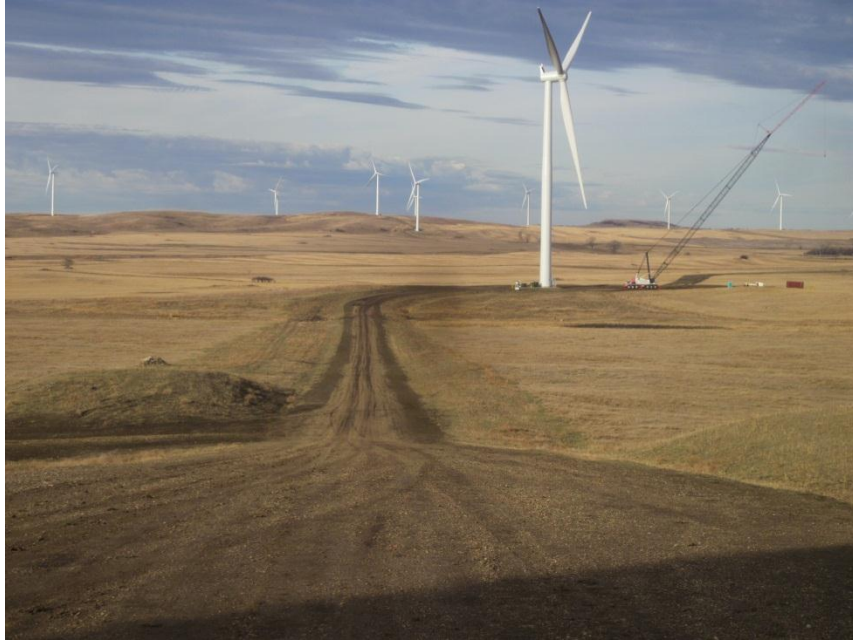
**Photo 1.** Direction: West. View from the access road to Structure 206 (shown, south of crane) and 207 (not shown). Topsoil had been segregated and replaced as evidenced by successful establishment of vegetation. Revegetation along roads was well established, and native species appeared to have been used.

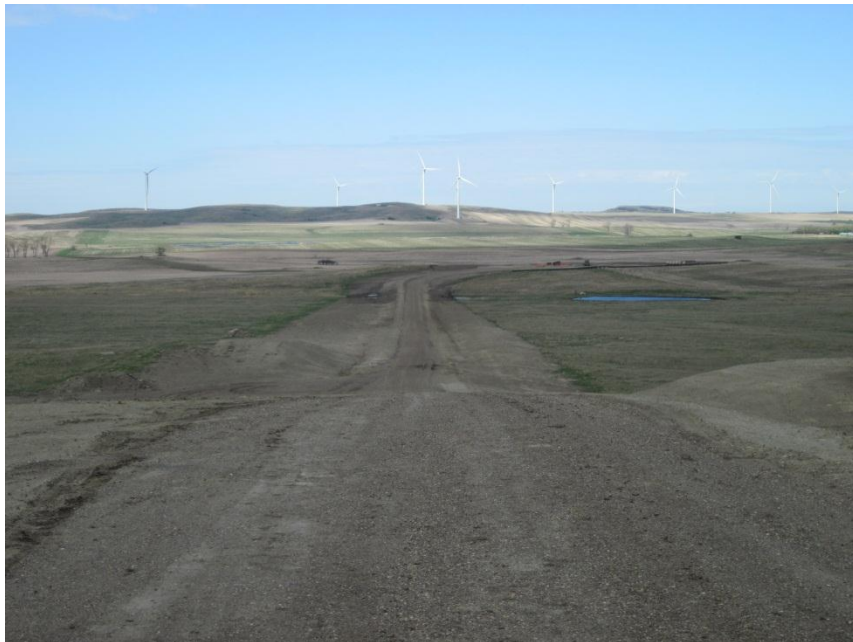
**Photo 2.** Direction: West. Same view as Photo 1, taken during the interim inspection in May 2012. Roads were in excellent condition during both inspections.

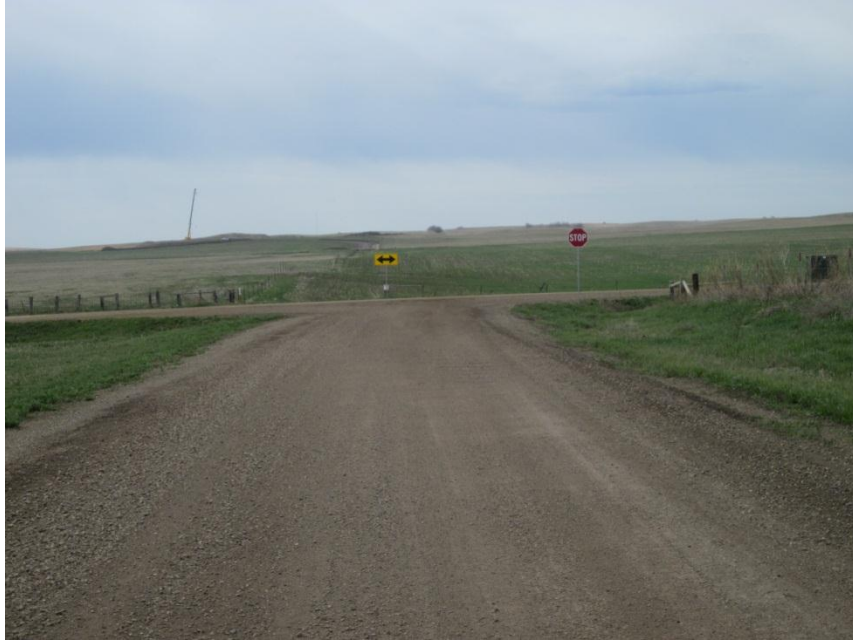
All fences and gates were in place and fully operable. Numerous new gates had been installed for the Project where access roads crossed fencelines (**Appendix A, Photos 3, 5**). Cattle guards were installed at the gates when necessary. Minnesota Power reported there had not been any agricultural fields with drainage tile impacted by construction of the Project. There was no waste, debris, or abandoned equipment observed during the inspection. The site appeared to be regularly maintained and no remnants of the construction phase were noted.

**Photo 3.** Direction: South. Intersection of 51<sup>st</sup> Ave and County Road 140 that had been improved, with appropriate stop signs at section lines.

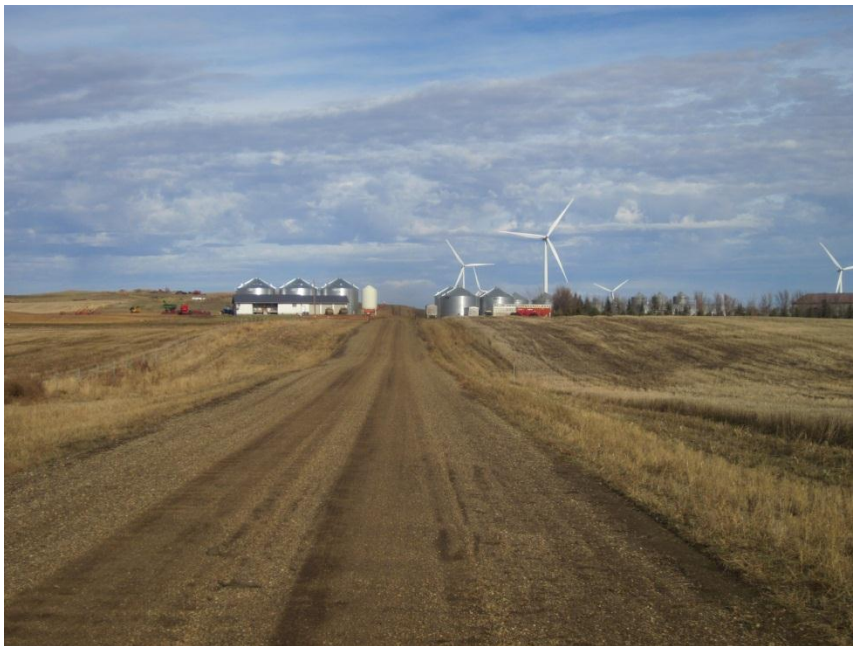
**Photo 4.** Direction: North. View of 52<sup>nd</sup> Ave showing an example of a typical improved section line road. This road accessed Structures 211-214.

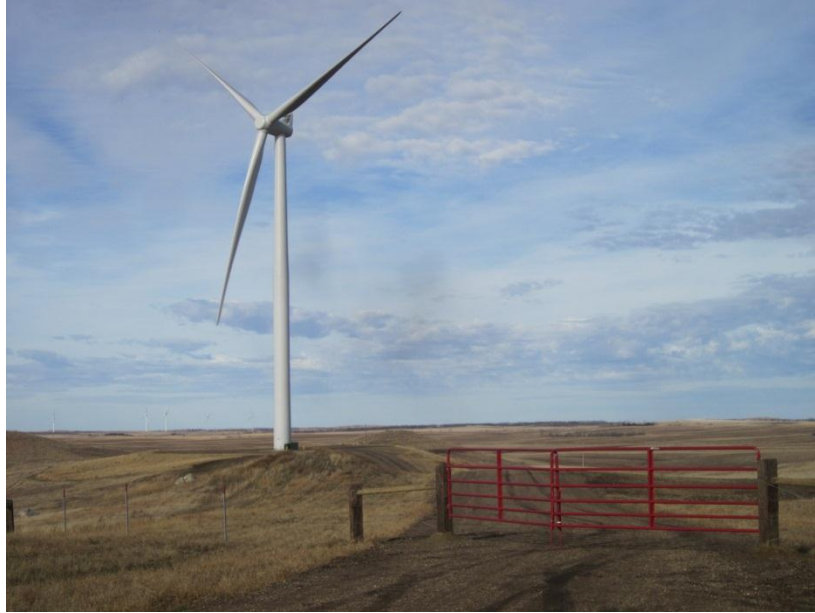
**Photo 5.** Direction: Northwest. View from the access road to Structure 215. Note repaired fence and new access gate.

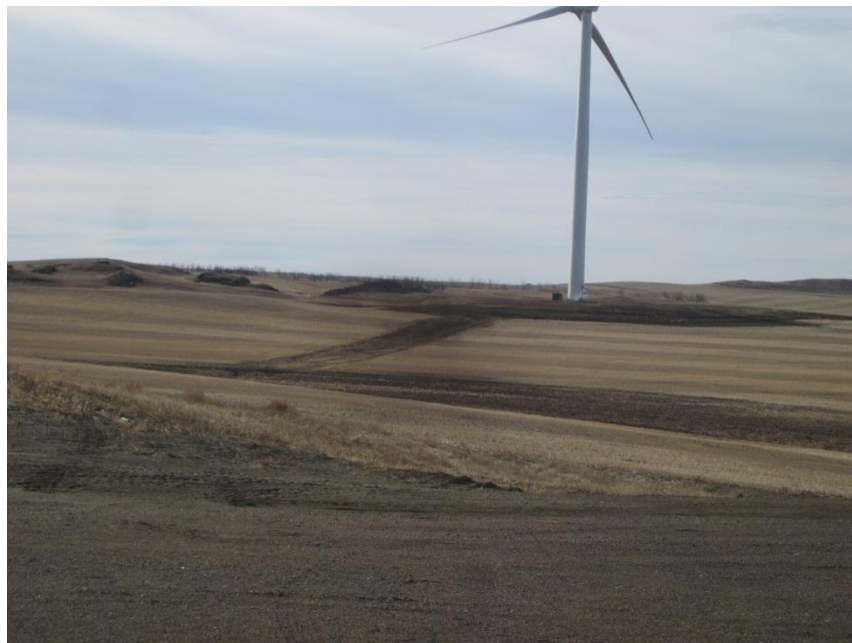
**Photo 6.** Direction: Southwest. From the pad of Structure 209, view shows feeder line scars leading to Structure 210. Reclamation of this area was still ongoing. Other areas where feeder line scars had been reclaimed appeared in good condition, with no impacts to agricultural production.

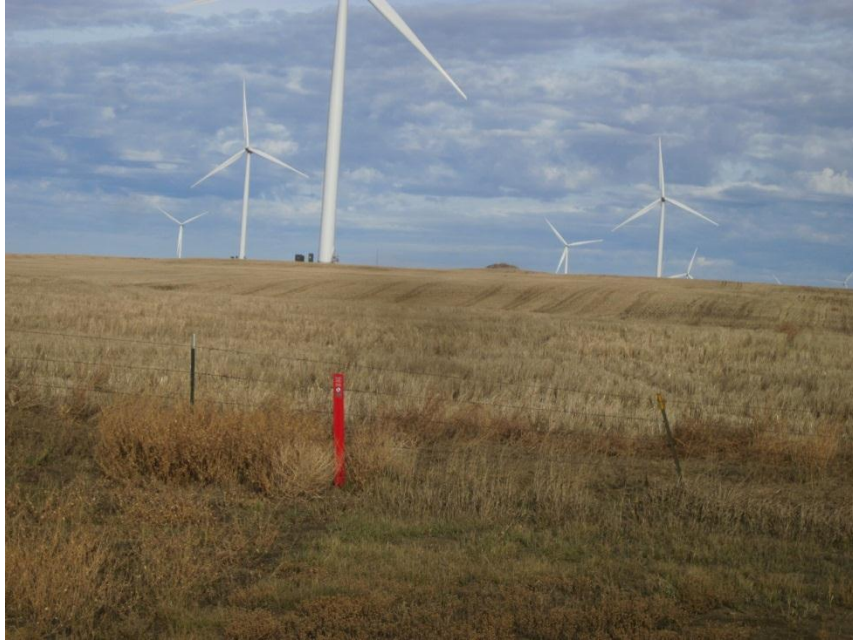
**Photo 7.** Direction: North. Example of marker indicating location of feeder line along County Road 140, Morton County.

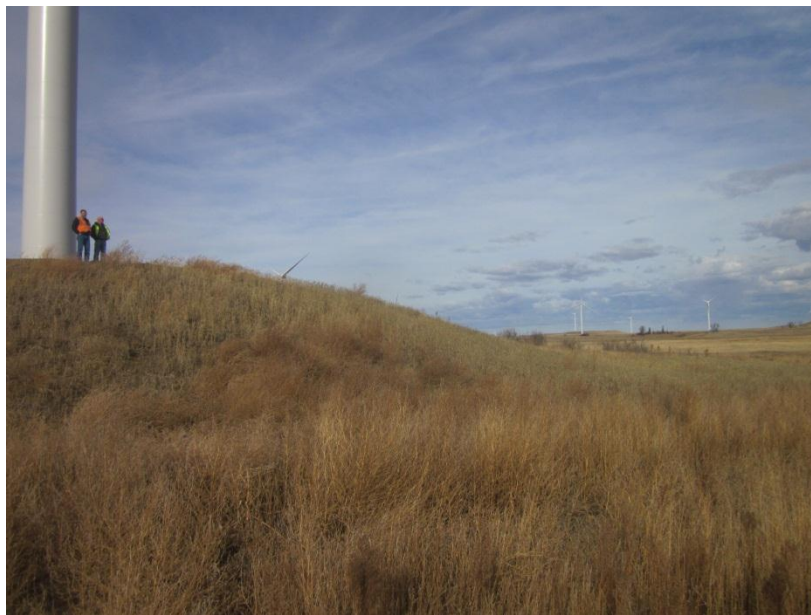
**Photo 8.** Direction: Northwest. View from a wetland area east of Structure 228. No sedimentation or disturbance was observed to the wetland area.

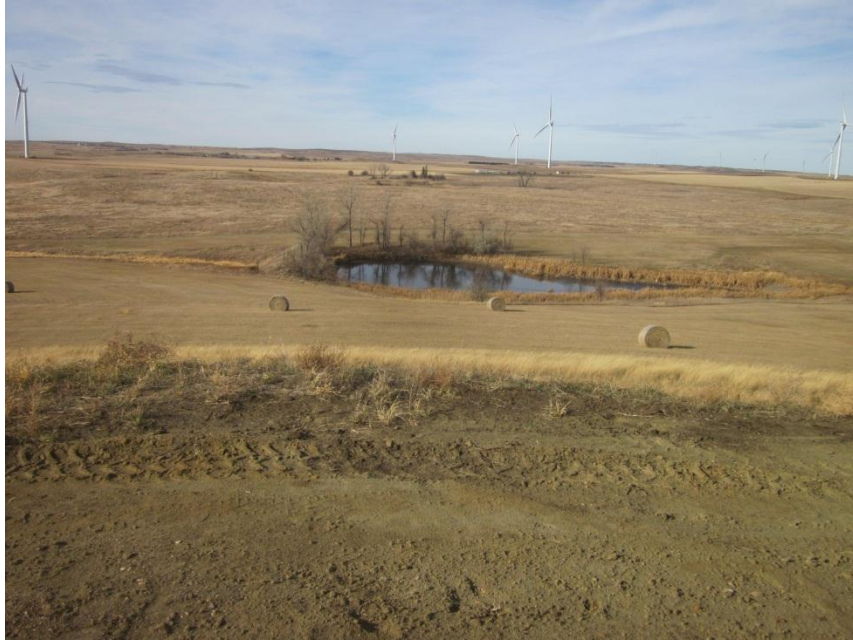
**Photo 9.** Direction: Southwest. View from Structure 226 toward a wetland that was avoided during siting. No sedimentation or disturbance to the wetland was observed.

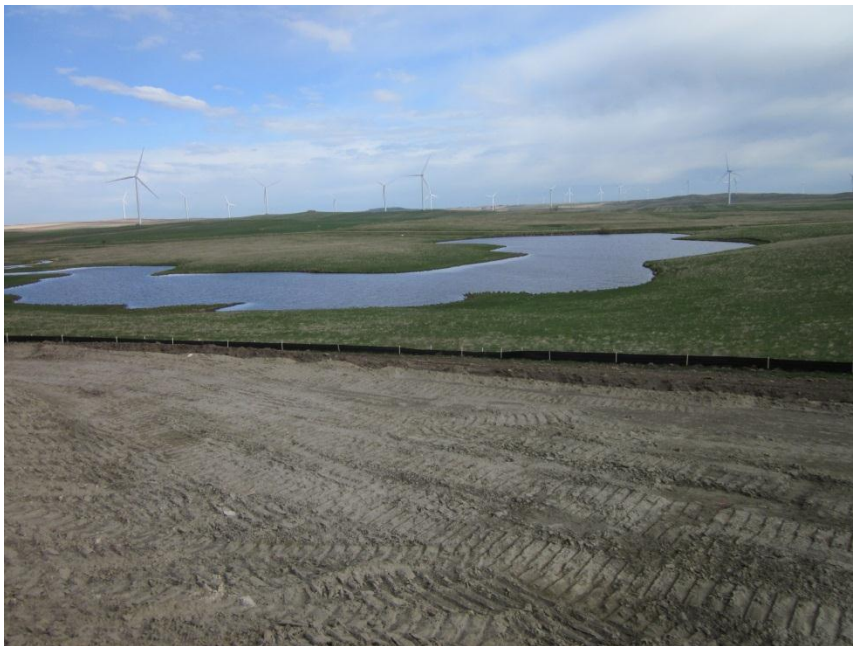
Best Management Practices (BMPs) were used as part of the construction and maintenance of the Project to minimize erosion and control sediment (**Appendix A, Photos 10, 11, 13**). Weekly Construction Reports for the Project (Docket #81, 82) documented repairing/maintaining erosion control structures. Culverts were installed where necessary to allow for the natural flow of drainage (**Appendix A, Photos 13**). No erosion problems were observed around the utility junction boxes; cement bollards and gravel were in place around each (**Appendix A, Photos 12**). In general, erosion problems were not an issue and infrastructure of the Project area was well-maintained.

**Photo 10.** Direction: Northwest. Example silt fence observed during the interim inspection preventing erosion to nearby wetland at Structure 208.

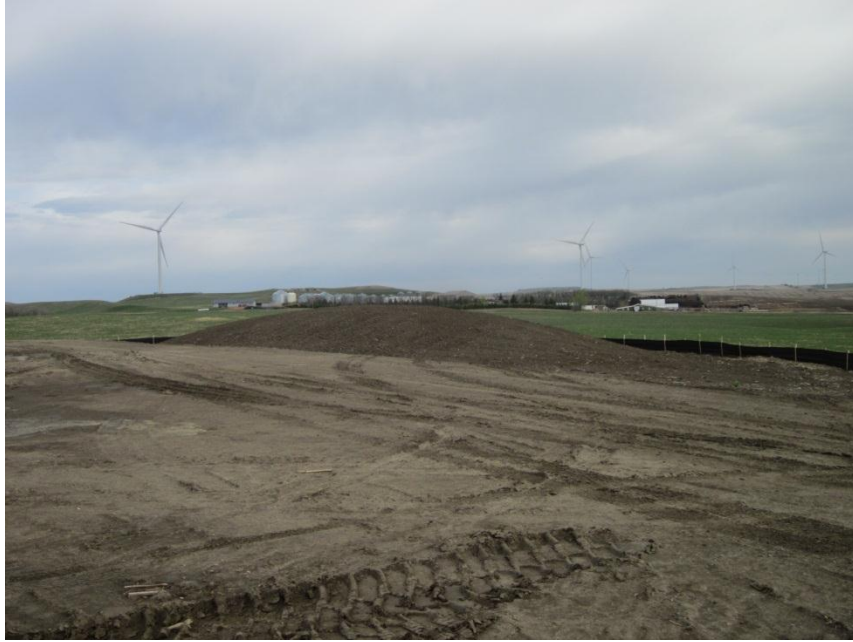
**Photo 11.** Direction: South. Example segregated topsoil pile at Structure 212 observed during the interim inspection. All topsoil was mounded on site, with appropriate erosion controls at all structure locations.

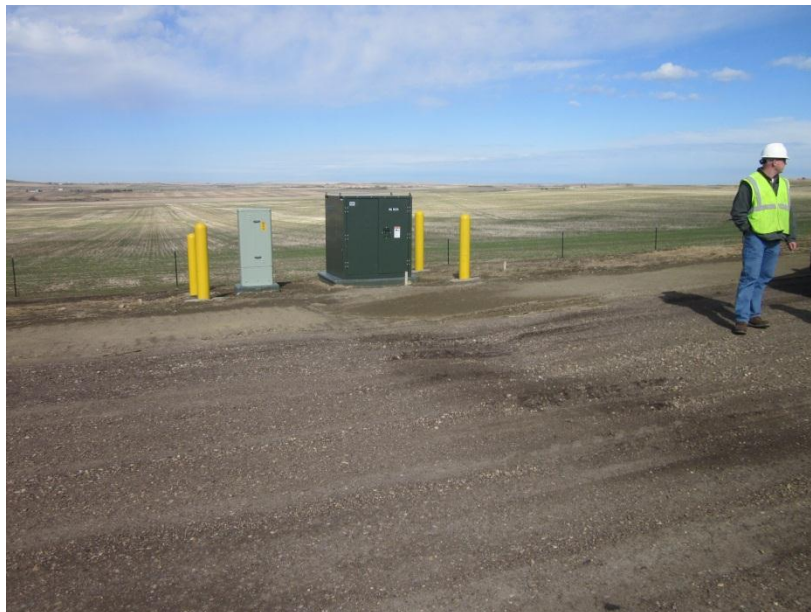
**Photo 12.** Direction: West. Transformer with appropriate safety bollards in place. The access road in this photo had a slight low area during the interim inspection, which had been repaired by the time of the final inspection.

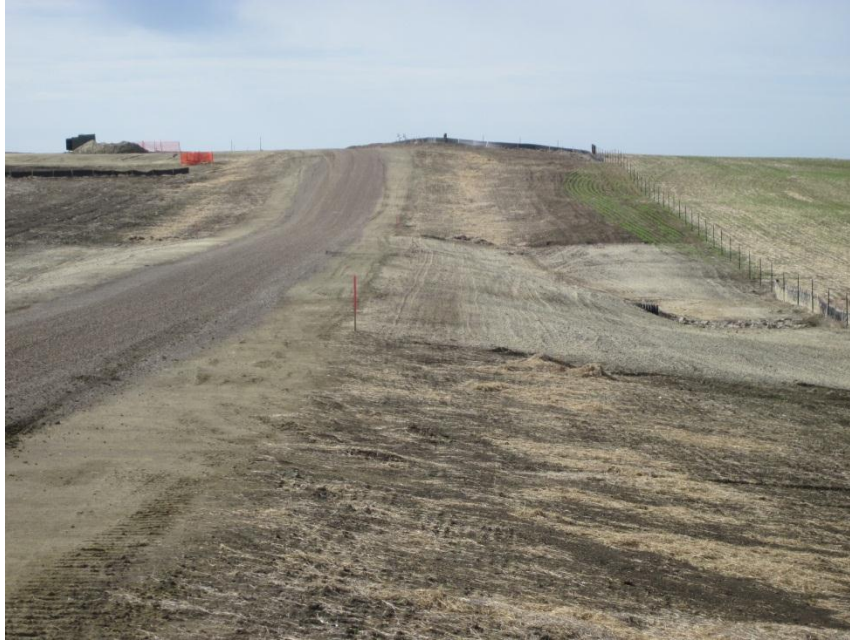
**Photo 13.** Direction: South. Access road to Structures 224 and 225. Note mesh netting and rocks at base of culvert for erosion control.

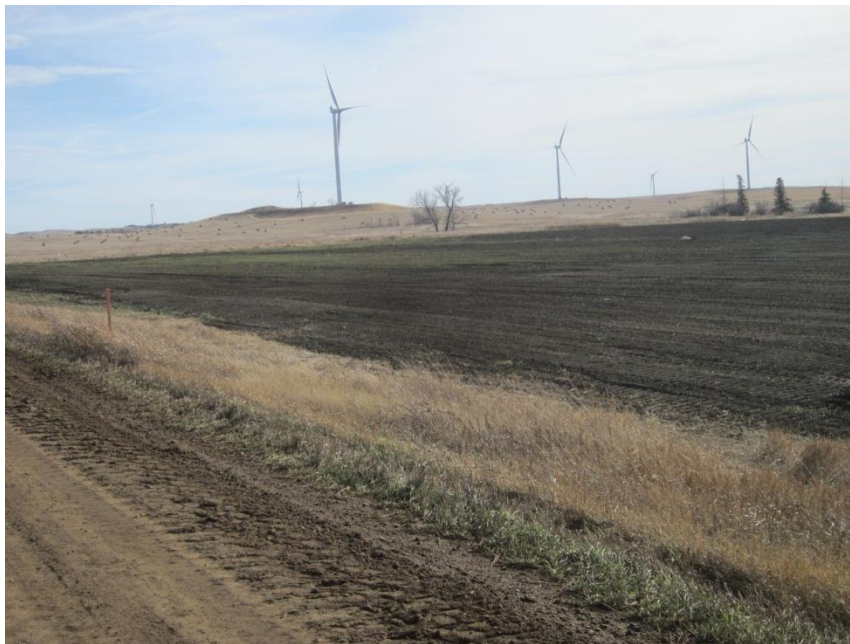
During the post-construction inspection, reclamation efforts were still in progress in several areas (**Appendix A, Photo 14**). Much of laydown yard had recently been reseeded and was establishing, but part of the yard was still being used for final demobilization. Additionally, a temporary crane path through an agricultural field had yet to be reclaimed. No erosion was noted in either of these areas. Since the Project was recently completed, this issue does not indicate non-compliance and revegetation will be expected to take several years to establish. Wenck recommends that the PSC request confirmation from Minnesota Power as reclamation continues.

**Photo 14.** Direction: Southeast. Reclaimed portion of the laydown yard used for the Project. Vegetation was beginning to establish throughout the area. Part of the laydown yard was still being used and would be reclaimed after demobilization.
