Carlson McCain, Inc. (CMI) conducted a construction inspection at the New Frontier Wind Energy Project – McHenry County (Case No. PU-11-69) on October 12, 2018, on behalf of the North Dakota Public Service Commission (PSC). The project consists of installing 29 wind turbines, along with their supporting access roads, and transmission lines.

147 PU-11-69 Filed 10/31/2018 Pages: 9  
Construction Inspection Report  
Carlson McCain, Inc.  
Todd Hartleben, Principal Engineer

**Photo Locations**  
**Construction Inspection**  
**Meadowlark Wind I LLC**  
**ND Public Service Commission**

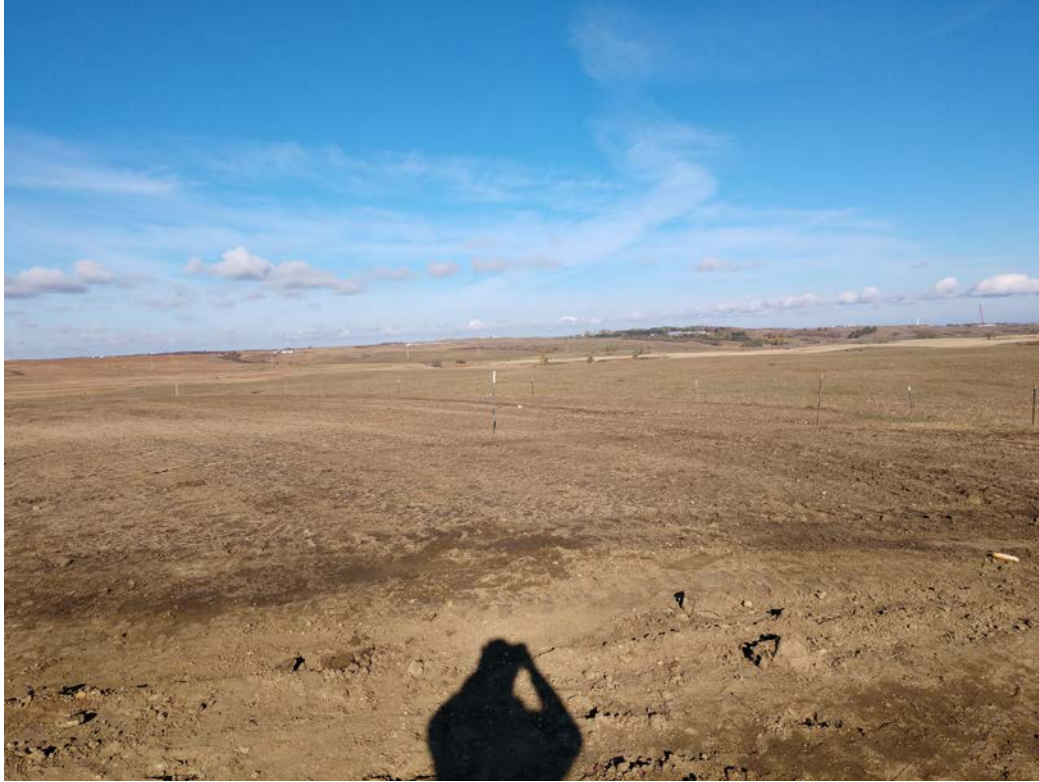
Capital Power reported (June 19, 2018) that approximately 0.53 acres of potential Dakota skipper habitat was disturbed during construction of Turbine 23. Capital Power has coordinated with the United States Fish and Wildlife Service (USFWS) to mitigate the disturbance. Mitigation includes re-seeding the area with native vegetation and constructing a new stock pond for the landowner to help with rotational grazing.

Photo 1. Photo of potential Dakota skipper habitat by Turbine 23 that was disturbed and since re-seeded and fenced off to prevent access. Photo taken facing north

USFWS NOTIFIED OF D. SKIPPER HABITAT DISTURBANCE. AREA HAS BEEN  
RE-GRADED, SEEDED W/ NATIVE MIX (SUSFWS) AND FENCED TO  
PREVENT ACCESS & CATTLE ENTRY. NEW STOCK DAM  
CONSTRUCTED TO AID FARMER W/ ROTATIONAL GRAZING.

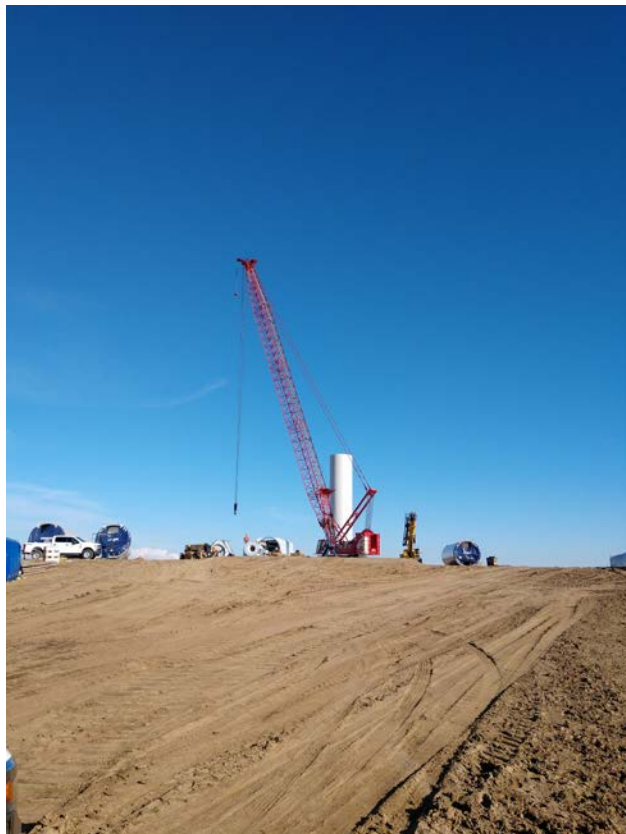
Photo 2. Photo of Turbine 13 pad taken facing east.

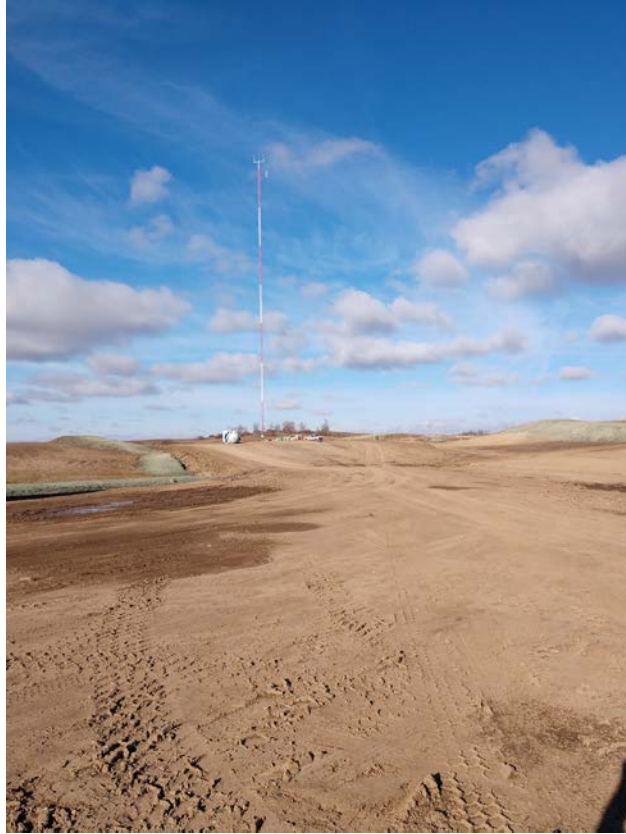
Photo 3. Photo of MET tower at Turbine 11 location taken facing west.

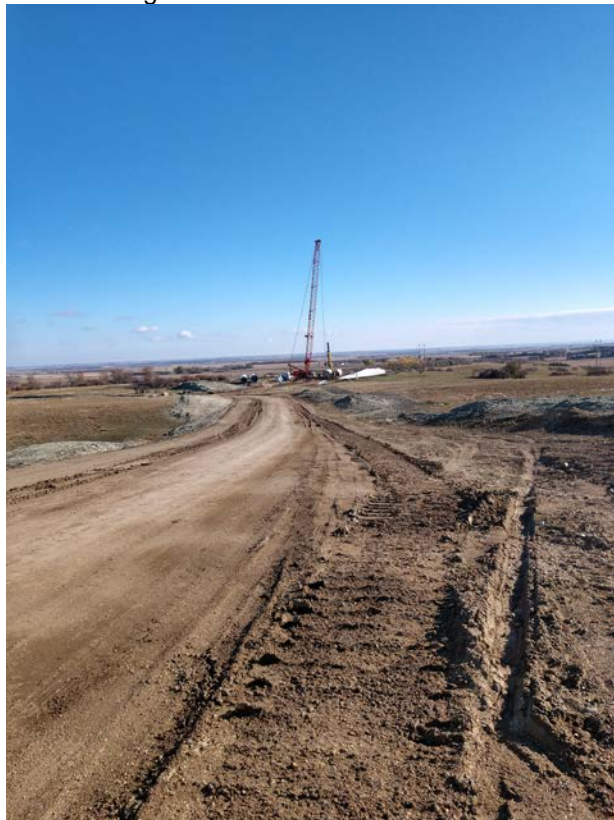
Photo 4. Photo of construction at Turbine 6 location facing northeast.

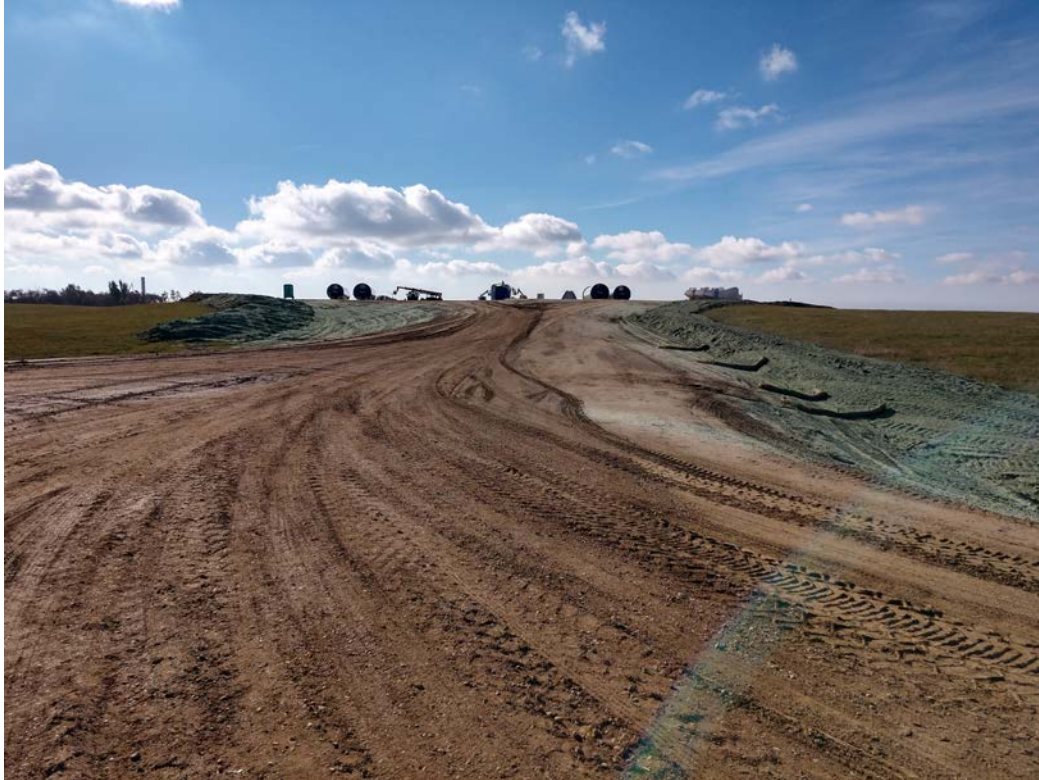
Photo 5. Photo of Turbine 54 access road. Hydromulch has been applied to topsoil to stabilize soil prior to freezing weather. Photo taken facing south.

HYDROMULCH BEING APPLIED TO TOPSOIL TO STABILIZE FOR WINTER  
EARTHWORK TO GRADE ROADS & PADS TO CONTINUE UNTIL FREEZE

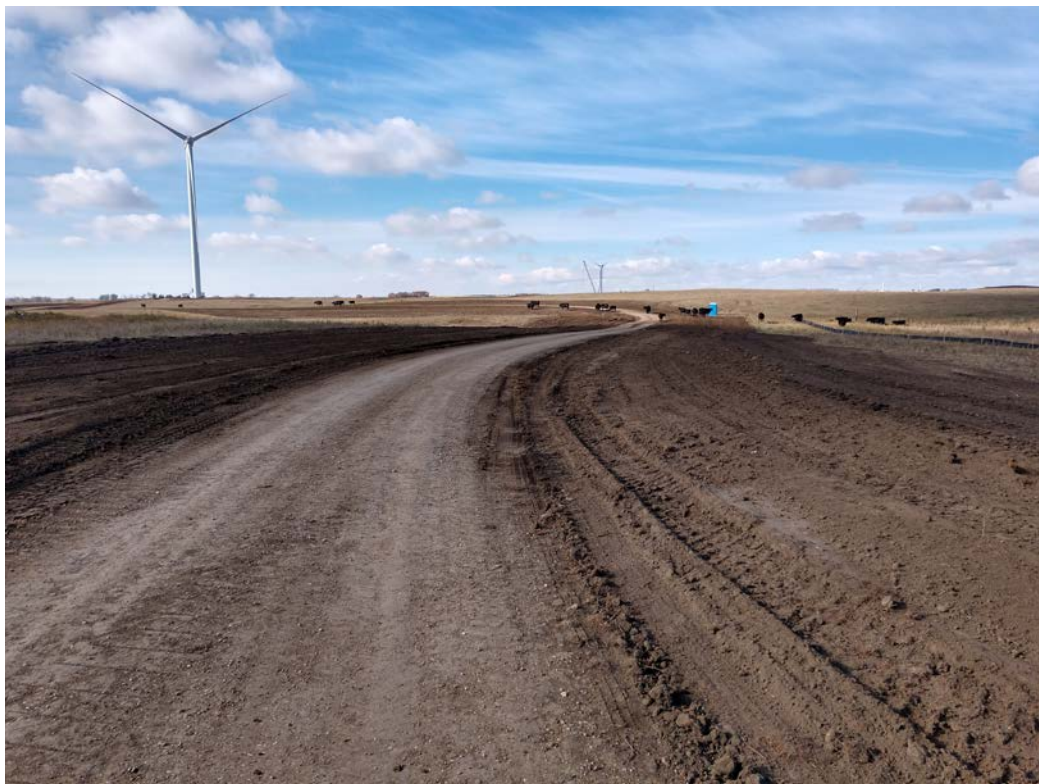
Photo 6. Taken facing southwest along access road to Turbine 42. Road side slopes have been graded to final contours.

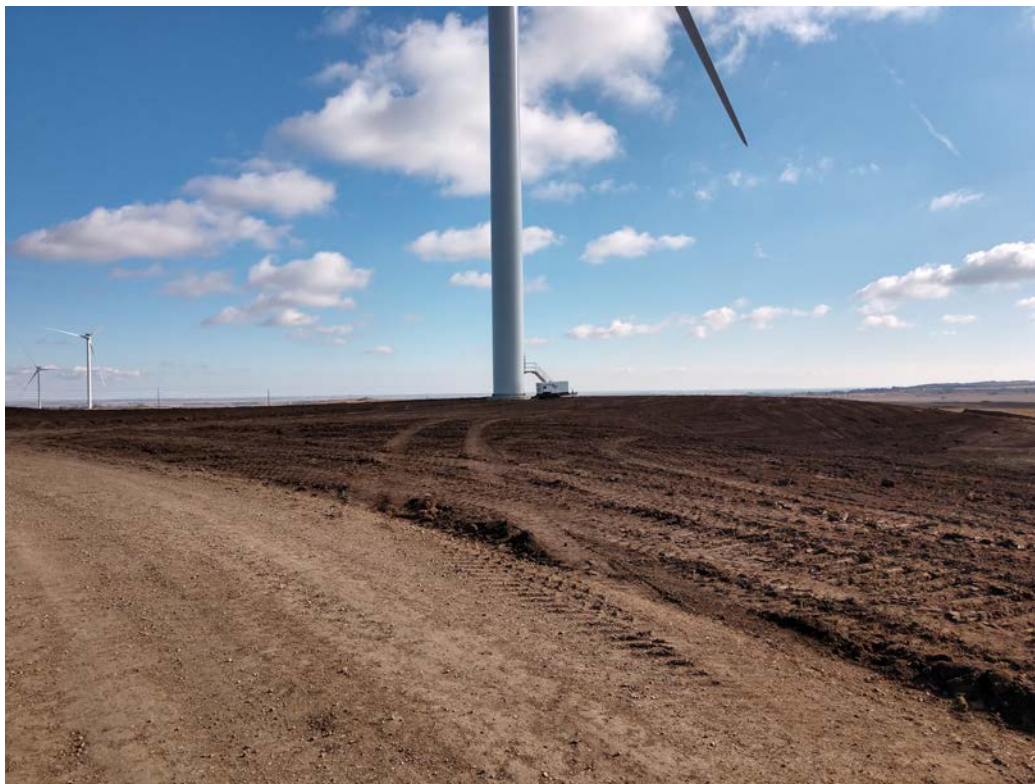
Photo 7. Taken facing east of earthwork around Turbine 42.

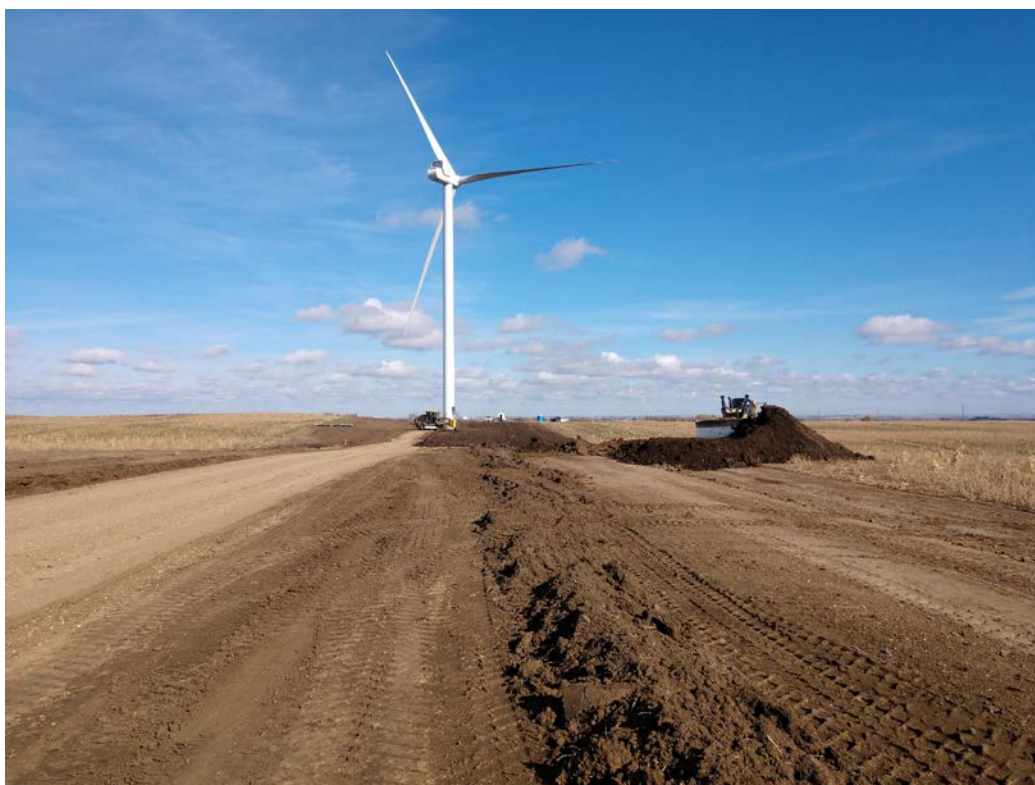
Photo 8. Photo taken facing north along access road to Turbine 64. Earthwork has commenced to redistribute topsoil along access road.

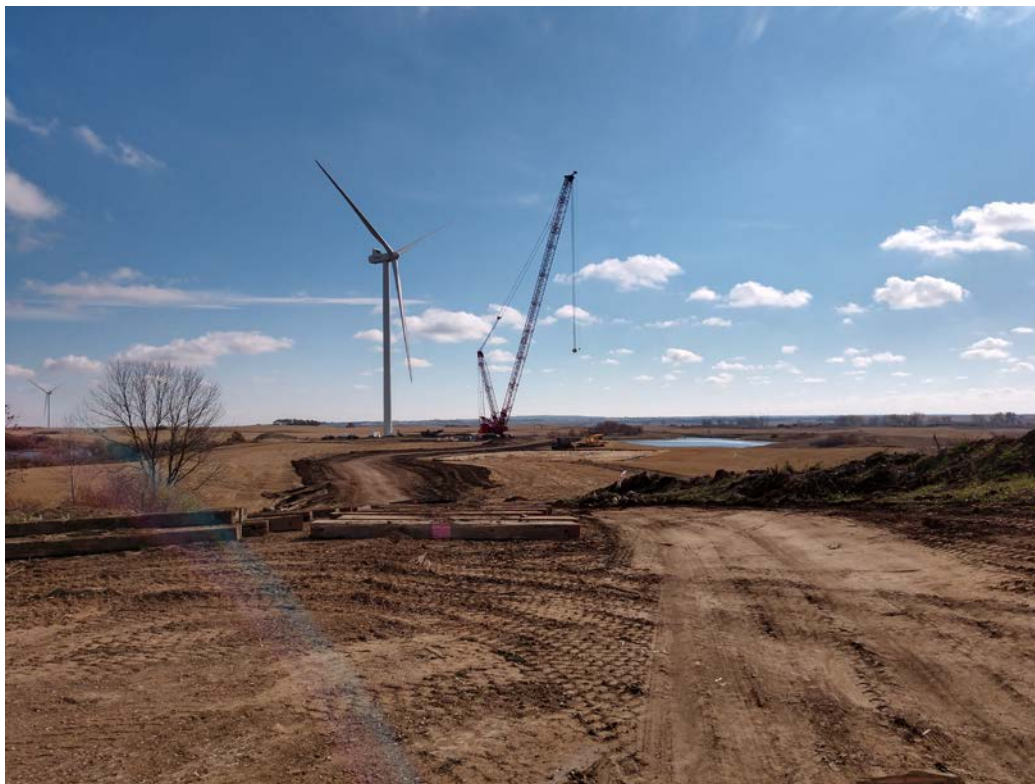
Photo 9. Photo of crane at Turbine 58 location. Photo taken facing east.

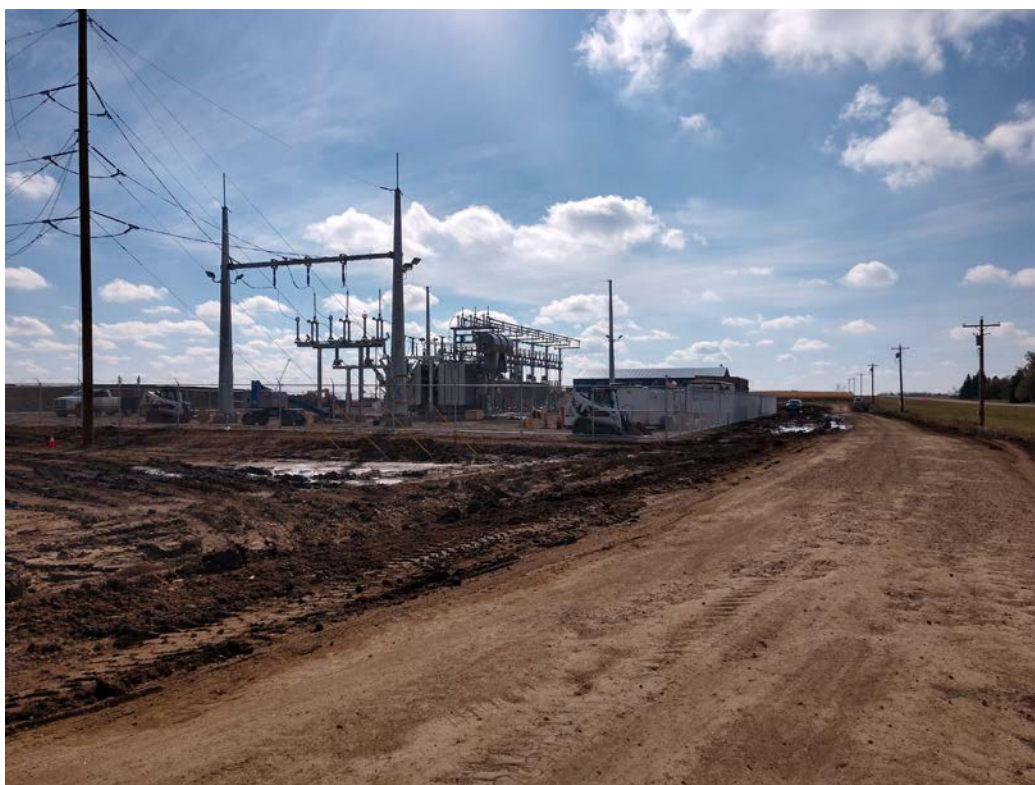
Photo 10. Photo of substation construction facing southeast.

SUBSTATION - 92% COMPLETE
