**RE: Reclamation Inspection
New Frontier Wind Energy Project PU-11-069**

212 PU-11-69 Filed 11/01/2021 Pages: 7
Reclamation Inspection Report
Carlson McCain, Inc.
Chad Tucker, Wildlife Biologist

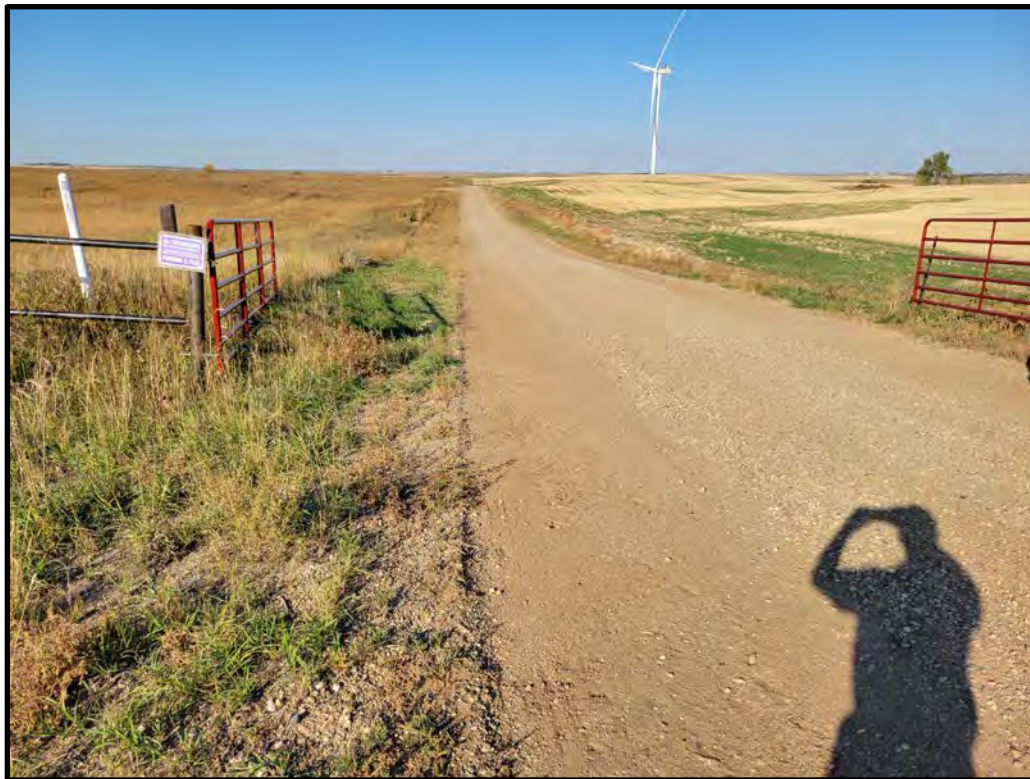
Photograph 1. View looking west along the access road to Turbine 31. Grass along the south side of the road was established.

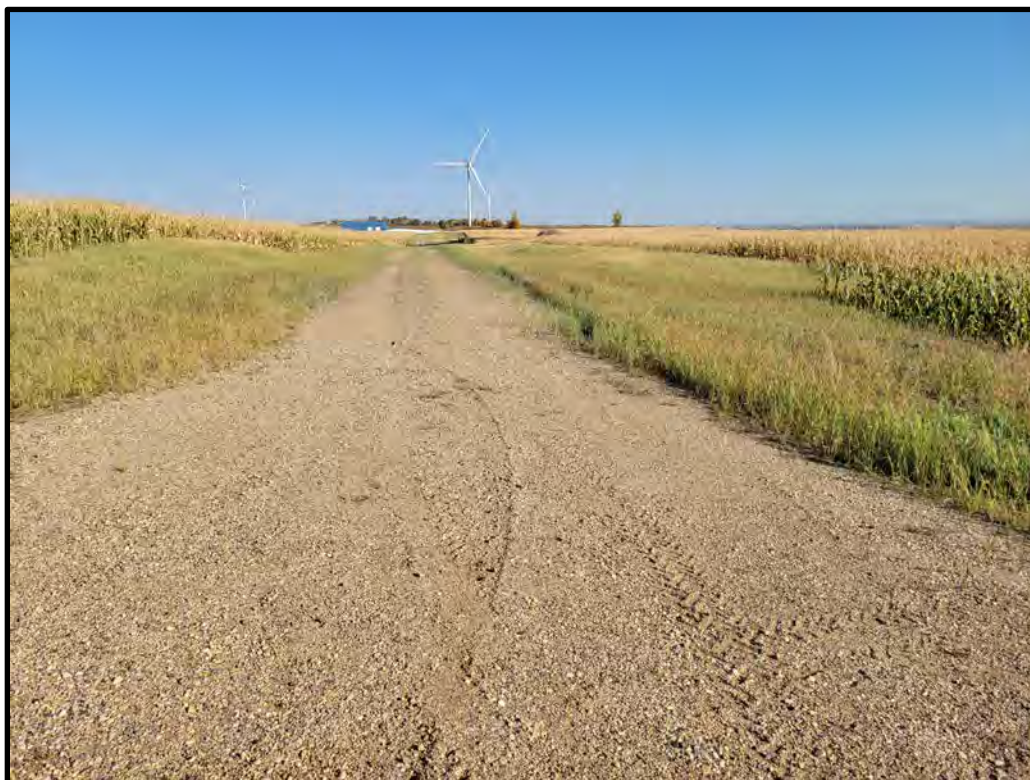
Photograph 2. View looking north up the access road to Turbine 33. The sides of the road were planted in grass, but will be cultivated by the farmer next spring.

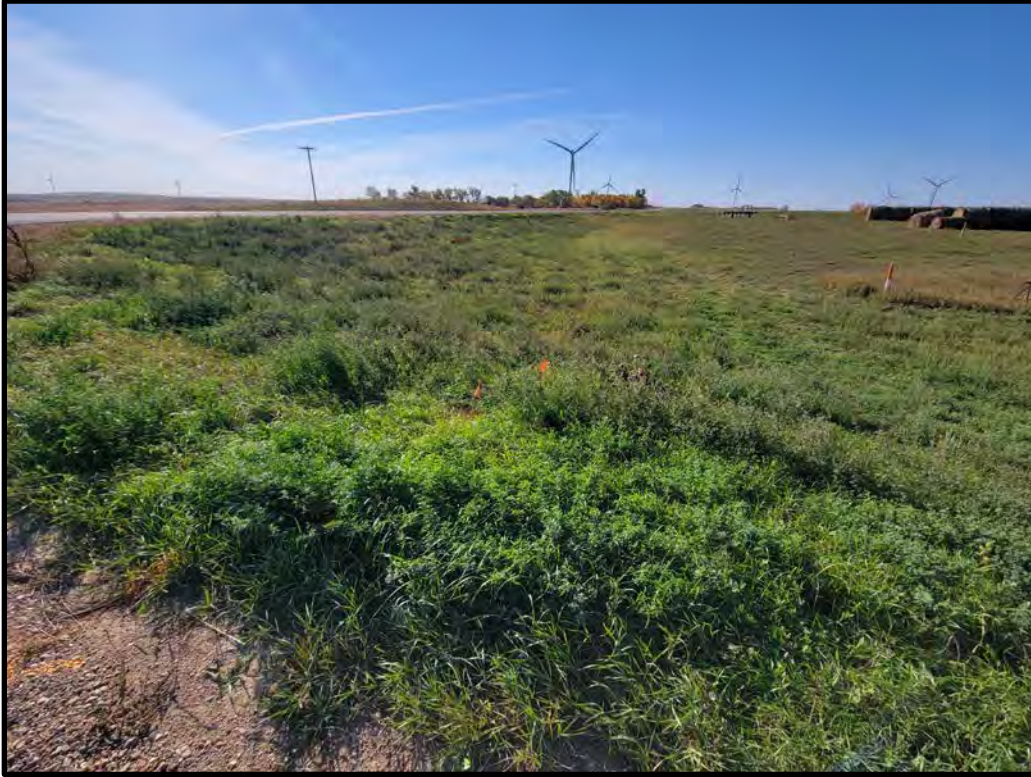
Photograph 3. View of successful grass planting on the southwest side of the junction of Hwy 41 and 32nd St. N.

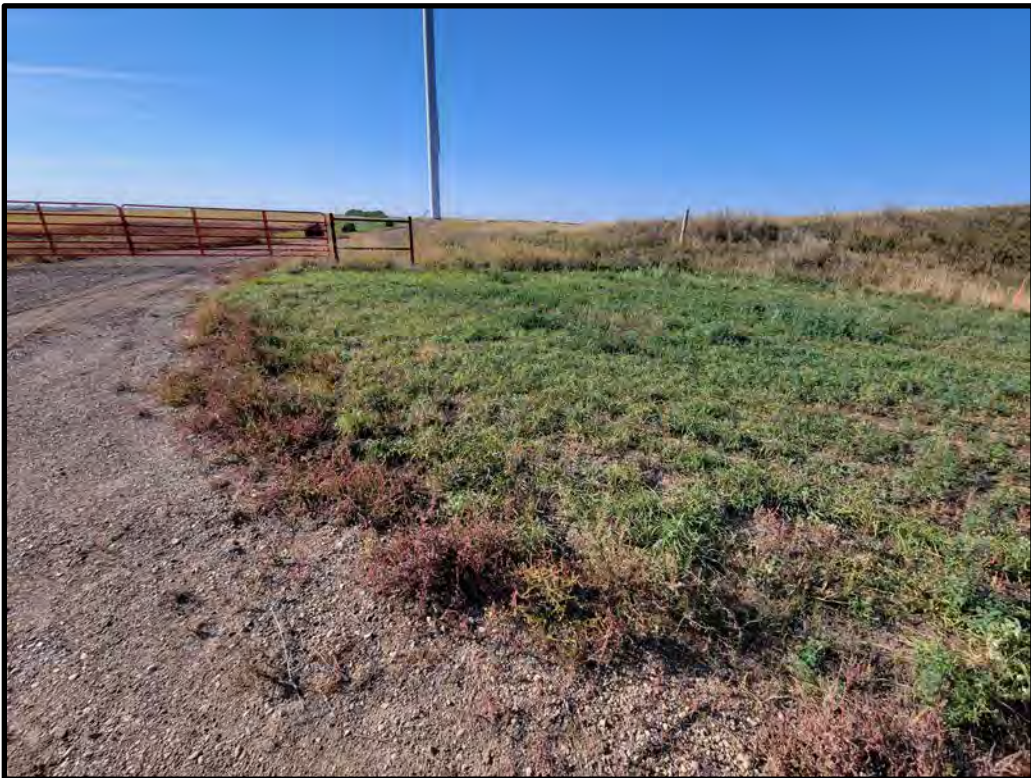
Photograph 4. View looking south down access road to Turbine 54. Due to drought conditions, this area was reseeded three times and appears successful.

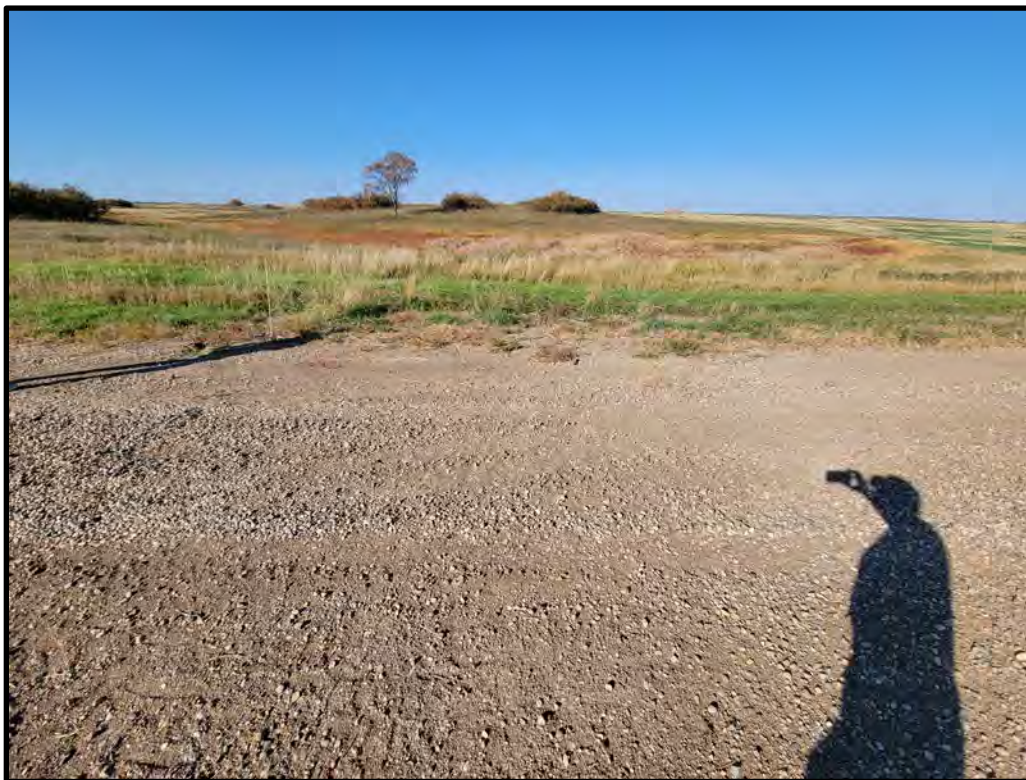
Photograph 5. View looking west from the access road intersection to Turbine 14. Surface water flow has caused rock to wash into the road shoulder. Crews are aware of this and working towards remediation.

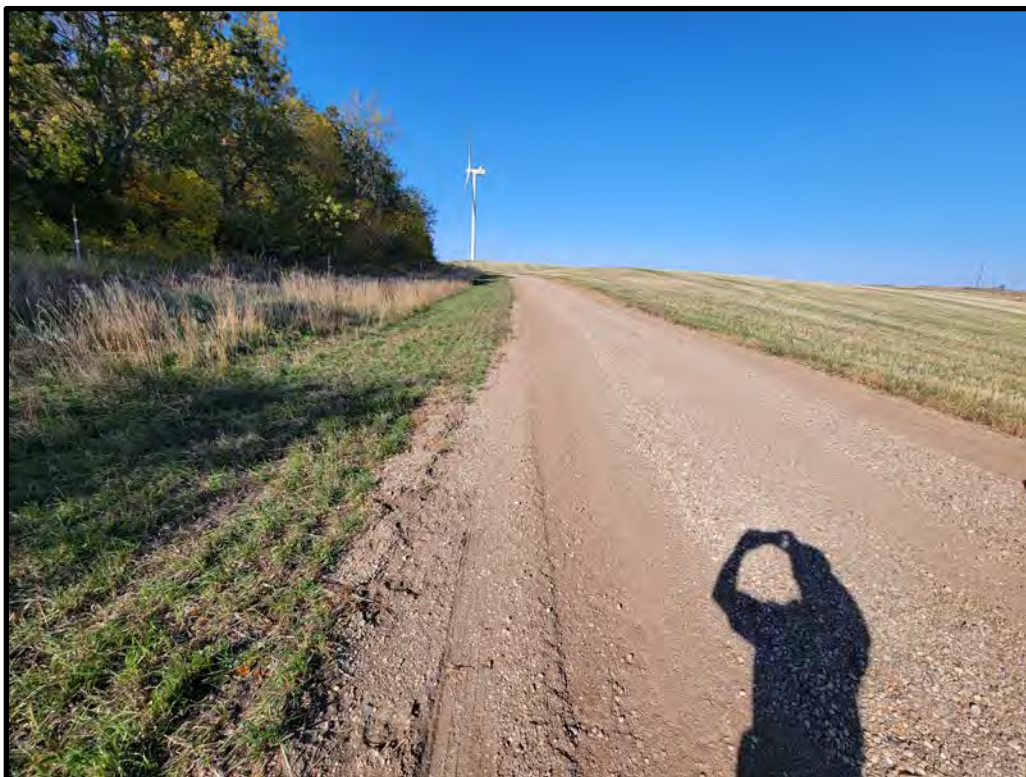
Photograph 6. View looking west down the access road to Turbine 8. The left side of the road was successfully planted in grass.

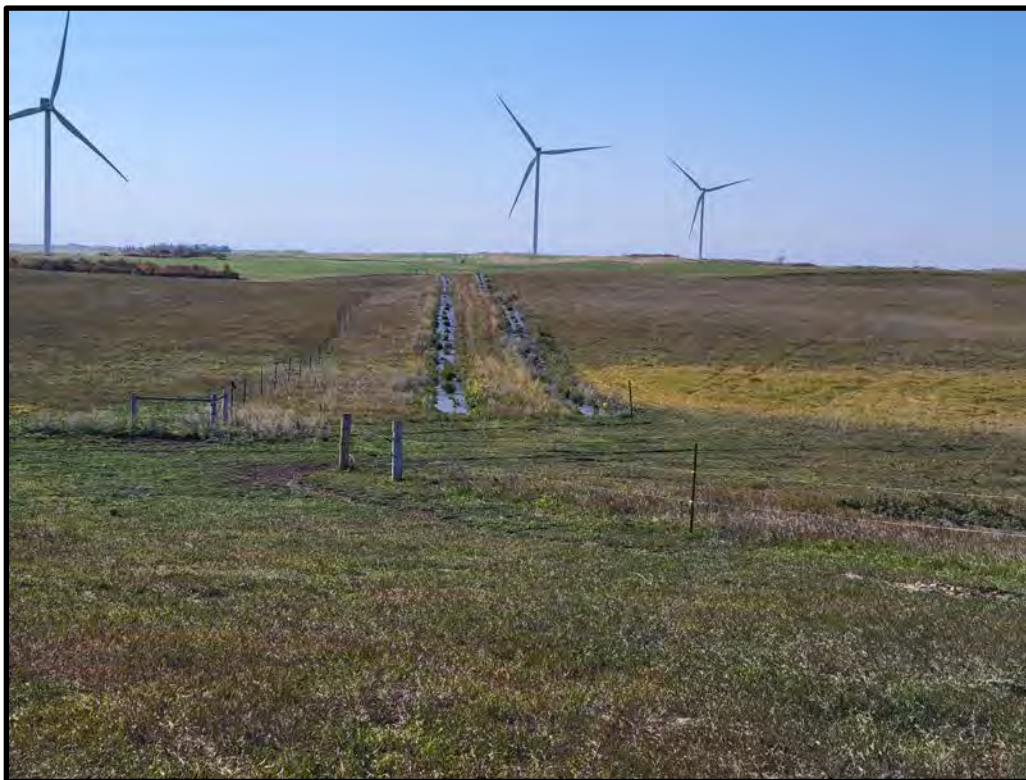
Photograph 7. View looking south down the planted tree and shrub rows on Curtis Nelson's property in Section 18, T151N, R80W.

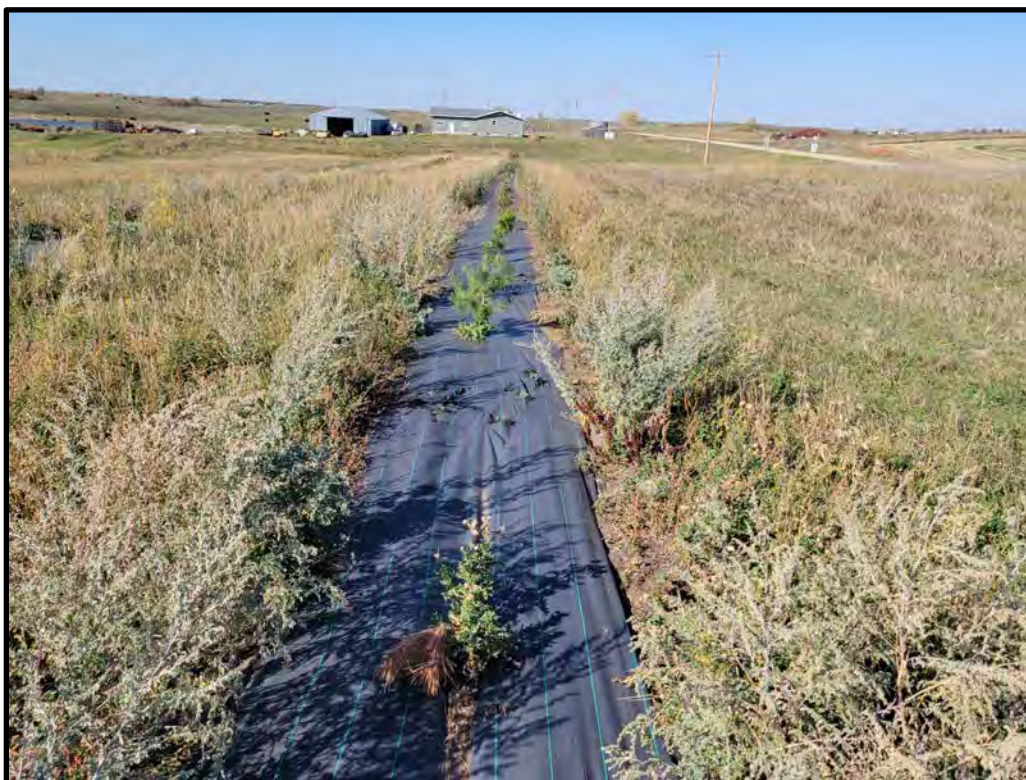
Photograph 8. View looking west at the planted tree and shrub rows on Fred Baluski's property in Section 30, T151N, R80W.

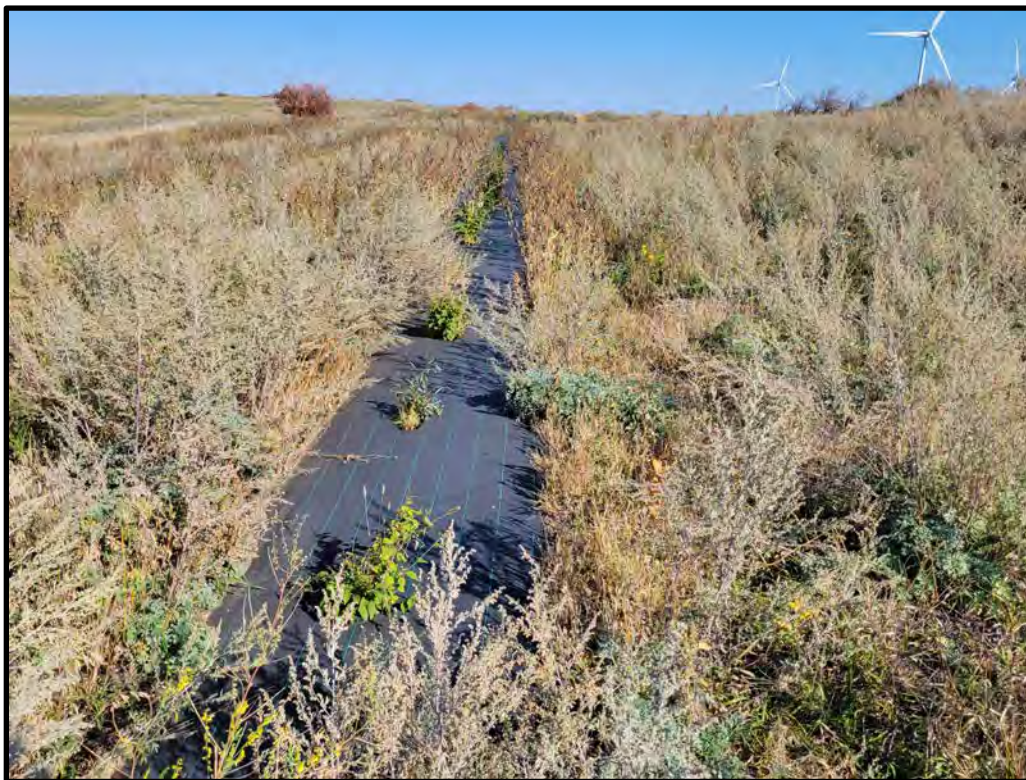
Photograph 9. View looking north at David and Wade Baluski's planted tree and shrub rows in Section 19, T151N, R80W.
