4 Bears to CDP Connect Pipeline Post-Construction Inspection Report PU-11-099

NORTH DAKOTA PUBLIC SERVICE COMMISSION

WENCK ASSOCIATES, INC.

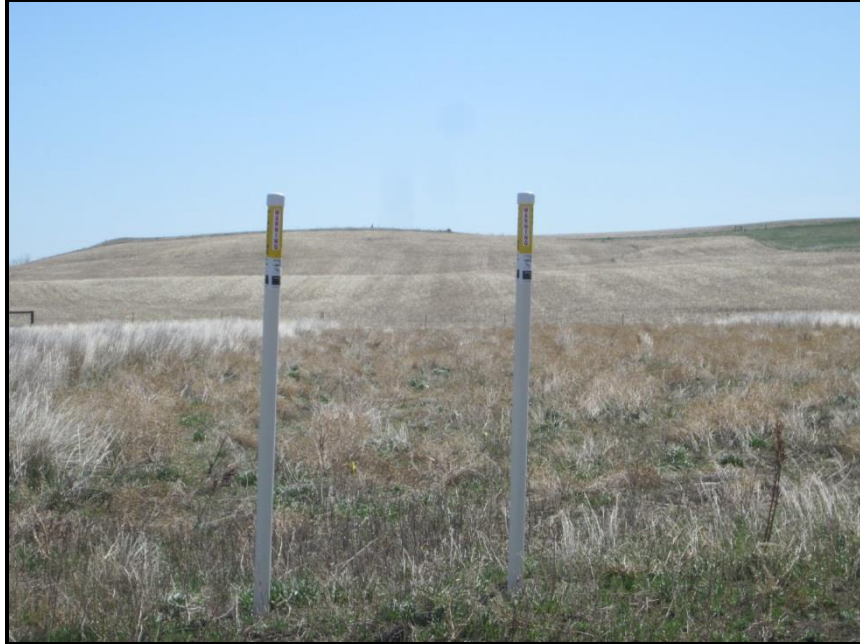
During the post-construction site inspection, Wenck observed pipeline markers and disturbance in an agricultural field to the south of the CDP facility that would indicate the pipeline followed the “south, then west” route (**Appendix A, Photo 1**), coinciding with the Application Maps. However, those markers could have also been associated with another pipeline continuing east from the CDP facility, evident on current aerial imagery (**Figure 1**). Based on this information, there is a concern that either 1) the pipeline was built in the approved project corridor, but as-built drawings are incorrect and do not reflect the actual built facility or 2) the pipeline was built as shown on the as-builts, but that route had not been an officially approved corridor.

Photo 1. Direction: East. Pipeline markers on the east end of the pipeline which appeared to indicate an east-west routed portion of the pipeline, parallel to the south edge of the CDP facility. This route did not correspond to the submitted as-built drawings for the Project, which denoted that the pipeline was routed north-south in this area, but it could have also been the route of another pipeline. The field appeared to have been disturbed in the recent past (note difference in coloration), but was reclaimed properly and revegetation growth was good.

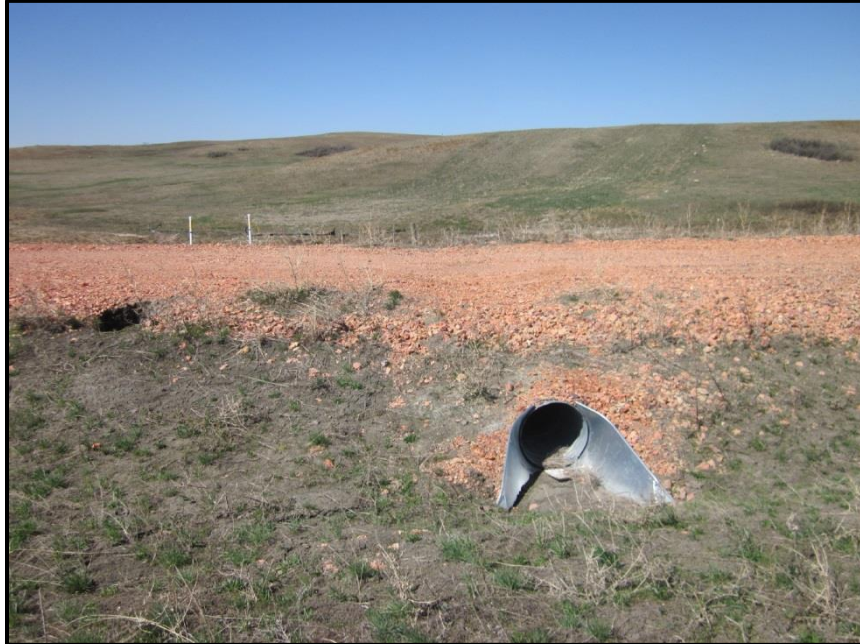
Photo 2. Direction: West. Access road (north-south alignment) crossed by the pipeline route. The as-built indicated the pipeline was bored underneath what was previously a trail through a field. The road had recently been built up and surfaced with scoria as access to new oil wells to the south. The road had a shallow dip where the culvert had been installed and the soil had settled. The Hiland representative stated that an oil company built and was responsible for the condition of the access road.

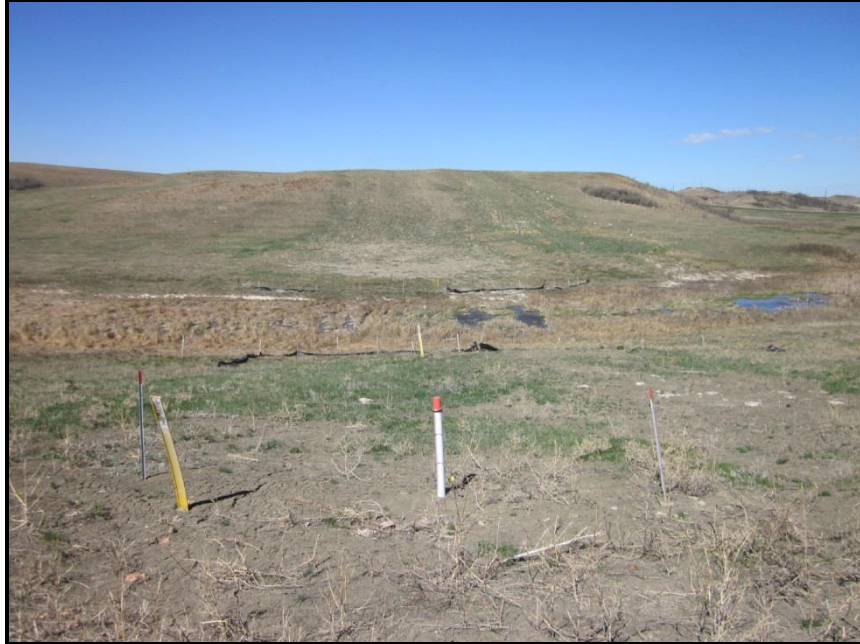
Native prairie was crossed on the east half of the Project corridor which was potentially suitable habitat for the Dakota skipper and Sprague's pipit (**Appendix A, Photo 3**) (Docket #7-10, Natural Resource Report). It was noted during the inspection that although potentially suitable, the grassland had been heavily grazed and was not currently likely to support either of these species. The width of the pipeline disturbance had been minimized to between 50-80ft, which was considerably less than the maximum proposed 120ft ROW, thus fulfilling the USFWS request. Reseeding of the disturbed area had been done in Fall 2012 as a way to mitigate disturbance (J. Coleman, 2013, pers. comm.).

Fences had been repaired where the Project crossed fencelines (**Appendix A, Photo 3**). Hiland reported there had not been any agricultural fields with drainage tile impacted by construction of the Project. There was no waste or debris observed at the site (**Appendix A, Photos 1-10**).

Photo 3. Direction: West. Crossing of Dry Creek on the east end of the pipeline route. Pipeline markers and cathodic protection system markers were in place. Note the new fence installed parallel to the creek in the foreground. The pipeline route is visible on the far side of Dry Creek going upslope to rolling hills of native prairie in the NE $\frac{1}{4}$ of Section 19. Note the bare patches of soil where vegetation had not yet established.

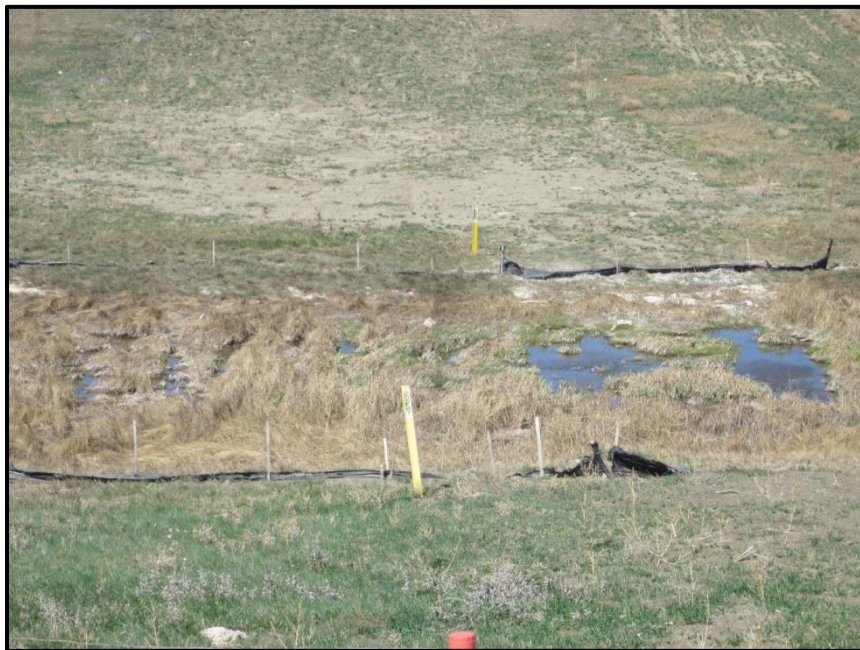
A wetland determination during the natural resource survey indicated the presence of two potential wetlands and one intermittent stream (Dry Creek) along the Project ROW (Docket #7-10, Natural Resource Report). A subsequent wetland delineation concluded that the potential areas did not meet criteria for consideration as wetlands (Docket #35, Wetland Delineation Letter Report). Wenck confirmed during the site visit that Dry Creek was bored to avoid impacts (**Appendix A, Photo 4**). Weekly construction reports also noted the progress of 6 bores along the route (Dockets #59, 61, 63-71, Weekly Construction Reports). Erosion and sediment control structures were in place and the vegetation within Dry Creek had not been disturbed. However it did not appear that an 80ft vegetation buffer had been left on either side of the Creek; rather the disturbed ROW was evident up to the stream edge (**Figure 1; Appendix A, Photos 3, 4**).

Hiland indicated that the pipeline is regularly inspected and maintained. There was no waste, debris, or abandoned equipment observed during the inspection. The site appeared to be regularly maintained. However, the silt fences along Dry Creek should be repaired and will need to be removed once vegetation has more fully established on adjacent slopes (**Appendix A, Photo 4**).

Photo 4. Direction: West. Closer view of Dry Creek crossing with silt fences on both sides. The vegetation and lowest margins of Dry Creek did not appear disturbed, which confirmed that the creek was bored underneath. Arrow had planned an 80-foot vegetation buffer on either side; however, the soils within the corridor were obviously disturbed up to within a few feet of the edge of the creek.

Though Dry Creek had been bored underneath to minimize impacts, it did not appear that an 80ft vegetated buffer had been retained as proposed. Hiland/Arrow should provide justification of why the buffer was not retained. Silt fences were still in place along Dry Creek, though most were not functional. The structures should be repaired so they can function until vegetation has established on adjacent slopes. Hiland should document with the PSC when erosion control structures are repaired and when they are removed.

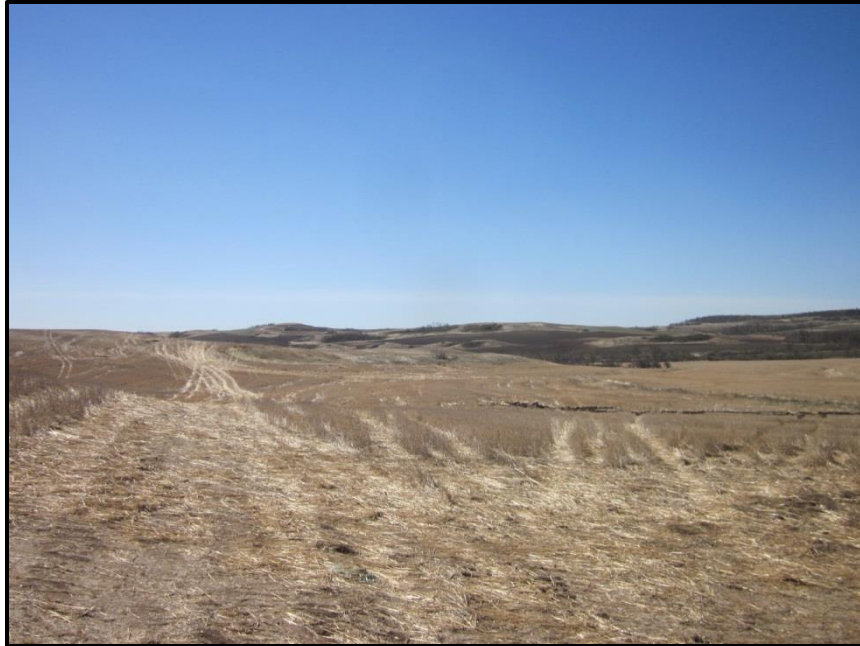
Photo 5. Direction: Southeast. View across field in the NE $\frac{1}{4}$ of the NW $\frac{1}{4}$ of Section 19. The pipeline route was diagonal to the southeast; a line of disturbed soils was faintly visible in the field. The Hiland representative stated the stubble was compressed from accessing the pipeline corridor, which would indicate the stubble was from the 2011 season and that a 2012 crop had not been planted.

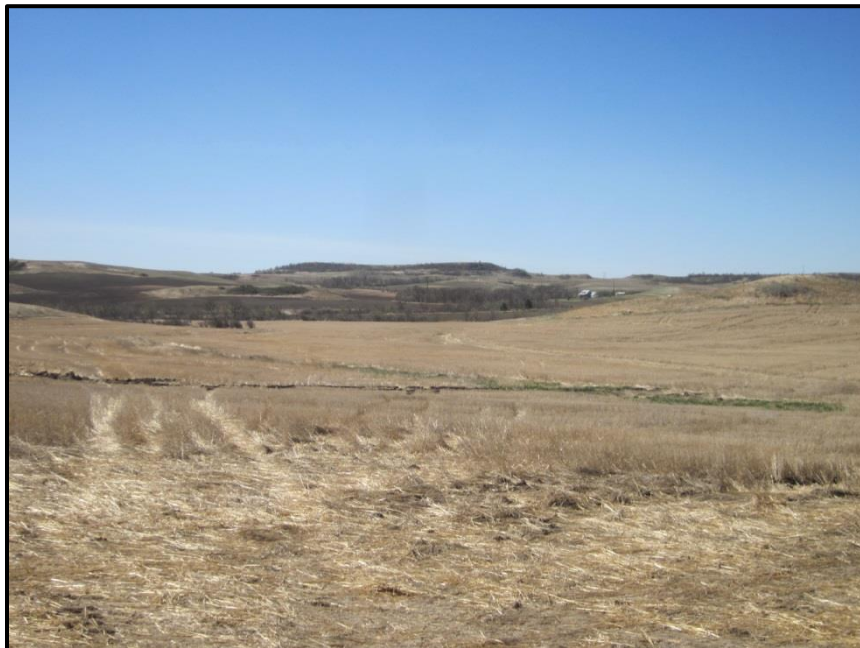
Photo 6. Direction: Southwest. View across field in the NW $\frac{1}{4}$ of the NW $\frac{1}{4}$ of Section 19. The pipeline route turned straight west across the remainder of the field. Reclamation appeared complete and the soils were stabilized.

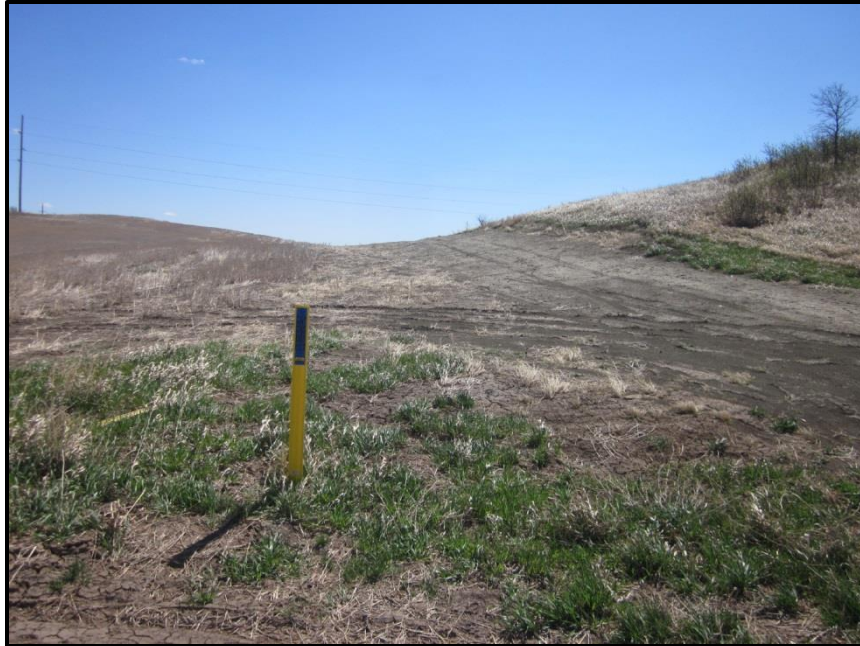
Photo 7. Direction: East. Pipeline route in the far northwest corner of the field from Photos 5 and 6, on the east side of 108th Ave NW. Pipeline marker was in place in the east ditch. Note the bare, lighter colored soils on the hillslope which could be an indication of topsoil/subsoil mixing.

There were a couple outstanding issues at the Project site related to reclamation. 1) Establishment of vegetation was ongoing within the grassland area on the east half of the corridor. 2) There were indications in a few areas that mixing of topsoil with subsoil had occurred, or that insufficient topsoil was replaced during reclamation. These areas had lighter-colored soils and poor revegetation establishment within the grassland area. Because of the timing of the site inspection, it was not clear whether these areas were impacting crop production. 3) It also appeared crop production may have been suspended due to pipeline construction activities. Though presumably crop losses were being monetarily mitigated, former land uses will need to be achieved within the next couple years. Wenck recommends the PSC request monitoring and documentation of these issues. Soil amendments or re-seeding may be necessary.

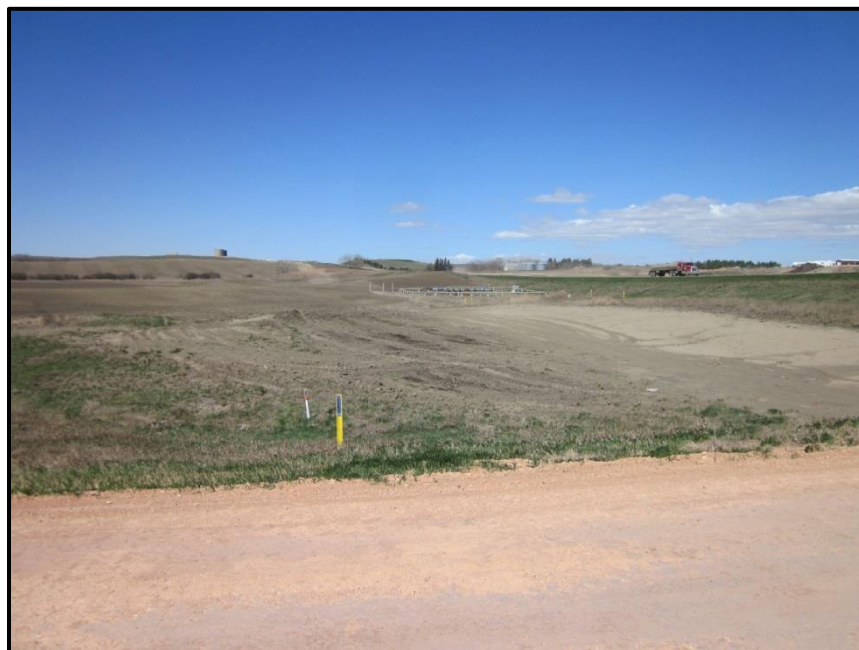
Photo 8. Direction: West. West ditch of 108th Ave NW. The existing road had been bored underneath. Pipeline markers and cathodic protection system markers were in place. Note the light colored soils in the corner of the field, which could be an indication of topsoil/subsoil mixing. The core portion of the field had been planted for this year's crop, but this far corner had been excluded.

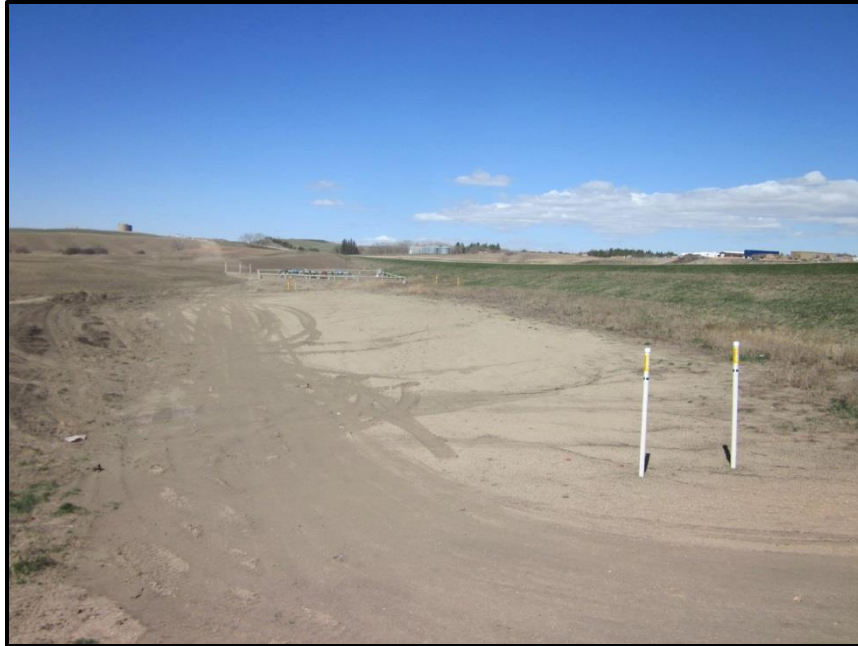
Photo 9. Direction: West. Markers were for an existing buried power line perpendicular to the pipeline route. Note the disturbed soils on the left of the photo where there were deep ruts (not visible) in the upper portion of a drainage, presumably due to heavy equipment, which needs repair. Otherwise reclamation was complete and soils were stabilized.

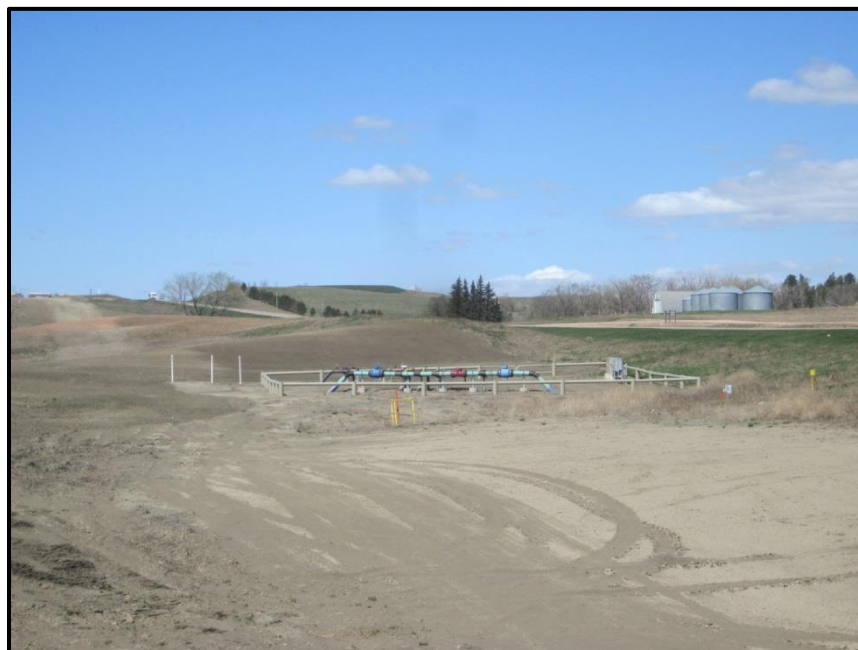
There was a metal fence structure around the tie-in, which prevented damage by farm equipment to the above-ground pipeline connections (**Appendix A, Photo 10**). Warning signs marking the location of the pipeline had been installed and were in place at all fencelines and road crossings (**Appendix A, Photos 1, 3, 4, 7, 8**). Hiland indicated that resident/landowner concerns and issues are handled promptly and Hiland makes every reasonable attempt to alleviate problems caused by the Project (J. Coleman, 2013, pers. comm.).

Photo 10. Direction: West. West end of pipeline at the tie-in to the existing 4 Bears Pipeline in the NE $\frac{1}{4}$ of the NE $\frac{1}{4}$ of Section 24.
