***Merricourt-
Ellendale
Transmission Line
Construction
Inspection Report***

***Montana-Dakota
Utilities Co.***

April 2012

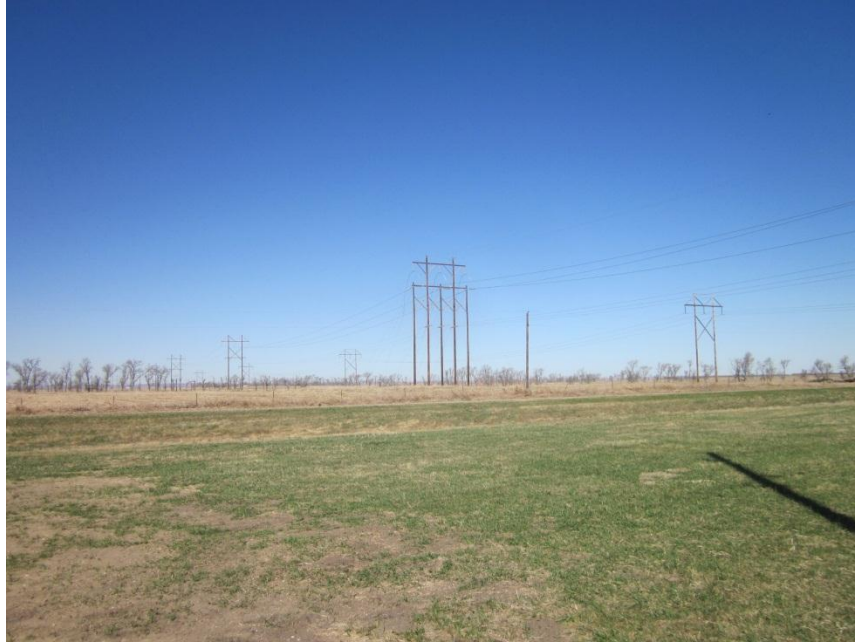
Photo 5. Direction: Northwest. New line leaving the Ellendale substation, which is located just behind where this photo was taken. Notice new line (larger structure on the left) parallels an existing line out of the substation.

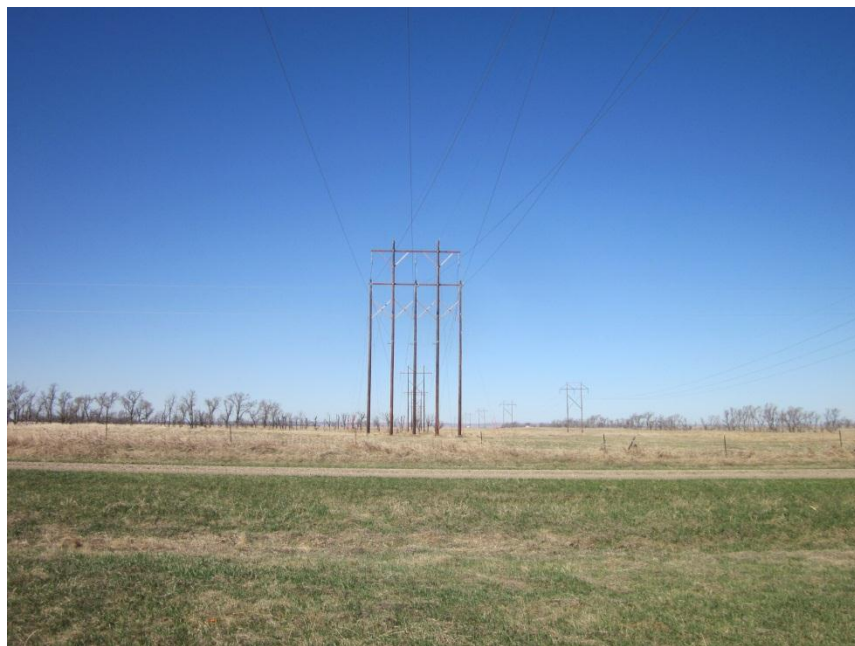
Photo 6. Direction: West. Double circuit transmission line leaving substation traveling west.

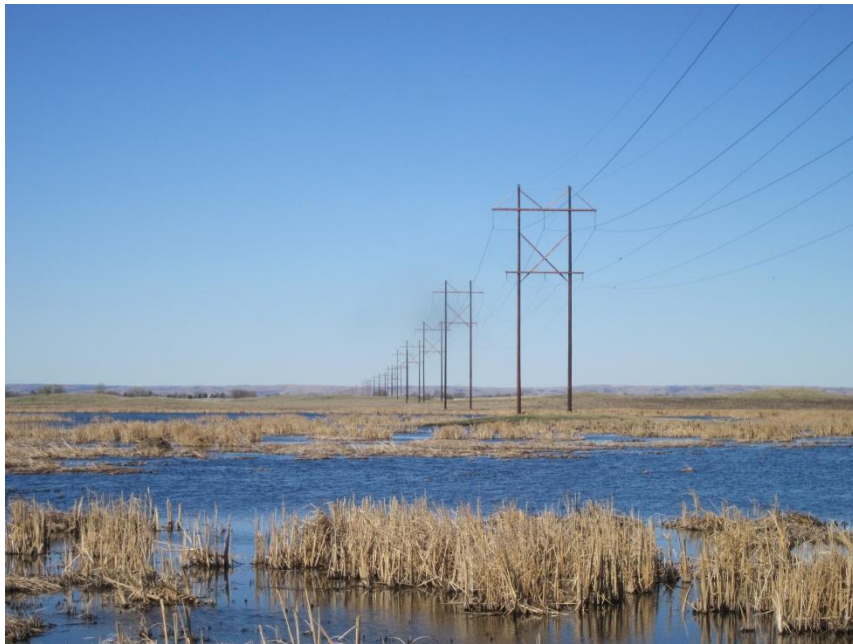
Photo 8. Direction: West. This is a closer picture of the wetland crossing shown in Photo 8. Note structure is not located in wetland, but on small island.

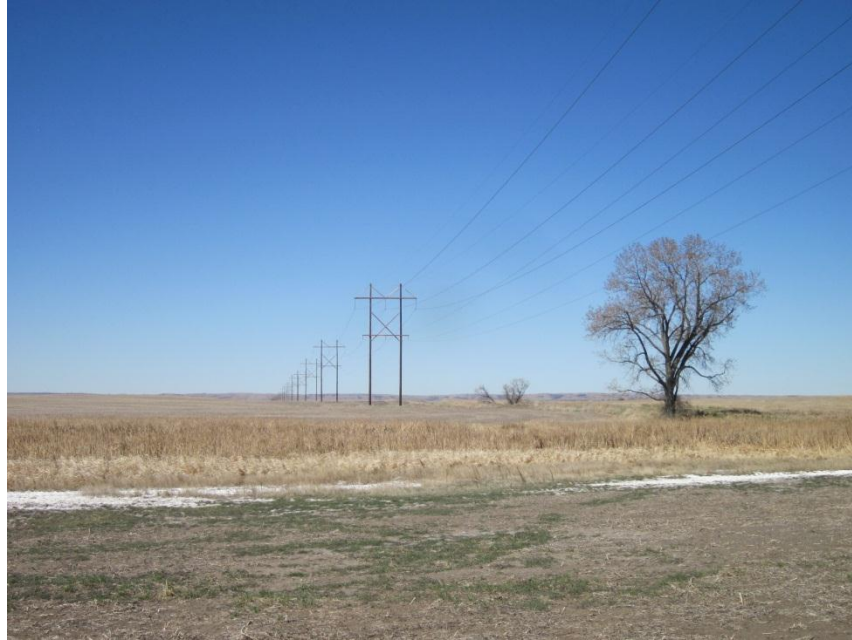
Photo 13. Direction: West. Transmission line spanning a cattail slough approximately 8 miles west of the Ellendale substation.

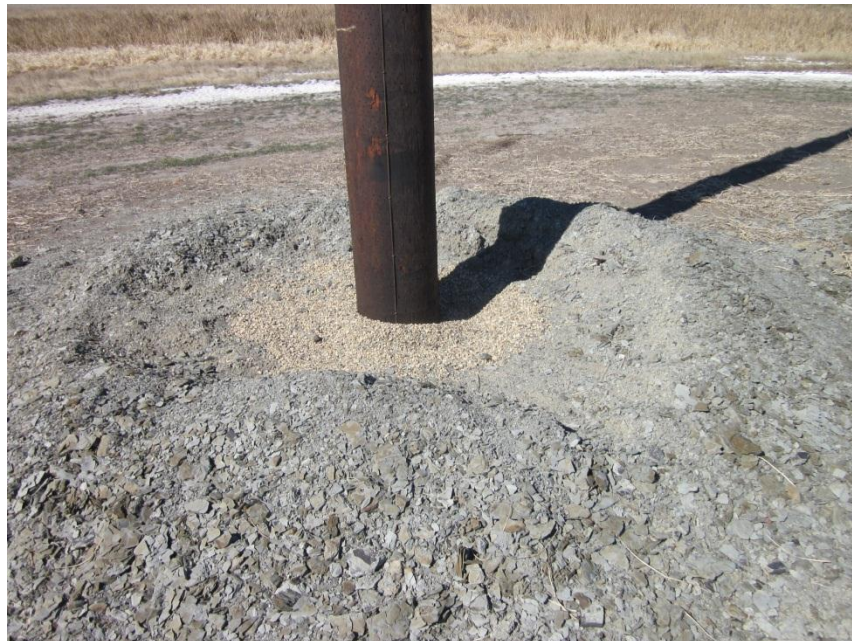
Photo 14. Example post hole filled with aggregate. Shale surrounding the hole was debris from underlying material as a result of post hole drilling. Upon final restoration, material will be cleaned, spread, or hauled away.

At the time of the site inspection, final restoration and reseedling had yet to occur on the Project site. Final restoration of debris surrounding structure poles, temporary staging areas, and other construction disturbances along the route needs to be completed upon Project completion to be considered in full compliance.

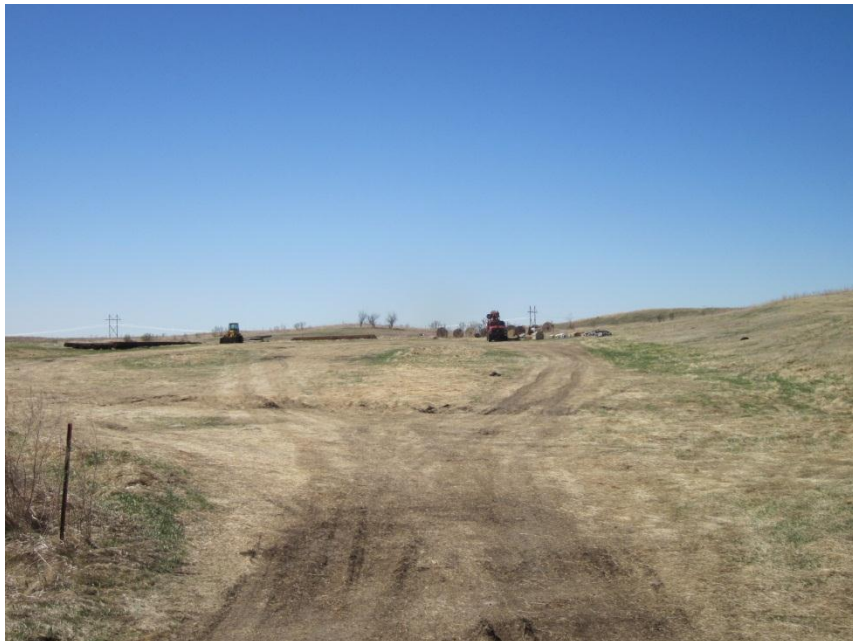
Photo 26. Direction: West. Laydown area leased from landowner Greg Brokaw located in the NE ¼ of the NE ¼ of Section 16, Township 130N, Range 166 W, Dickey county. Laydown area will be used through October 2012 for other line maintenance work nearby. Area seemed in good order without excessive disturbance or erosion present.

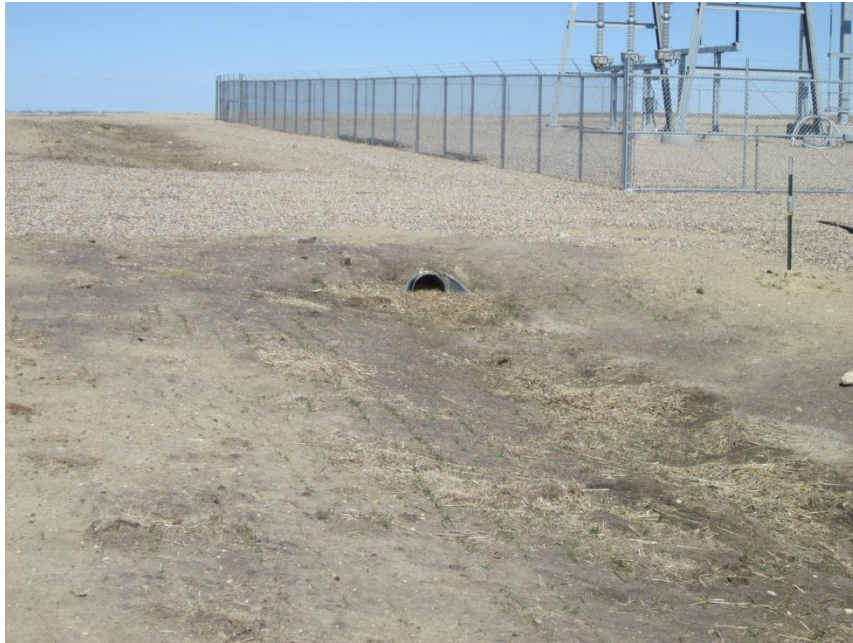
Photo 33. Direction: North. Example of storm water and erosion control measures with culvert underneath access road to substation.

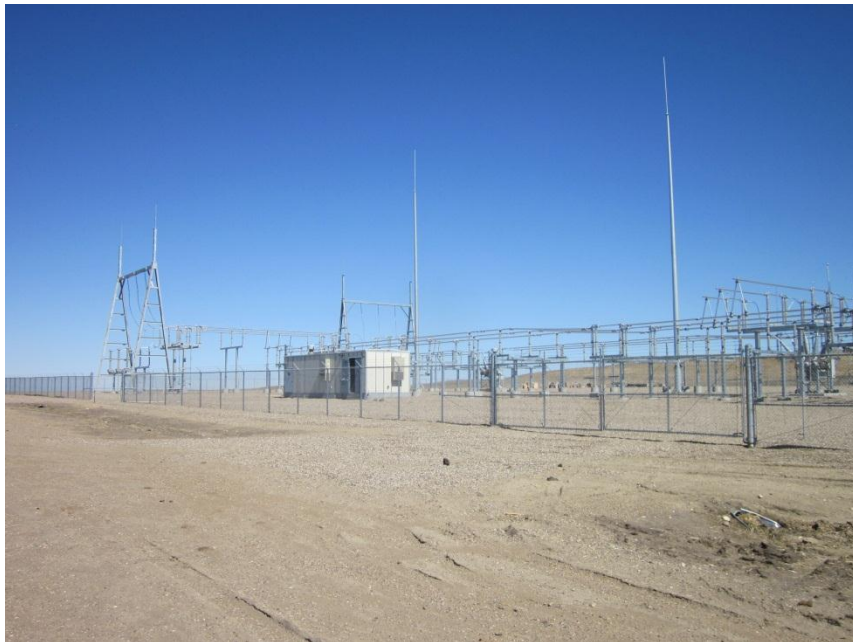
Photo 34. Direction: Northeast. Merricourt substation showing storm water control culverts and approaches. Substation appeared to be in good order with no erosion or other impacts noted.
