**RE: Final Construction Inspection Report for the Whiting Belfield Oil Pipeline  
PU 11-102**

***Whiting Belfield  
Oil Pipeline  
Construction  
Inspection Report***

***Whiting Oil and Gas  
Corporation***

**PSC Case No.  
PU-11-102**

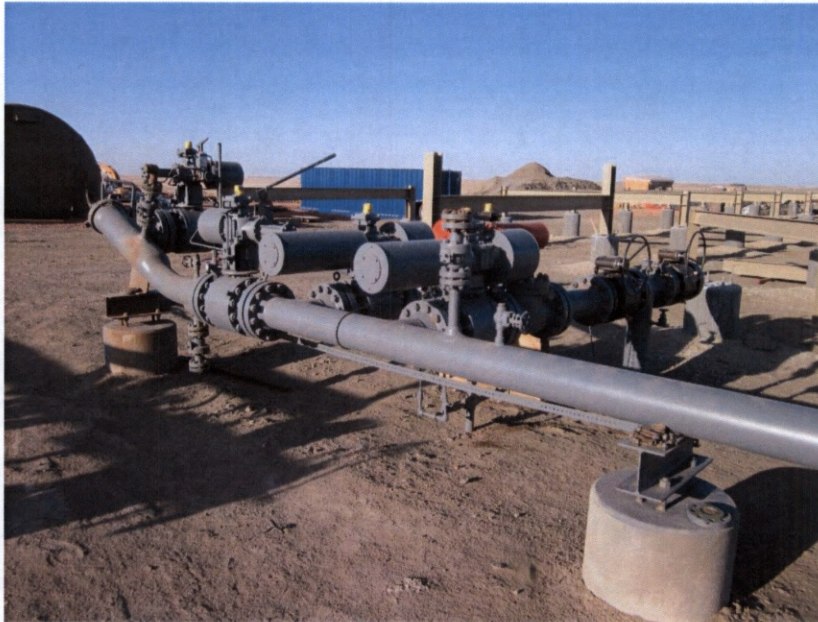
**Photo 1.** Direction: Southwest. Start of pipeline at Belfield Oil Terminal. All aboveground structures were in order and constructed per PSC and application guidelines. Located in Section 14 Township 141N Range 99W.

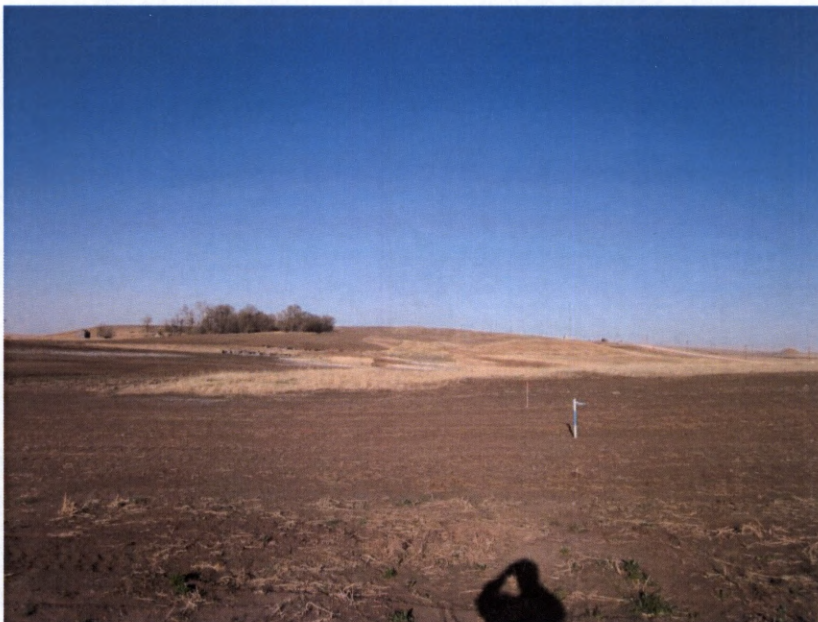
**Photo 2.** Direction: West. Belfield Oil Terminal is behind ridge in background. Pipeline is located north of the trees on the ridge and travels east. Stakes in foreground show where pipeline directs north.

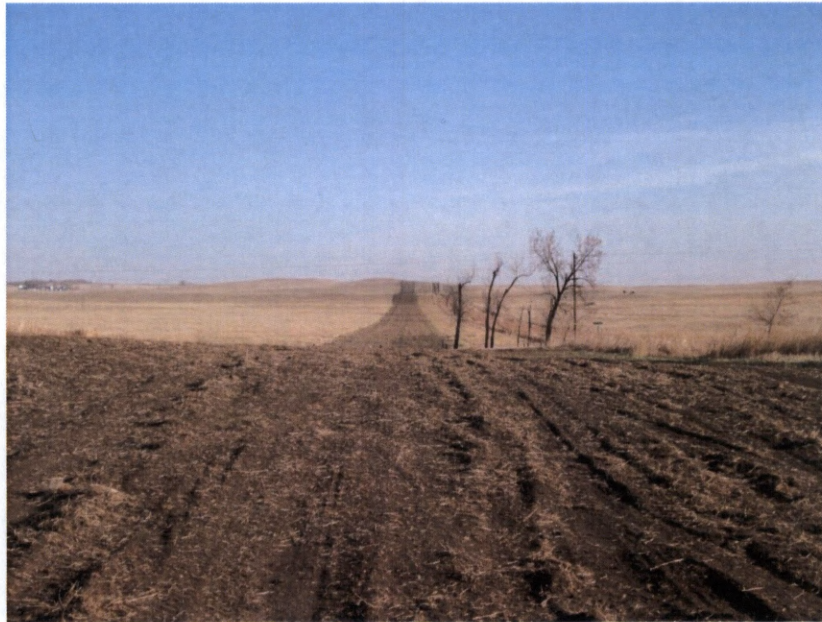
**Photo 3.** Direction: North. Same location as Photo 2. This photo shows the right-of-way for the Whiting Pipeline. At the time of our site visit the right-of-way needed final seeding and restoration

At the time of the site inspection, final restoration and reseeded had yet to occur on the Project site. Although a relatively minor issue, reseeded would help prevent possible erosion to soil within the Project route. Wenck recommends that the PSC obtain verification that the route has been reseeded and vegetation has established later in the growing season.

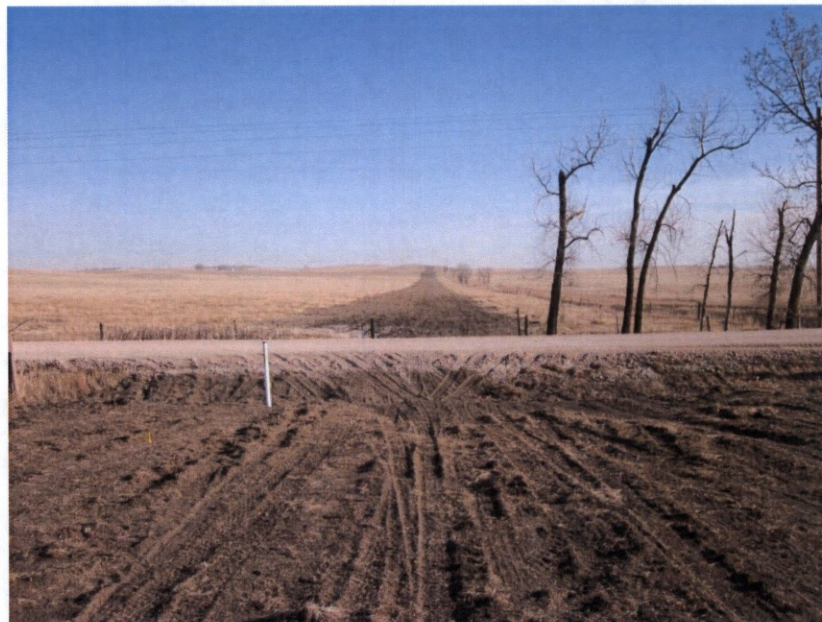
- *Road Crossings Bored.* The Project bored under several roads throughout the ROW, which included 32<sup>nd</sup> Street, 30<sup>th</sup> Street, 124<sup>th</sup> Avenue, and 28<sup>th</sup> Street (**Figure 1; Appendix A, Photos 4, 16-20**). Wenck observed that the pipeline route was marked at these bore locations and that no settling or erosion to roads was evident.

**Photo 4.** Direction: North. This photo shows the right-of-way of the Whiting Pipeline where it bores under 32<sup>nd</sup> Street.

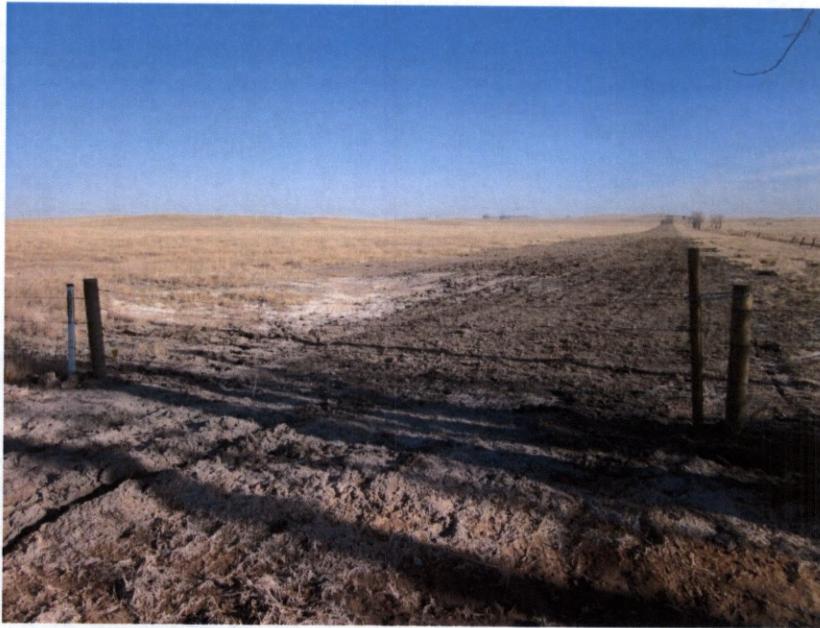
- *Fences/Gates Repaired/Replaced.* Wenck observed that fences and gates had been repaired as construction concluded (**Appendix A, Photos 5, 20**). Some fences had been replaced temporarily, but Whiting stated that these fences would be permanently replaced during final restoration in early spring.

**Photo 5.** Direction: Northwest. Northern side of 32<sup>nd</sup> Street bore. Fence had been repaired and was in good condition. No erosion or other problems were evident.

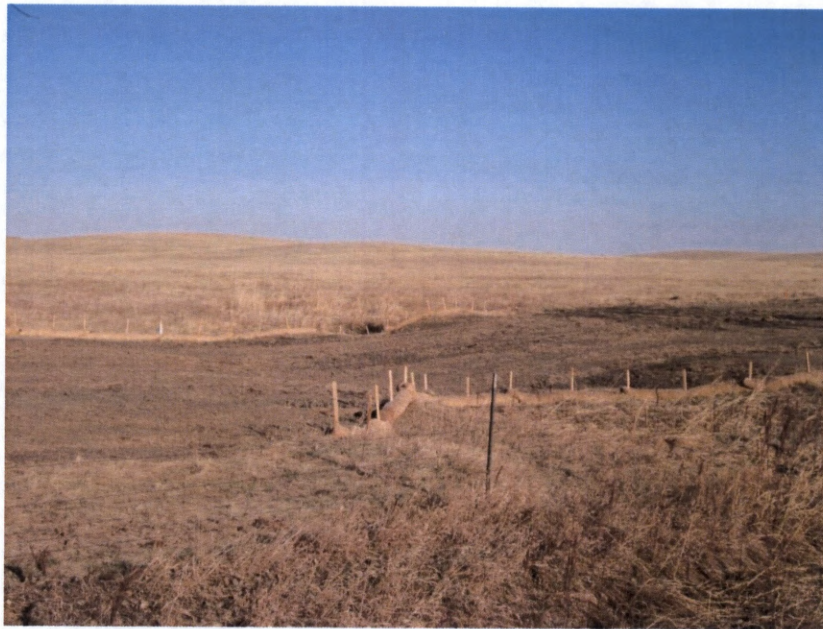
**Photo 6.** Direction: West. Photo shows erosion control structure located at a low area along the pipeline right-of-way at observation point 125 (**Figure 1**). Structures similar to this were located at all low areas and wetlands throughout the right-of-way.

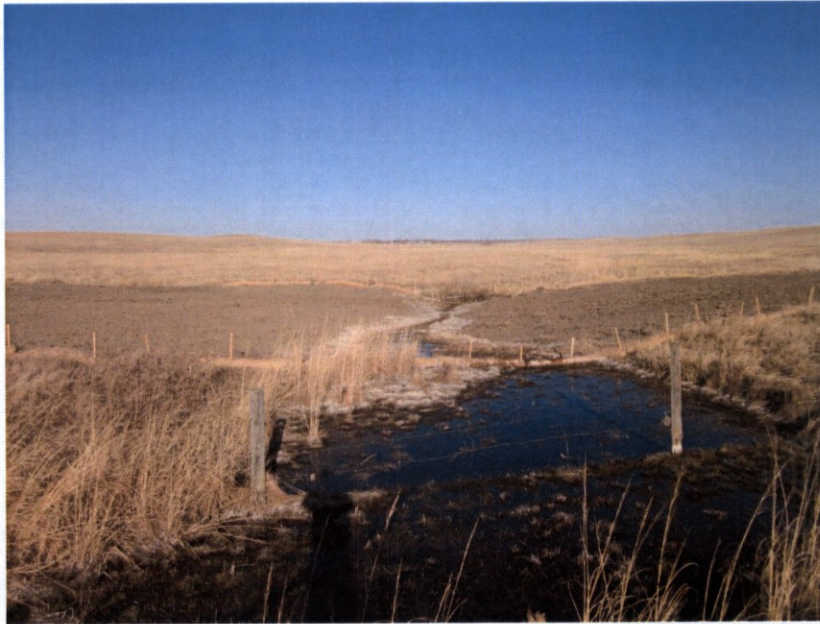
**Photo 7.** Direction: West. Erosion control structure located along pipeline right-of-way. No erosion or sedimentation was noted within the water body.

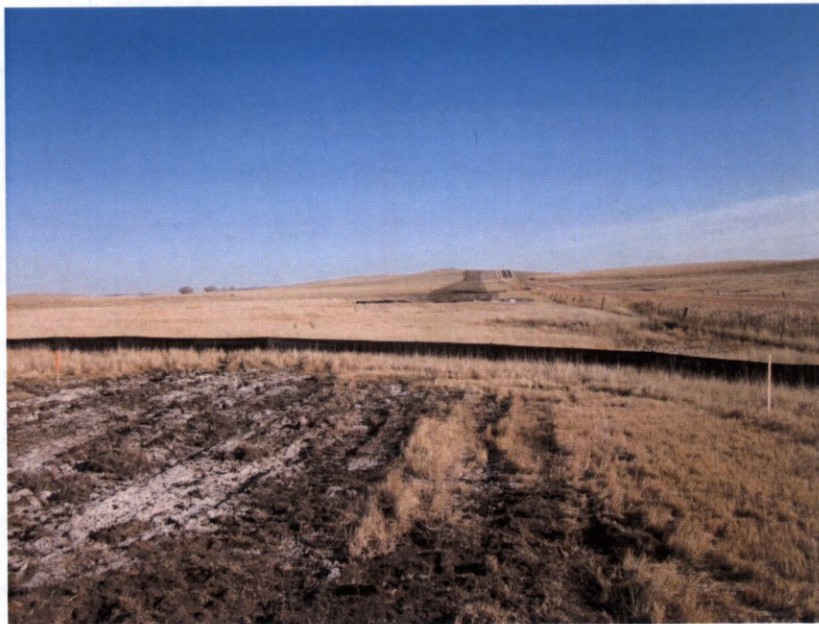
**Photo 8.** Direction: North. Photo shows pipeline right-of-way where it bores underneath a wetland at observation point 127 (**Figure 1**). Erosion control structures were in place and no erosion to the water body was evident.

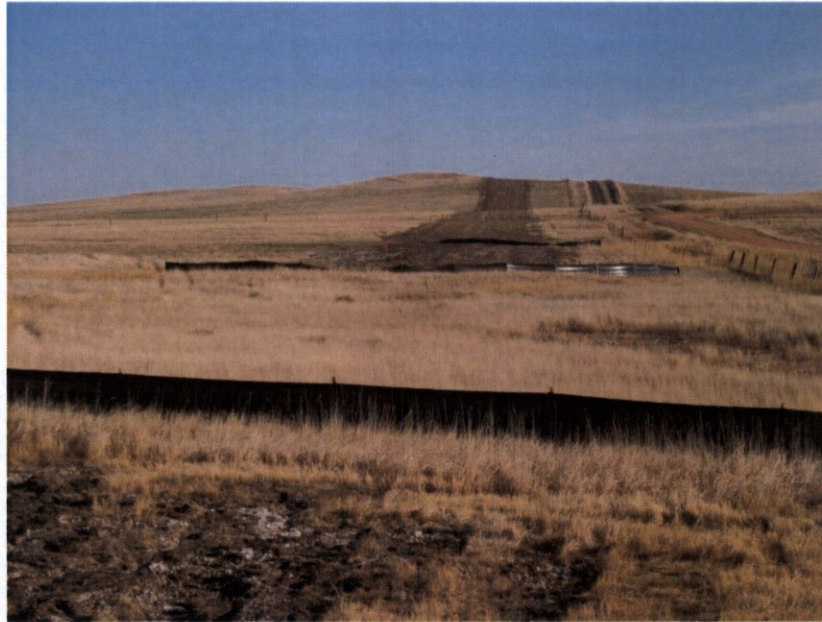
**Photo 9.** Direction: North. This is a closer picture of the pipeline boring underneath a wetland. Note erosion control structures in place.

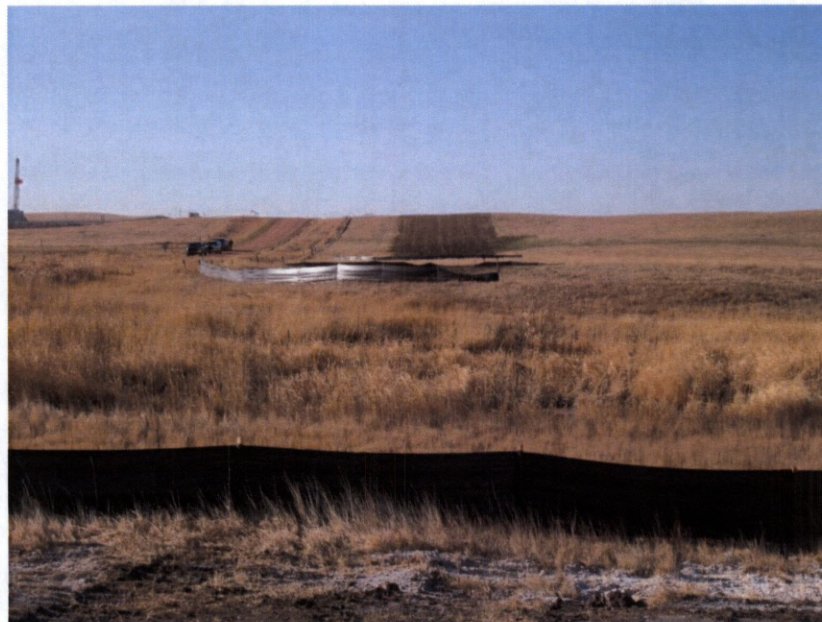
**Photo 10.** Direction: South. Photo shows pipeline right-of-way where it bores underneath a wetland at observation point 128 (**Figure 1**). Erosion control structures were in place and no erosion to the water body was evident.

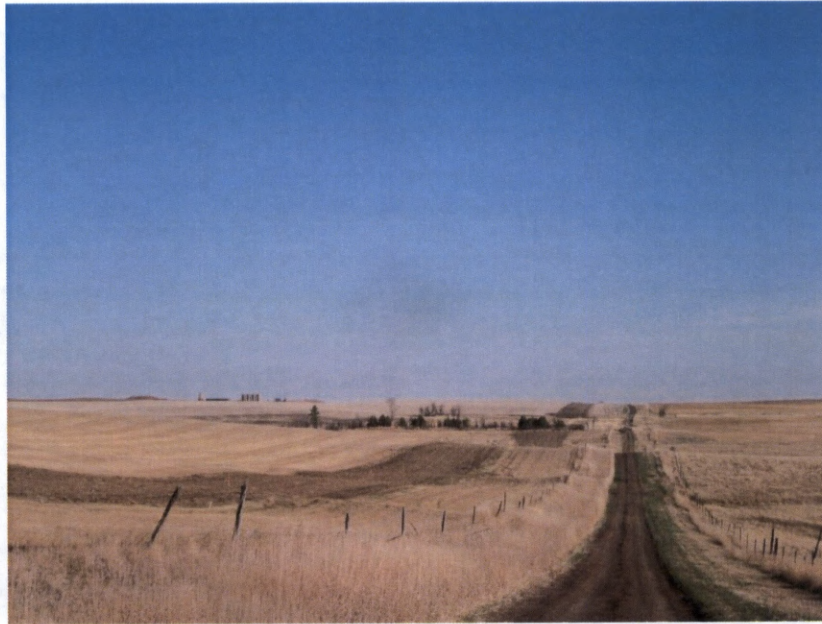
**Photo 11.** Direction: Northwest. This photo shows the pipeline right-of-way as it directs north. At the time of the site visit, final seeding and restoration had yet to occur.

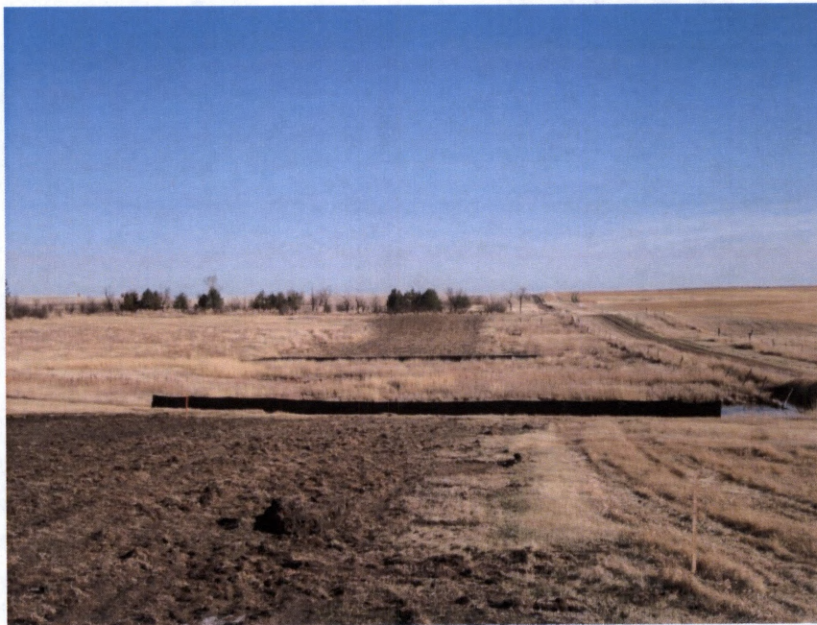
**Photo 12.** Direction: North. Photo shows pipeline right-of-way where it bores underneath a wetland at observation point 131 (**Figure 1**). Erosion control structures were in place and no erosion to the water body was evident. Tree row in background was also bored with no impacts to surrounding vegetation.

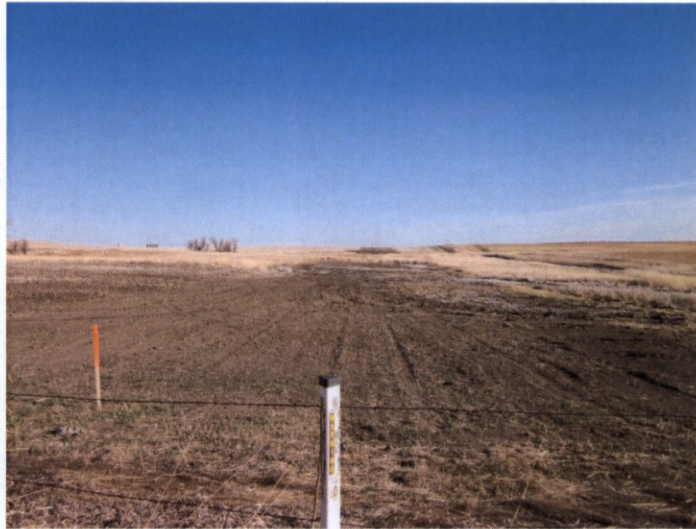
- *Safety Measures to Restrict Public Access.* Wenck observed that appropriate signage was in place at all road, fence, and section lines where the pipeline ROW intersected these areas. (**Appendix A, Photos 13, 17, 19, 20**). Traffic control appeared to be controlled during construction.

**Photo 13.** Direction: North. Photo taken just north of tree row in Photo 12. Note signage indicating belowground pipeline. Similar signage was found throughout the pipeline right-of-way at all fences, section lines, and road crossings.

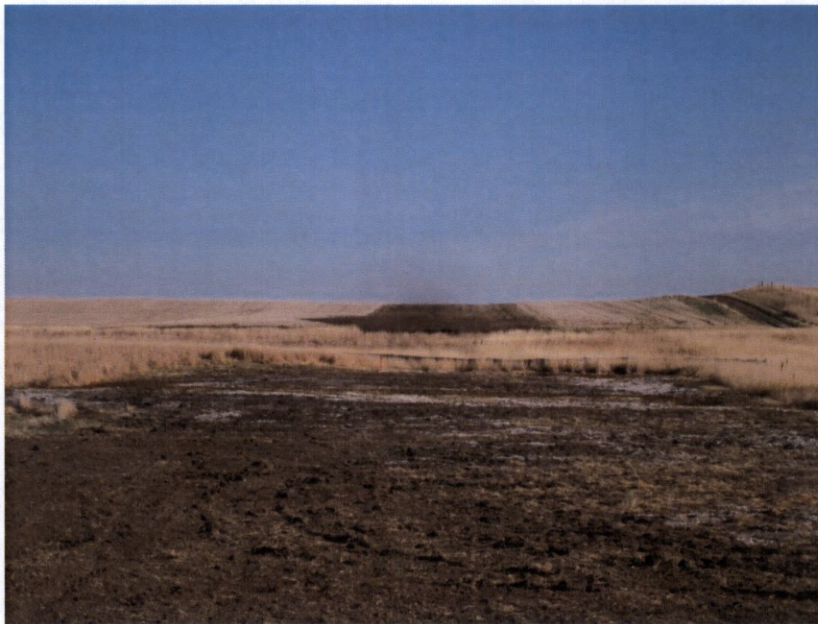
**Photo 14.** Direction: North. Photo shows pipeline right-of-way where it bores underneath a wetland less than 0.25 miles north of observation point 131. Erosion control structures were in place and no erosion to the water body was evident.

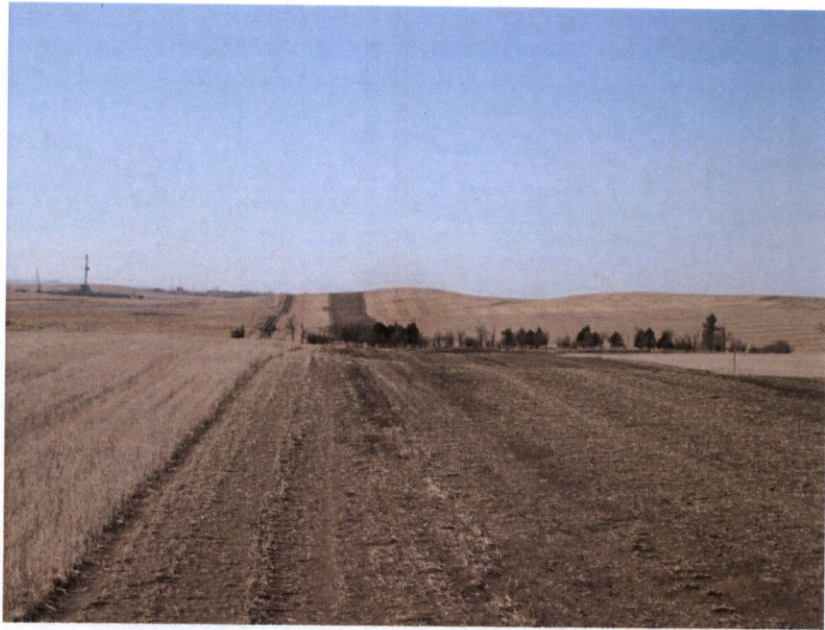
**Photo 15.** Direction: South. Photo shows pipeline right-of-way north of where the pipeline bores under the tree row and about a quarter mile south of 30<sup>th</sup> Street.

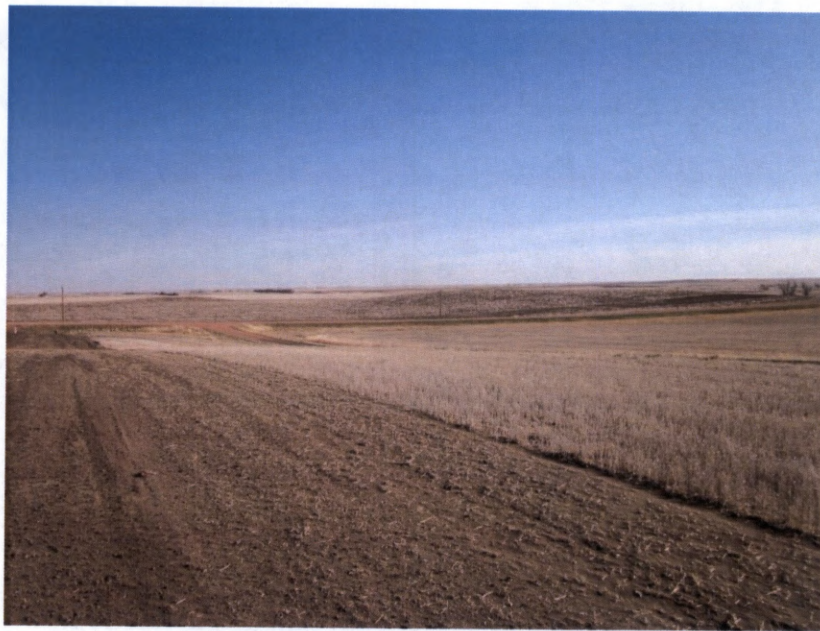
**Photo 16.** Direction: Northeast. Photo shows pipeline right-of-way as it bores under 30<sup>th</sup> Street and directs west.

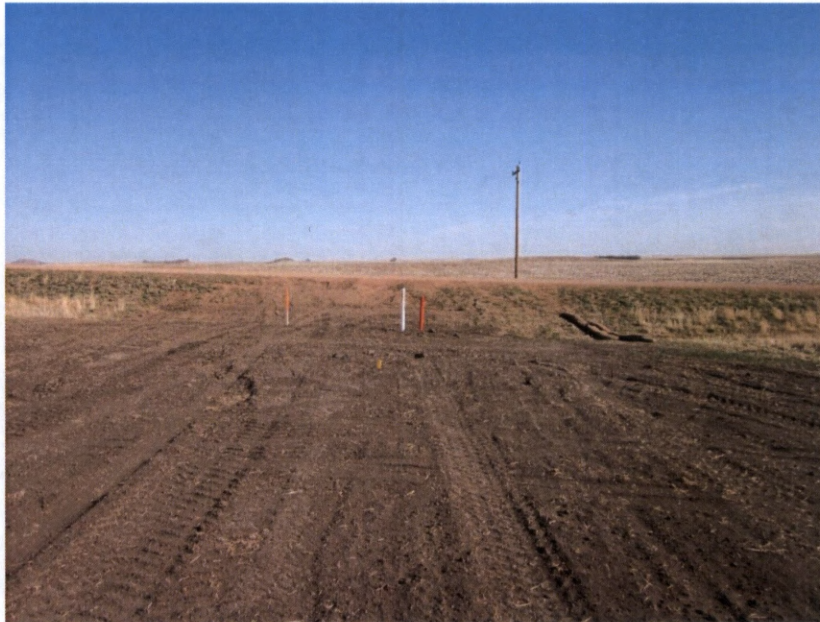
**Photo 17.** Direction: North. This photo shows the right-of-way of the Whiting Pipeline where it bores under 30<sup>nd</sup> Street. No erosion or other issues were noted. Example cathodic tester indicated by the orange pole; testers were located at every mile along pipeline ROW.

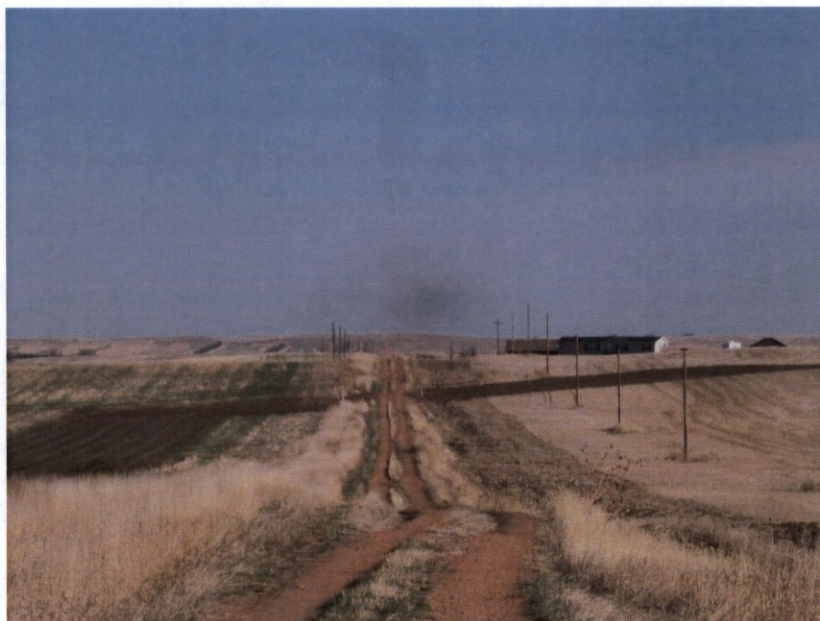
**Photo 18.** Direction: North. Photo shows where pipeline right-of-way bores under 124<sup>th</sup> Avenue. From this point, the right-of-way parallels the existing Bridger Pipeline to the Skunk Hill Station.

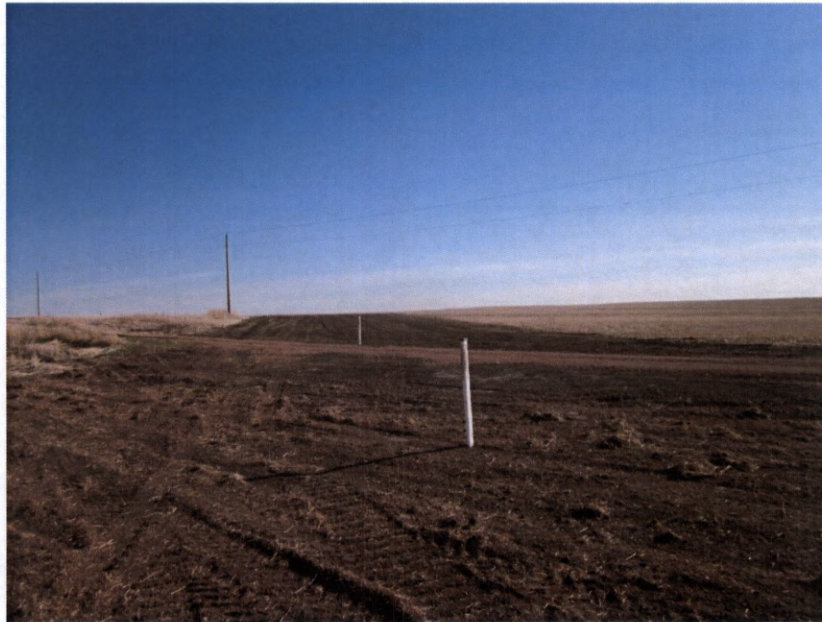
**Photo 19.** Direction: Northeast. This photo shows the right-of-way of the Whiting Pipeline where it bores under 124<sup>th</sup> Avenue at observation point 136 (**Figure 1**). Note signage on both sides of the road, which was typical of all road crossings along the pipeline route.

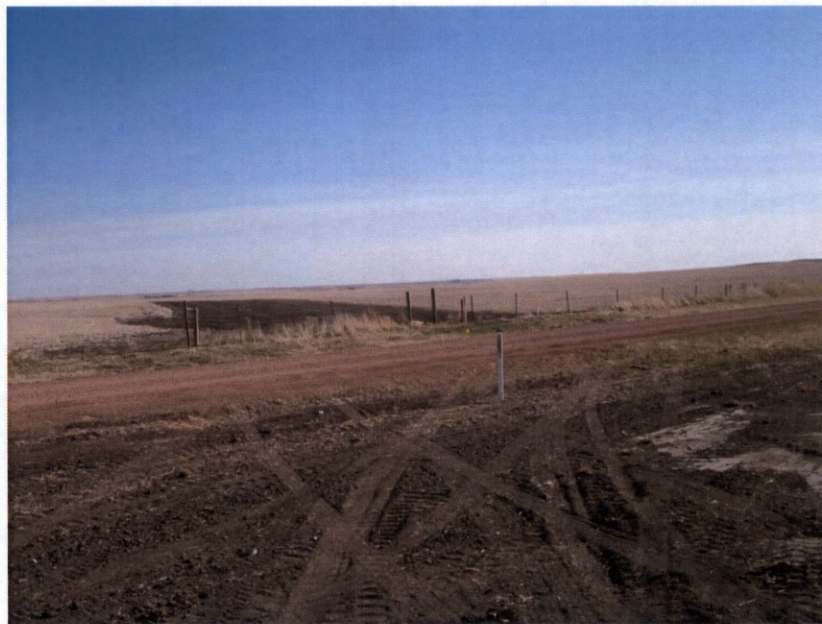
**Photo 20.** Direction: Northeast. This photo shows the right-of-way of the Whiting Pipeline where it bores under 28<sup>th</sup> Street. Fence in background was repaired and in working condition. Cathodic tester is barely visible to the right of gate (orange pole).

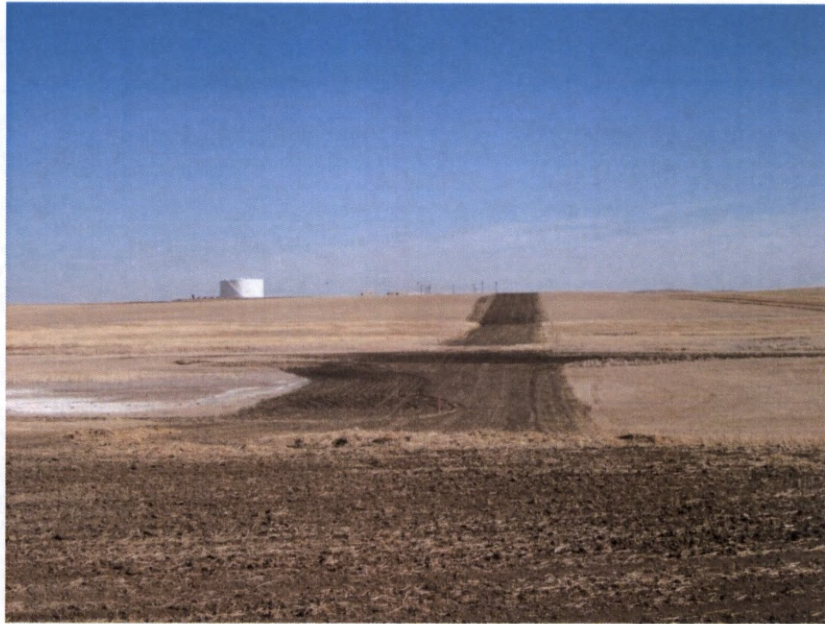
**Photo 21.** Direction: Northeast. Photo shows Skunk Hill (located to the left) and the pipeline right-of-way.

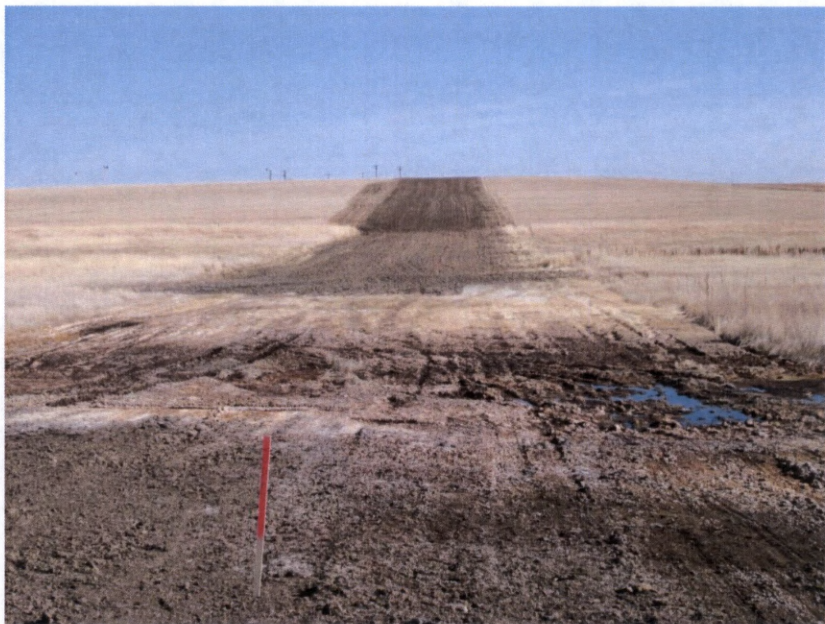
**Photo 22.** Direction: Northeast. Photo shows pipeline right-of-way where it bores underneath a wetland just north of observation point 138 (**Figure 1**). Erosion control structures were in place at time of bore but removed so landowner could have access to field; tracks/ruts are a result of landowner crossing.

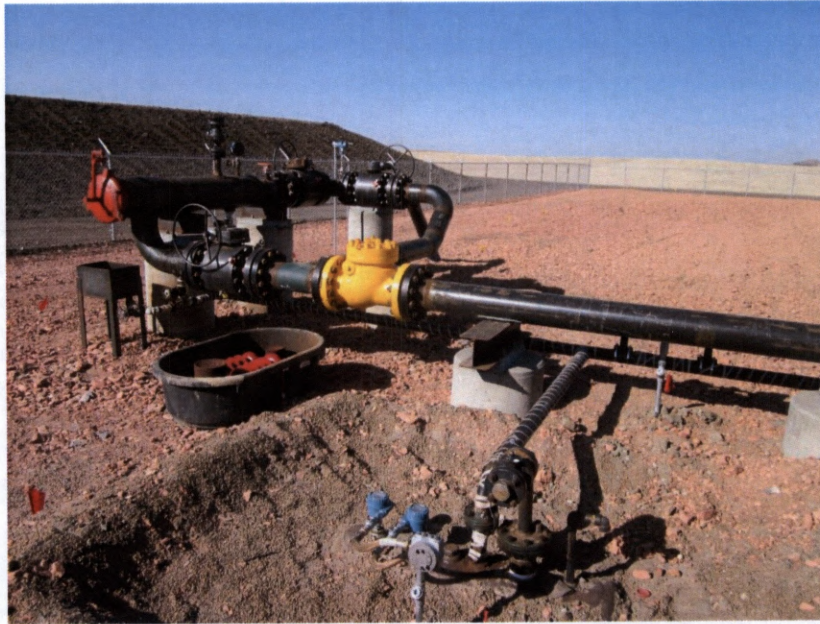
**Photo 23.** Direction: Southwest. Skunk Hill receiver indicating the end of the pipeline right-of-way; no erosion or settling was noted at receiver. Pad was in good order with appropriate safety measures in place. Located in Section 21 of Township 141N Range 98W.

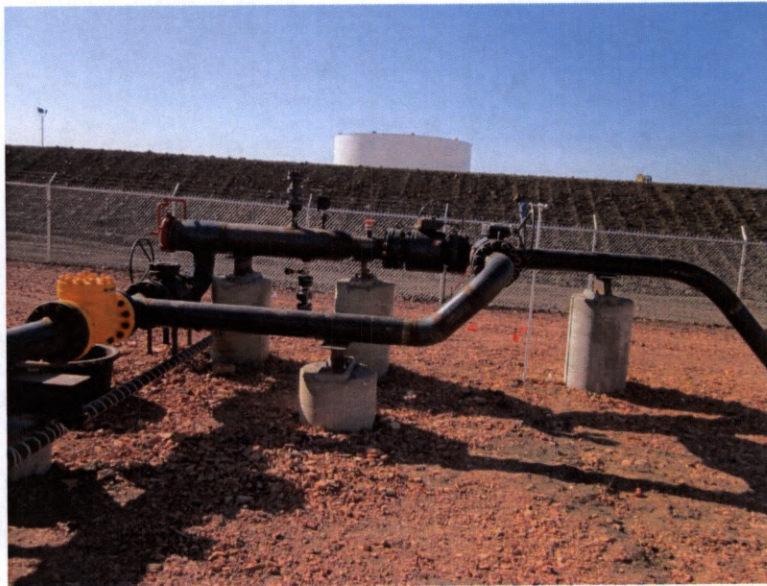
**Photo 24.** Direction: South. Receiver indicating the end of the pipeline right-of-way. Pipeline leaves the ground and enters the receiver at the right of this photo.
