Carlson McCain, Inc. (CMI) conducted an onsite inspection of the Hess Corporation (Hess) Tioga NGL Pipelines Project (Case No. PU-11-104) on September 25, 2013, on behalf of the North Dakota Public Service Commission (PSC). The project consists of installing 3.6 miles of pipelines (three natural gas liquid pipelines), which will connect the Tioga Gas Plant to the Tioga Rail Terminal (TRT). The project is being referred to as the Tioga Natural Gas Liquids Project (TNGL or Project).

Construction Inspection Summary
Hess Tioga NGL Pipelines Project - Williams County
PSC Case No. PU-11-104

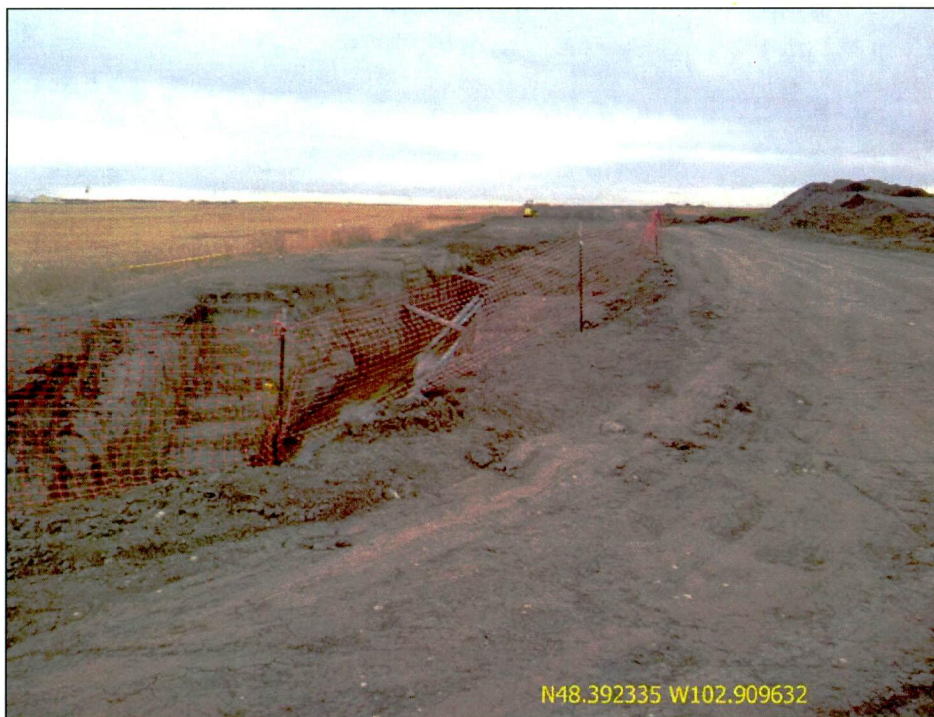
Figure 1. Photo taken of ROW looking south from 67th Street NW. The HDD bore pit work area and foreign line crossing is visible.

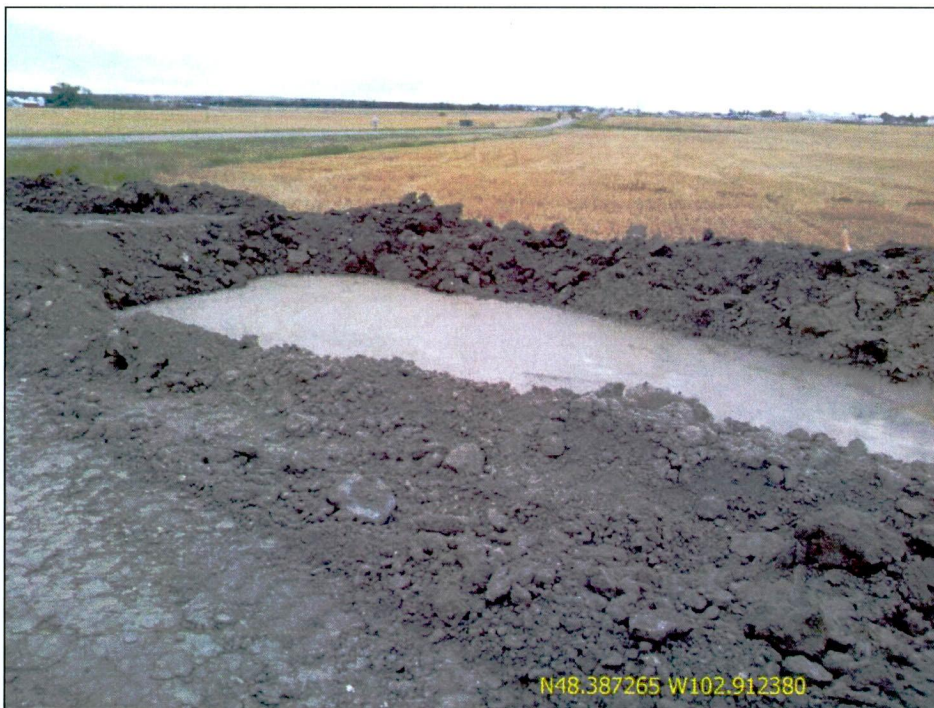
Figure 2. Photo of dewatering pit constructed of trench sub-soils within the ROW. These temporary sediment catchments will be reclaimed as HDD bore is complete and pits are backfilled.

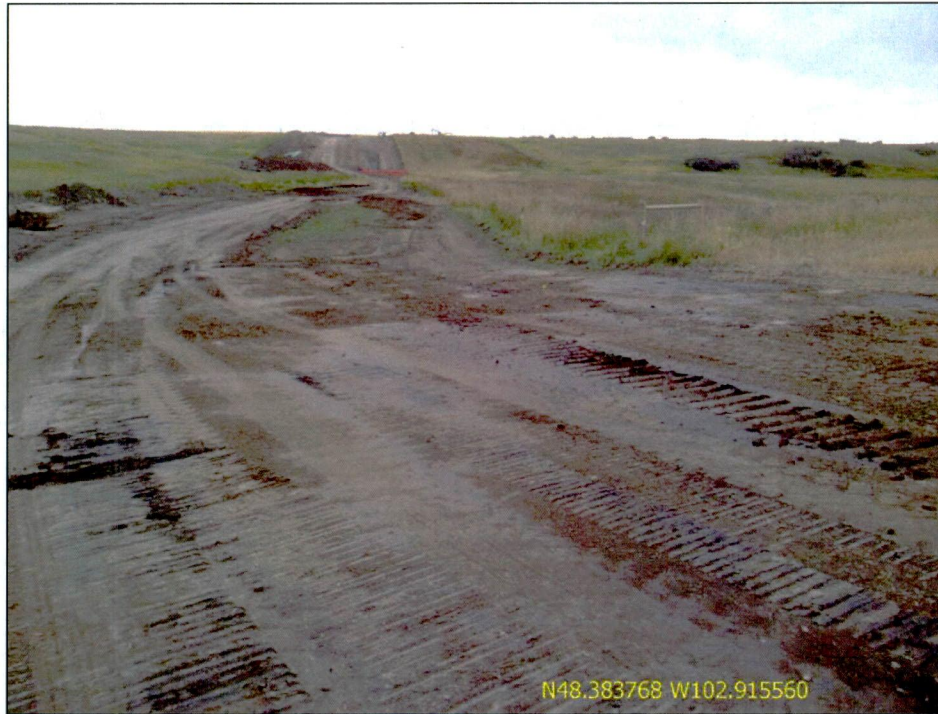
Figure 3. Photo of first stream crossing south of 67th Street NW. ROW width has been reduced and HDD bore has taken place.

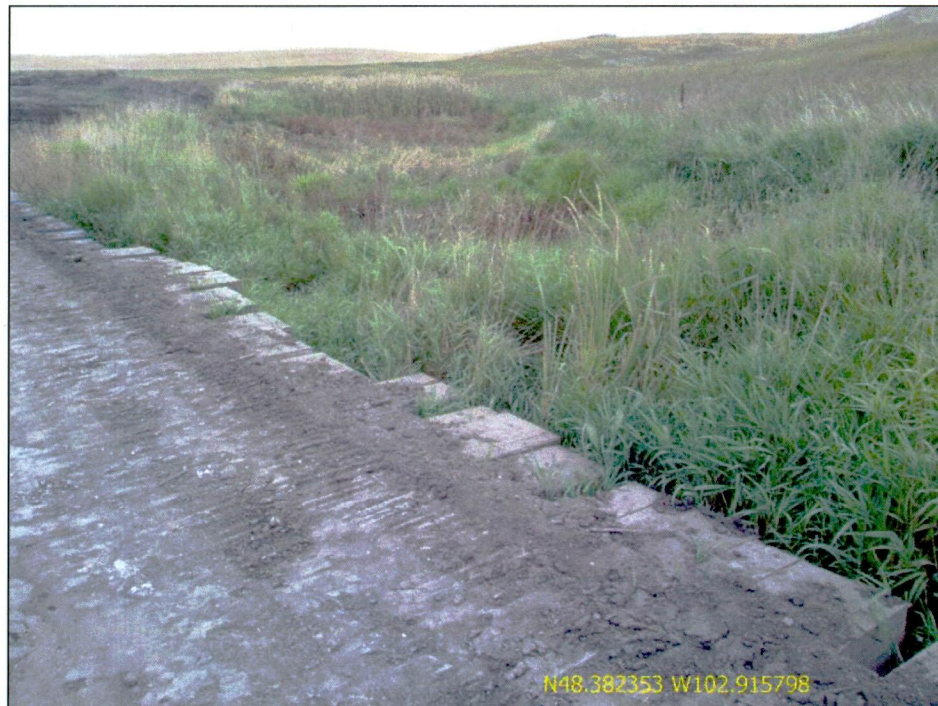
Figure 4. Wooden mats are in place for equipment to traverse the stream/wetland area. Additional silt fence or other ECD was recommended at both ends of crossing to reduce chance of sediment migration.

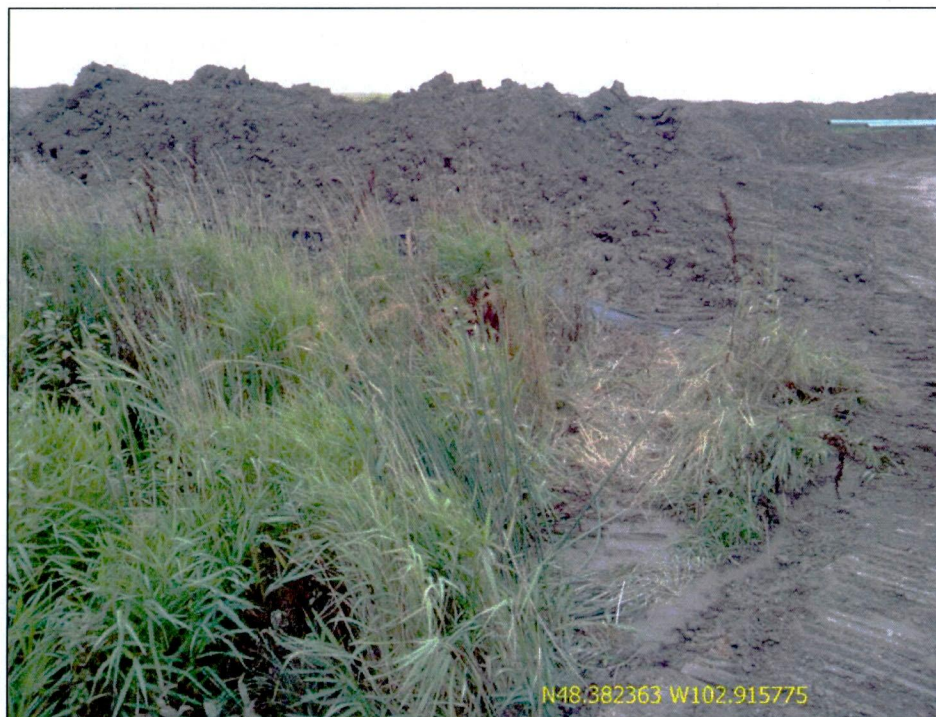
Figure 5. Silt fencing damaged by construction equipment from recent HDD pit digging which was in need of maintenance. Hess EHS Advisor assured maintenance will occur immediately.

- Minor silt fence repair (completed)
- Install silt fencing down slope south of bore pit (completed)

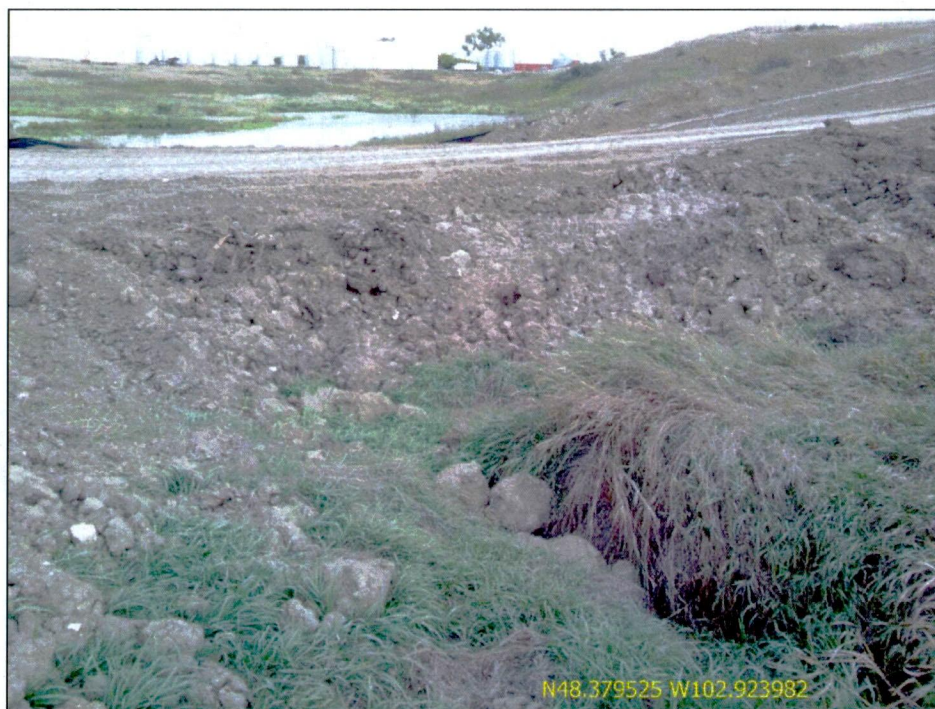
Figure 6. Photo of ephemeral drainage crossing. Steel drain pipe is in place; however, the entrance was covered with soil and may have prevented proper drainage.

*Ephemeral drainage pipe plugged on the upstream side due to excavation of roadway (drain pipe unplugged/completed)

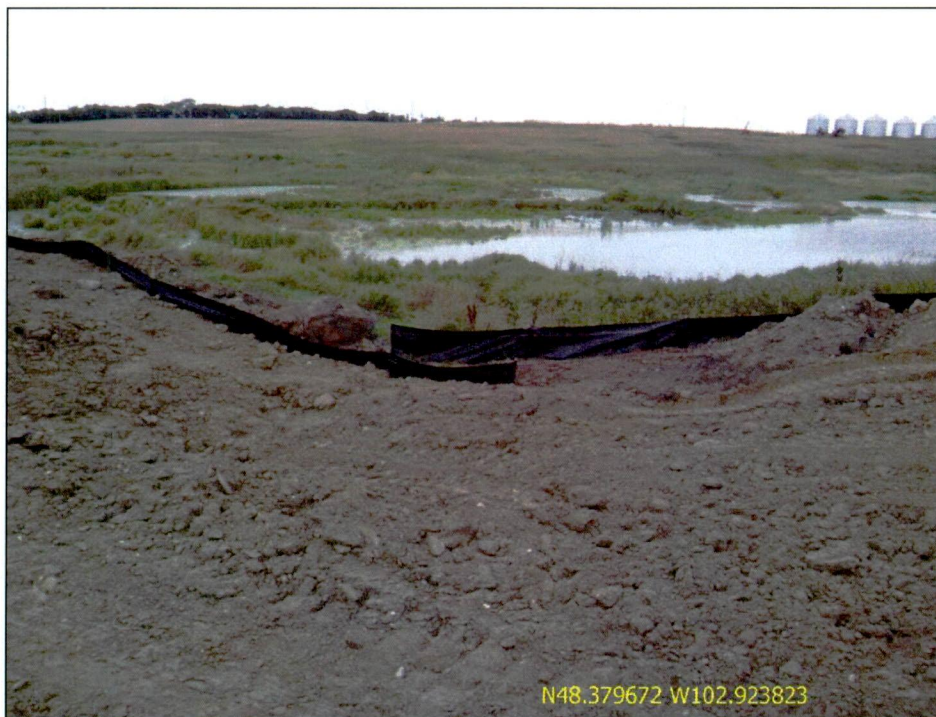
Figure 7. Silt fence improperly installed directly above stream/wetland complex. No sediments had washed through. Hess EHS Advisor assured maintenance will occur immediately.

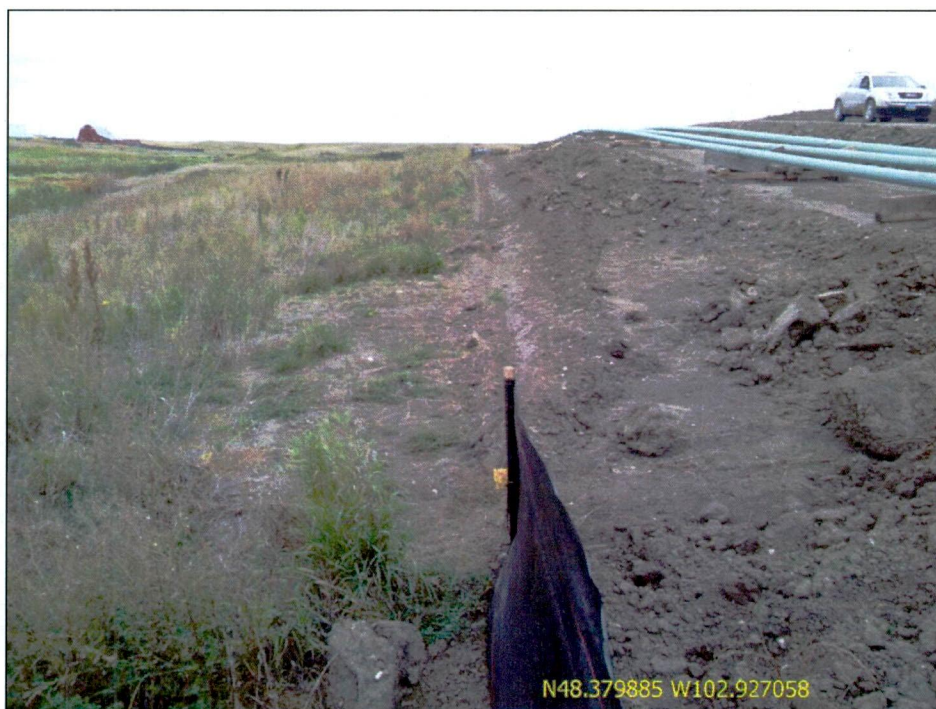
Figure 8. Additional silt fencing recommended to be installed along downslope of ROW just east of Highway 40 crossing.

*Silt fence missing a 200-250' section east of HWY 40 (repaired/completed)

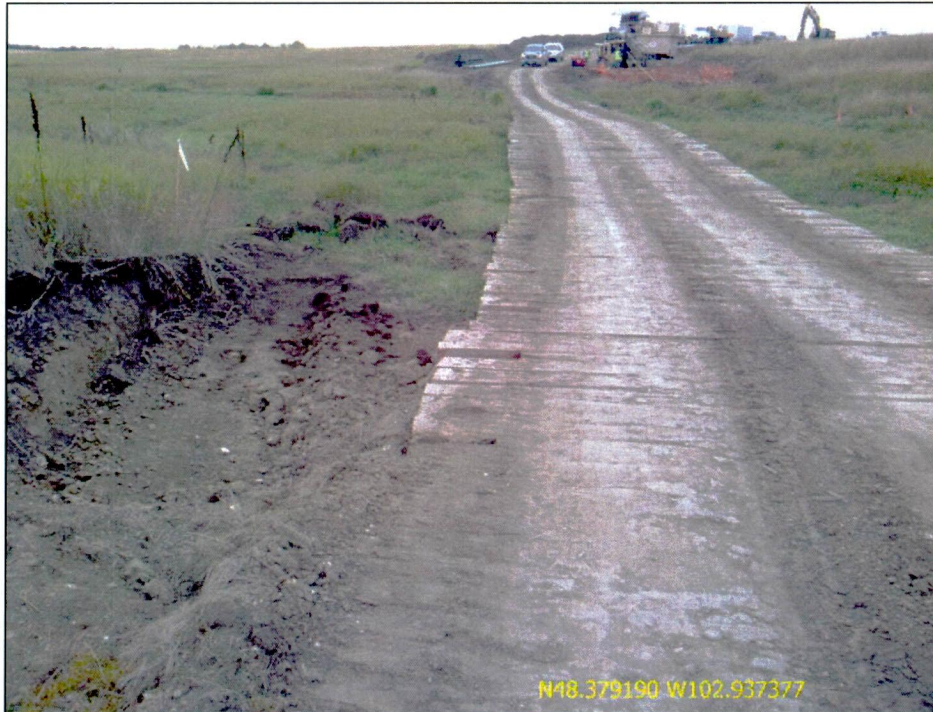
Figure 9. Photo of wooden matting placed to minimize surface impact of stream/wetland crossing west of Highway 40. Additional silt fencing was recommended at crossing entrances and below the HDD bore pit.

- Silt fencing missing below bore pit and west of crossing on the fill slopes (completed/repaired)

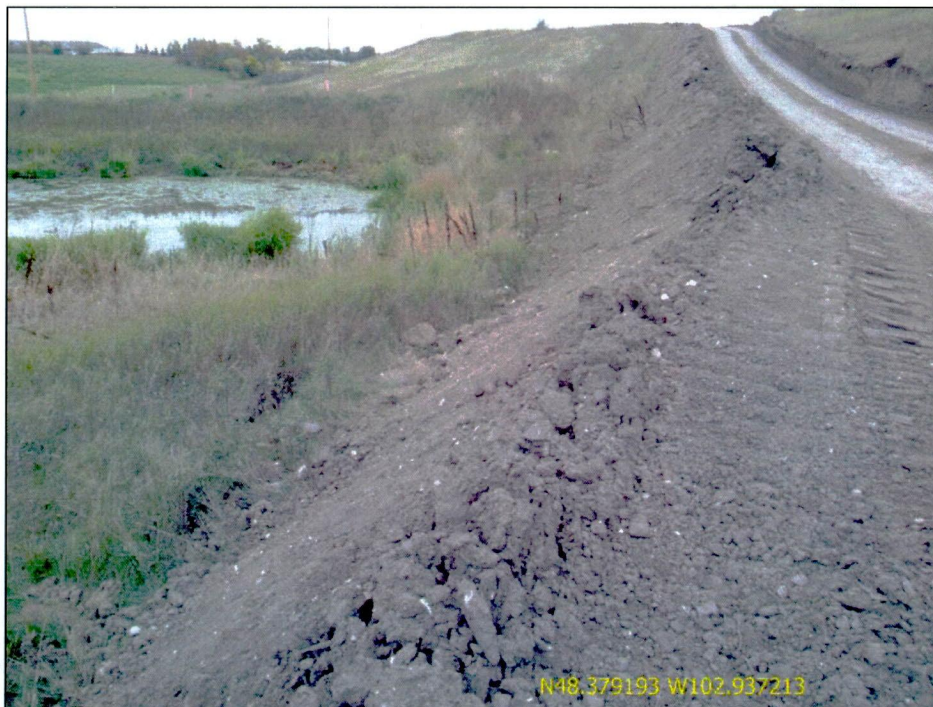
Figure 10. Photo of temporary access road built up along the edge of a wetland complex. Additional ECDs recommended to reduce potential sediment deposition into wetland.

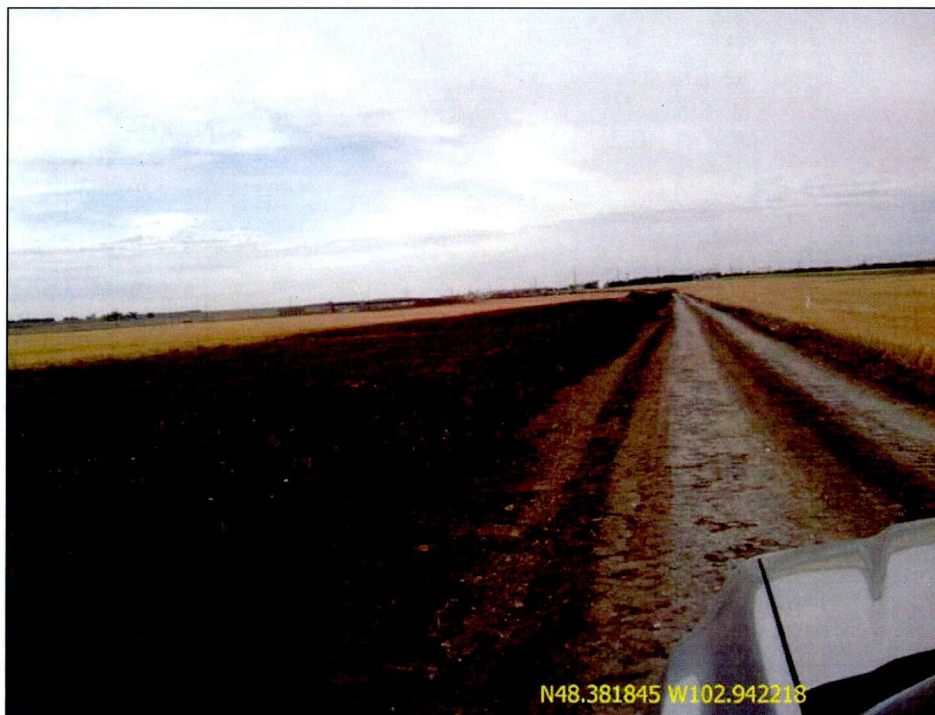
Figure 11. Photo of ROW in which pipeline installation has occurred and topsoil has been redistributed across ROW (except for on utilized access route).
