Vantage Pipeline US LP Weekly Report for the week ending August 31, 2013

Case Number PU-11-109

PSC Weekly Report

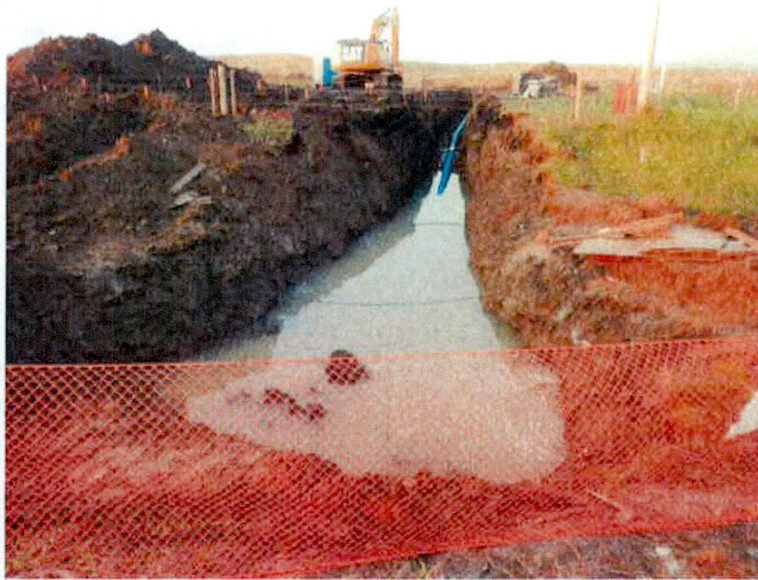
August 25 – Water collected in a boring pit and trench.

- Please comment on Erosion Control implementation and include 3 or 4 pictures (eg. erosion control silt fences, welding pipe, tape coating, road crossings, trenching, bending of pipe, supports and braces, safety measures for traffic control, etc.).**
 - Stormwater BMPs have been installed to Mile Post 32.94 (approximately 41.1% complete). Silt fence is installed around drainages and wetland areas for sediment control. Soil berms and vegetative buffer zones will also control sediment discharge. One rainfall event occurred on August 29, 2013 with a rainfall depth of 0.41 inches reported. No notable erosion or sediment discharge was observed as a result of rainfall since the start of construction. Water from the event accumulated in boring pits and associated trenches and depressions along the RoW. A pump was used to evacuate the water from boring pits and trenches into a dewatering bag.

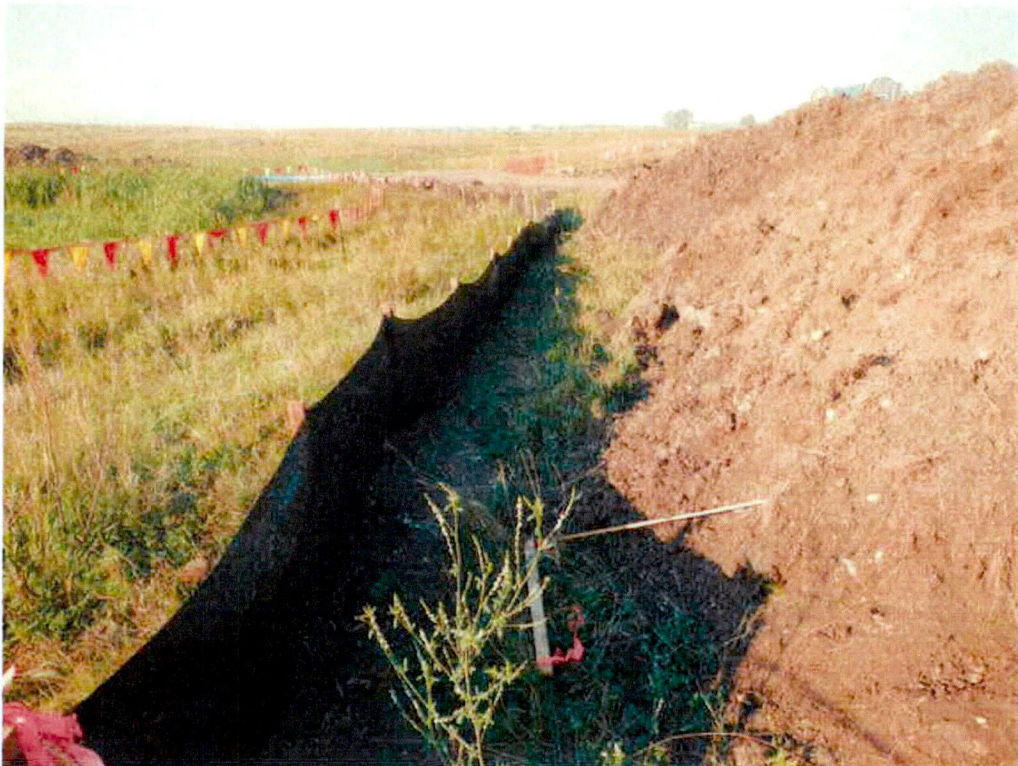
August 25 – Topsoil stockpile near a wetland protected by silt fence.

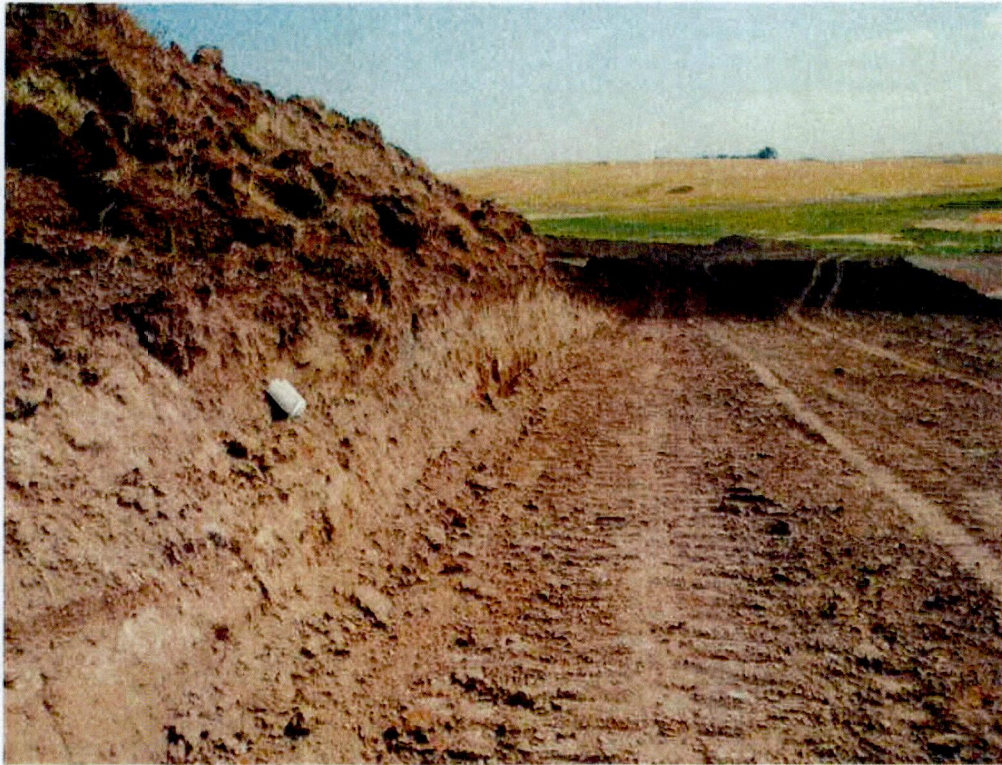
August 28 - Topsoil segregation, grading, and subsoil leveling.

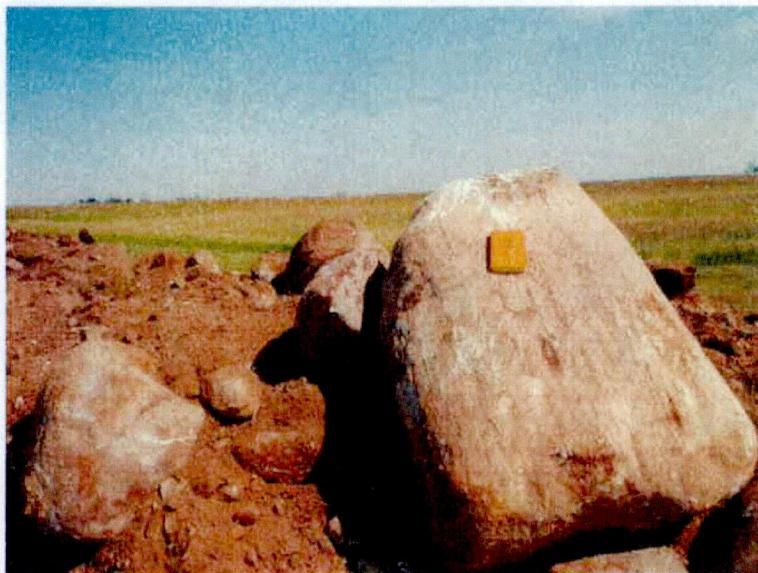
August 30 - Boulders in granular soil encountered in native grassland.
