PSC Weekly Report

Vantage Pipeline US LP Weekly Report for the week ending September 7, 2013

Case Number PU-11-109

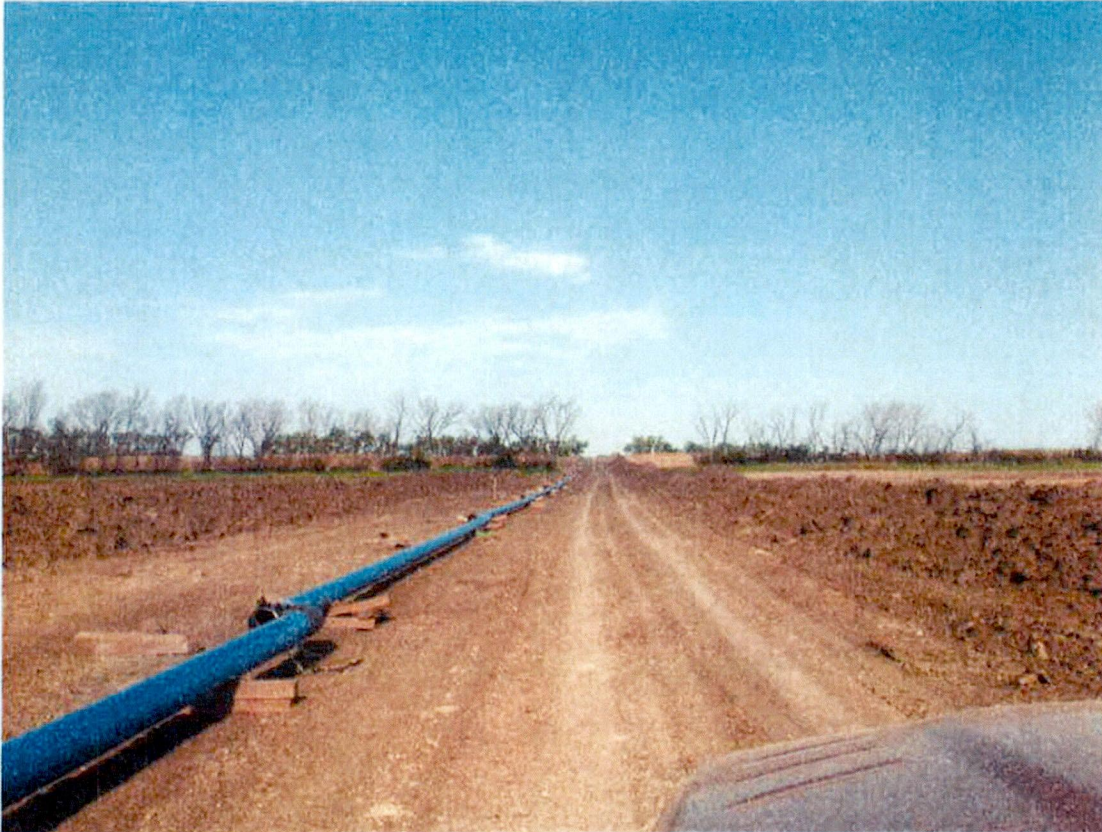
September 4, 2013 – Several shelter belts shown with pipe stringing.

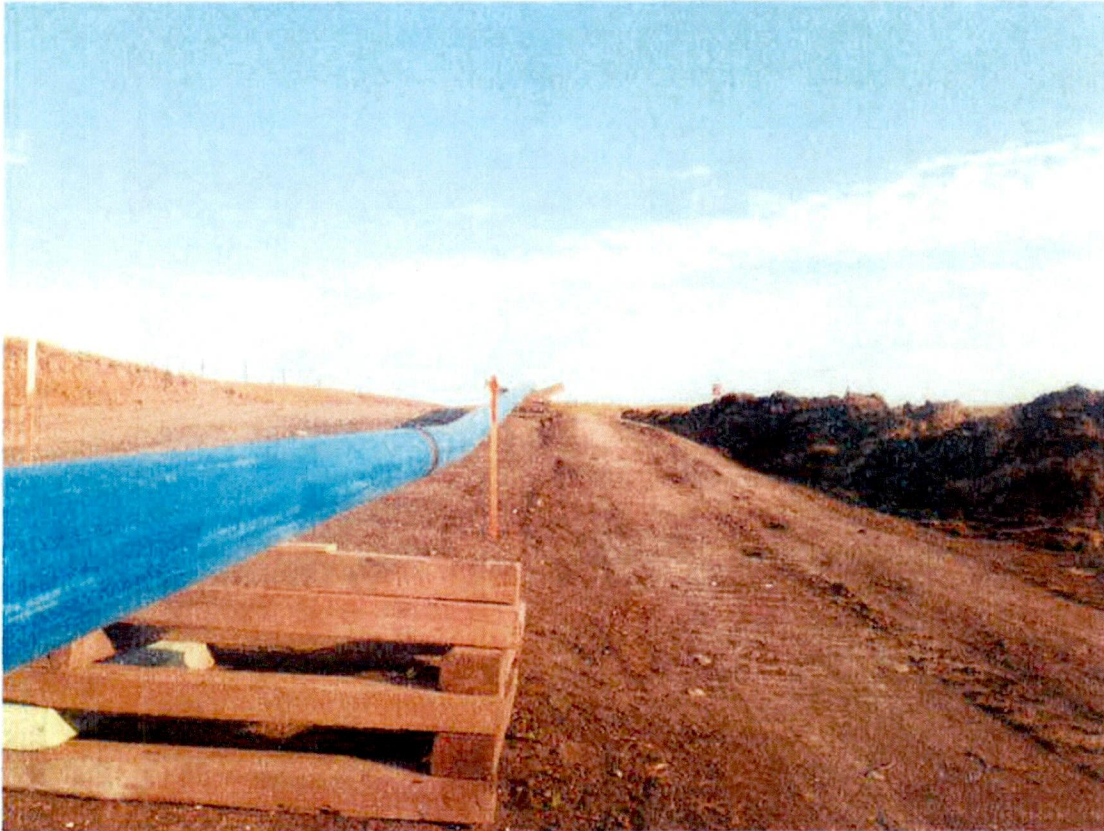
September 5, 2013 – Pipe stringing and welding at MP 0.54

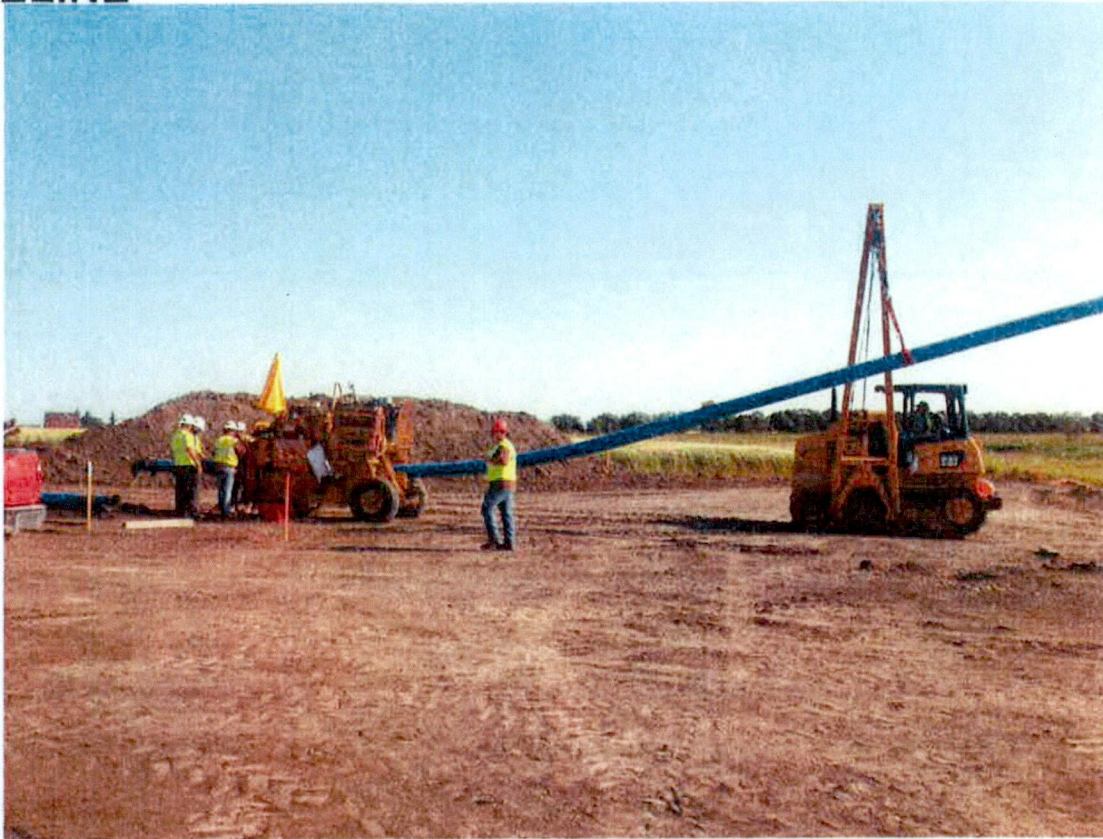
September 5, 2013 – Pipe bending operation at MP 12.03

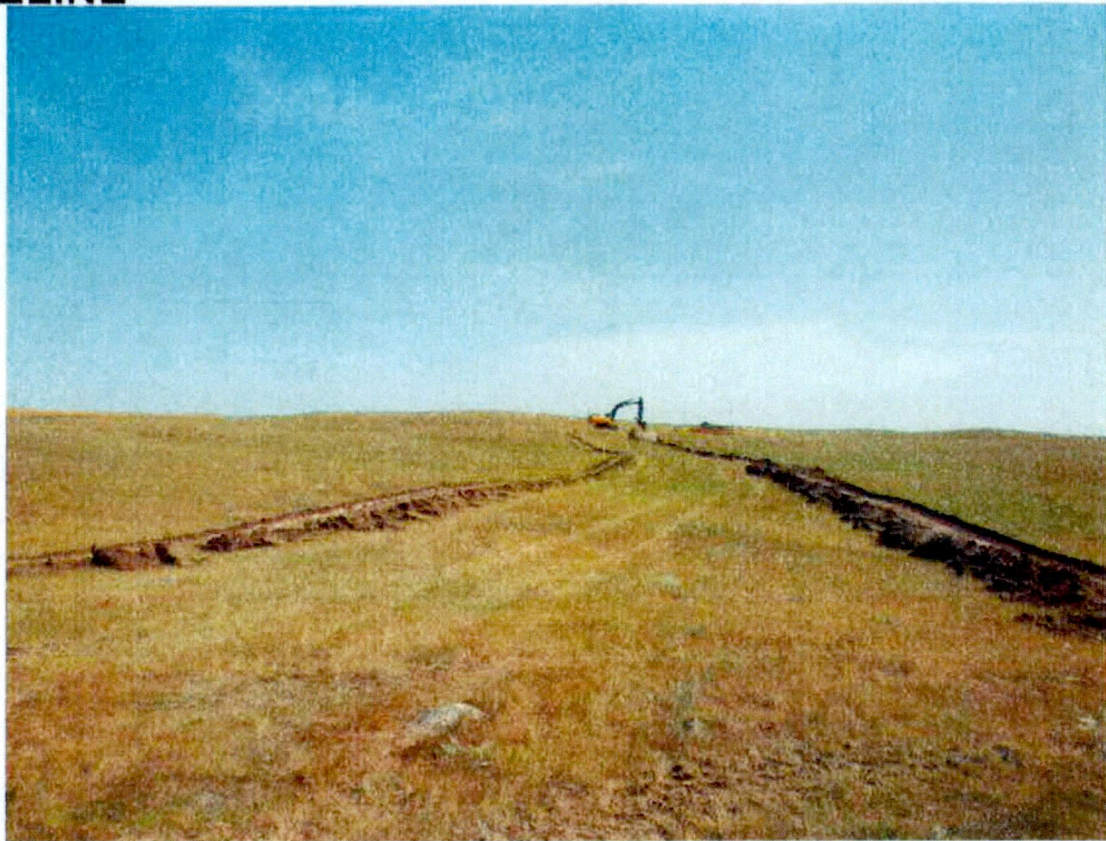
September 3, 2013 – Stripping activities near MP43.03
