Vantage Pipeline US LP Weekly Report for the week ending October 5, 2013

Case Number PU-11-109

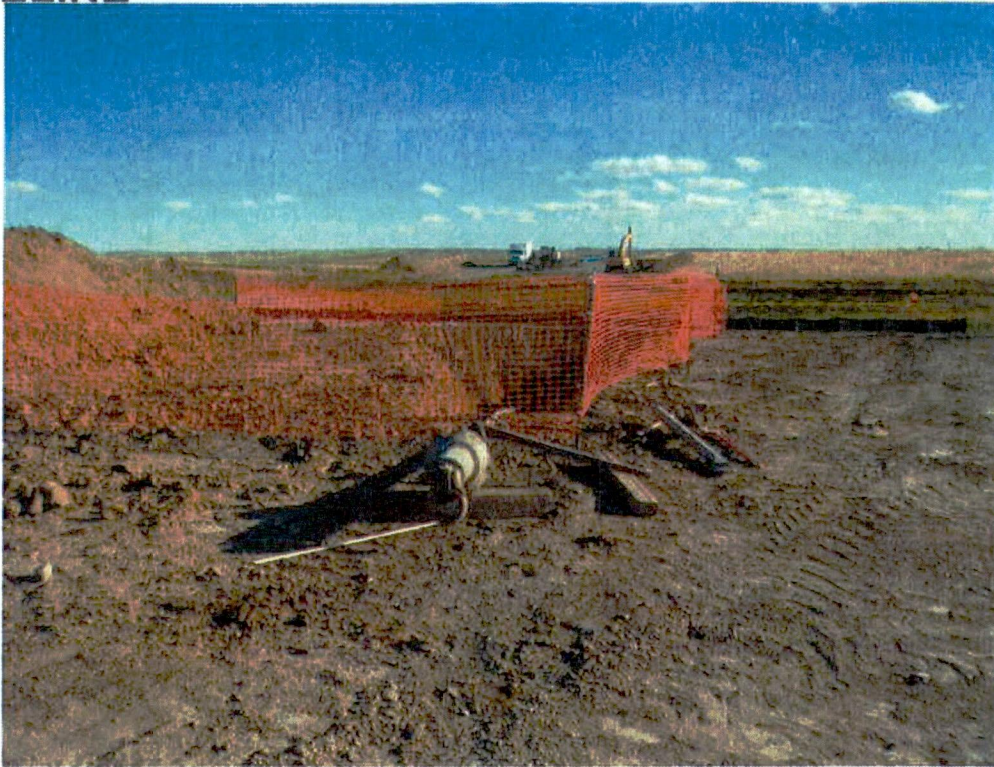
End of directional bore at MP 56.79, prior to pulling pipe back through bore.

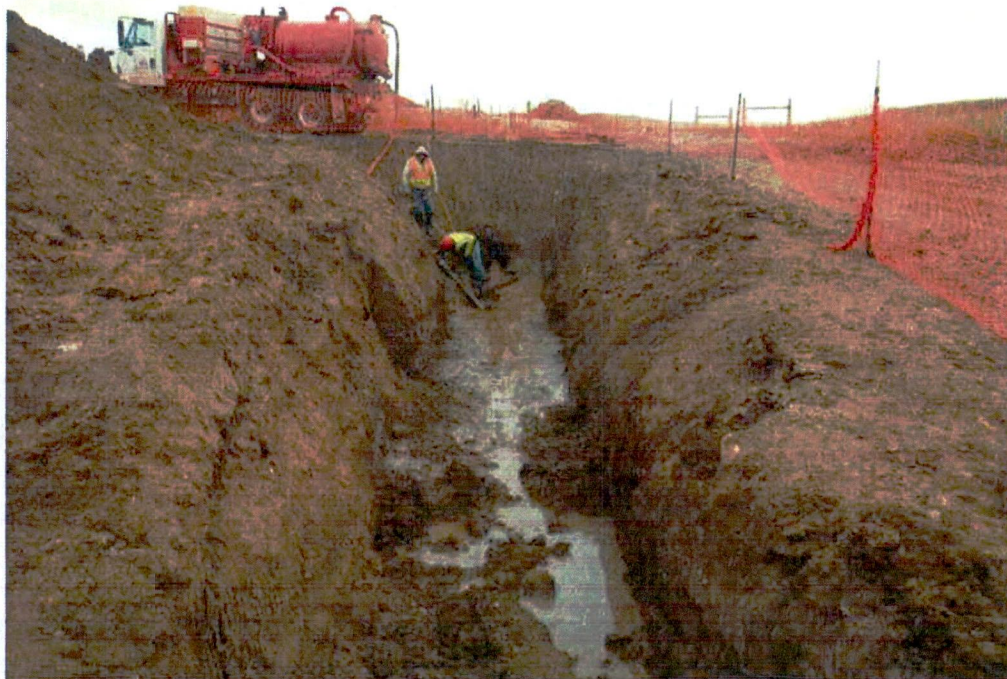
Removal of mud and water at the end of directional bore started at MP 59.19.

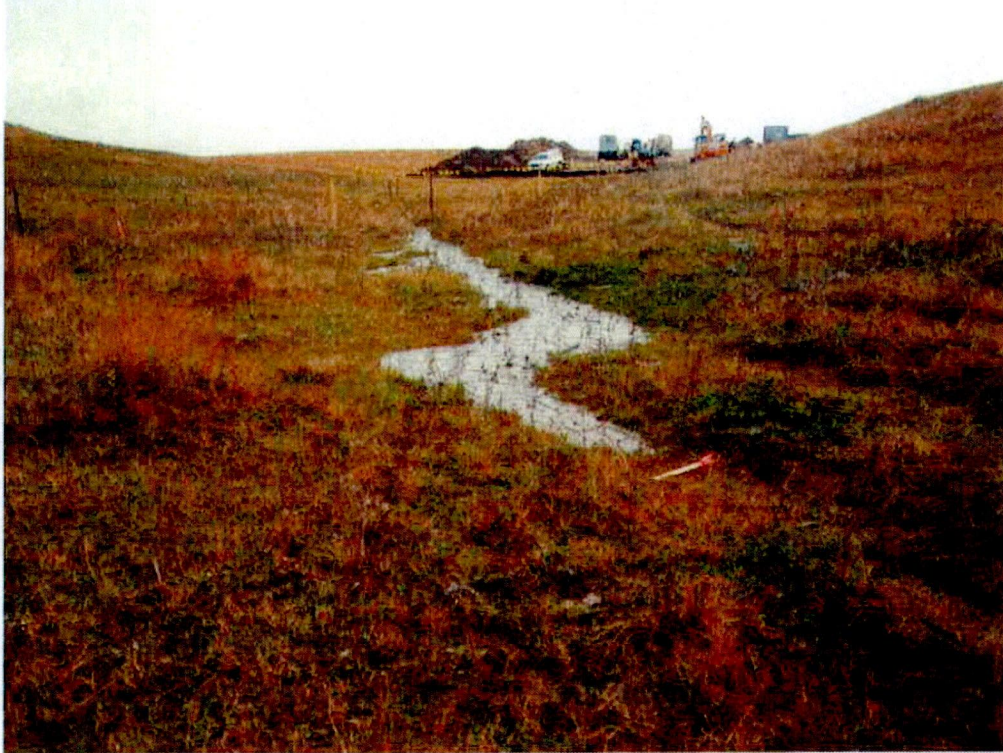
Directional drilling of the two wetland area beginning at MPs 56.79 and 57.99 were completed by October 3, 2013. Also, a directional boring was completed under a grasslands easement at MP 59.19 on October 4, 2013. Mud pits associated with drilling activities at completed locations were backfilled and compacted with native material. No environmental issues were noted at these three drilling locations. No environmental concerns were noted associated with conventional drilling under major roads and wetlands during the reporting period. In addition, a relatively lengthy directional bore was initiated under a cultural site beginning at MP 74.98. Some release of mud and water was observed just downslope of the bore beginning. This small release of mud and water will be cleaned up once the bore has been completed.

Mud and water release at directional bore site under cultural area at MP 74.98.

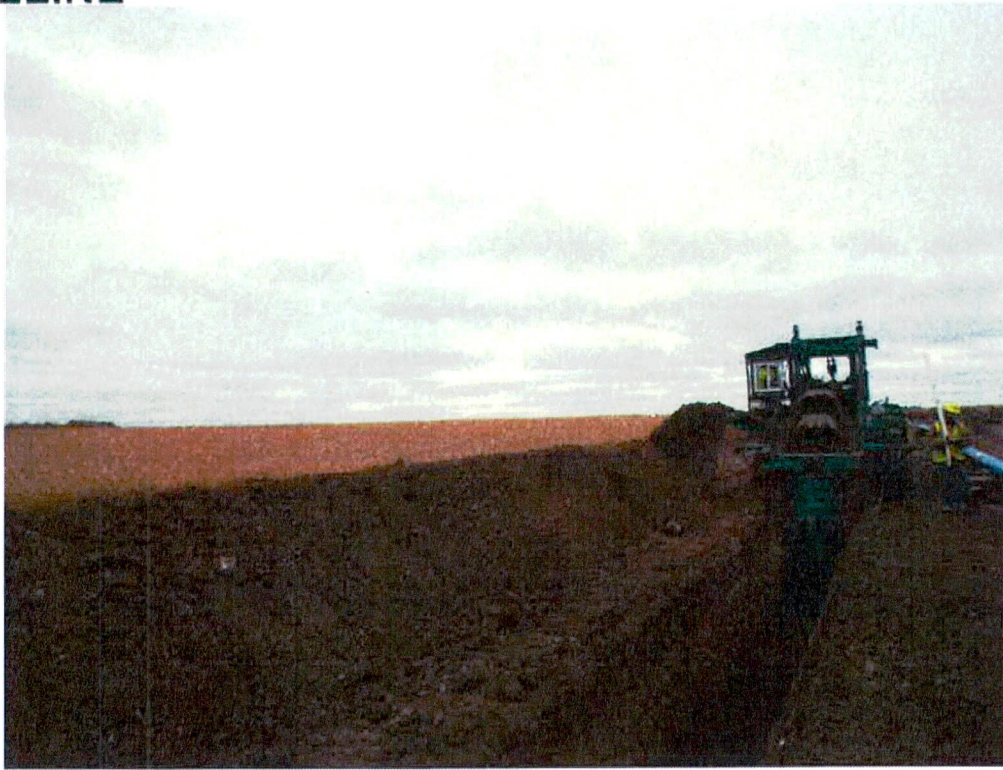
A trenching machine on the ROW.

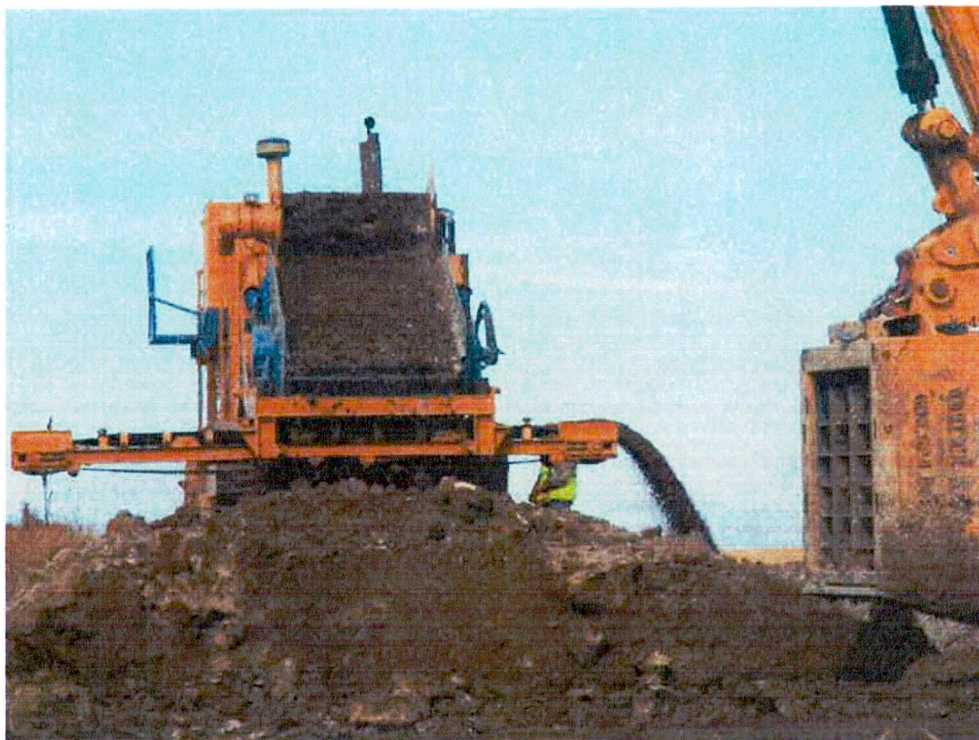
Remote operated backfill shaker, padding the pipe.

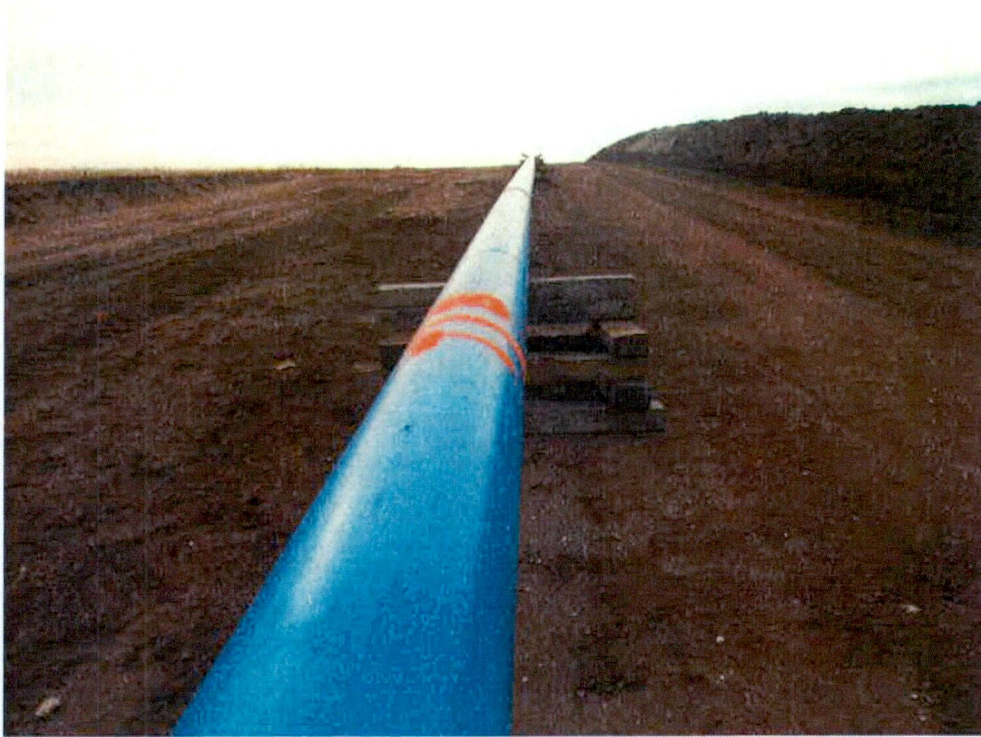
A trench break marked near MP 44.16 along a slope in the ROW.

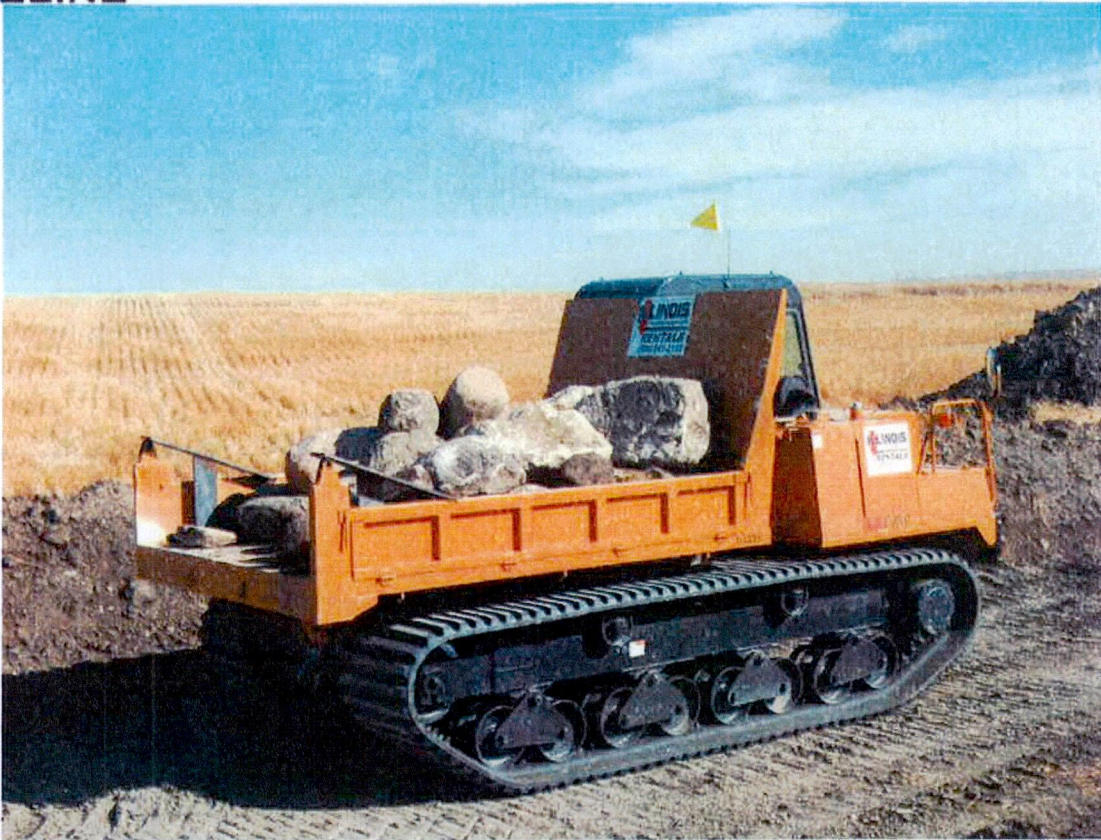
Oversize rock removal during final topsoil placement.
