Vantage Pipeline US LP Weekly Report for the week ending October 12, 2013

Case Number PU-11-109

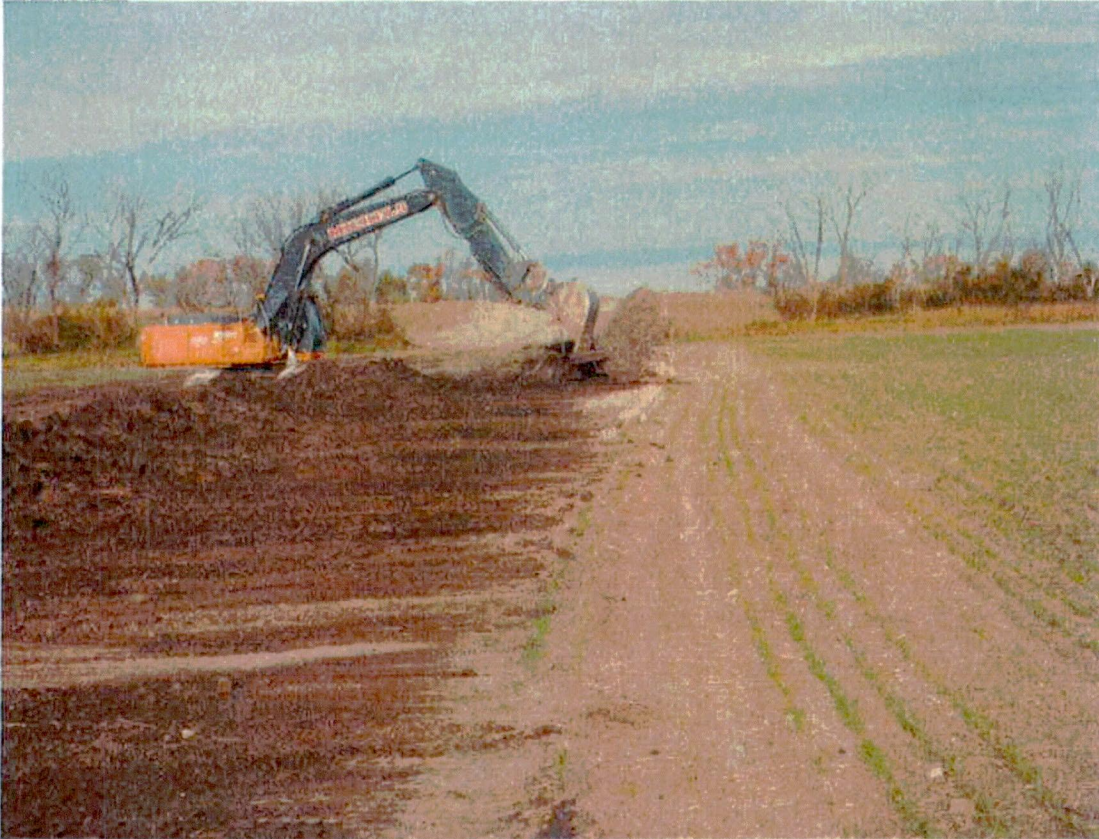
An excavator pulls topsoil back onto the ROW for spreading

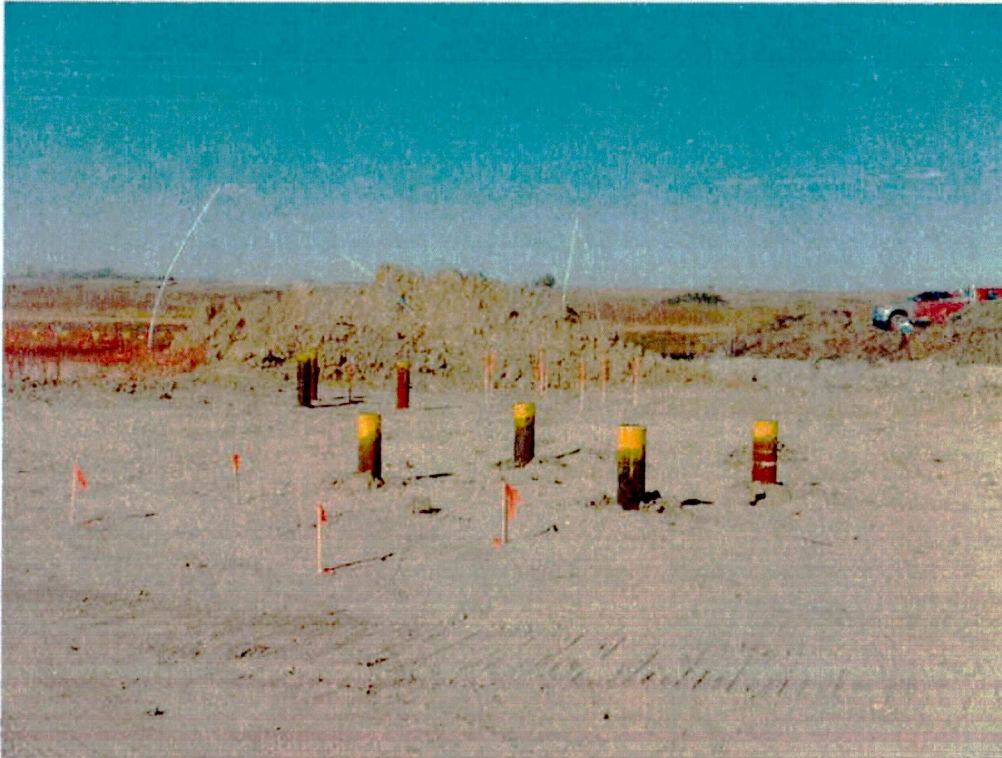
Set-up began for block-valve construction along 74th Ave during this reporting period.

Block-valve pad location just south of 74th Ave.

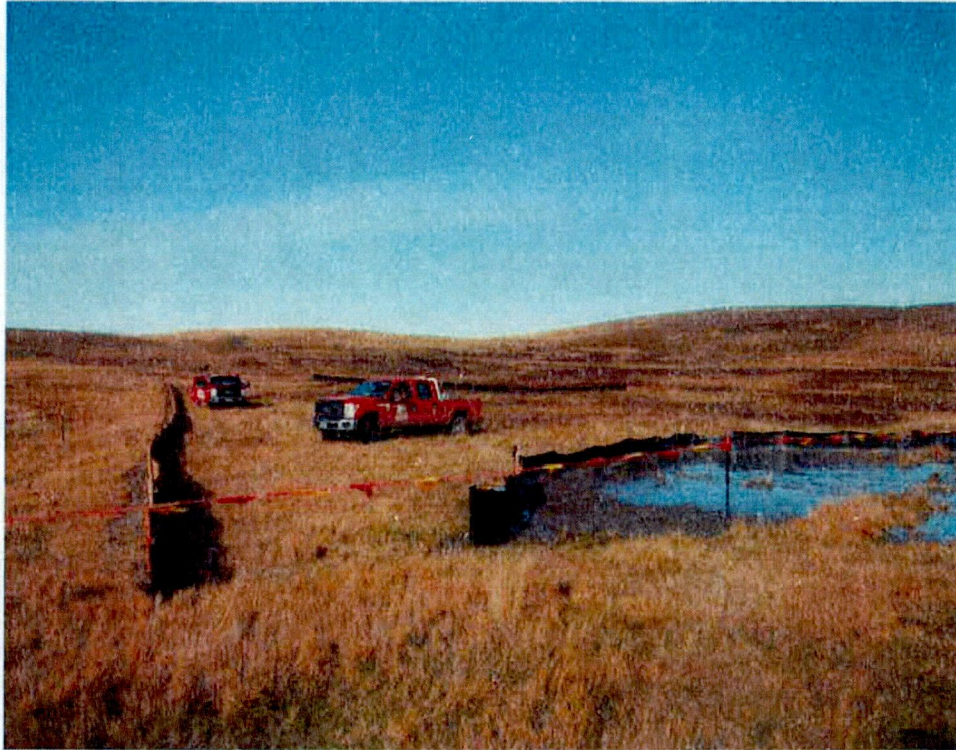
Conventional drilling under major roads and wetlands was completed during the reporting period. Four HDD areas remain to be completed. The directional bore under a cultural site beginning at MP 74.98 ending at MP75.39 continued during this reporting period. Various amounts of mud and water from the drilling appeared on surface. All releases were promptly contained with silt fence and straw wattles. No wetlands or riparian areas were impacted by mud release.

Silt fence contains drill mud.

Where reasonable, the mud releases will be cleaned up. In some cases mud releases will be left and reclaimed during the seeding process.
