Vantage Pipeline US LP Weekly Report for the week ending October 26, 2013

Case Number PU-11-109

Vantage Pipeline US LP Weekly Report for the week ending October 19, 2013

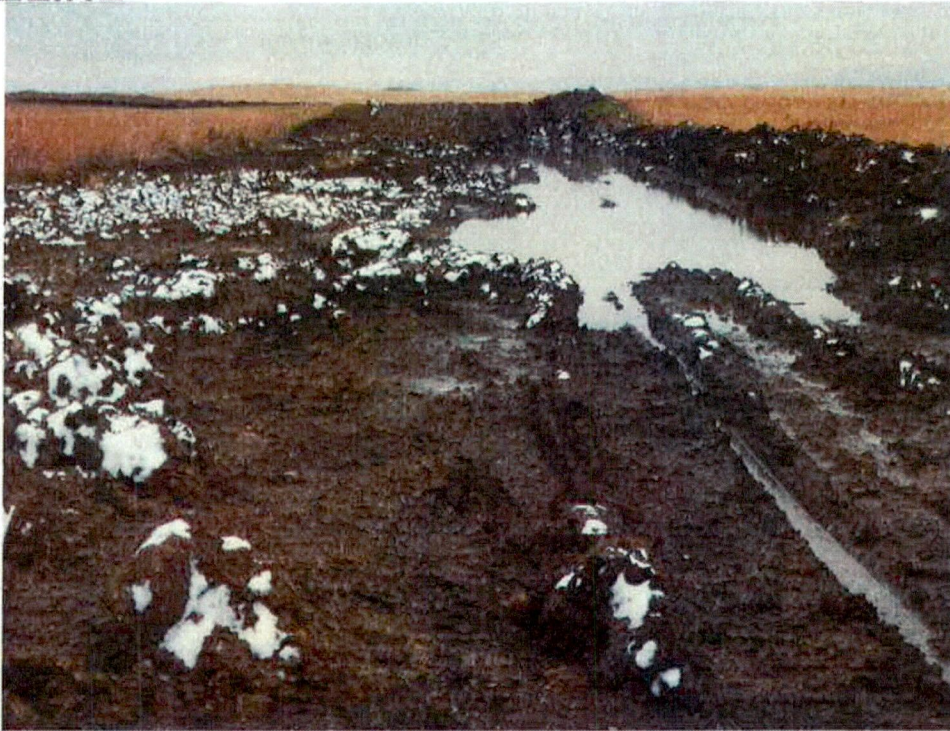
Difficult surface conditions encountered by the reclamation crew.

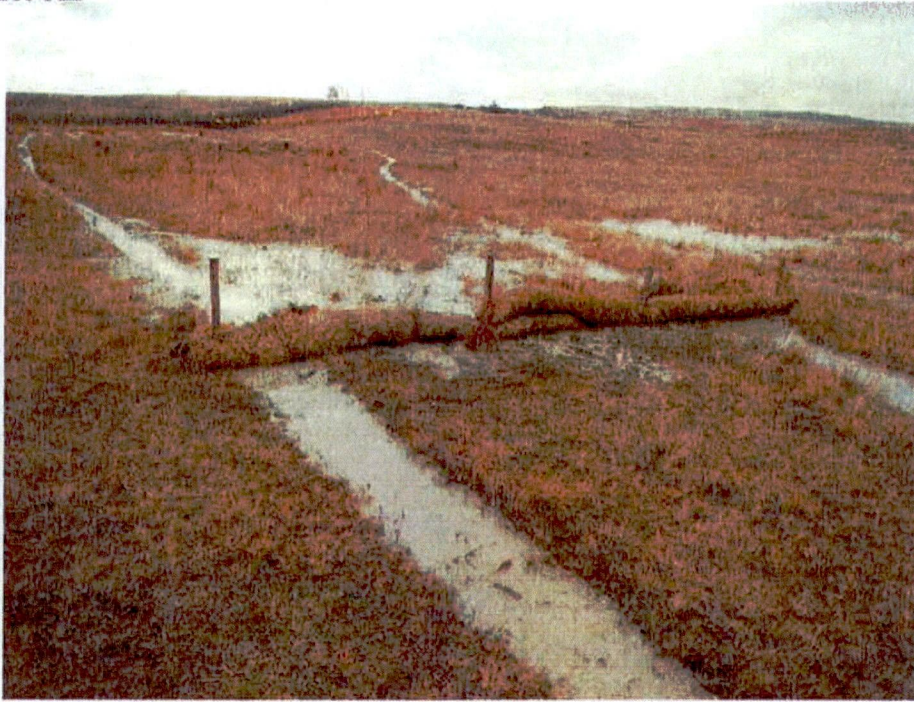
Straw wattles placed to divert water from cow paths onto pipeline corridor near MP68.06.

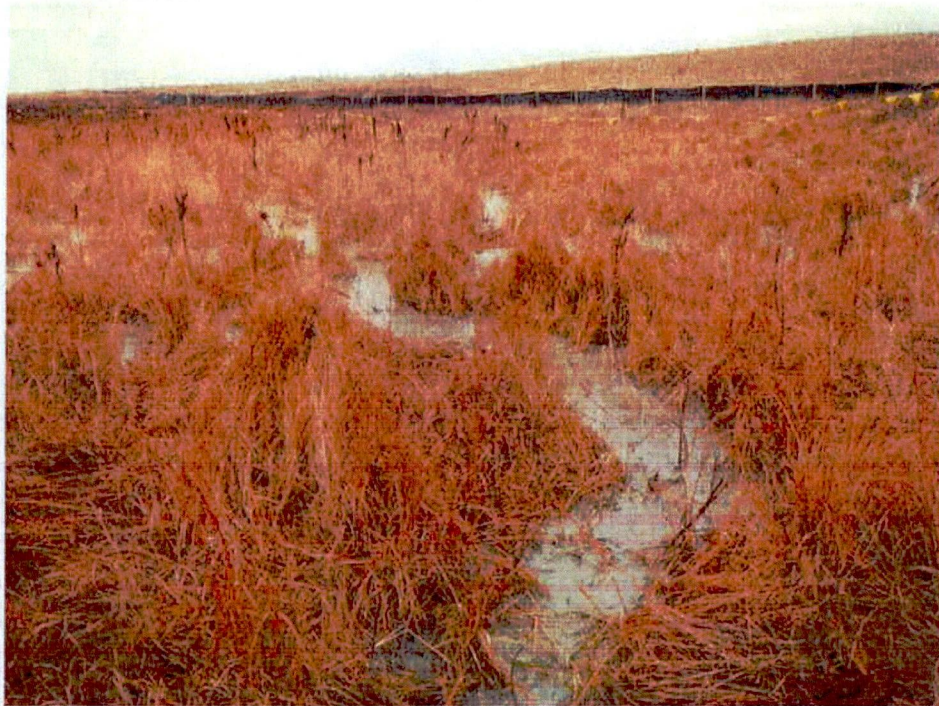
Conventional drilling under major roads and wetlands has been completed, with the exception of the wetland near MP 51.79. One HDD bore location remains to be completed. The directional bore site under a cultural site beginning at MP 68.37 ending at MP 67.85 continued during this reporting period. Release of mud and water has been observed along this drill line. All releases have been promptly addressed with the installation of silt fence and straw wattles. A dry wetland near MP 68.02 received some mud and water from the drill. Cleanup of the releases will begin after drilling is complete and pipe has been installed. Since the wetland is within a wetland easement, cleanup methods will be determined based on U.S. Fish and Wildlife Service requirements. Scott Williams with the USFWS was contacted about the release and visited the site on 10/25/13.

Wetland impacted by water and mud near MP 68.03.

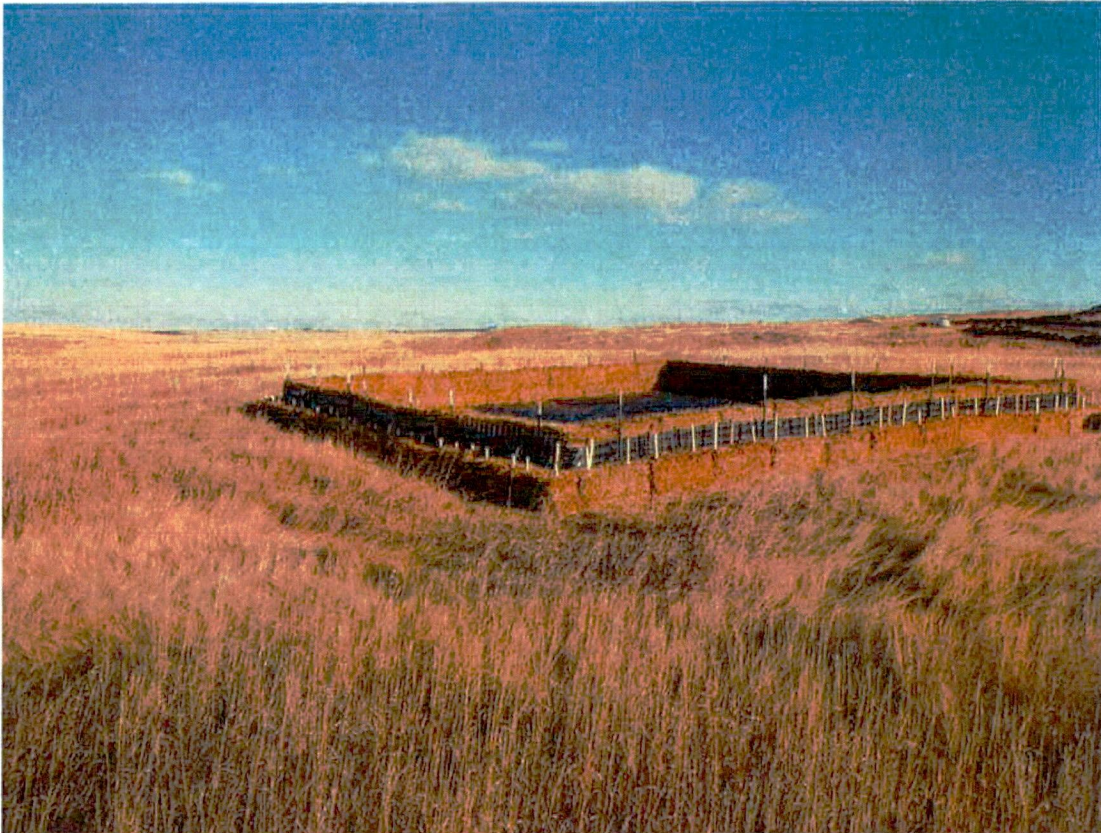
A water containment area was constructed during this reporting period near MP 30.93. The containment structure, constructed consistent with Detail 9 of the project EPP, will be used to dissipate discharge water from hydrostatic testing of the pipeline from MP 0.17 to MP 30.88.

Containment area near MP 30.93, constructed to dissipate discharge water used during hydrostatic pipeline testing.

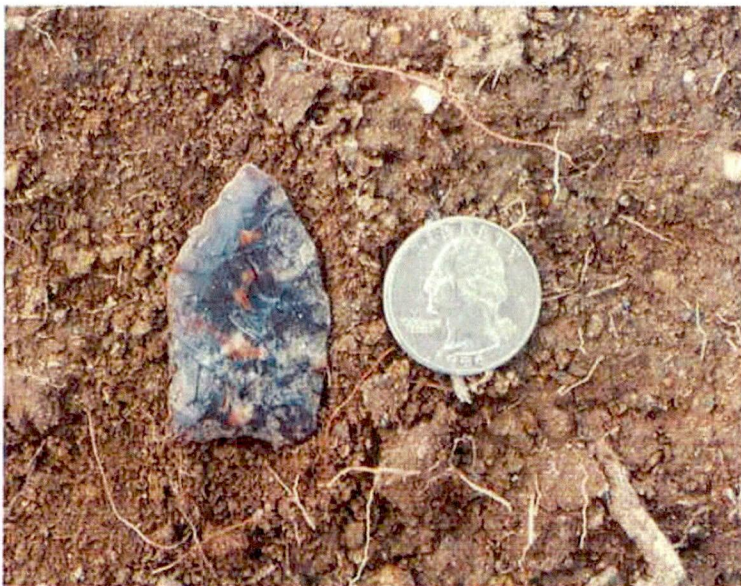
Projectile Point found during monitoring near MP 38.34.

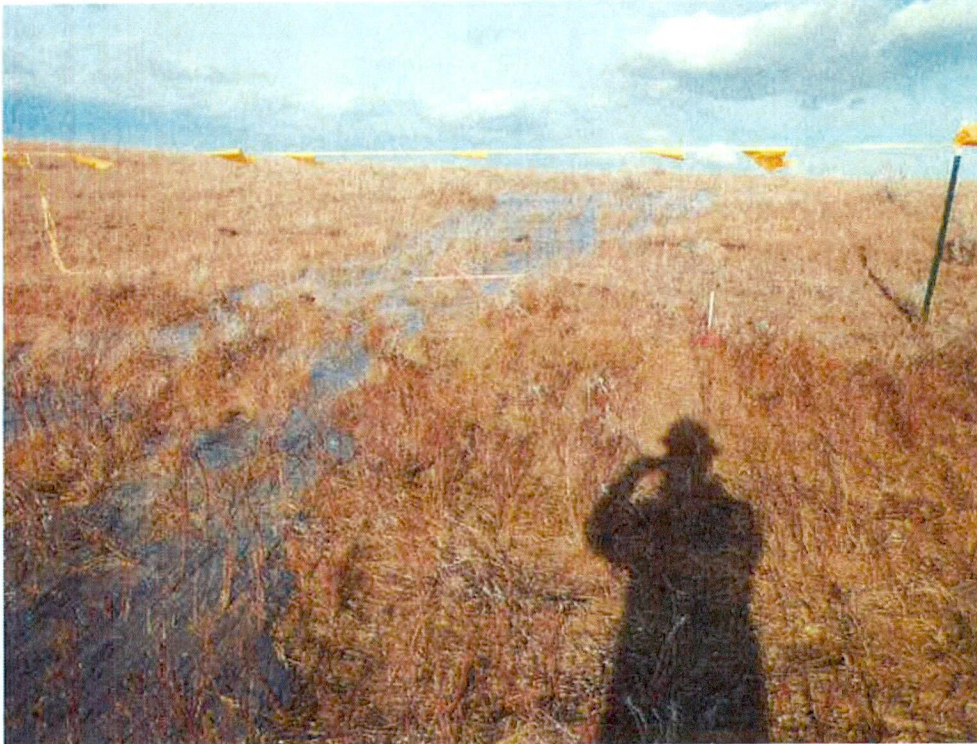
ending at MP 67.85 was initiated during this reporting period. Release of mud and water from the drill occurred during this drill. All releases have been promptly contained with silt fence and straw wattles. No wetlands or riparian areas were impacted by drill mud release. Cleanup of the releases will begin after drilling is complete and pipe has been installed. Cleanup methods of releases within exclusion zones will be determined based on landowner requirements.

Release of mud and water northeast of ROW at MP 68.01.

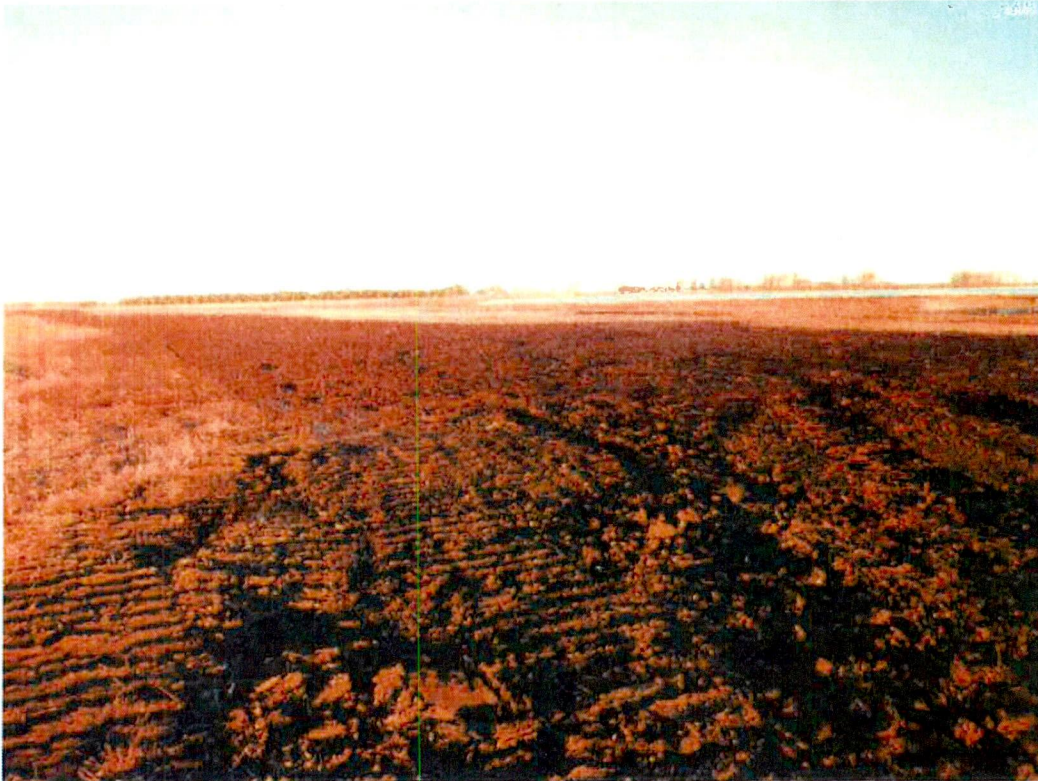
Re-graded ROW after topsoil placement.
