Vantage Pipeline US LP Weekly Report for the week ending November 2, 2013

Case Number PU-11-109

PSC Weekly Report

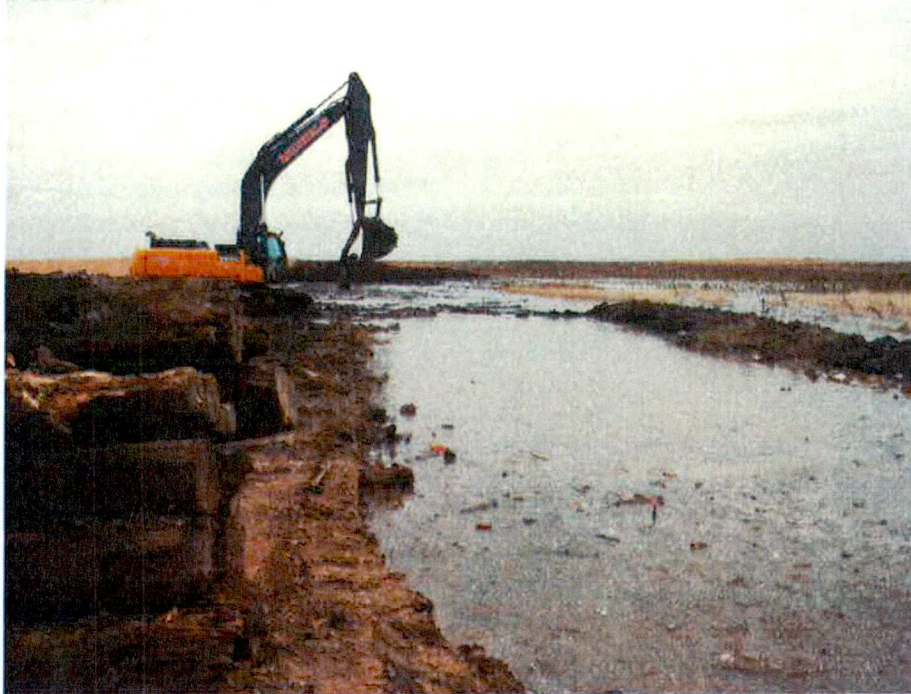
Storm water from past precipitation events continues to be removed from boring pits, trenches, and within low spots along the ROW. Water is being removed by pumping water into sediment bags that are placed in heavily vegetated areas for water dispersion and in some cases placed behind an existing silt fence where space is limited. Michel's environmental crew is systematically addressing details of any required maintenance noted during stormwater inspections.

Stormwater accumulation in a low spot along the ROW.

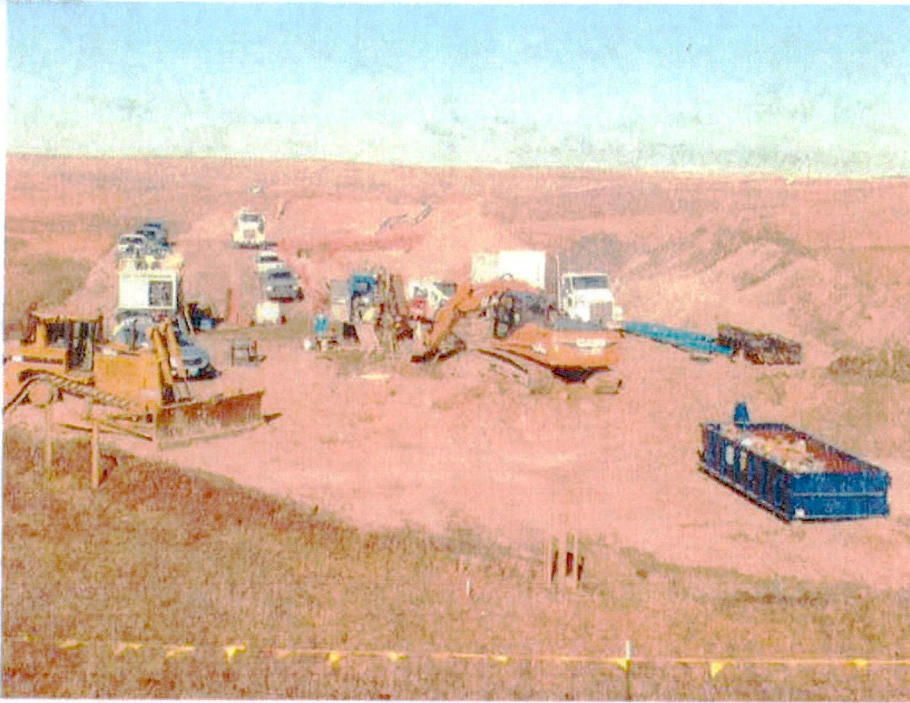
One HDD bore location remains to be completed. The directional bore site under a cultural site beginning at MP 68.37 ending at MP 67.85 continued during this reporting period. Release of mud and water during the drill has been observed along this drill line. All releases have been promptly addressed with the installation of silt fence and straw wattles. The mud/water mix broke thru a silt fence and a dry wetland near MP 68.02 received approximately 4.5 yards of drill fluid. Cleanup of this release into the dry wetland will begin after drilling is complete and pipe has been installed. Wetland cleanup methods will be submitted to the USFWS for approval before commencement. Cleanup methods of releases within cultural areas will be determined based on landowner requirements.

HDD boring activities at MP68.37.

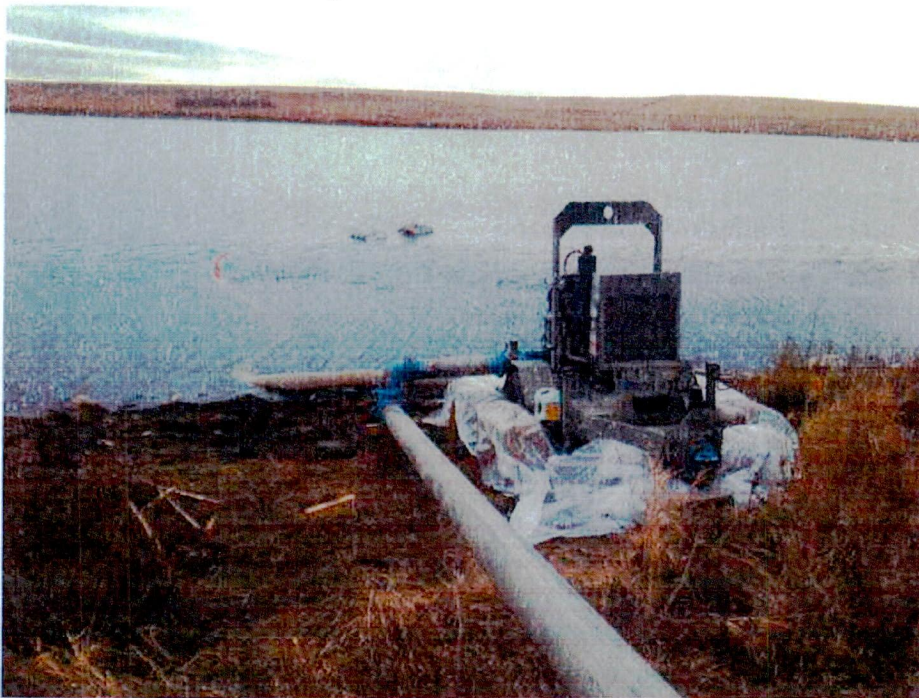
Pump setup for hydrostatic testing from Cottonwood Lake

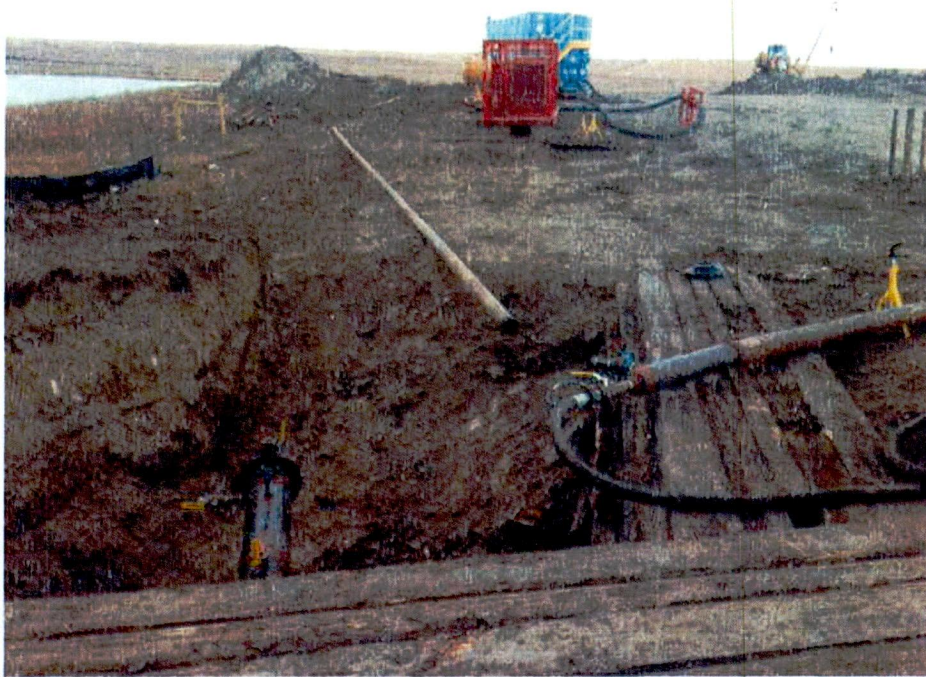
Pipeline preparation for hydrostatic testing with discharge pipe on the right.

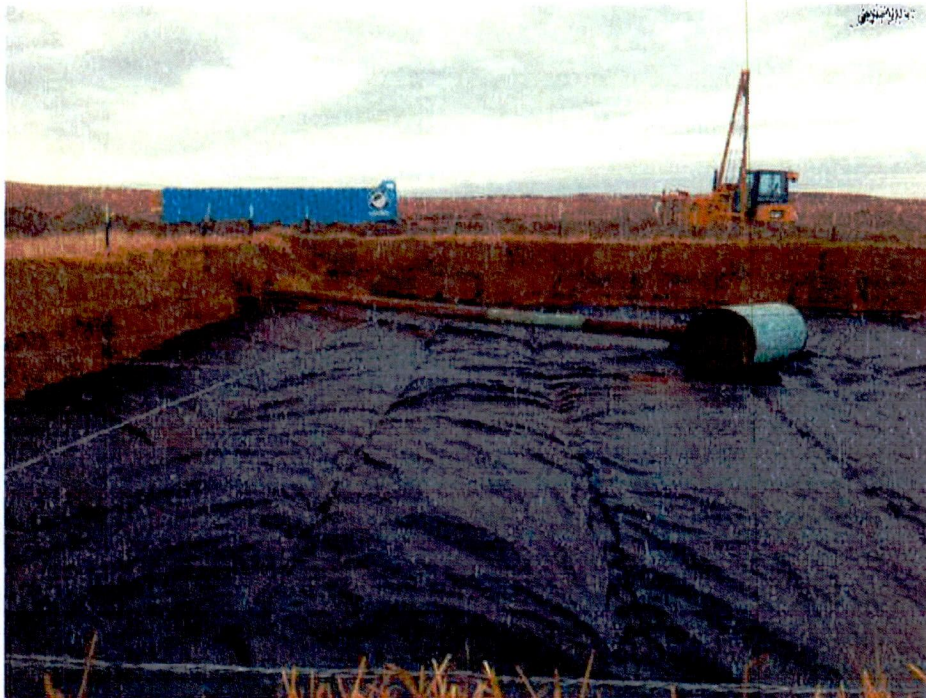
Discharge water containment area with dissipater
