**Vantage Pipeline US, LP
Tioga, ND to Canada Border
Construction Inspection Report**

November 26, 2013

Case No. PU-11-109

Keitu Engineers and Consultants (Keitu) performed a construction inspection of Vantage Pipeline US. LP 80 mile, 10-inch Ethane pipeline project in Williams and Divide County, ND for the purpose of ensuring that the facility authorized by the North Dakota Public Service Commission was constructed in compliance with the siting laws and rules and applicable Commission orders.

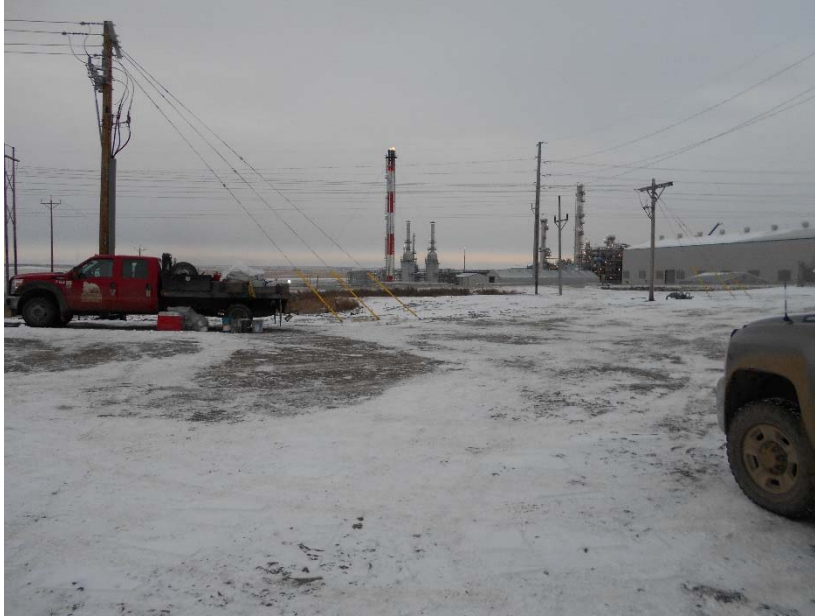
Photo 1 – Beginning of pipeline just north of the Tioga Hess Natural Gas Plant.

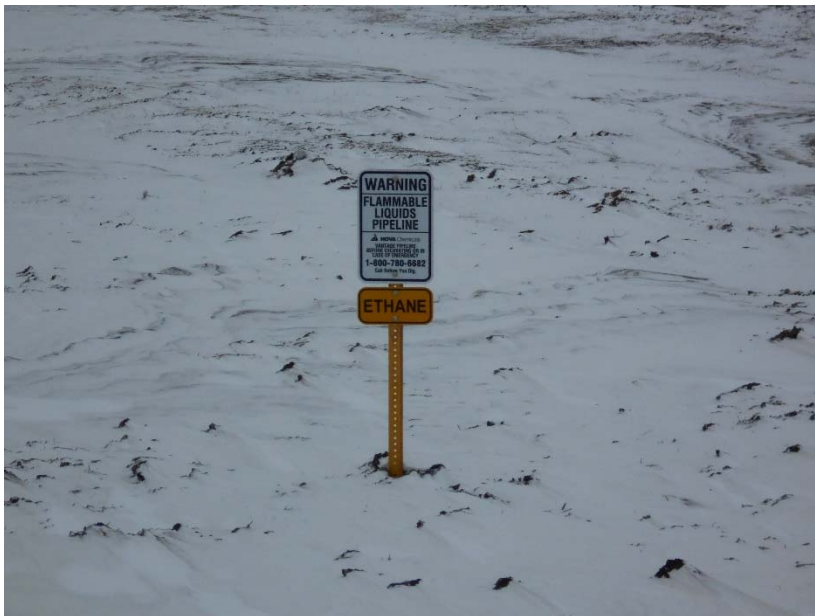
Photo 2 – Typical pipeline marker at road crossing.

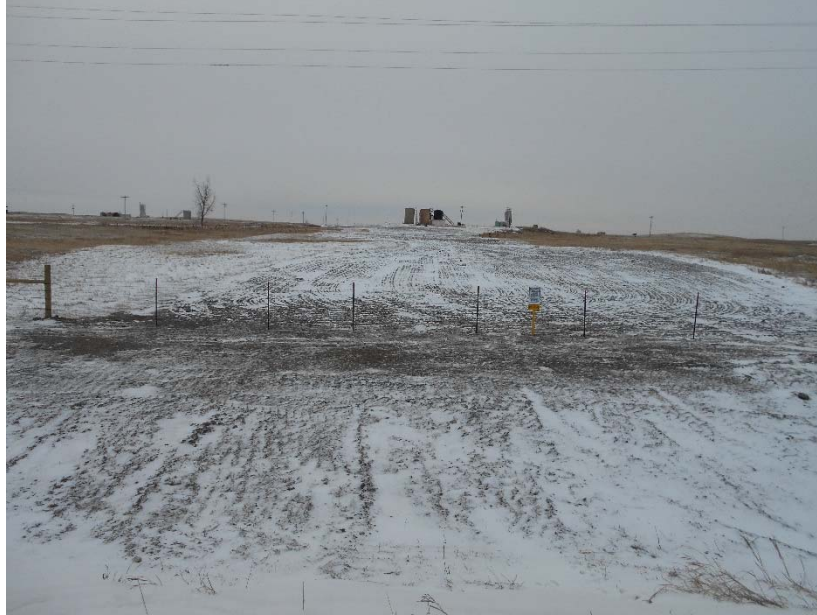
Photo 3 – Replaced fenced and pipeline marker.

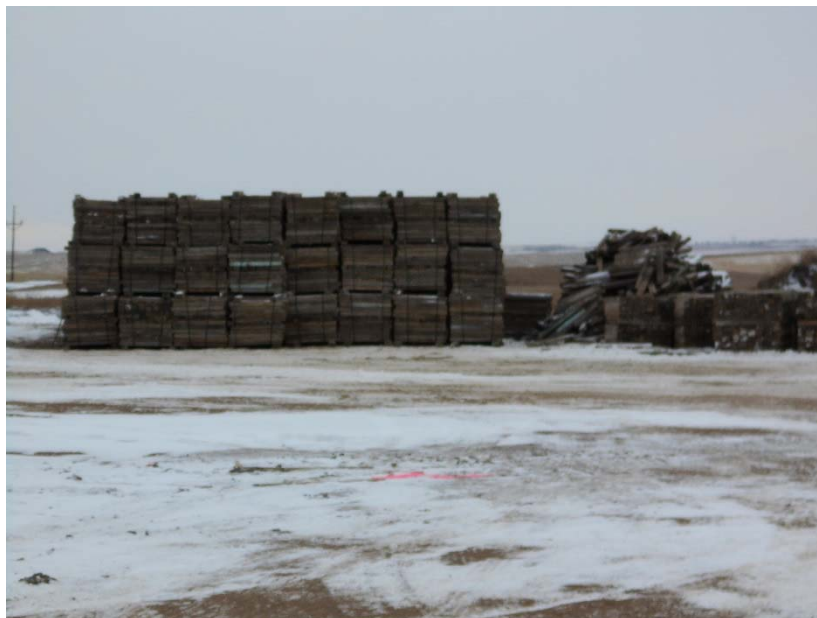
Photo 4 – Matting storage at contractor's laydown area.

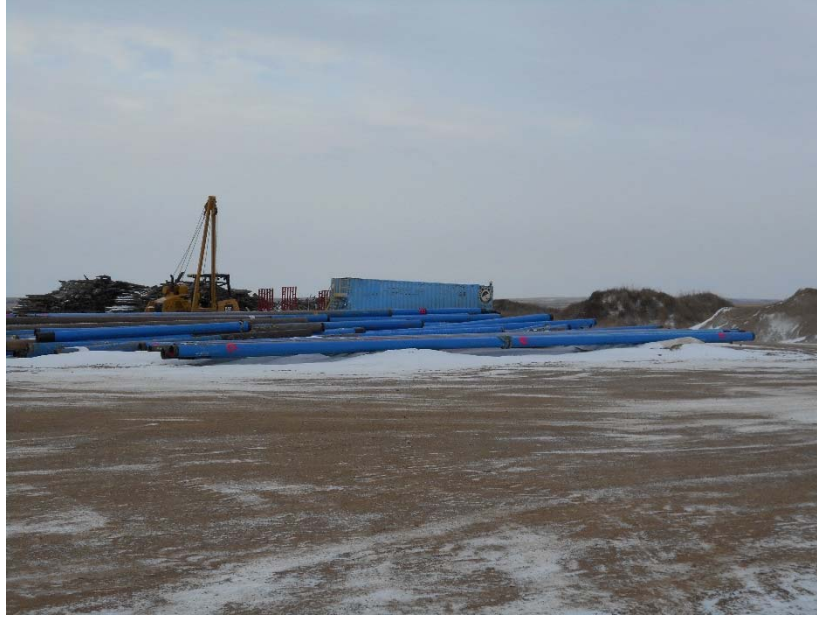
Photo 5 – Piping storage at contractors’ laydown area.

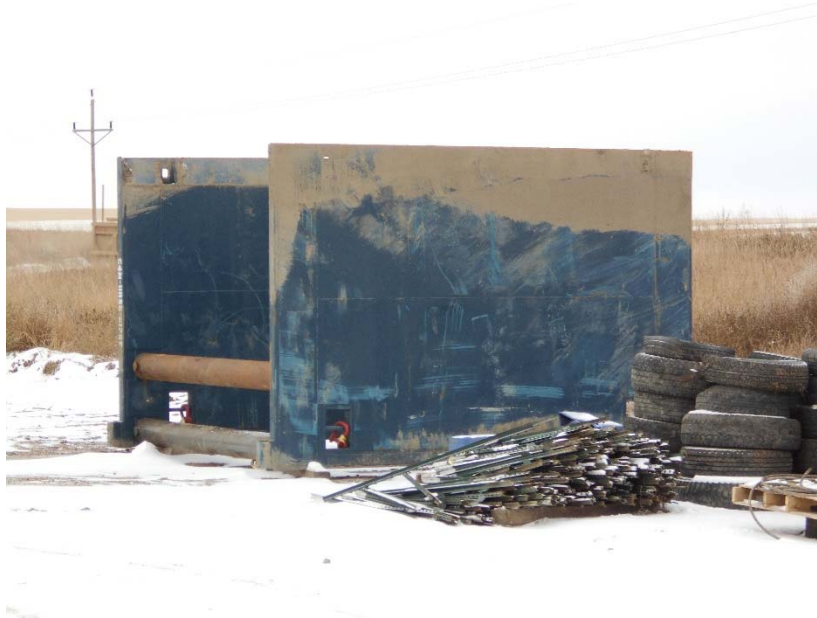
Photo 6 – An example of trench shoring used during construction of the project.

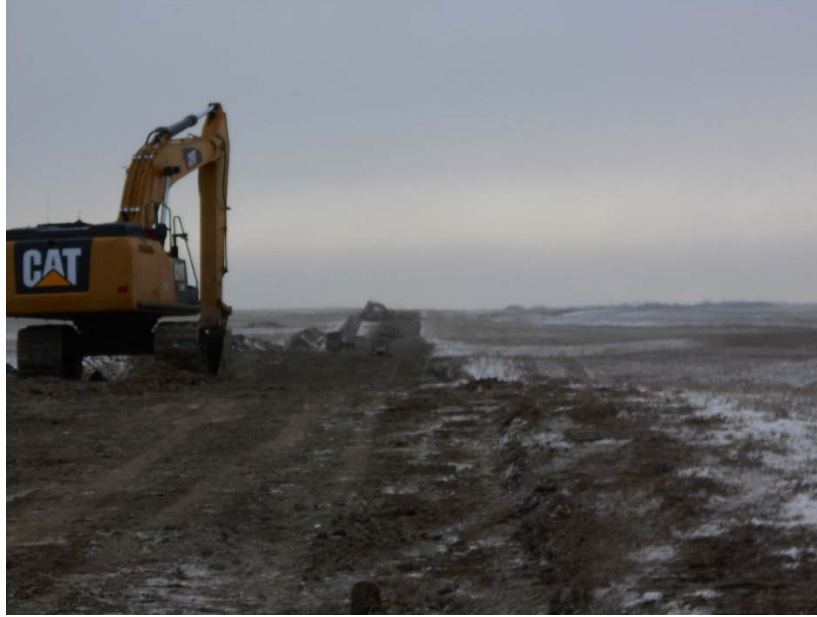
At the time of the inspection, backfill of the pipeline trench has been refilled and compacted. The construction crews were now placing the topsoil, which had been separated out from the backfill soil, on the pipeline. Due to the freezing conditions, reseeding and replanting is going to be restarted as the conditions allow with completion anticipated in the spring of 2014 per David Cameron with KC Harvey Environmental. To date approximately 30 miles of the project has been reseeded. Projects of this type typically are subject to PSC stipulations to monitor revegetation and restoration by October 1st for 3 years following completion of construction. In other areas, if reseeding is still unsuccessful after 3 years, additional topsoil may be necessary for vegetation to colonize the area.

Photo 7 – Construction equipment replacing topsoil along the pipe route.

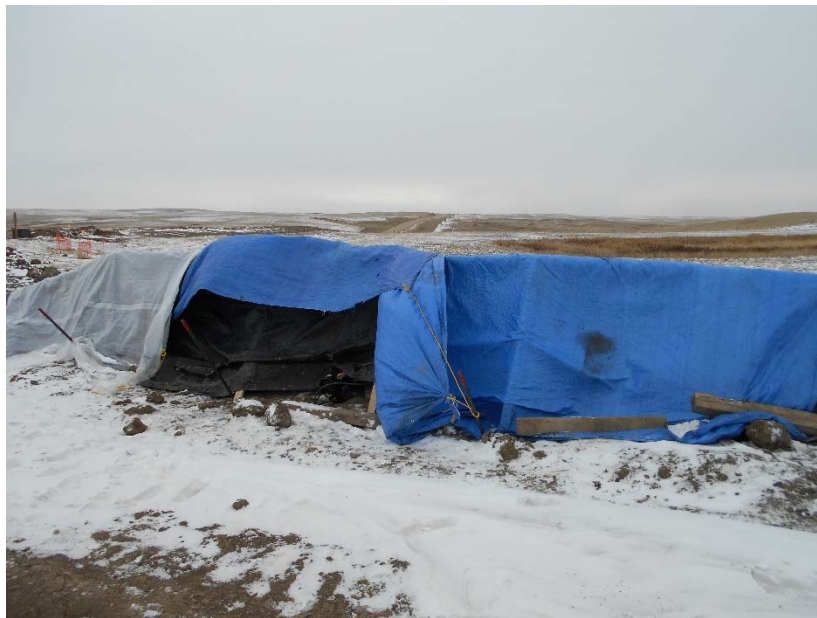
Throughout the project the construction crews were diligent in laying down matting where excessive rutting could occur. Near block valve 6 it was noticed that matting was still in place in order to prevent rutting in a high traffic area.

Photo 8 – Block valve #6 at pipeline crossing of ND Highway 85.
