Vantage Pipeline US LP Weekly Report for the week ending December 7, 2013

Case Number PU-11-109

## PSC Weekly Report

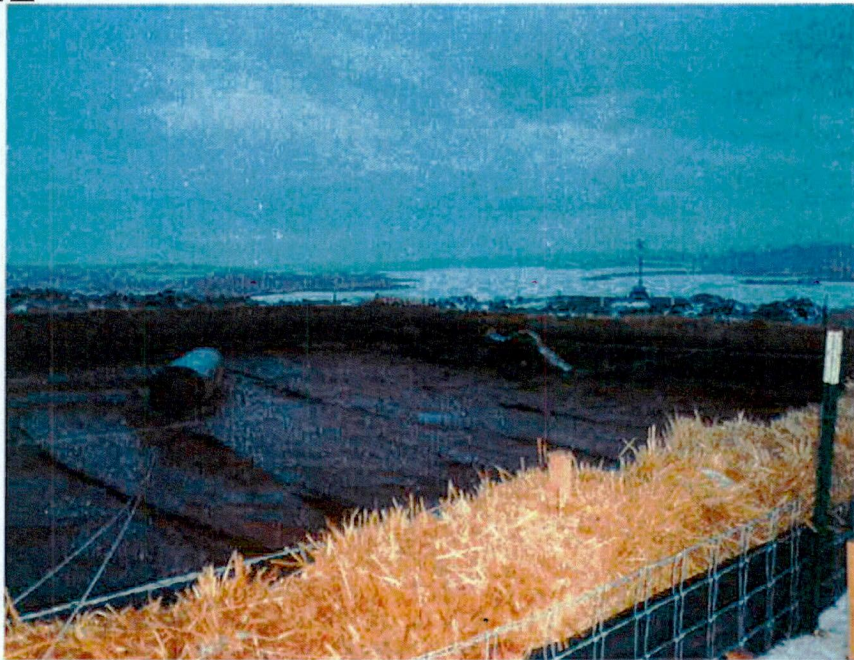
Hydrostatic testing of the final 50 miles of pipeline was completed on November 30 and discharge of test water was completed on December 1. Discharge was conveyed, via pipe, to the energy dissipation structure previously used for hydrostatic discharge. Additional rolled sediment matting, with flocculent was used as a secondary BMP place downslope of the dissipation structure. An inspection of the area following discharge indicates that flocculants functioned as planned, as abundant iron precipitate was observed in the dissipation structure and secondary BMP structure. Discharge sample were collected and submitted to Energy Laboratory for testing per requirements of the discharge permit.

MP 30.91 Discharge energy dissipation structure following discharge. Note abundant iron precipitate.

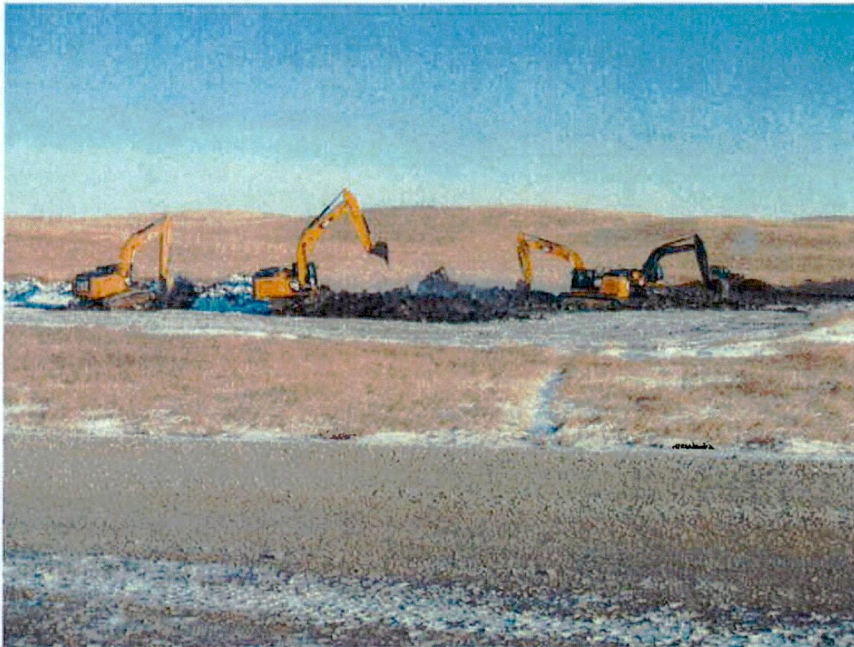
Topsoil spreading near MP77.5.

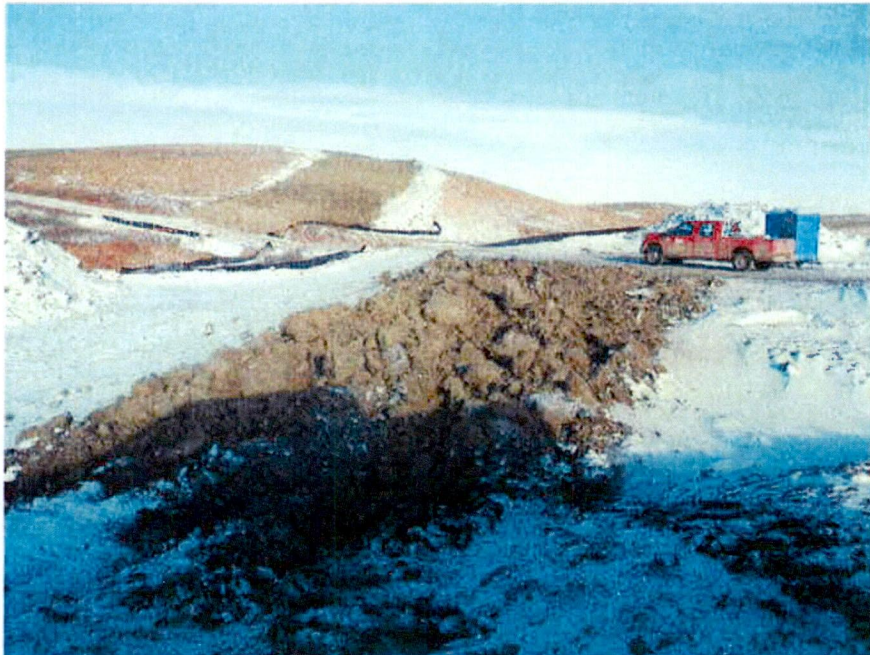
Frozen subsoil ripped with Dozer prior to spreading near MP 78.
