Allete, Inc. Bison 3 Wind Project
Construct 105 MW, 35 wind turbines in Oliver and
Morton Counties, ND

Construction Inspection - October 23, 2012

Case No. PU-11-162

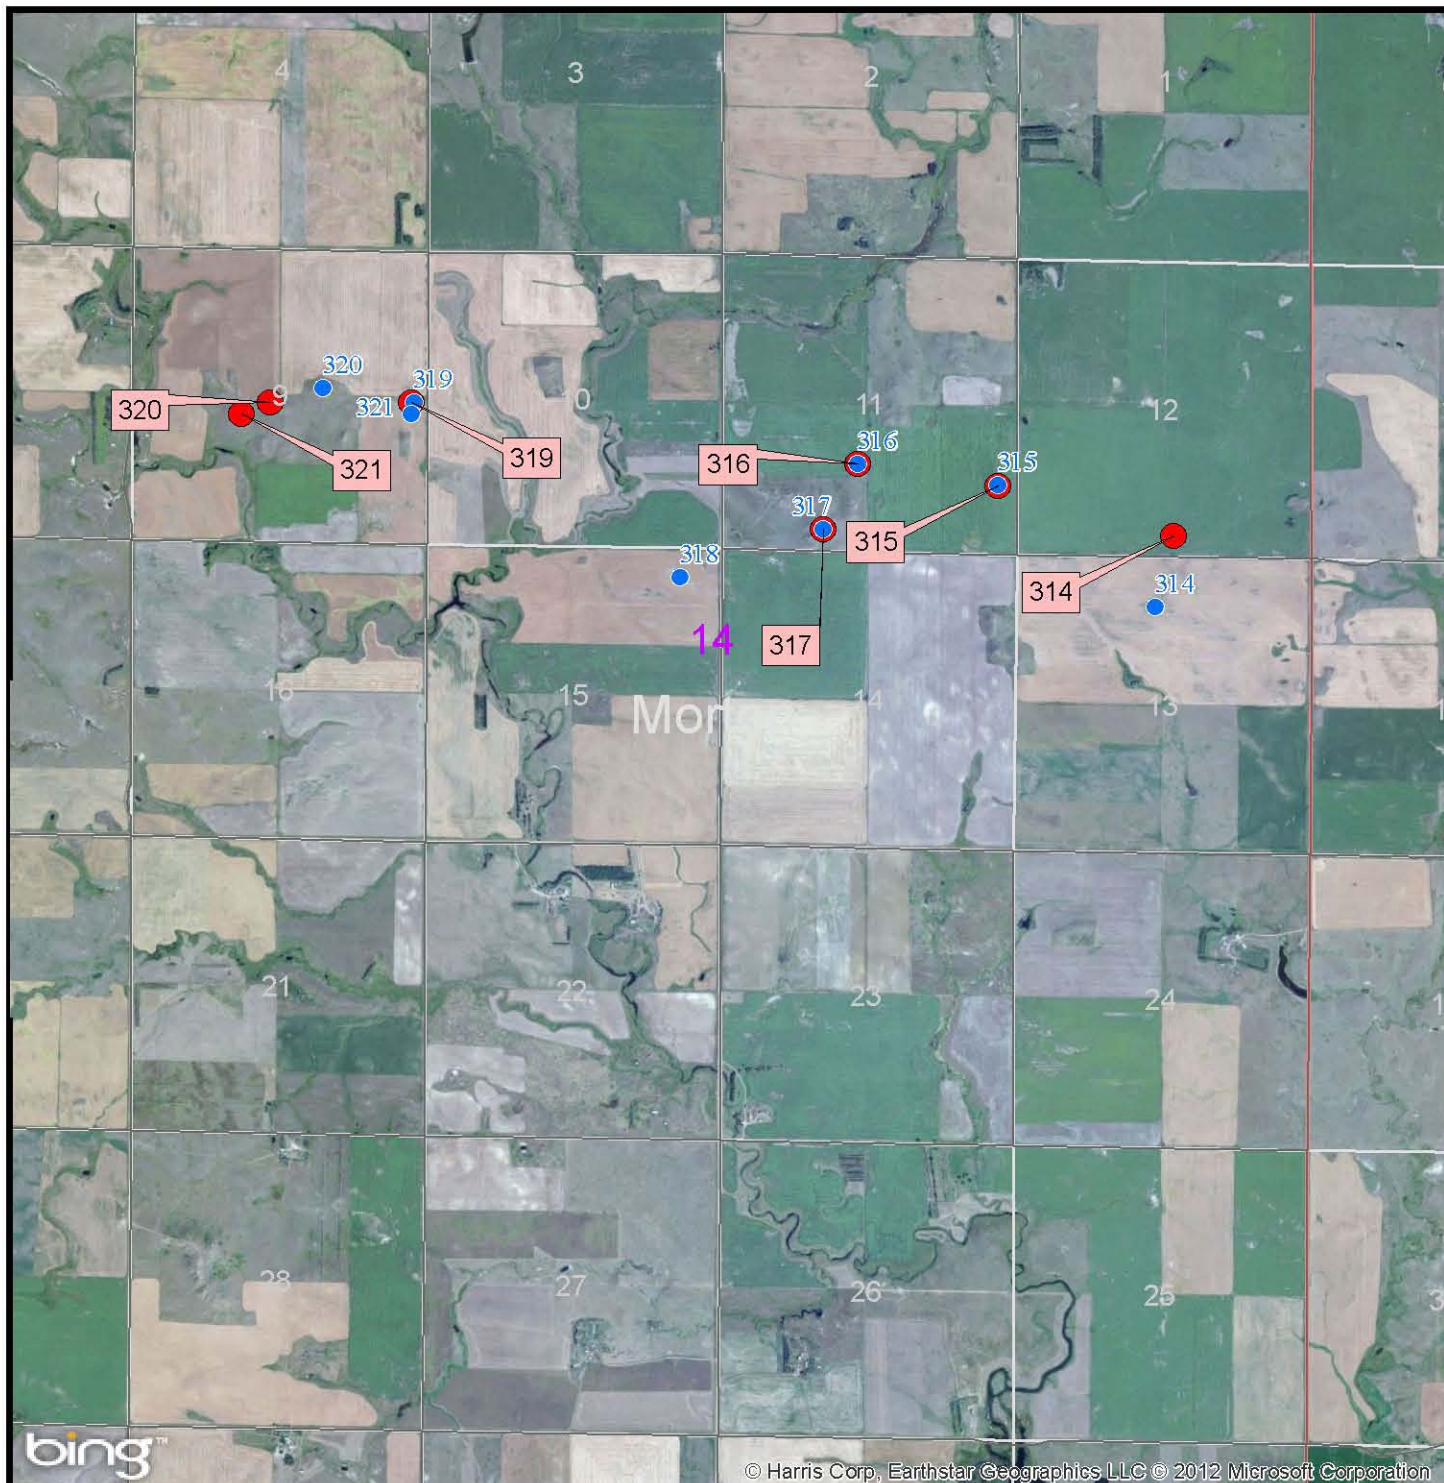
APPENDIX A BISON 3 WIND TOWER CHECKED LOCATIONS

Second, Allele stated that no turbine locations were moved or relocated after construction started. No record was found in the case file of any turbines being relocated. During the construction inspection, seven as-builts locations were checked to verify turbines were not relocated. It was determined that the as-built locations for turbines 314, 319, 320 and 321 were not constructed in their proposed locations according to the turbine table coordinates of proposed locations on Drawing C-04 (Docket #47). Allele mentioned concerns with turbines 314, 319, and 321 during the inspection. Therefore, some turbine

locations were constructed in different location compared to the turbine table design drawing coordinates issued for construction. This will also affect the UG conductor/fiber route to these turbines. Appendix A graphic shows PSC application locations versus field check locations.

If the location was changed, was PSC approval granted before construction at the site started? No record of location changes were found in the case file. Turbines 314, 319, and 321 were identified by Allete during the construction inspection as having location changes but have no PSC approval.

Coordinates from the final as built drawings should be compared to the turbine table coordinates in the drawing issued for construction to identify changes. The Post Construction inspection should verify more turbine location coordinates with a field check. The Commission may want to discuss this issue directly with Allete, Inc. as location discrepancies were found during the construction inspection.

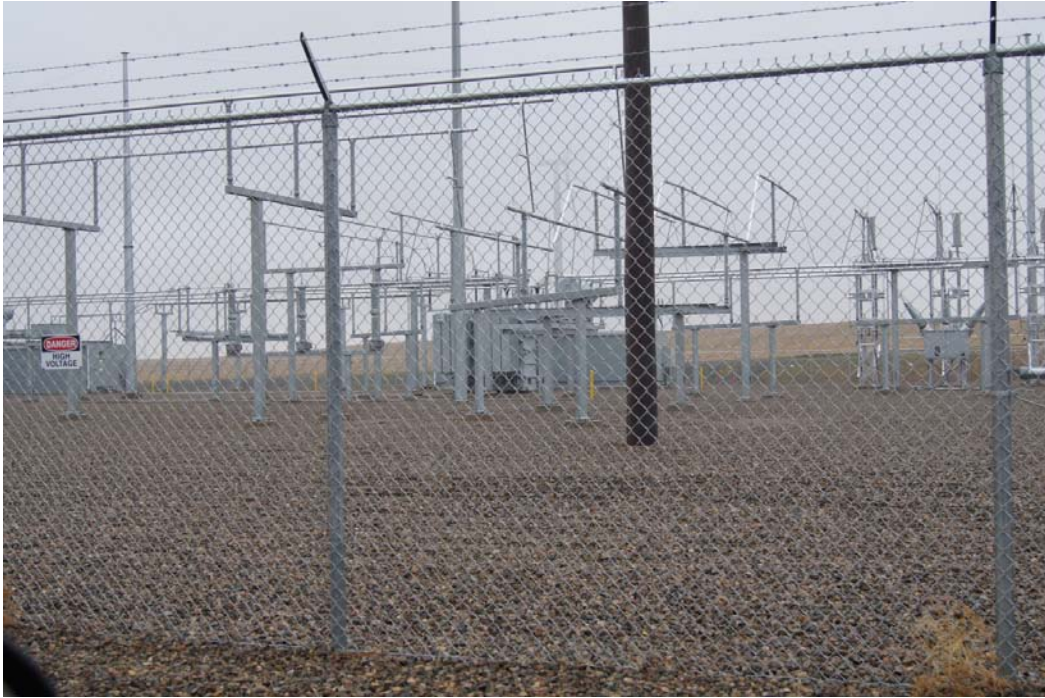
Bison 3 Substation Bay within Bison substation – fencing, Danger high voltage fence signs

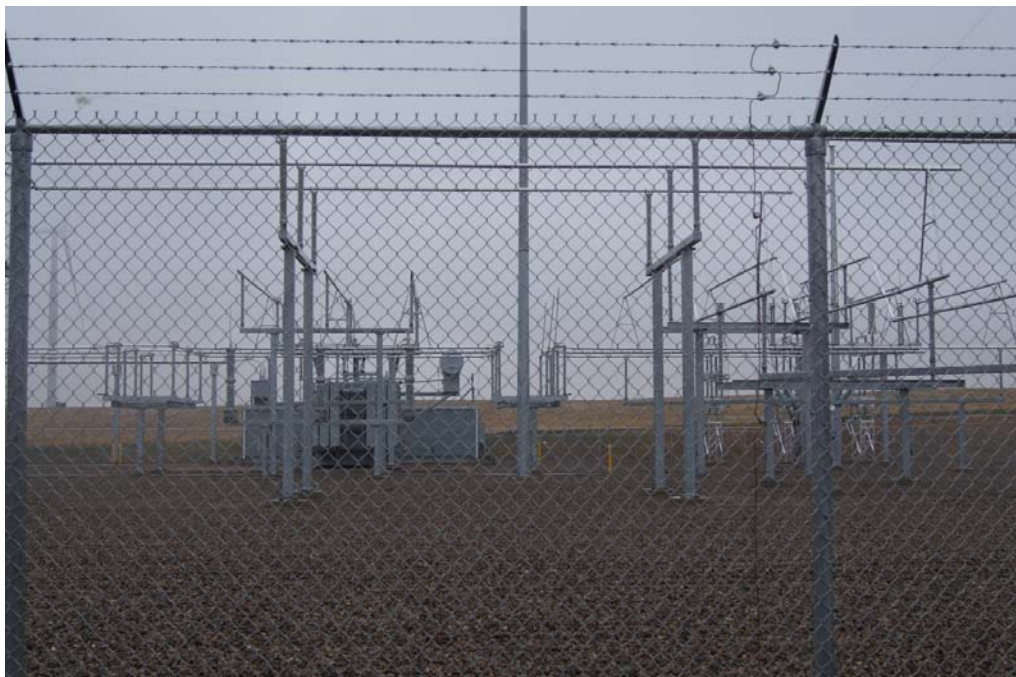
Bison 3 Substation Bay within Bison substation – fencing and fence grounding

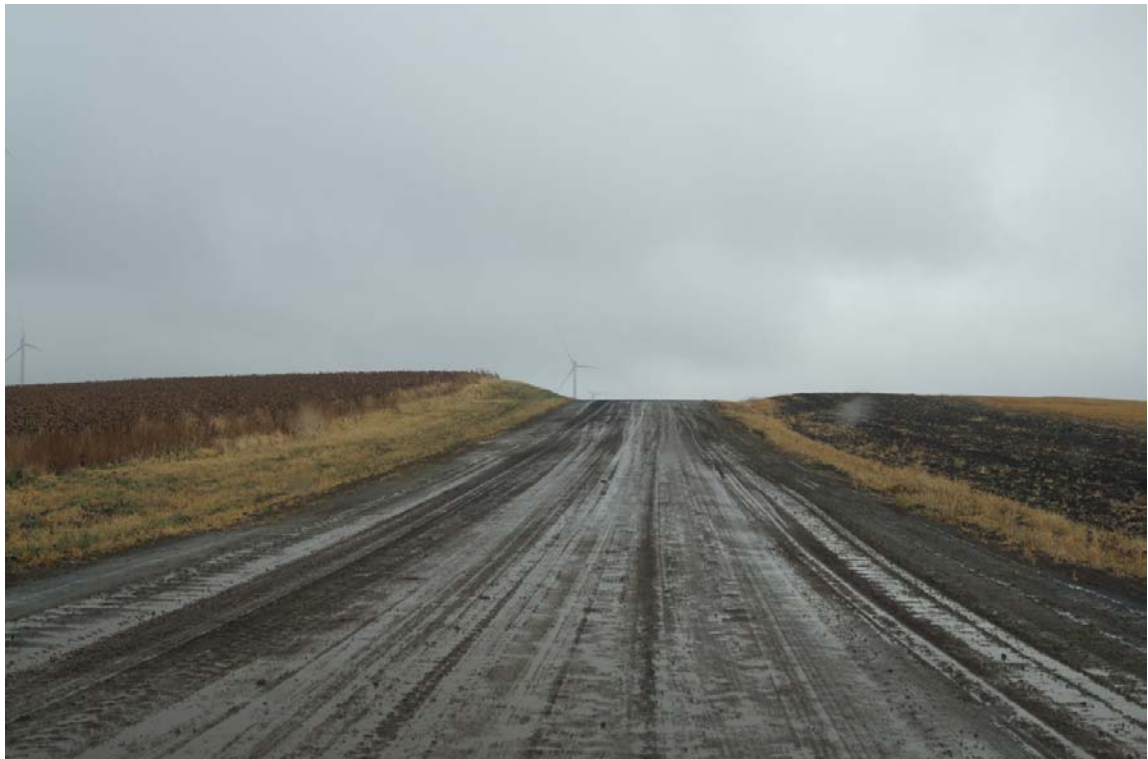
Were access roads constructed of a 16 to 23 feet width and have aggregate surfacing, adequate to support the size and weight of maintenance vehicles under all weather conditions? Roads were constructed to a width of 20 feet with 6 feet shoulders of each side of the road. This design width was used so that the roads could be used for crane travel as much as possible. Adequate aggregate surfacing was observed during the construction inspection. The inspection was conducted during a rain day with wet roads present. No major ruts were observed in roads during construction inspection travel. Roads where crane travel had occurred were verified with no ruts in roads. Allete had road graders on site and one was operating the day of the construction visit. Concern satisfied.

Access roads with shoulders

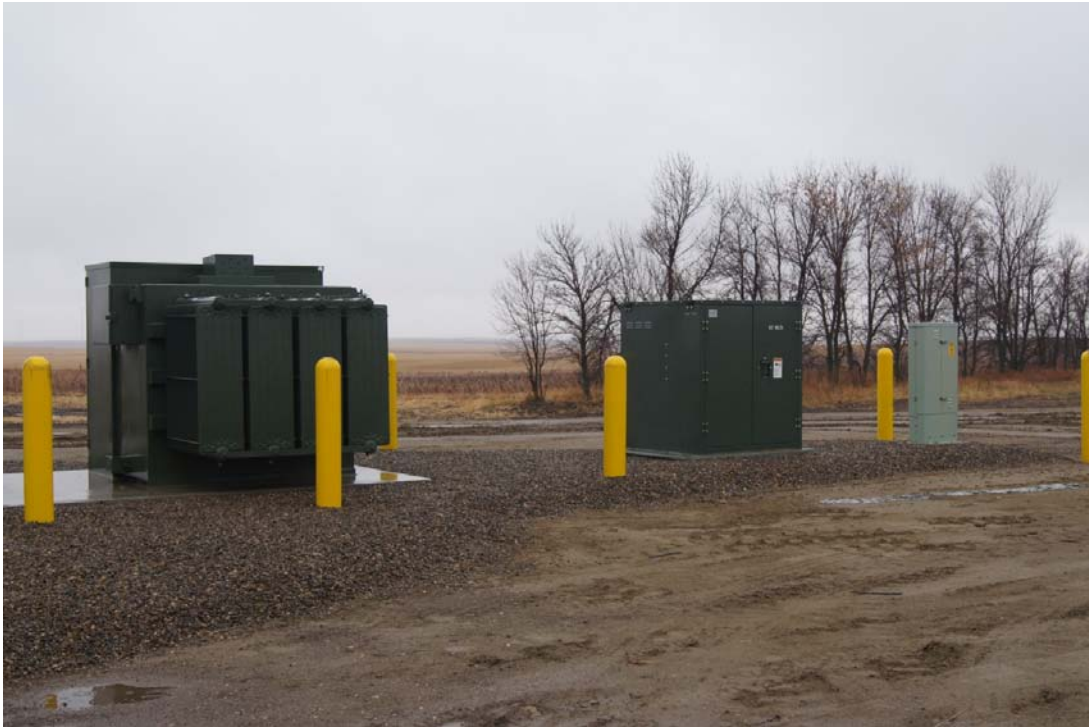
Does each turbine have a step-up transformer installed at the base to raise the voltage to a collection-line voltage of 34.5 kV? Yes. Bison 3 also had switching pedestals for the collection system and fiber communication at some turbine site to assist with sectionalizing of the system as needed. Ground fault transformers were install also to prevent stray voltage on the electrical system. All enclosures observed were located in high elevations away from drain paths. Concern satisfied.

Turbine transformer, collector system switch pedestal, and communication switch pedestal

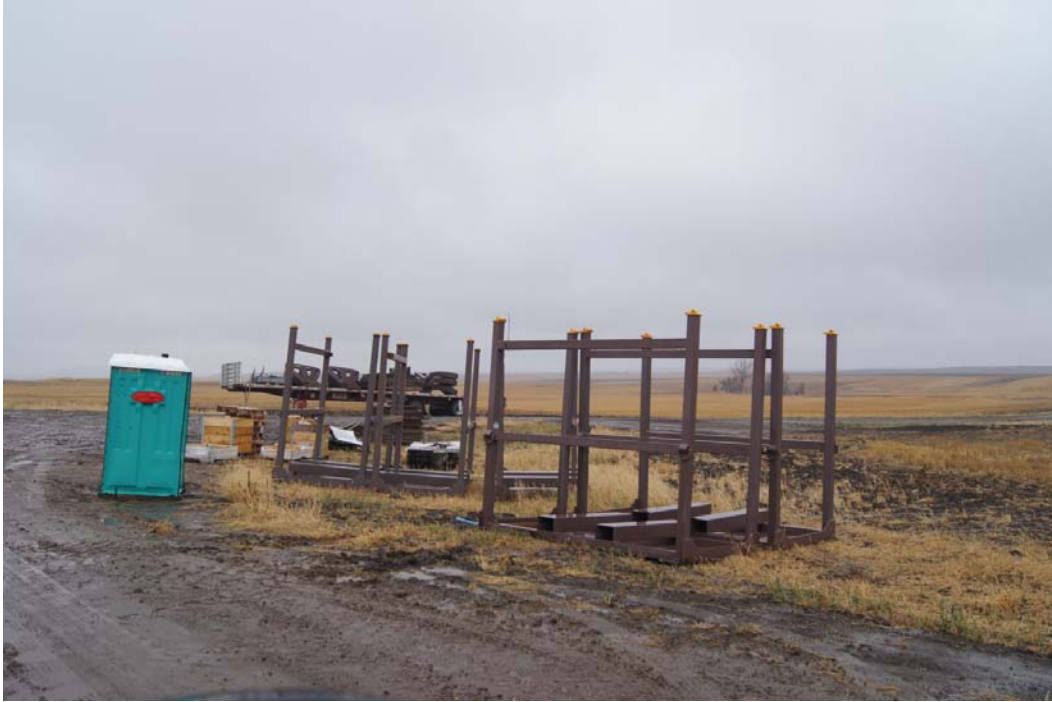
Was any waste or construction related debris observed along the site route? Material such as excess construction materials or litter generated by the construction crews are to be removed. Yes. Restoration is still occurring at the site. Storage containers at turbines and one construction materials site to be removed. See pictures. Concern satisfied.

Construction related debris to be removed, portable bathroom.

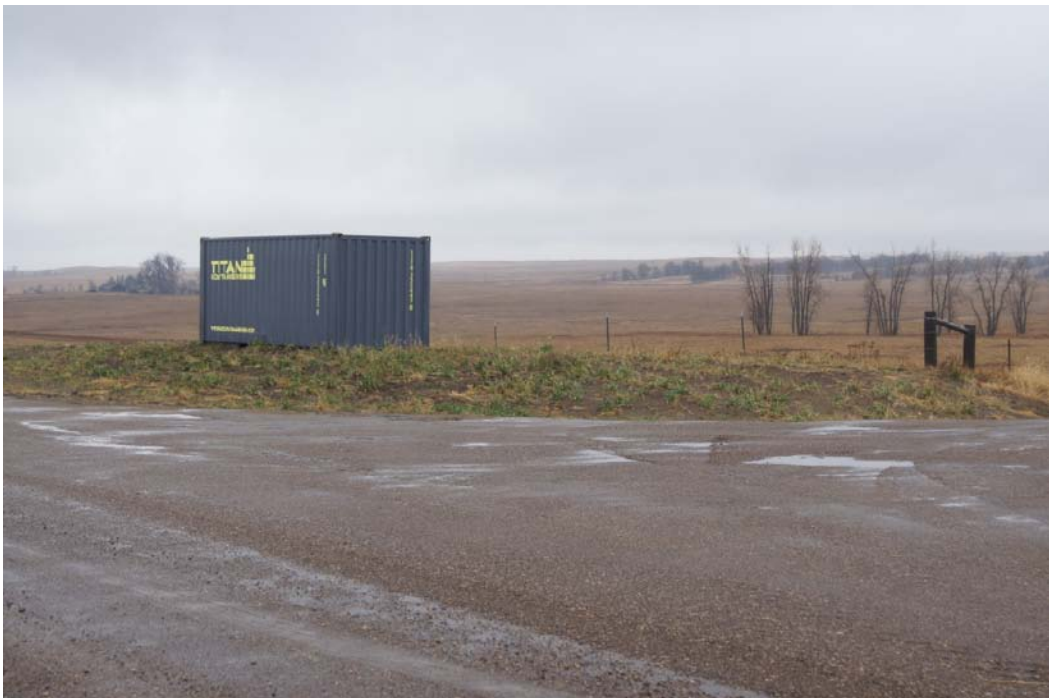
Container storage by each turbine to be removed for final restoration

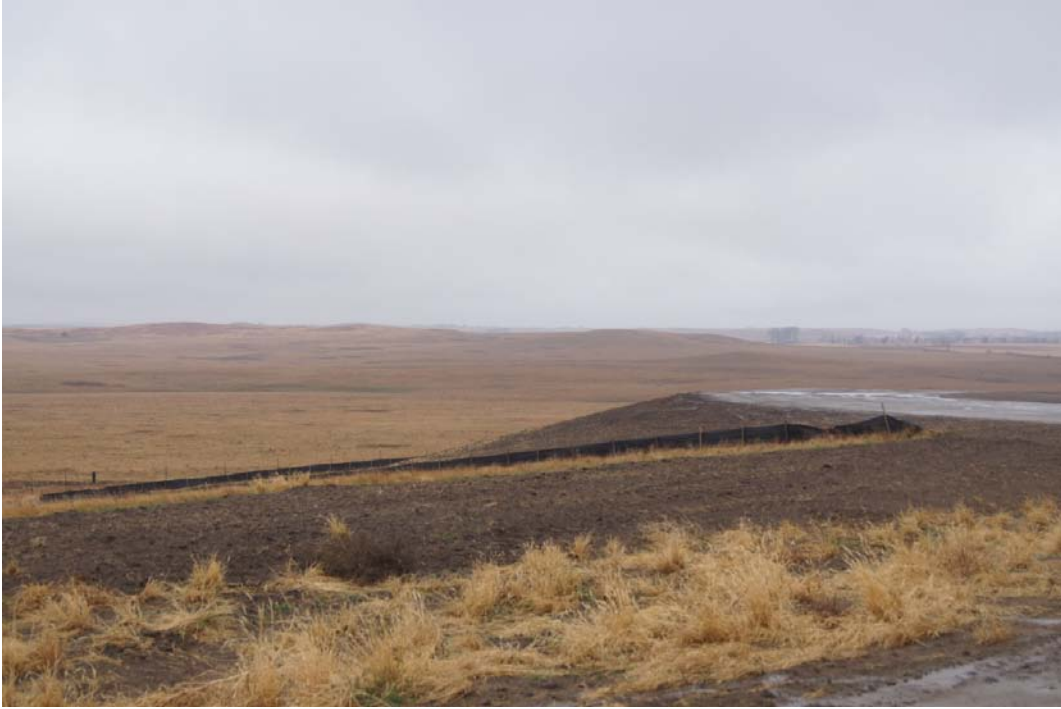
Is erosion control measures used on site as needed? Yes. Drawings numbers C-05 and C-06 of the proposed construction drawings issued to the PSC on October 4, 2011 (Docket #47) documented erosion control details to be used for the project. Erosion controls were documented in the progress reports and were observed being used proper during the field inspection. Concern satisfied.

Erosion Control -Silt fencing

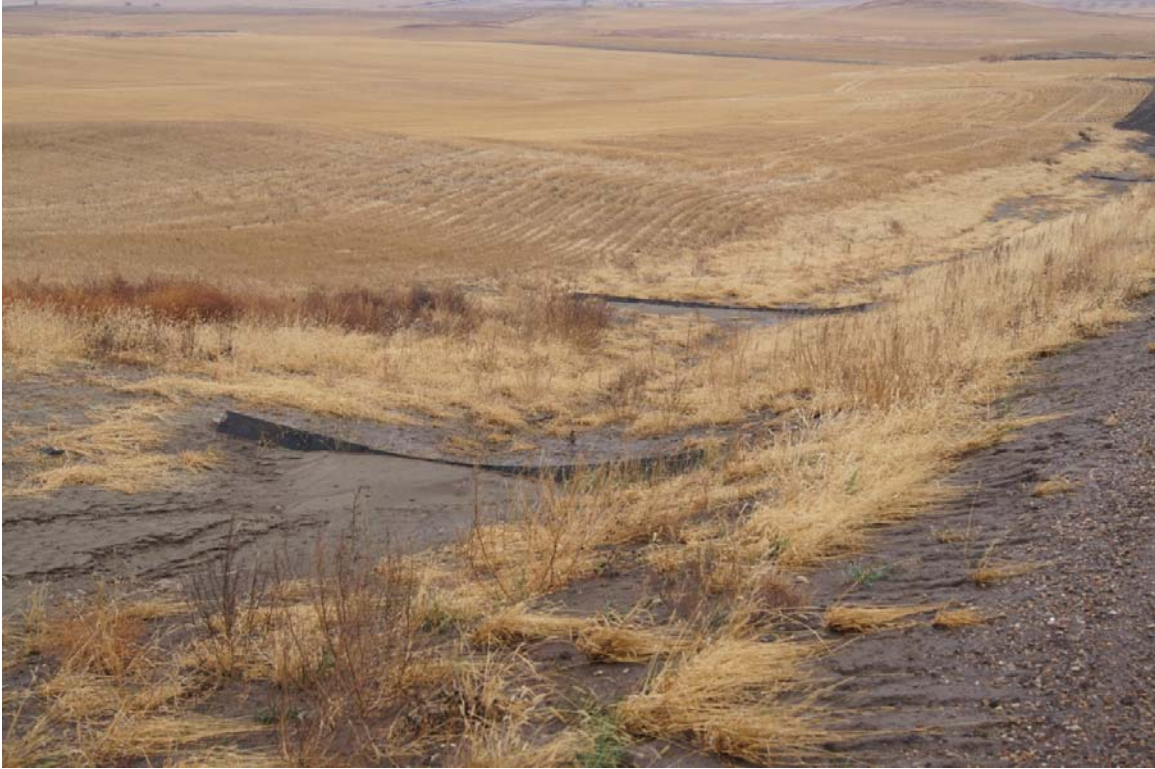
Erosion Control- Triangular containment fencing

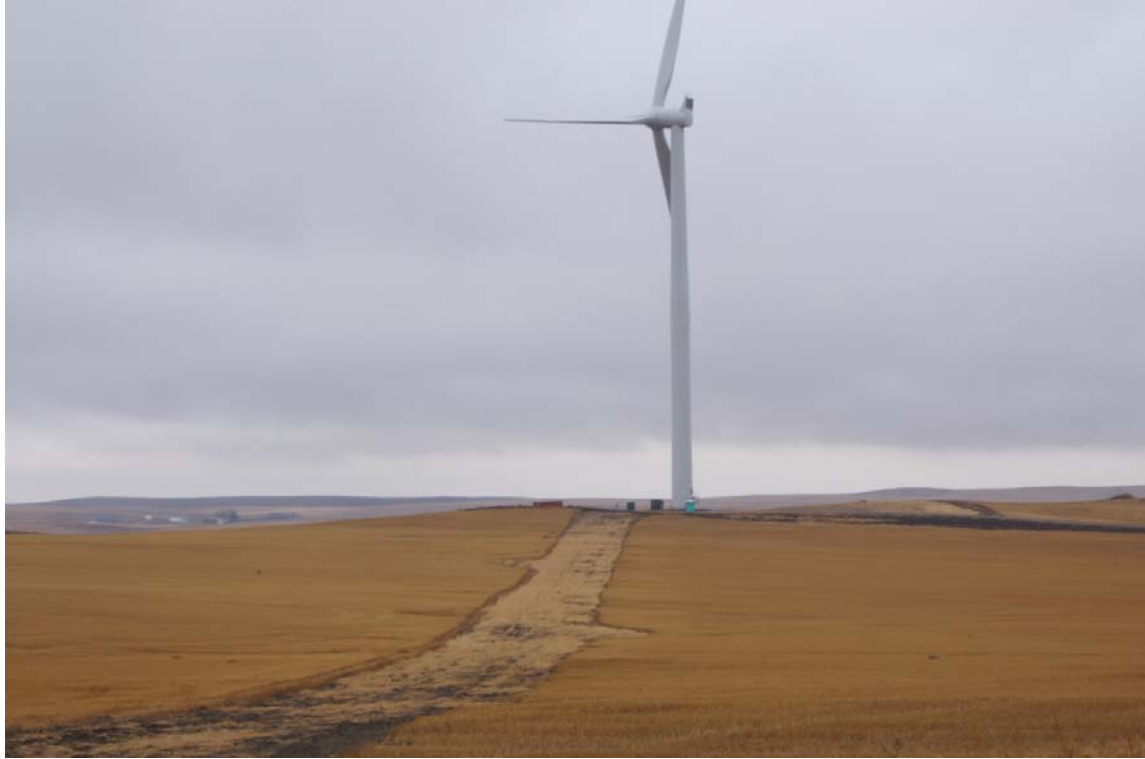
Was compaction being done as part of the reclamation? No compaction was being required as part of the reclamation. However, de-compaction was required along crane paths. Crane paths were ripped to de-compact the soil. Crane paths along roads required gravel touch ups. Crane paths on roads and soil were observed during the construction site visit. Concern satisfied.

Crane path route restoration

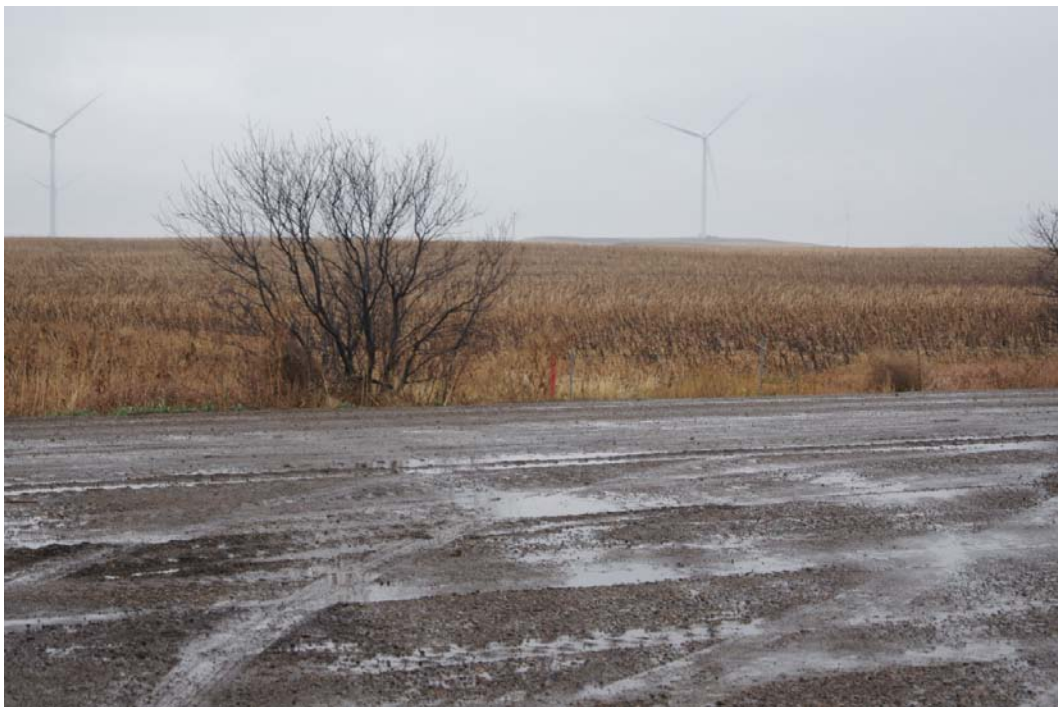
How often are line markers installed? Line markers were observed installed on both sides of road crossings. Allete (Minnesota Power) participates in the North Dakota One Call System and stated line marker signs were installed at each road crossing. Concern satisfied.

Line marker signs located at road crossings.

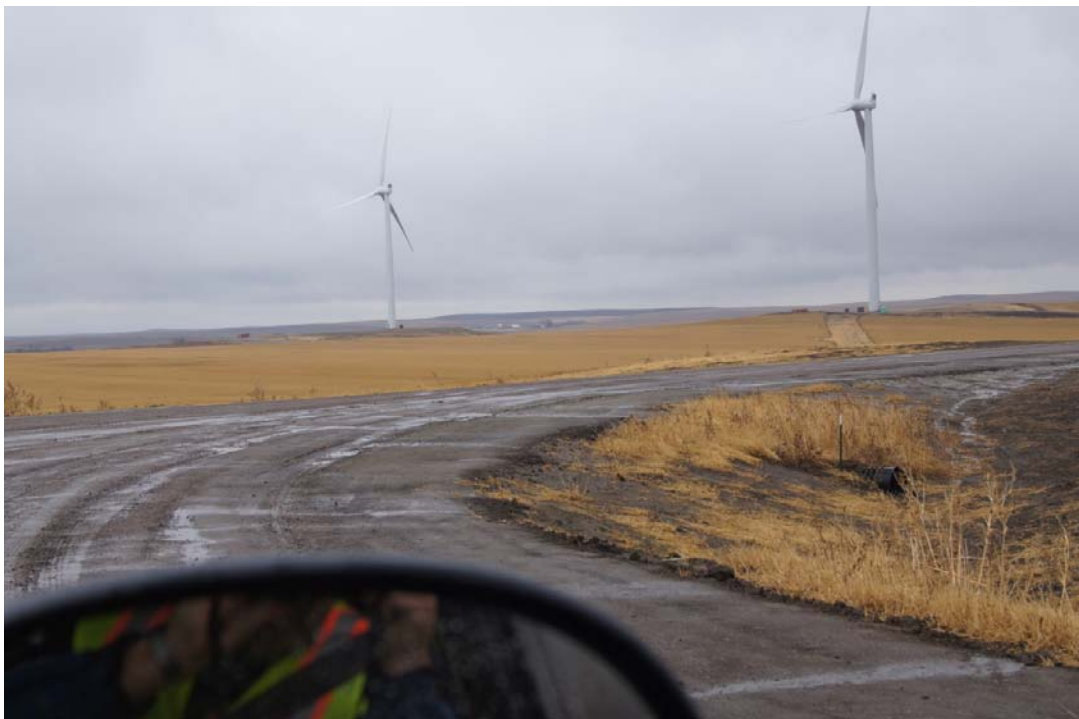
Road curves with proper shoulders

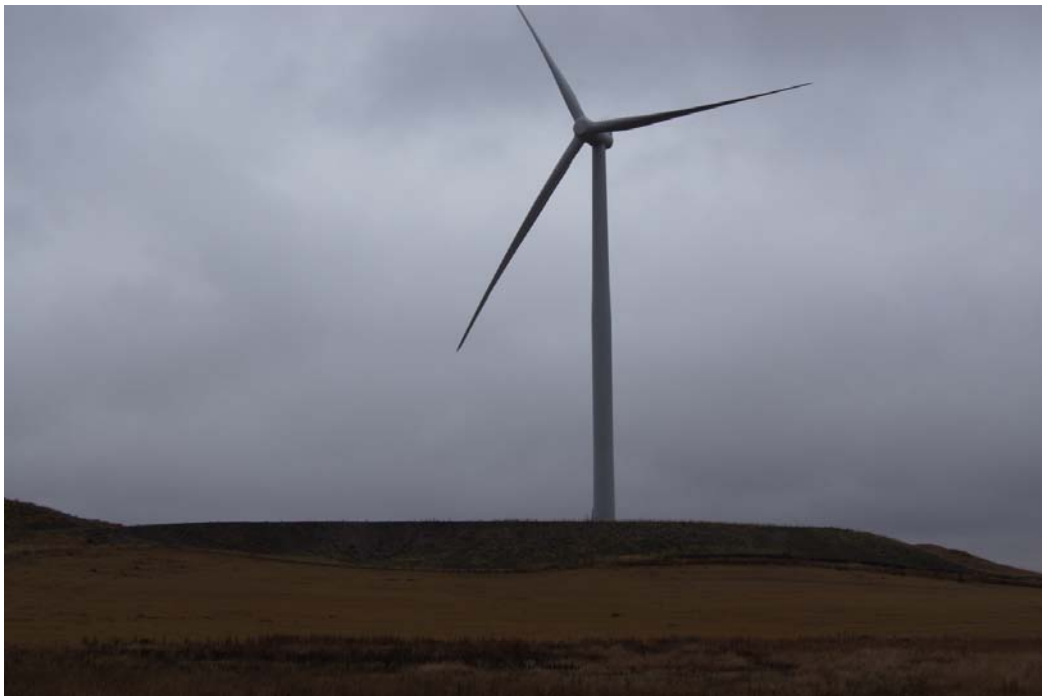
Were any rock areas along the excavation area found during the site visit? If yes, identify locations. Yes. Allete found rock in site areas for turbines 310, 313, 316, 320, 322, 330. Concern satisfied.

Turbine site 313 – sandstone rock area with final proper contouring

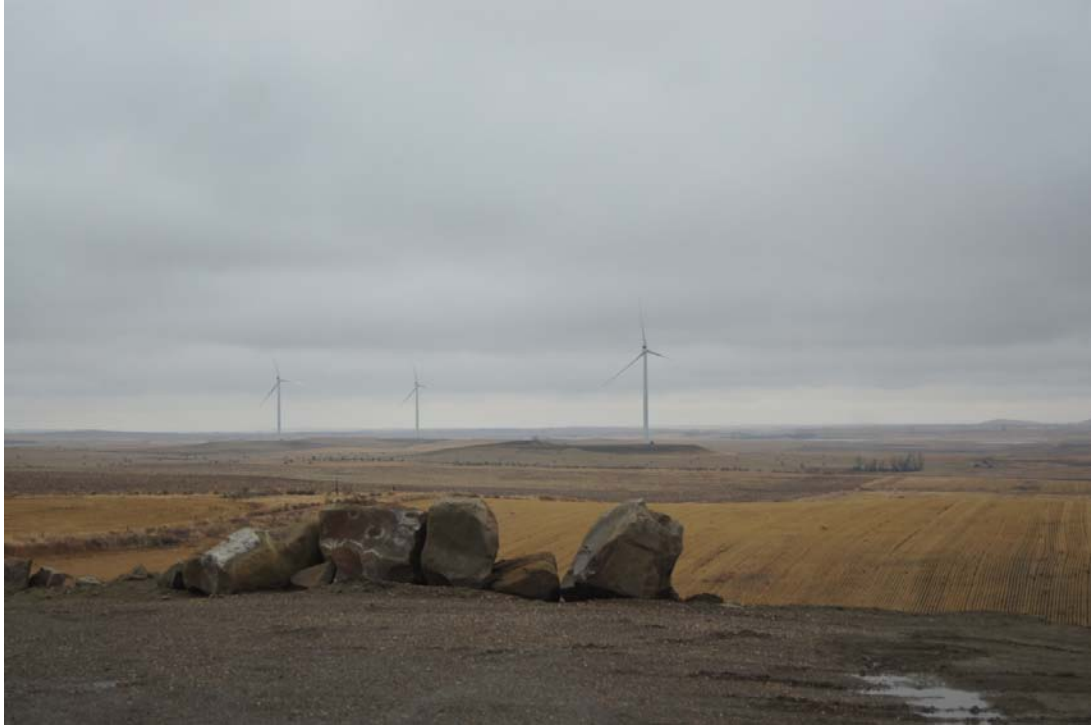
Was any excess soil and rock removed from the site unless otherwise requested by the landowner? Yes. The project areas disturbed were contoured back to original shape. All rocks were removed from the site except for several large rocks at turbine 313. These rocks were left on site and aligned to prevent a vehicle from going over a steep incline in elevation change along the road. Reduction of road radius excess soil was being used for improvement of existing roads. No other rocks or excess soil were observed during the construction inspection. Concern satisfied.

Rocks at turbine 313 used for road barricade

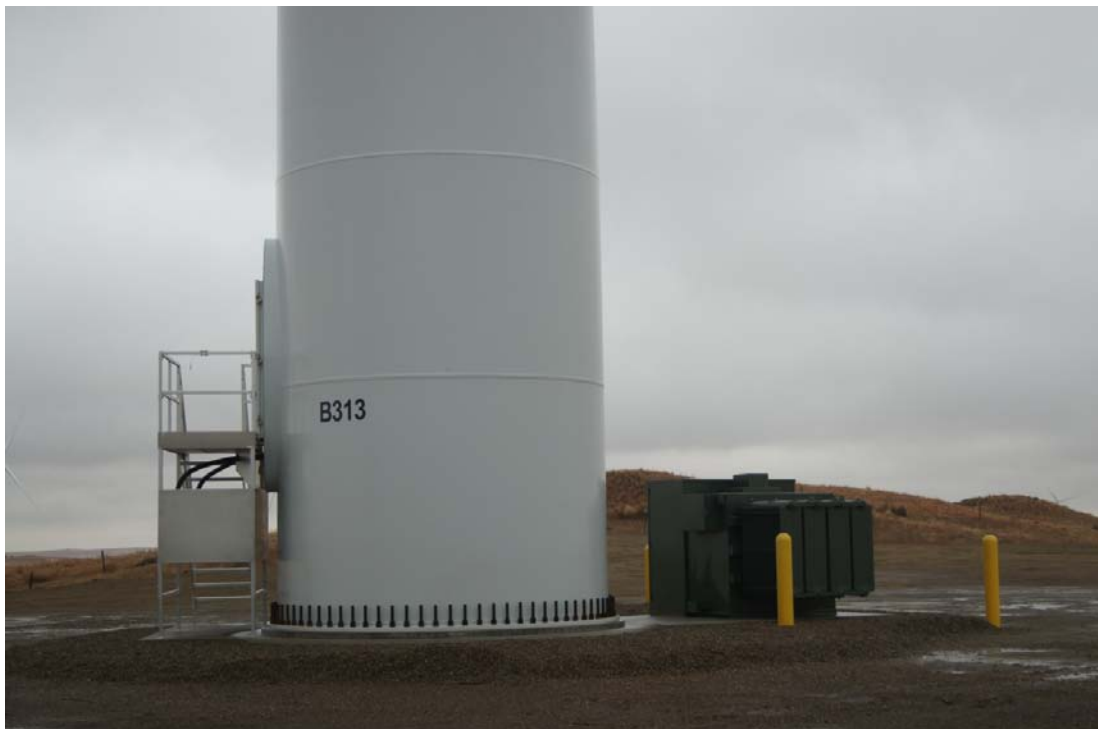
Turbine 313 located in sandstone rock

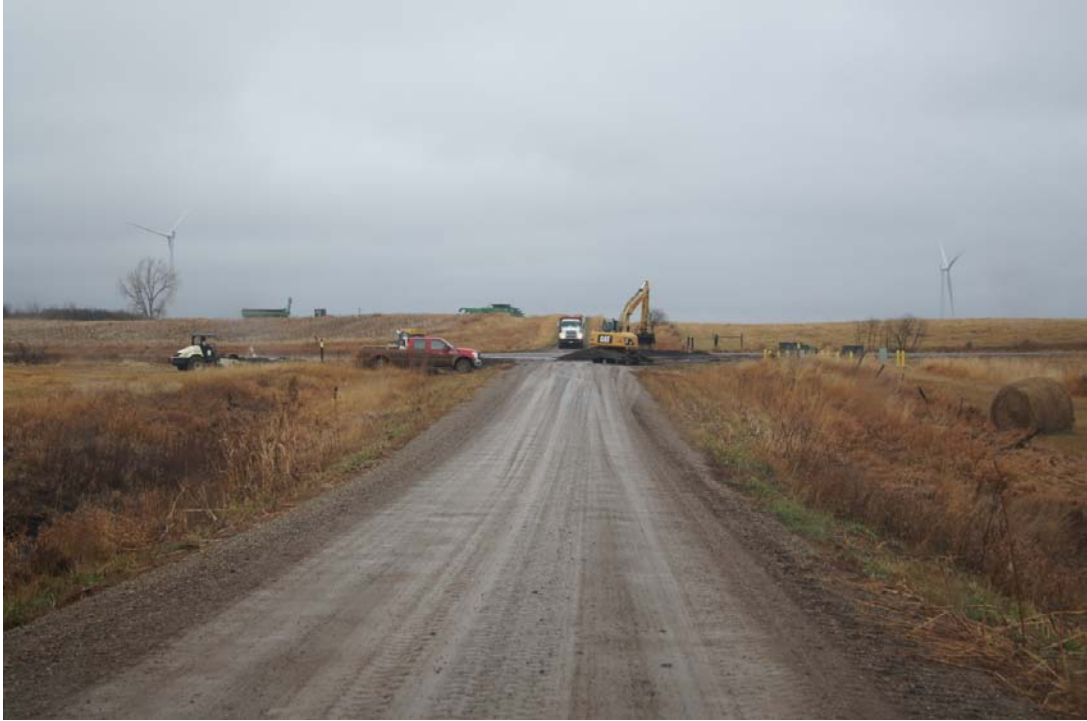
Who is the environmental monitor on site today? Tower erection was completed on October 20, 2012. Restoration activities were occurring on site. Allete/MP personnel were observed on site with restoration crews working on reduction of road radius activities. Concern satisfied.

Road radius reduction at road corners, this road was a crane traveled road.
