To: <u>North Dakota Public Service Commission</u>	Project No: <u>2839</u>	Date: <u>11/21/12</u>
Attn: <u>Executive Secretary</u>	Project: <u>Berthold Station Expansion Project</u>	
<u>600 E. Boulevard, Dept. 408</u>	<u>Construction Inspection Report</u>	
<u>Bismarck, ND 58505-0480</u>	From: <u>Tom Nickel</u>	
<u>Docket No. PU-11-232</u>	<u>tnickel@prosourcetech.com</u>	
	<u>(763) 786-1445 or (888) 422-4449</u>

**BERTHOLD STATION  
EXPANSION PROJECT**

**FIELD INSPECTION REPORT**

GENERAL INFORMATION		
Inspector Name: Thomas Nickel	Inspection Date: 11-15-2012	Report Number: 002
Weather: Clear and cold, 20 degrees	Precipitation (past 24 hours): 0.00"

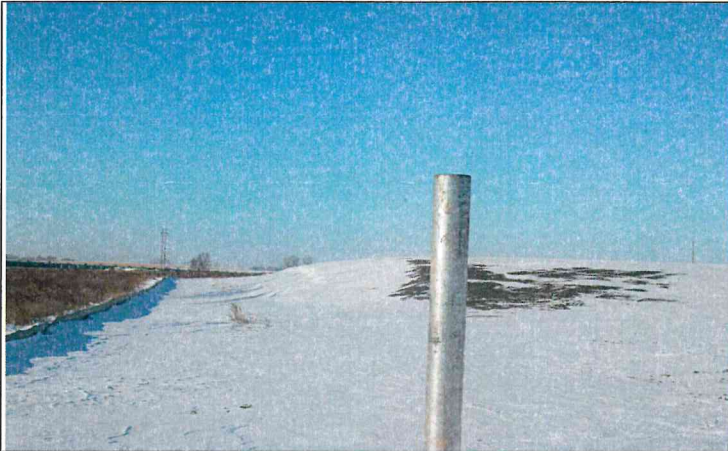
View of southeast Berthold West Property line, looking southwest.

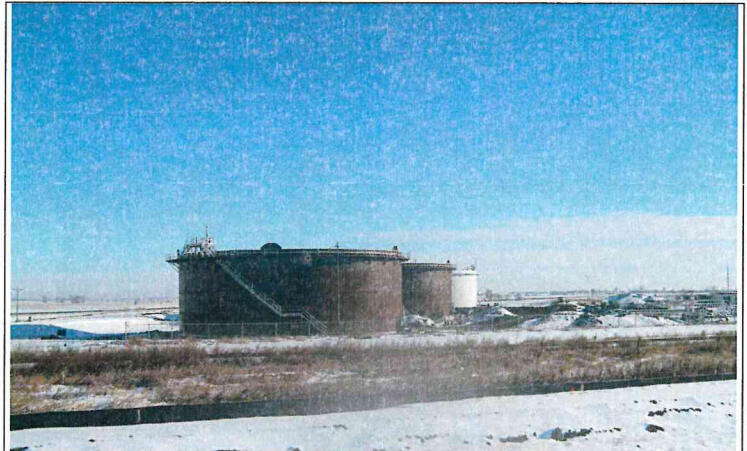
View of the eastern side of Berthold West Property, looking east.

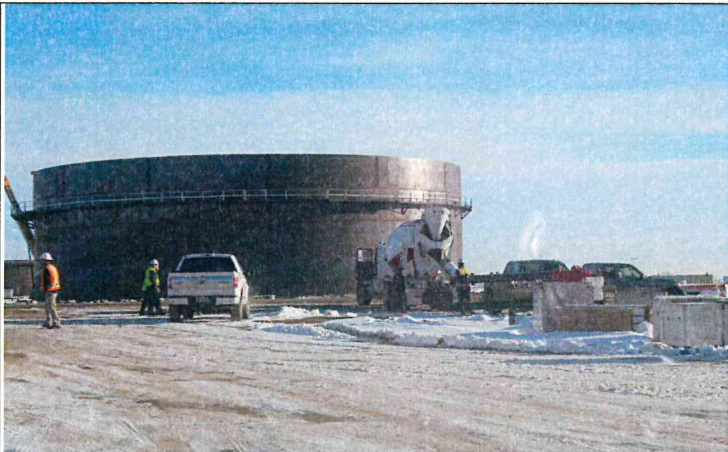
Partially complete tank, looking east.

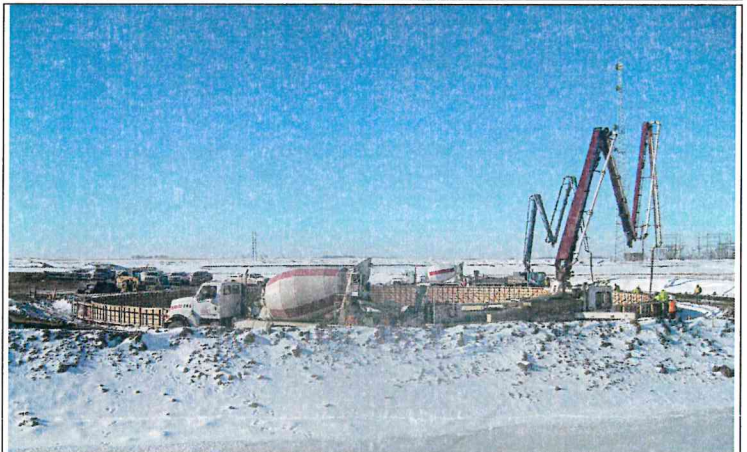
Pouring concrete for foundation ring wall for tank, looking west.

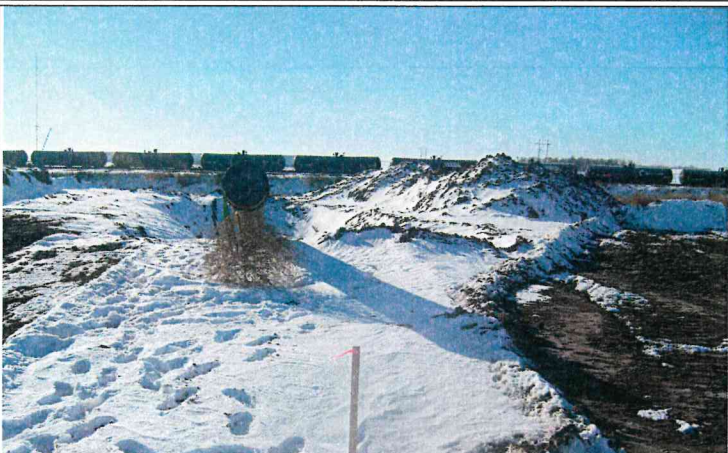
20-inch pipe, installed under railroad tracks.

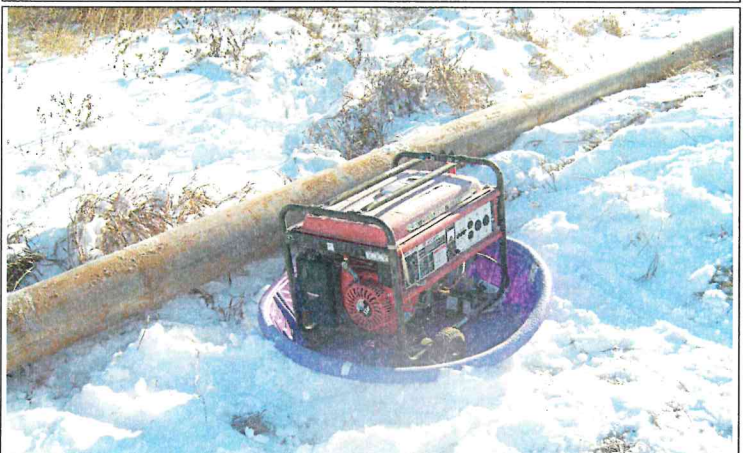
Use of secondary containment structure.
