RE: Thunder Spirit Wind, LLC - 150 MW Wind Energy Project
Case No. PU-11-601

101 PU-11-601 Filed: 5/12/2015 Pages: 4
Thunder Spirit Wind incident report

THUNDER SPIRIT WIND FARM
Laceration to Employees Leg
Laydown Yard
Wanzek Construction Inc.

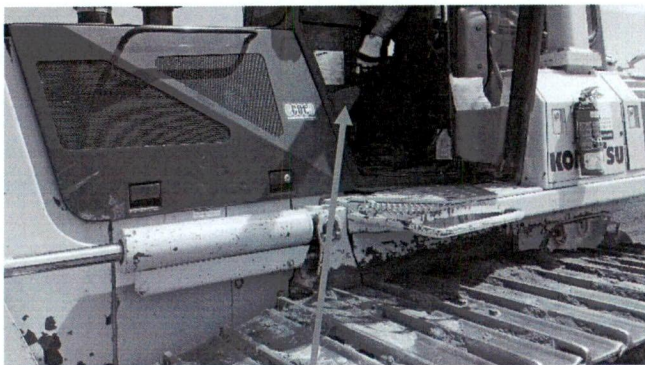
1. Not recognizing the protrusion of the foot rest in the entry/ exit of the bull dozer as a hazard.
2. Employee was not wearing pants of suitable material that could have provided a better protective layer between the metal foot rest and the leg.
3. The foot rest is made of metal and could have had a softer protective pad placed around the perimeter of the step or on it to possibly prevent such an incident.

EE pointing out location of foot rest

1. Continue to raise awareness of site conditions and recognizing items that could be a potential for tripping or restricting access and egress.
2. The foot rests were removed from the equipment and other equipment evaluated for potential hazards.
3. A stand down was performed on site by the Superintendent and Project Engineer. A discussion on the incident and the importance of noting issues and bringing them to our attention so that we can take appropriate corrective actions.
4. Pants of suitable material will only be allowed on site, no sweat pants.
5. Operator was evaluated and release without any further actions needed to be taken and will continue to be monitored by Wanzek Supervision.

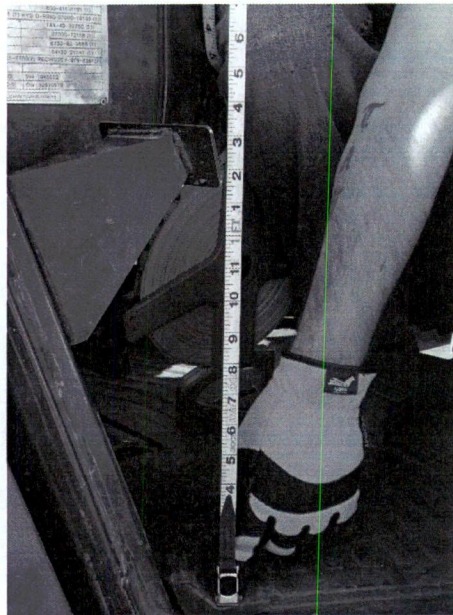
Height of Foot Rest From Floor

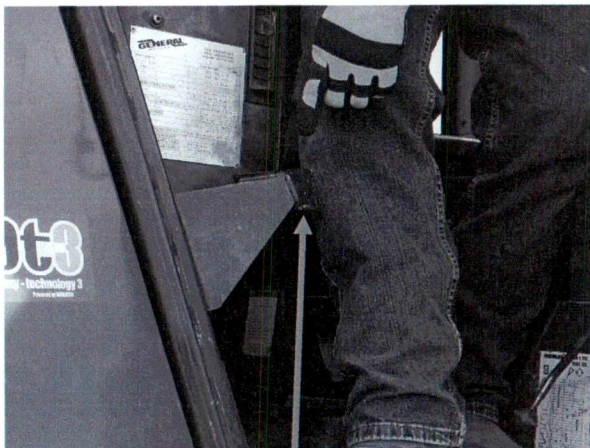
Leg to Foot Rest Comparison

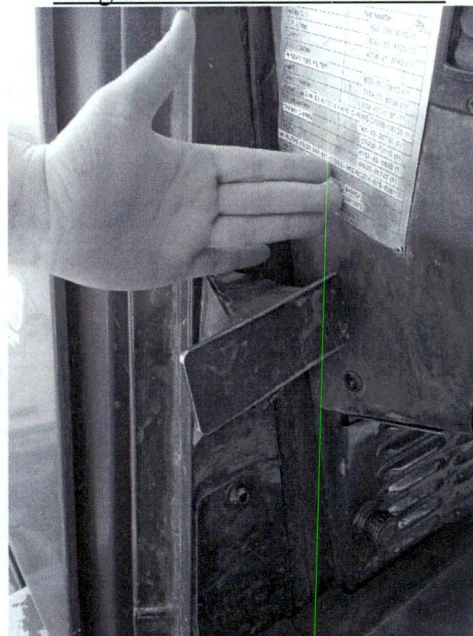
Hand to Foot Rest Comparison

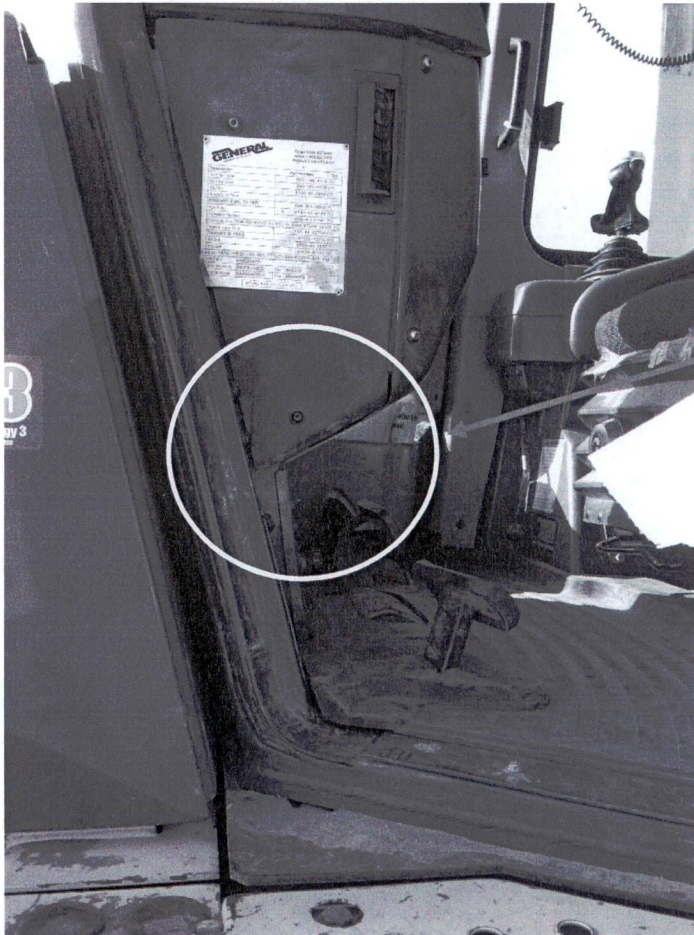
Foot Rest Removed

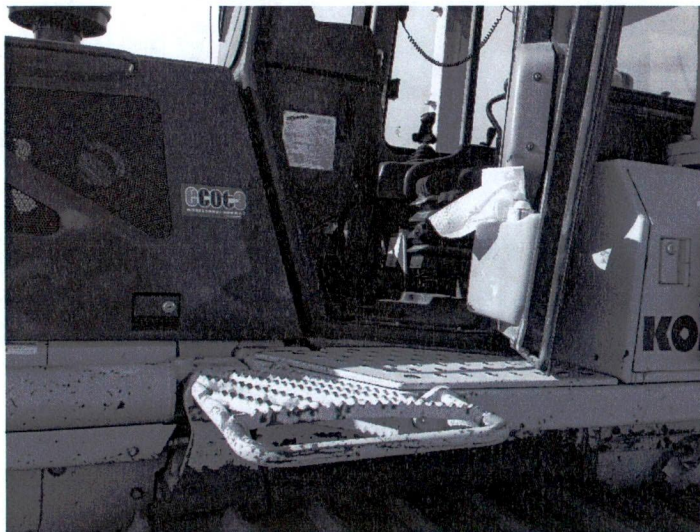
Foot Rest Removed - Zoomed Out
