Re: ALLETE Clean Energy through Thunder Spirit Wind, LLC
Thunder Spirit Wind Project
Case No. PU-11-601

124 PU-11-601 Filed: 8/3/2015 Pages: 6
June 24, 2015 power line strike incident report

THUNDER SPIRIT WIND FARM
Power Line Strike
Access Road to 37
Wanzek Construction

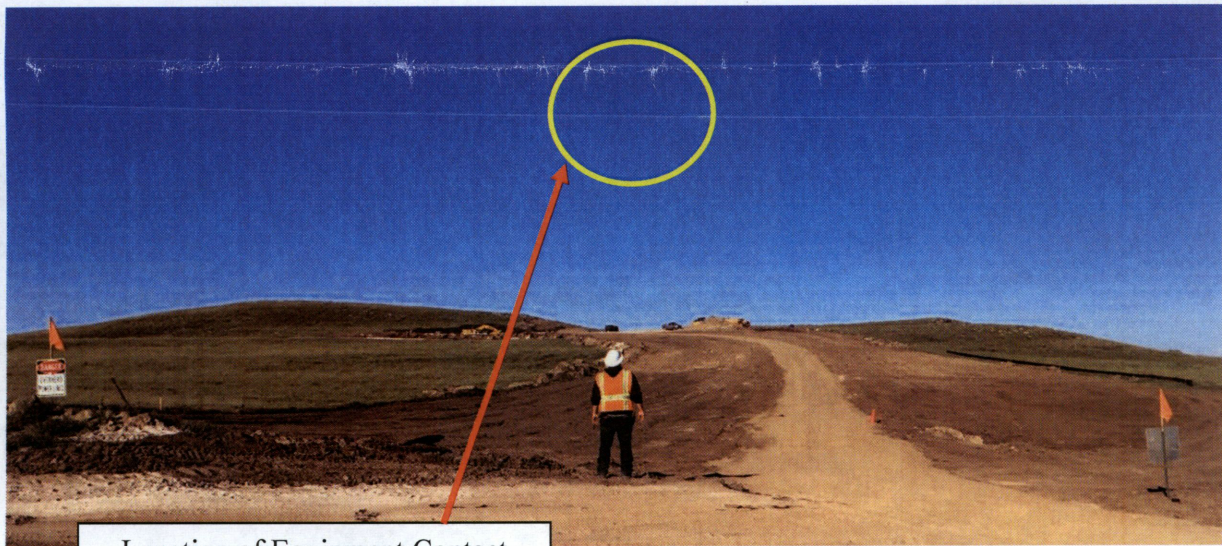
Over view: On July 24th, 2015 at approximately 5:30 PM it was discovered that the reason for the power outage on site, which started at 1 PM, was the result of an arc that occurred between the overhead neutral wire and live power wire at the entrance to the access road to tower site 37 from 4th Ave. Fairly recent equipment tracks were found going under the power line on the north side of the access road, leading to the discovery of a damaged spot in the neutral power line. Further investigation found that the tracks were those of an excavator and inspection of the boom turned up a small fragment of aluminum along with a clean scrape about 12 inches in length along the out most side of the boom on the operators side. The point of contact between the neutral and live line were approximately 20 feet away from the point where the boom of the excavator made contact with the neutral line leading to the conclusion that the line rolled off the boom and whipped back into the live line resulting in the arc. No injuries were a result of the incident.

Location of Equipment Contact

1. After the notification from the utility company about the location of the arc, a full investigation was conducted.
2. The known operator of that piece of equipment that day was contacted by the supervisor.
3. Notification was made to the client when the cause of the incident was determined.
4. The operator and spotter have been removed from the project.
5. Proper equipment walking procedures and spotter procedure reviews were conducted by crew's supervision to refresh our team.
6. Looking into the possibility of having the utility company install an orange rubber cover on the power lines over access roads impacted by the project.

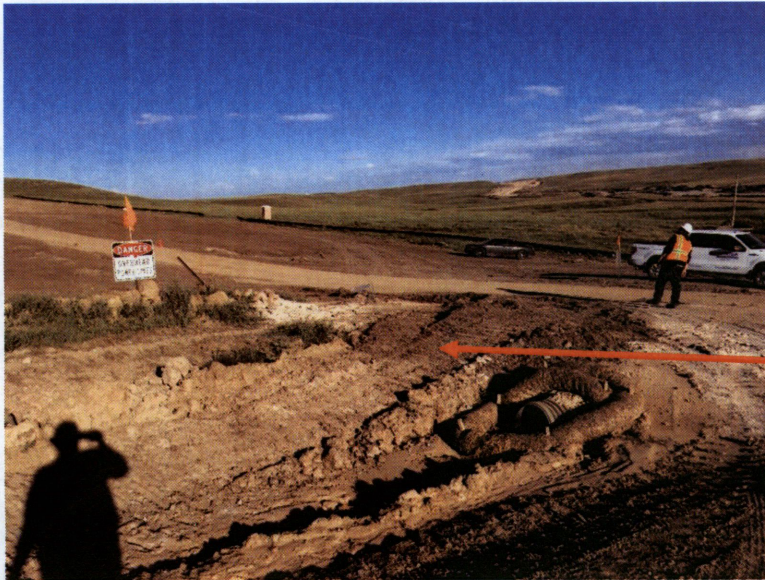
1. The potential for contact with stationary objects/ materials was not recognized
2. Proper spotter procedures were not being followed
3. Warning signs were not heeded
4. Judging by the tracks and travel path followed; when the excavator went from the road into the ditch to start heading in the direction to tower site 37, it would have resulted in the operator needing to raise the boom slightly in order to avoid dragging the back boom cylinder into the ground while crossing the ditch, but when the piece of equipment started traveling on level ground the boom was not lowered closer to the ground to gain the needed clearance between the equipment and the overhead power line resulting in the line strike.

Ditch Crossed and Tracks

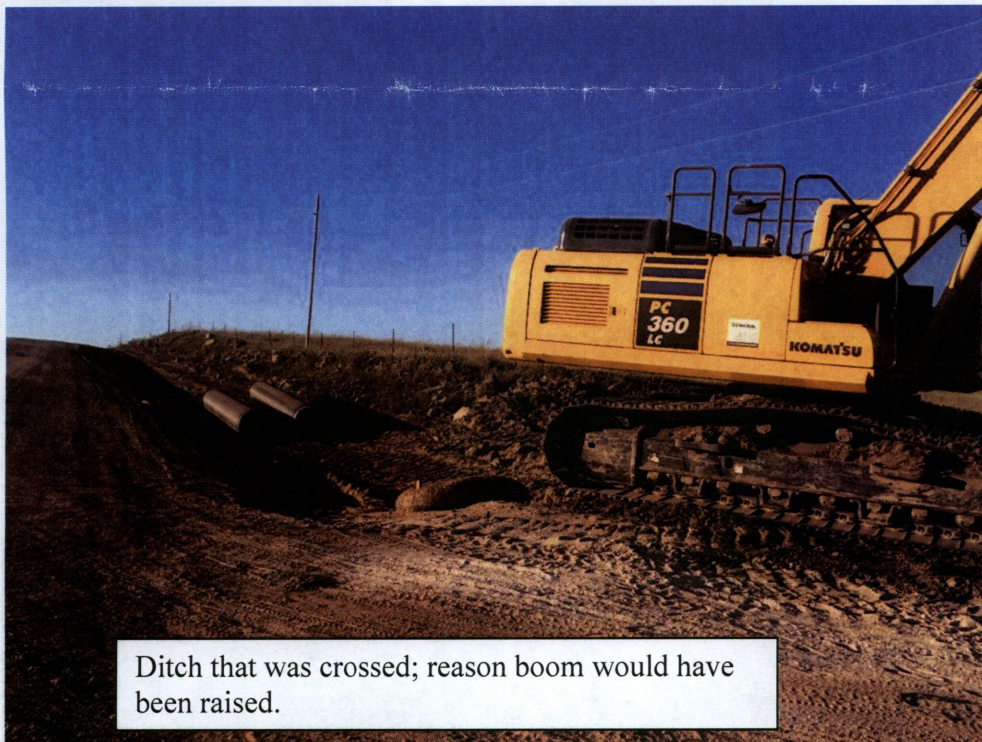
Ditch that was crossed; reason boom would have been raised.

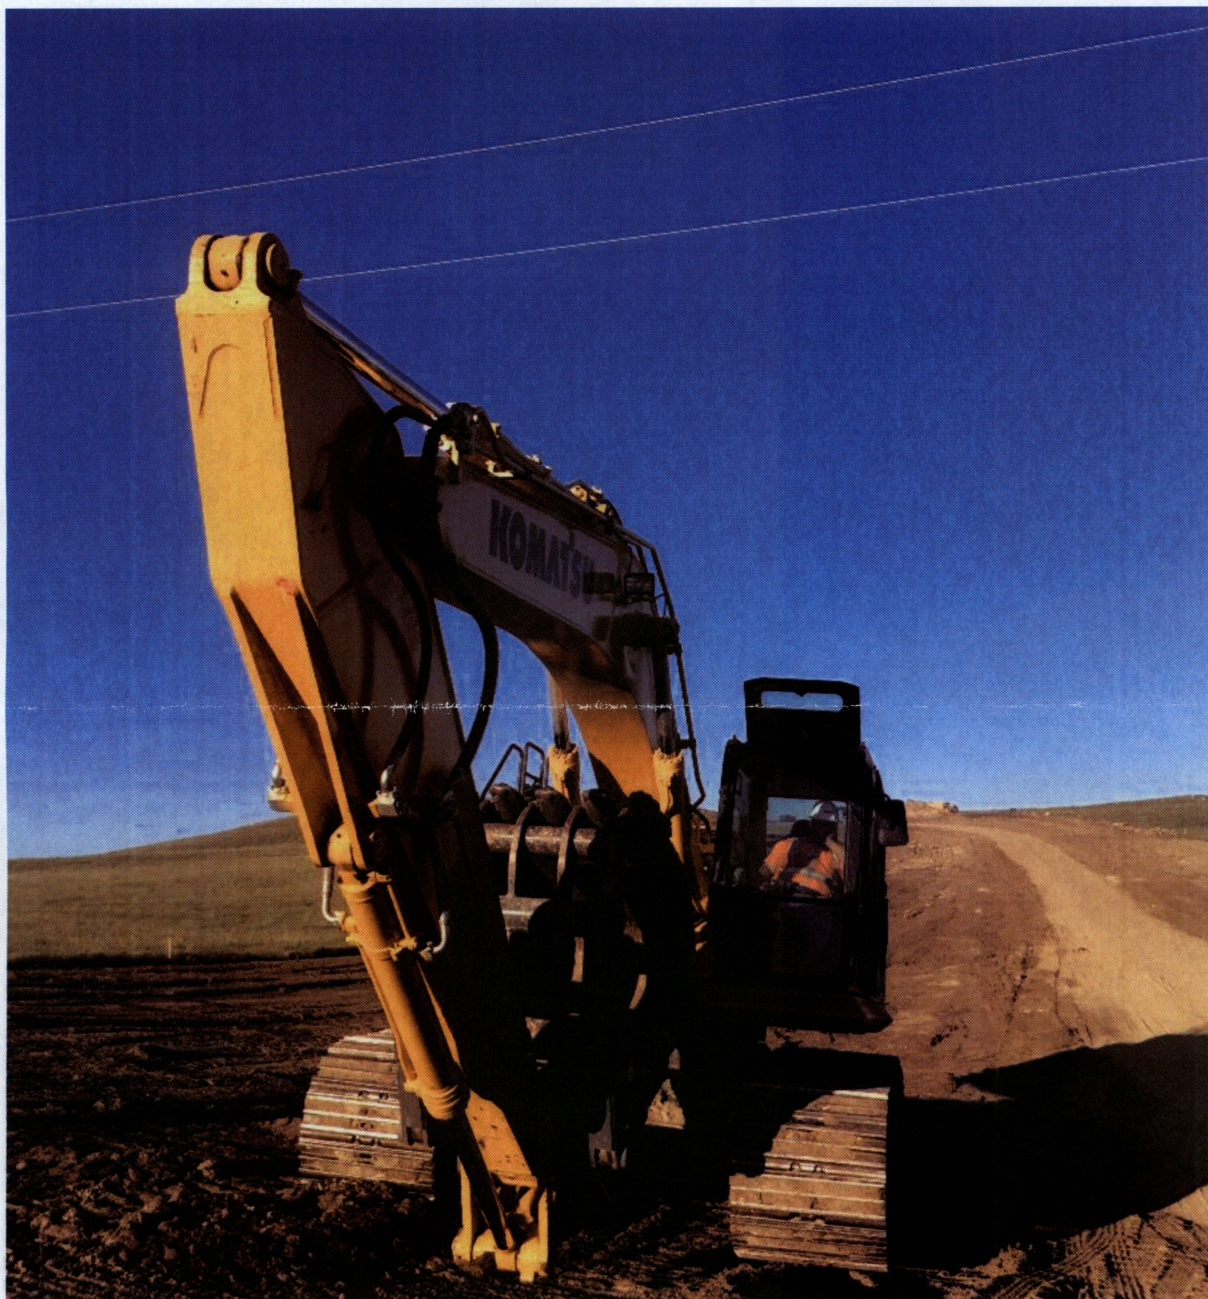
Proper Boom position to walk under power lines
