Re: ALLETE Clean Energy through Thunder Spirit Wind, LLC  
Thunder Spirit Wind Project  
Case No. PU-11-601

133 PU-11-601 Filed: 9/21/2015 Pages: 5  
Thunder Spirit Wind progress report – week ending  
9-18-2015

## Thunder Spirit Wind Weekly PSC Update

## **Employee Shocked During VLF Testing Colstrip Electric Inc.**

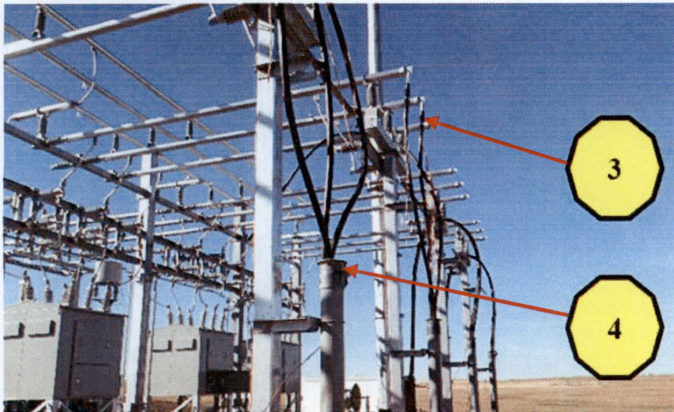
Circuit 4 that was to be tested, circuit 3 that the substation crew were working on
