Re: ALLETE Clean Energy through Thunder Spirit Wind, LLC
Thunder Spirit Wind Project
Case No. PU-11-601

Please find attached in the above-referenced case, ALLETE Clean Energy's October 10, 2015 Underground Fiber Optic Cable Incident Report.

135 PU-11-601 Filed: 10/13/2015 Pages: 12
Underground fiber optic cable incident report

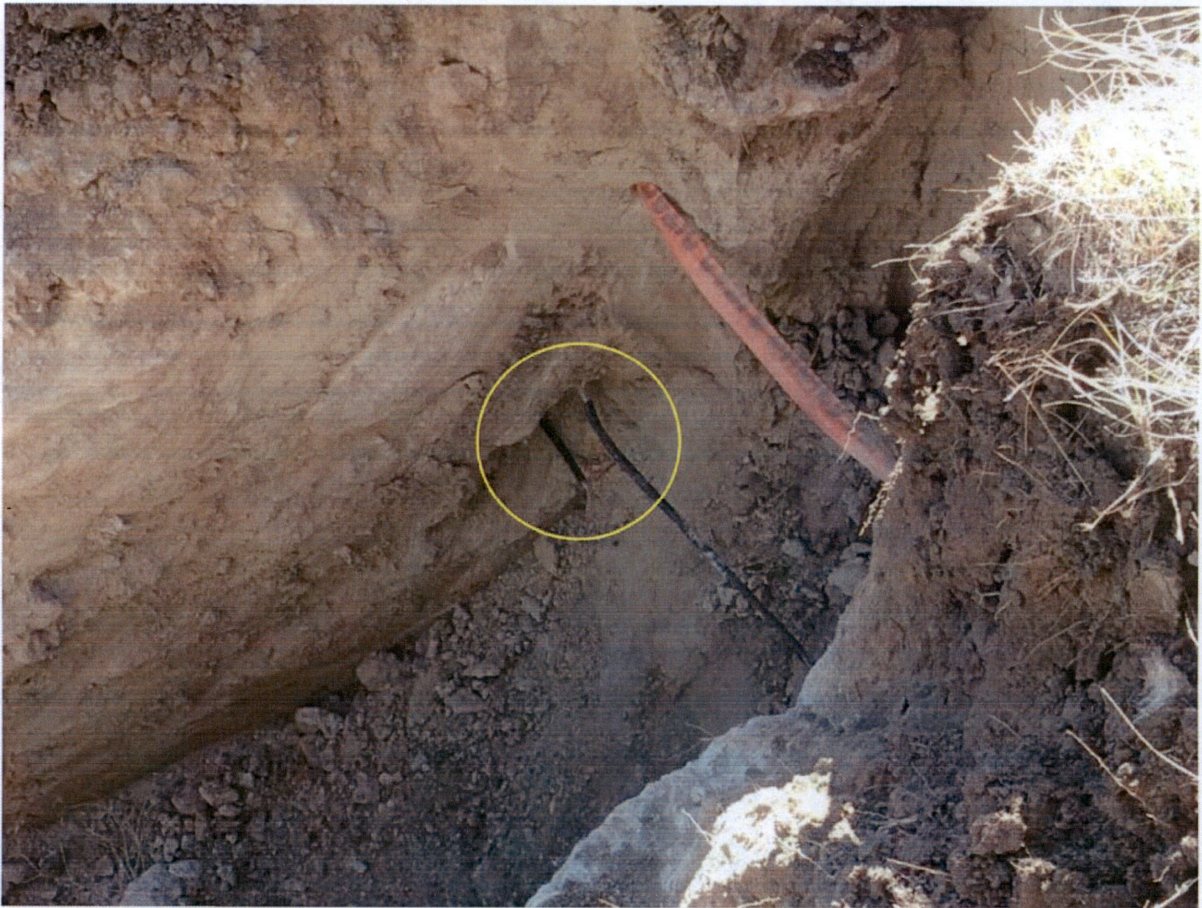
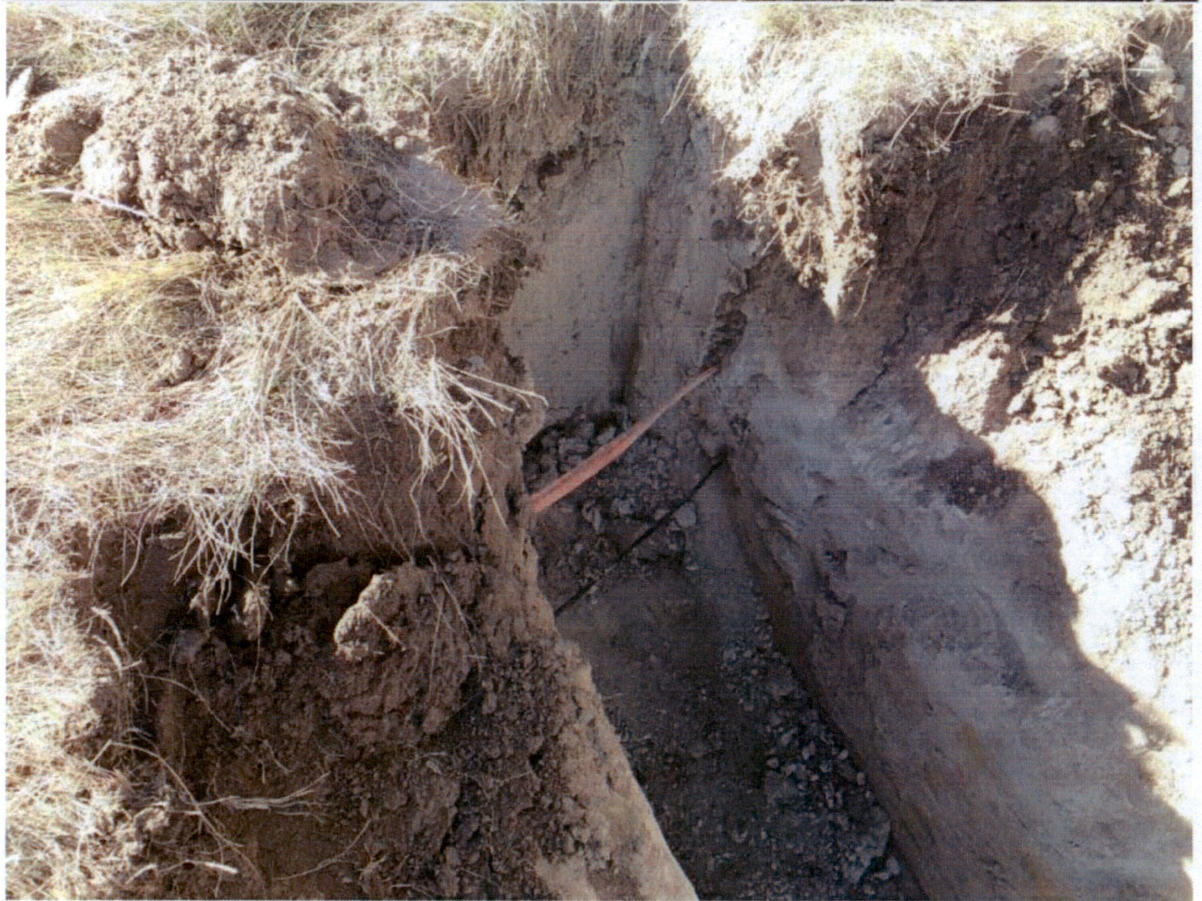
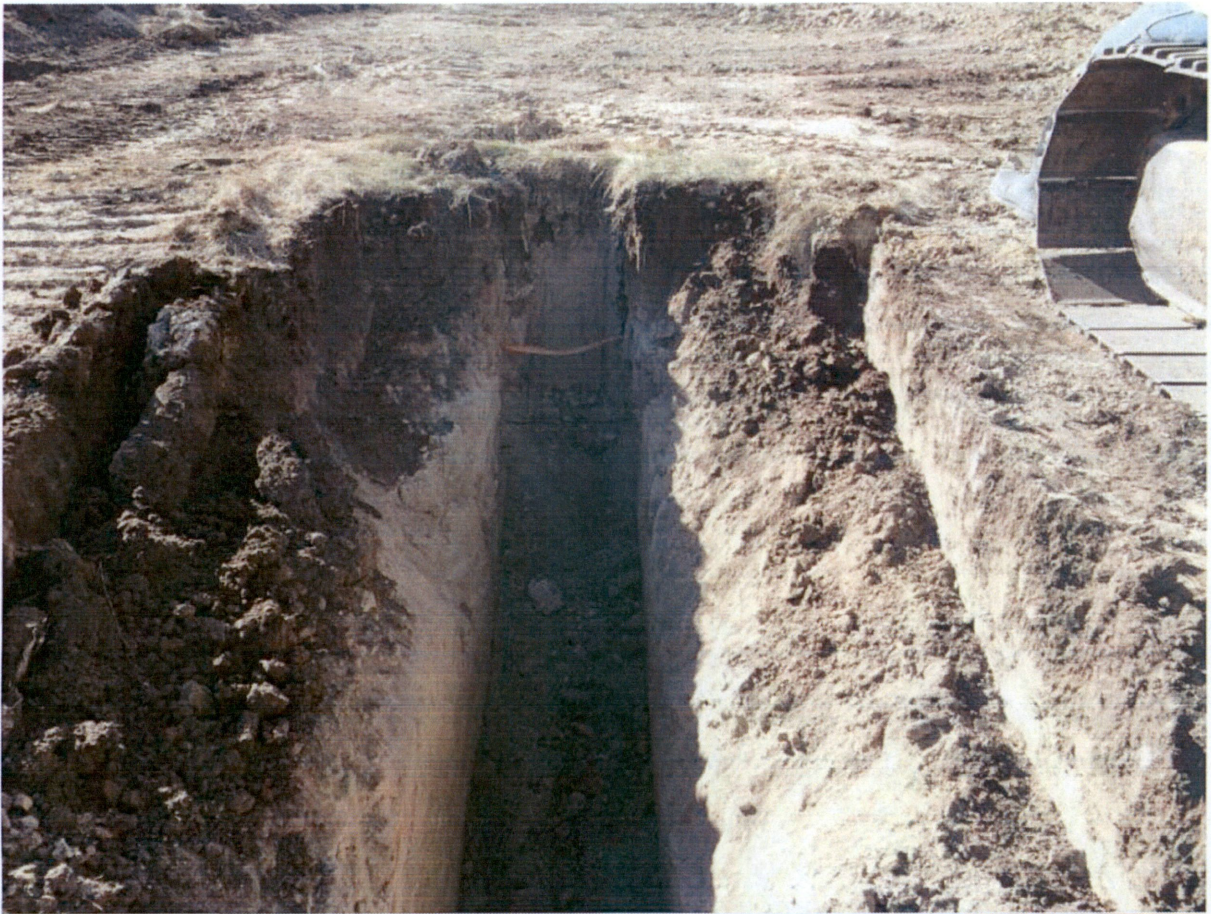
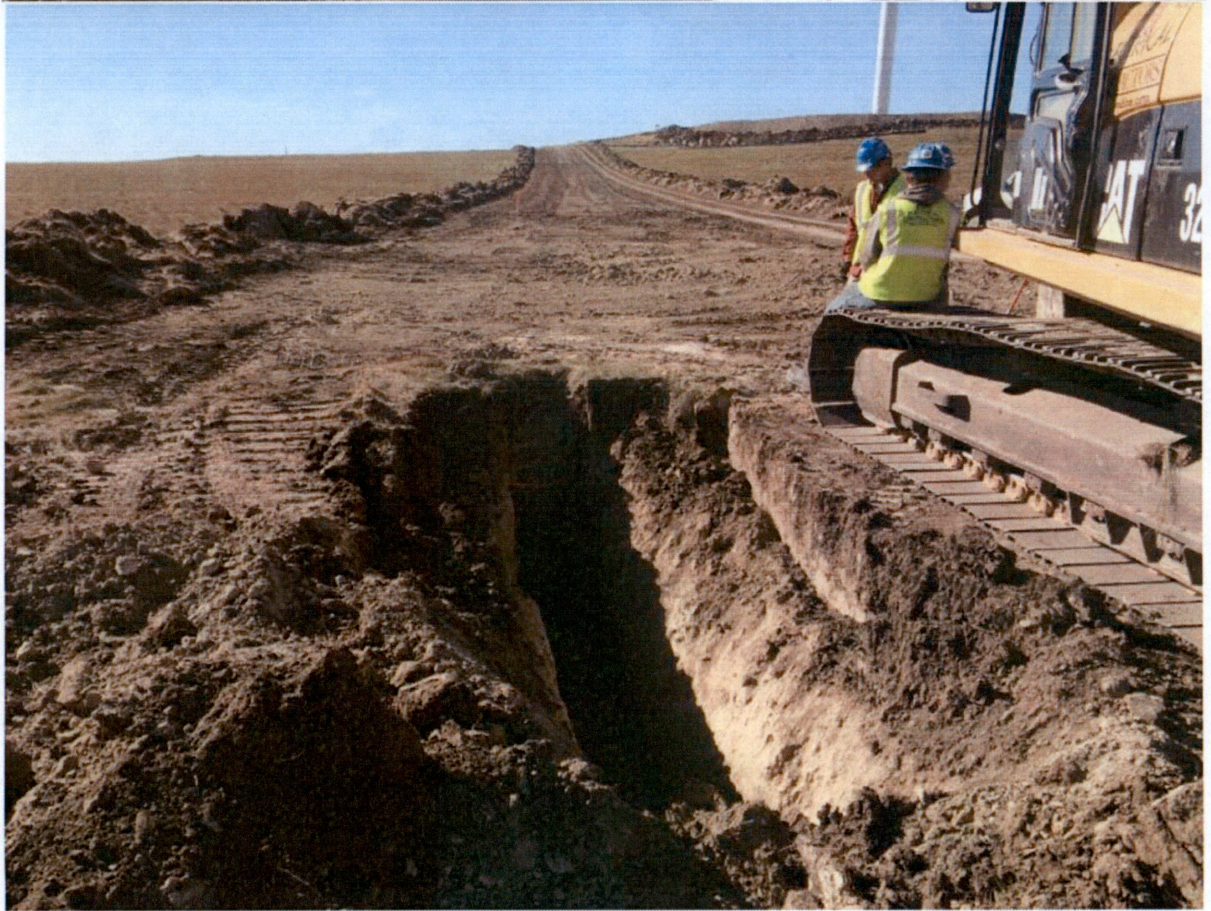
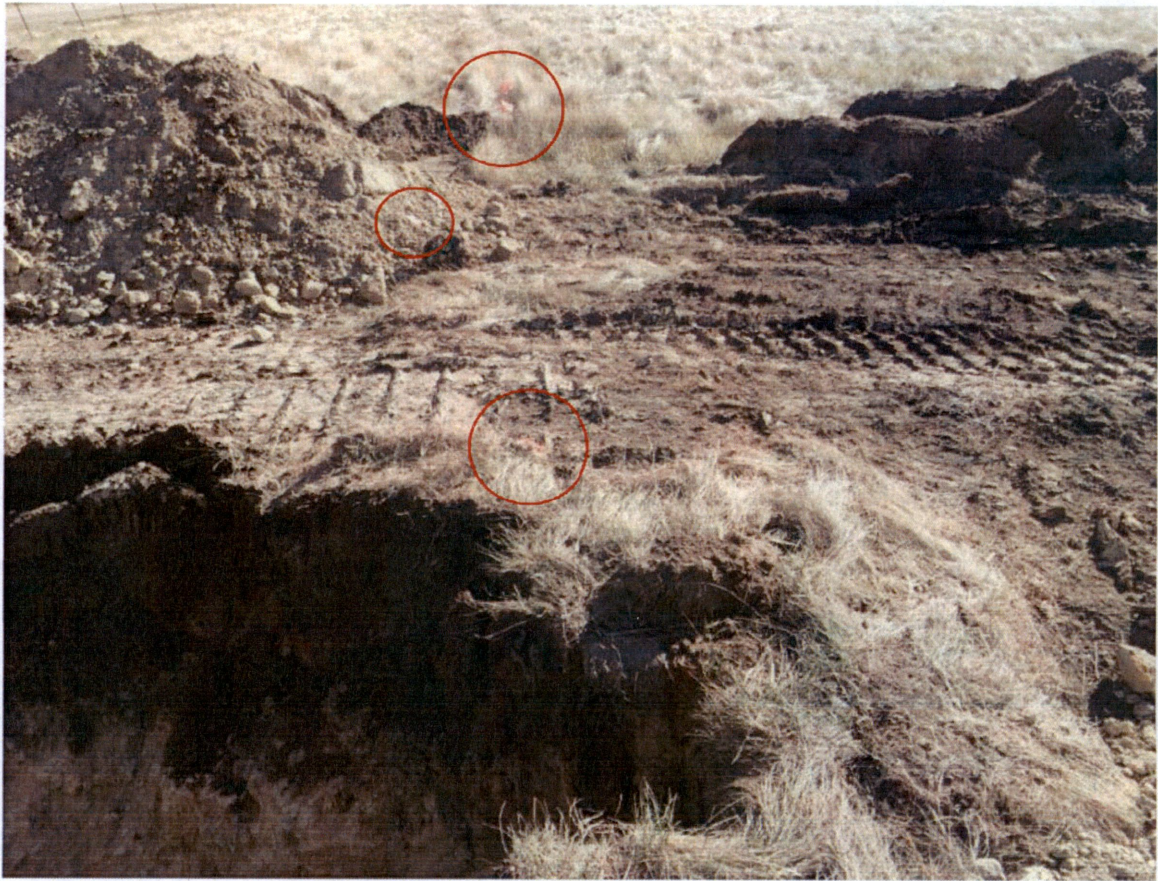
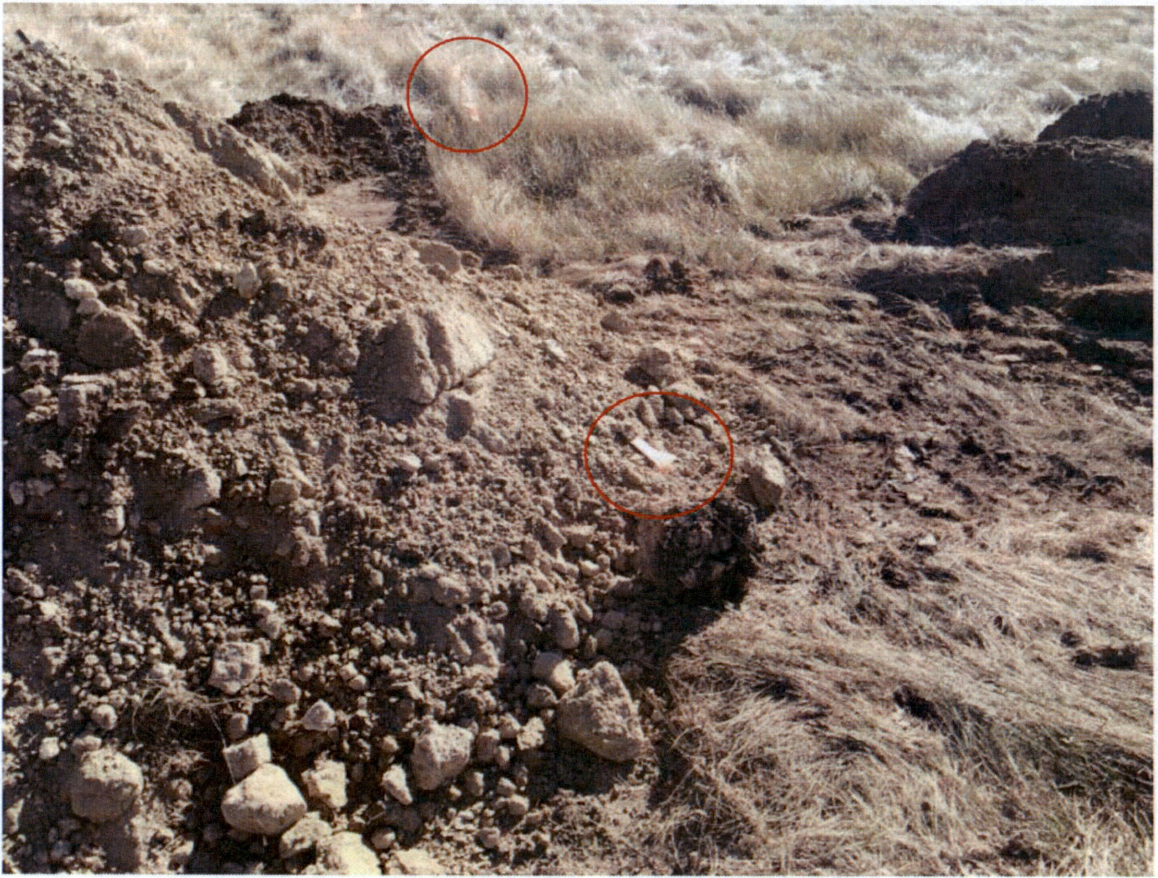
On October 10, 2015 at approximately 9:50 AM, the trenching crew cut through the 12 strand fiber optic cable located on the south side of 5th Ave where circuit 3s home run crosses the road. The trenching crew had moved to start circuit 3s homerun to turbine site 24. The crew had to cross under the buried fiber cable which had been pot holed using a vacuum truck several weeks prior. Prior to digging the operator and the spotter cleaned tumbleweeds out of the hole for the fiber cable prior, once the hole was cleared the operator then proceeded to dig the dirt away to open up the trench. The trench tape and fiber cable were visible at that time. A trench was opened up approximately 2 feet on the north side of where the pot holed fiber cable was located. As the operator was working his way back towards the fiber, with the spotter watching the right side of the trench, the spotter signaled to the operator to stop when he got close to the trench tape. As the operator pulled the excavator bucket away from the trench tape, the left tooth of the excavator bucket caught the fiber cable resulting in the cut fiber line. After seeing the cut fiber cable, the crew shut down immediately and the foreman contacted his supervisor. At around 10 AM Wanzek was notified of the incident and it was reported to ACE a few minutes later. Wanzek site safety arrived at site around 10:08 AM, asked for the dig permit which he was provided, took pictures of the damaged cable and the crew was instructed to barricade the location and return to the laydown yard to begin the investigation portion of the incident which was headed by CEI. Several attempts were made to contact known local Consolidated (public utility company) employees but contact was finally made at 11:35 AM and the incident reported. CEI received a call at approximately 12 PM from Consolidated stating that they were on their way. The fiber repair crew arrived on location at around 3 PM, repairs took 2 and a half hours to make and the fiber repair crew left site around 5:30 PM. All trenching activities were shut down until a corrective action plan is drafted and submitted to Wanzek.

- 1) Operator was too close to the fiber cable
- 2) Spotter should have been behind the fiber so he could see the hole trench opening
- 3) Work within close proximity to the utility was not done by hand
- 4) Deviation from proper procedures/ poor decisions were made

- 1) Insufficient worker training – Spotter needed to know where and what to look for, operator should not have operated heavy equipment within close proximity to an existing public utility
- 2) Communication – operator should have communicated with the spotter for proximity updates, spotter should have relayed proximity
- 3) Foreman should have communicated the process better and ensured it was understood by all involved

- 1) Equipment operator was too close to the fiber
- 2) Better communication should have been utilized and need improvement by both the operator and spotter
- 3) Training for work activities near or around utilities both public and new during exaction activities along with advanced spotter training

- 1) Notification of the incident was made to CEI Supervision, Wanzek and ACE Management.
- 2) Incident location was barricaded and work activities shut down
- 3) Consolidated was notified of the incident and a repair team was sent to the incident location
- 4) Crew was stood down and an investigation started
- 5) Excavation at the location of the incident 30 feet both east and west of the strike location over the fiber line was made by CEI to assist Consolidated with the repair
- 6) The trenching crew reviewed CEI's policy on Trenching and Excavation
- 7) Repairs were completed by Consolidated and the area was barricaded until further notice
- 8) Accountability measures are currently being discussed for the operator and spotter and will be finalized after Monday's stand down with CEI
- 9) Wanzek has requested a corrective action plan from CEI prior to trench crew activities resuming

- 1) Crew Training/ retraining on spotter procedures and working distance from known objects
- 2) Review of CEI trenching policies
