150 MW Thunder Spirit Wind Project, Minnesota Power (PSC Case No. PU-11-601)

Permit Compliance Review

Reporting Period: December 9, 2013 – September 10, 2015

Prepared By: Houston Engineering, Inc. / Josh Kadrmas, Environmental Engineer, Emmy Baskerville, Environmental Scientist and Bart Schultz, Project Manager

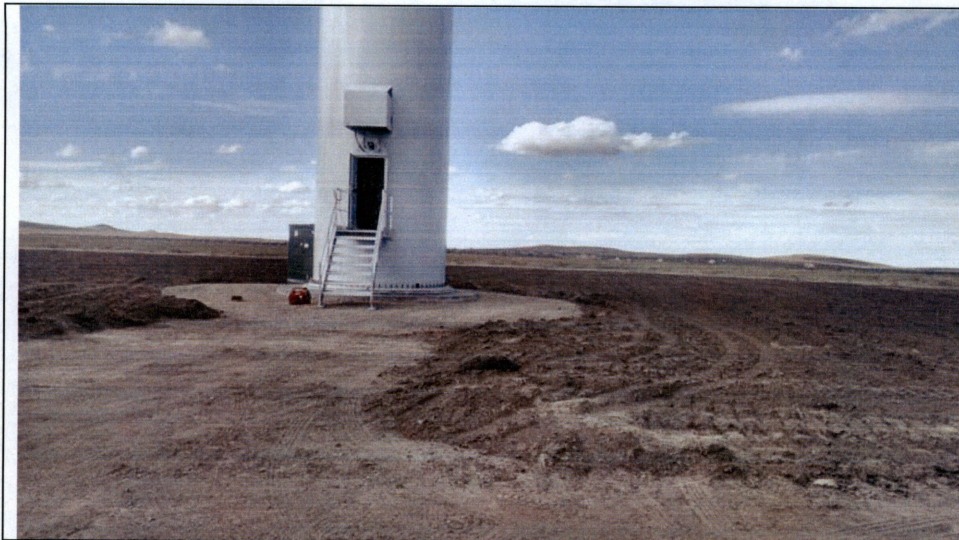
Photo 1:
Completed turbine site, awaiting final preparation of seed bed.

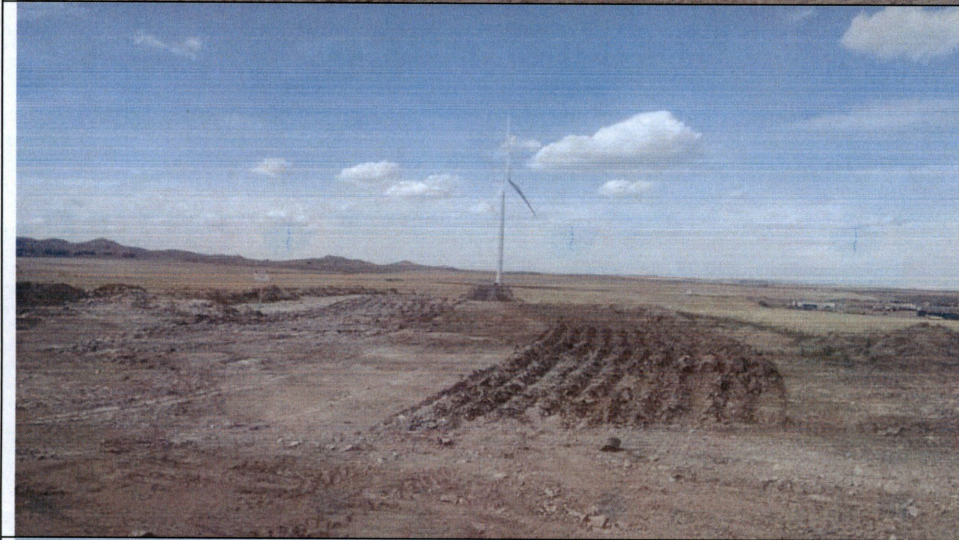
Photo 2:
Topsoil respreads on reclaimed right-of-way.

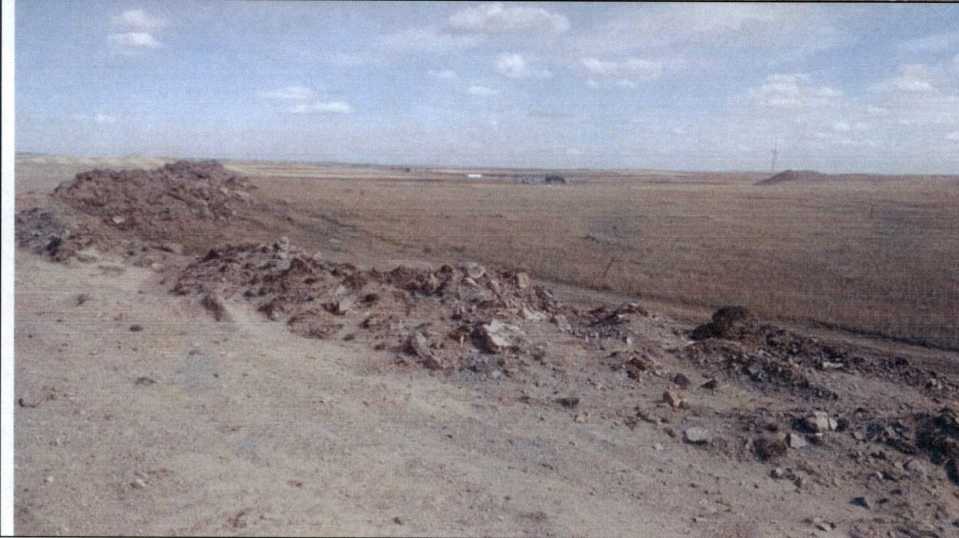
Photo 3:
Fenced-off cultural resource area, near Turbine 13.

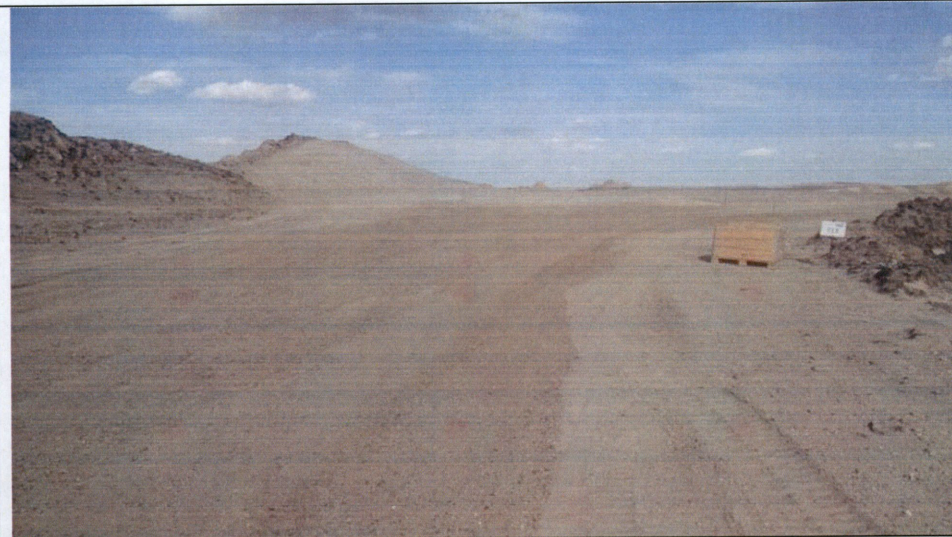
Photo 4:
Foundation and
subsurface
grading complete
at Turbine 13.

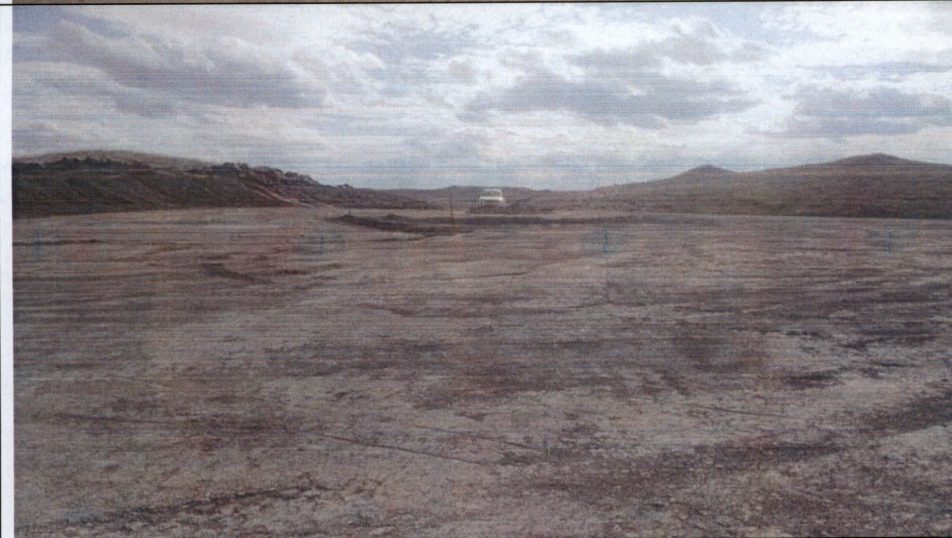
Photo 5:
Completed
subsurface
grading at Pad
for Turbine 9.

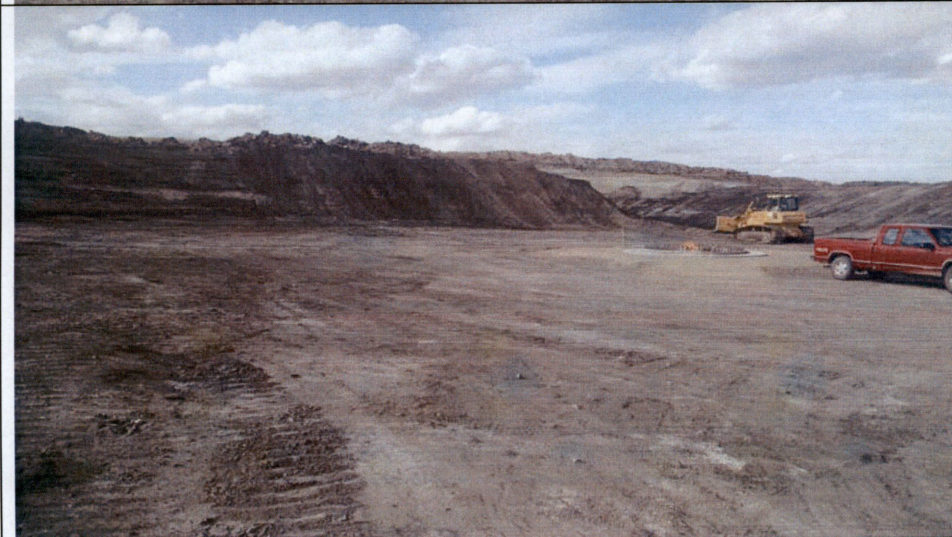
Photo 6: Re-
spreading topsoil
over excavated
slope near
Turbine 8.

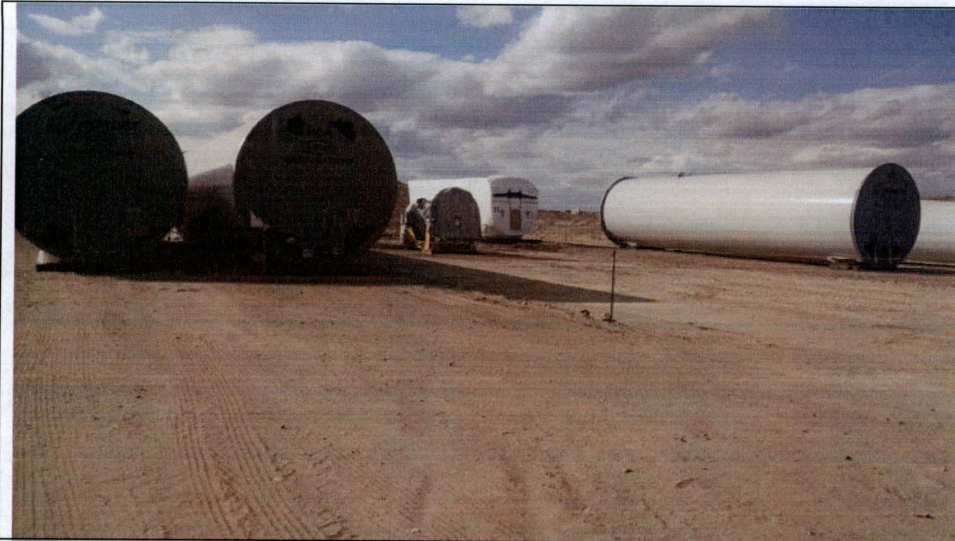
Photo 7: Tower sections and nacelle staged on the pad for Turbine 15.

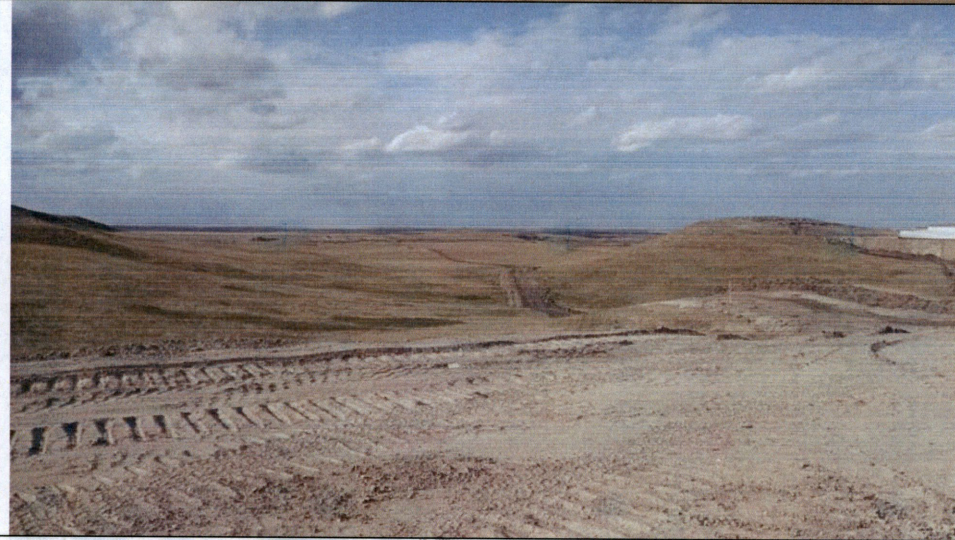
Photo 8: Looking north at collector line right-of-way from the pad site for Turbine 14.

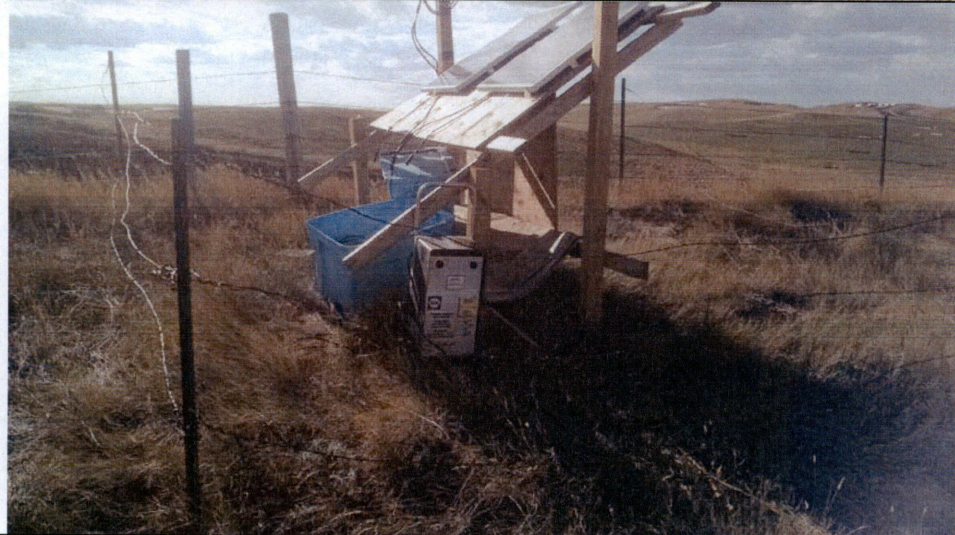
The temporary communication tower was located in the cultural resource area (Area) between Turbine site 19 and 2nd Street North. See **Photo 9**. Four - 4x4 posts had been driven into the ground in the area. According to Wells and Chris, the tower was inadvertently installed while the contractor was setting up onsite, and before survey could mark the exclusion area. HEI personnel were informed that the PSC had already been notified and that Allete was working with Beaver Creek Archeology to mitigate the disturbance.

Photo 9: Temporary communication tower accidentally installed in cultural area, west of Turbine 19.

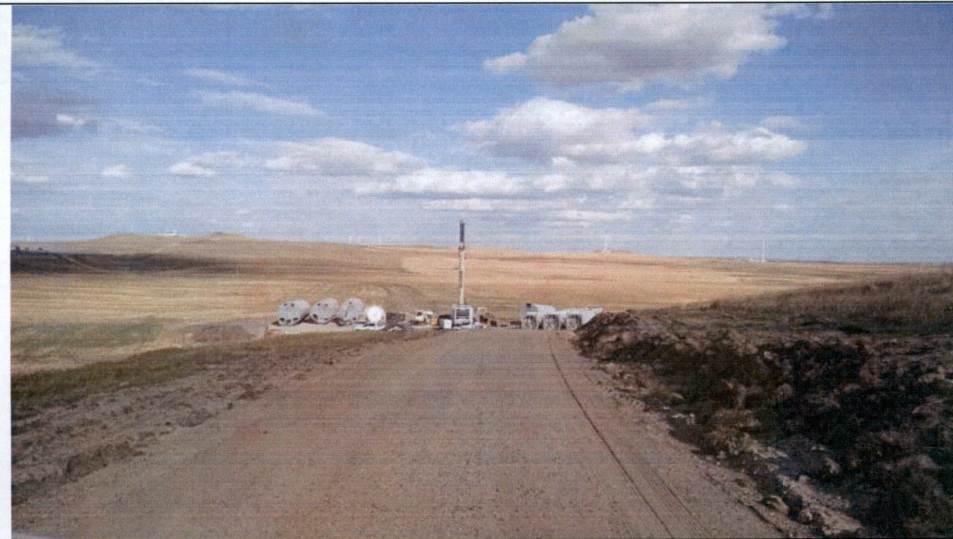
Photo 10:
Preparing to
assemble tower
at Turbine 27.

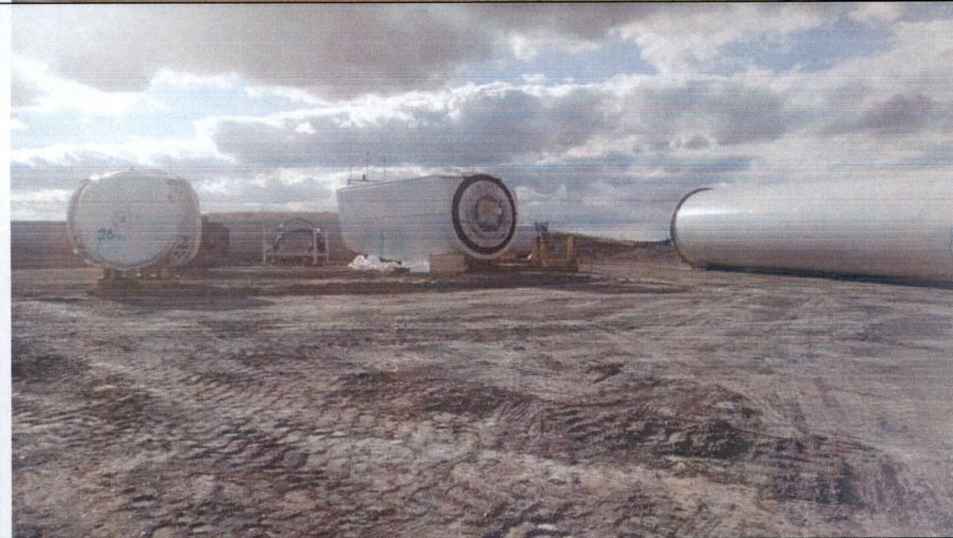
Photo 11:
Tower sections
and nacelle
staged on the pad
for Turbine 26.

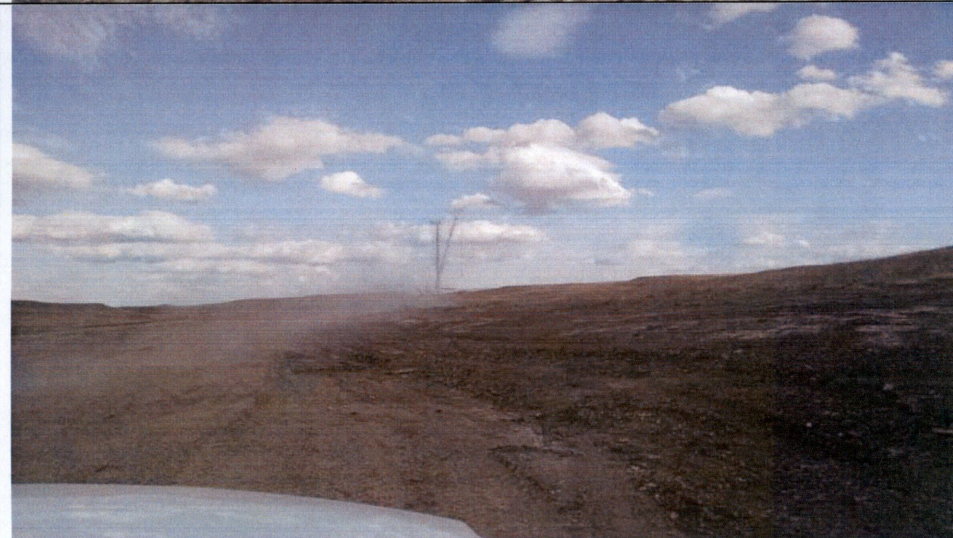
Photo 12:
Preparing to
raise blade
assembly at
Turbine 36.

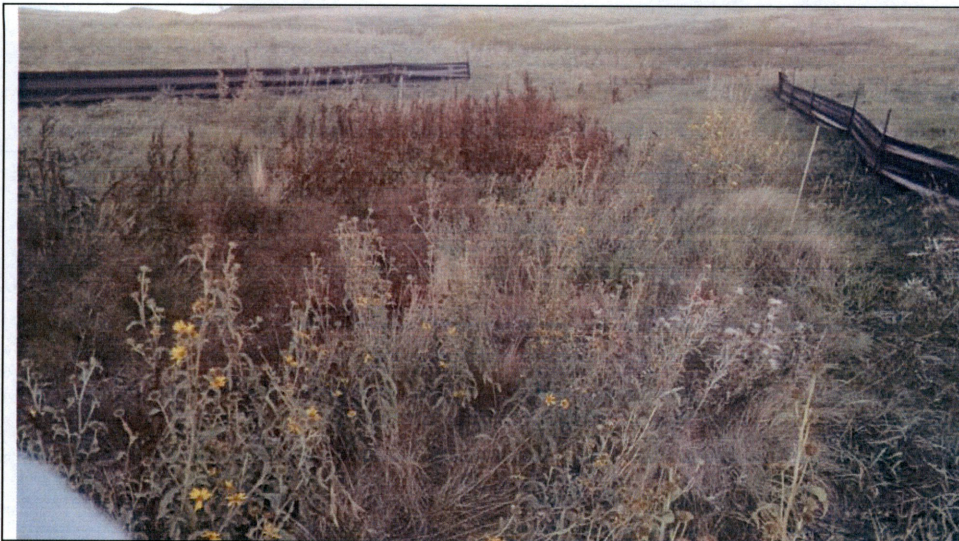
Photo 13:
Looking east at
wetland that
crosses collector
line right-of-way
between
Turbines 36 and
37.

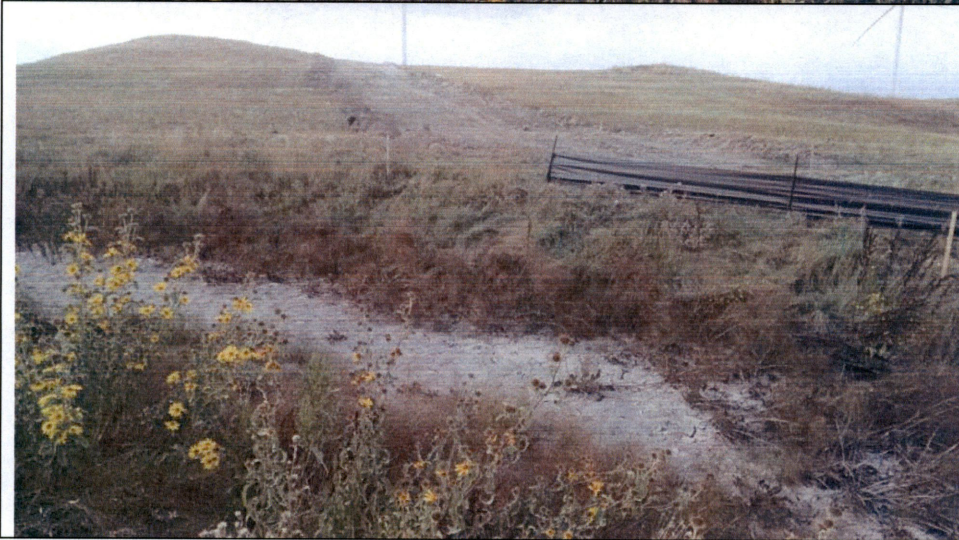
Photo 14:
Looking north at
wetland that
crosses collector
line right-of-way
between
Turbines 36 and
37.

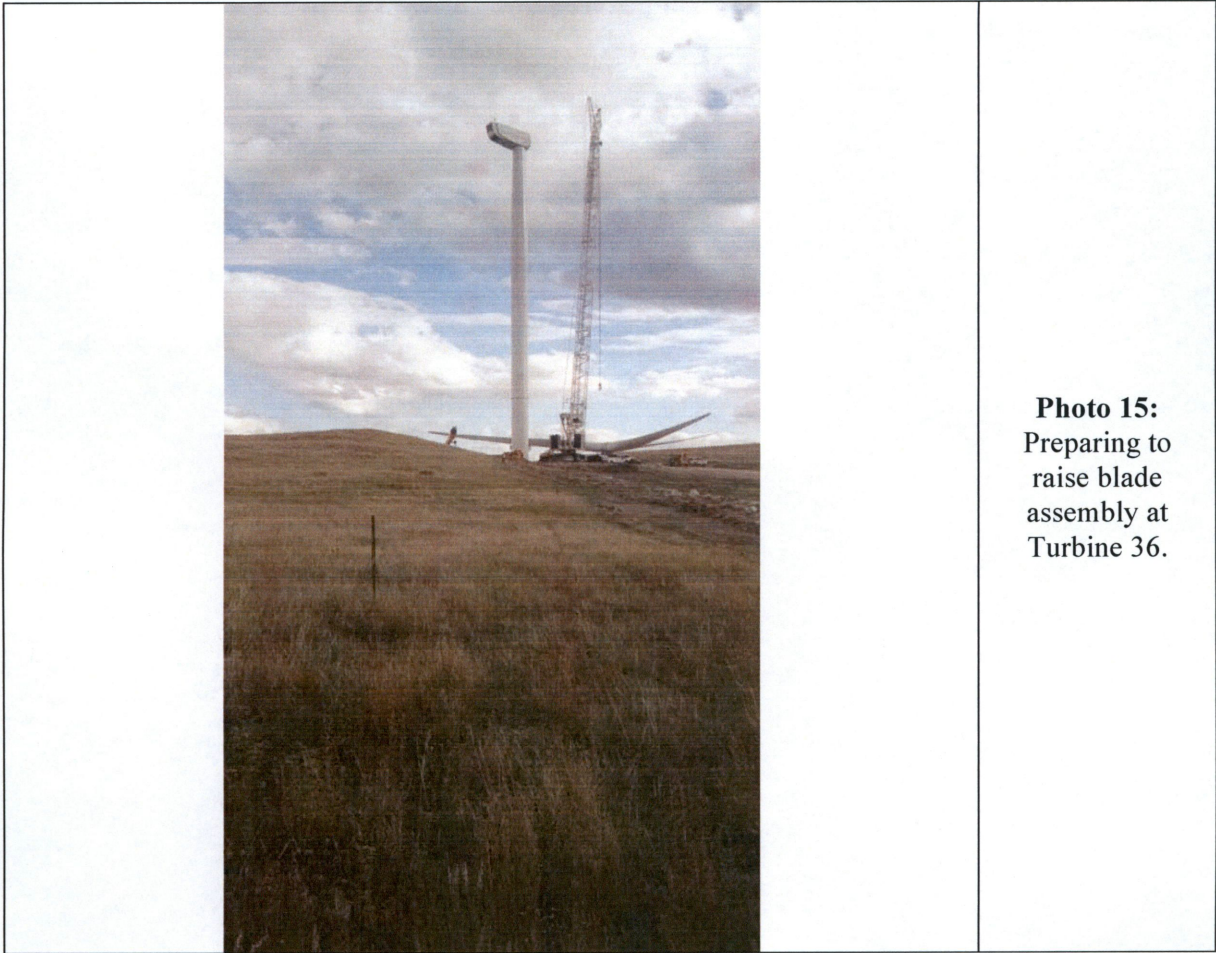
Photo 15:
Preparing to
raise blade
assembly at
Turbine 36.
