# 150 MW THUNDER SPIRIT WIND PROJECT, (PU-11-601)

## Permit compliance inspection report #2

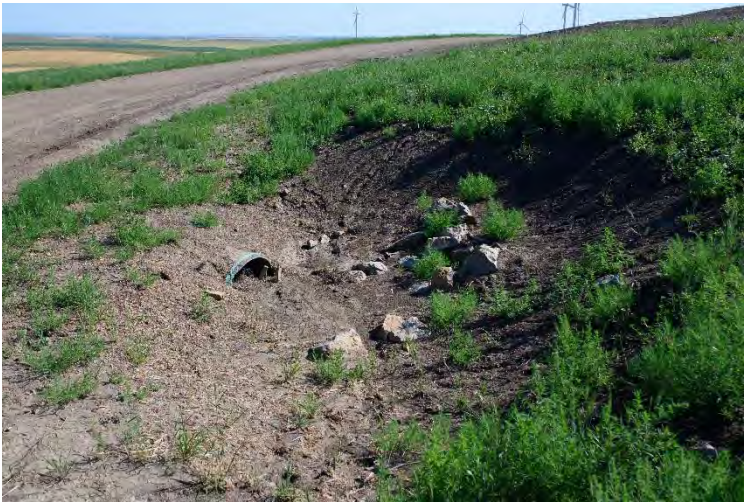
erosion were observed in the area of the buried line between Towers 30 and 40, which is not vegetated (**Photographs 3 and 4**). A wetland crossing was bored along the buried line between these towers; no temporary or permanent impacts were observed. Another buried power line crossed a wetland (**Photograph 15**) and temporary impacts were observed. Also between Towers 30 and 40 is a culvert running under the road (**Photograph 2**). The area around this culvert is not vegetated and was found with soil stability/erosion issues; the culvert was found 66% filled with sediment and does not have sufficient capacity to convey stormwater.

**Photo 2:** Between Tower 30 and  
31 (facing North). Significant  
erosion, culvert filling with  
sediments (approximately 66% full)

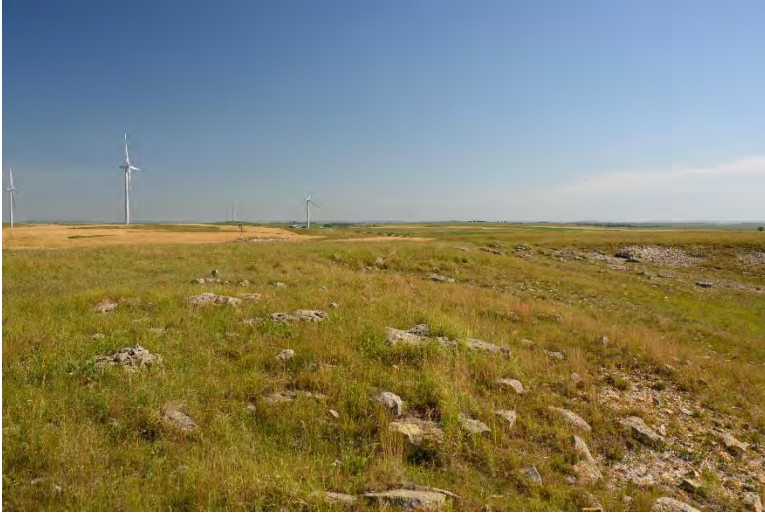
**Photo 5:** Tower 31 (facing Northeast).

No impacts were observed to the cultural site located in the vicinity of the Tower 31 roadway. Vegetation at this tower was established and observed adequate. Another culvert under the roadway between Towers 30 and 40 appears to be experiencing minor sediment loading (**Photograph 8**) as there is some minor erosion observed along the roadway. The access road was observed to be experiencing erosion of the surface aggregate (**Photograph 14**).

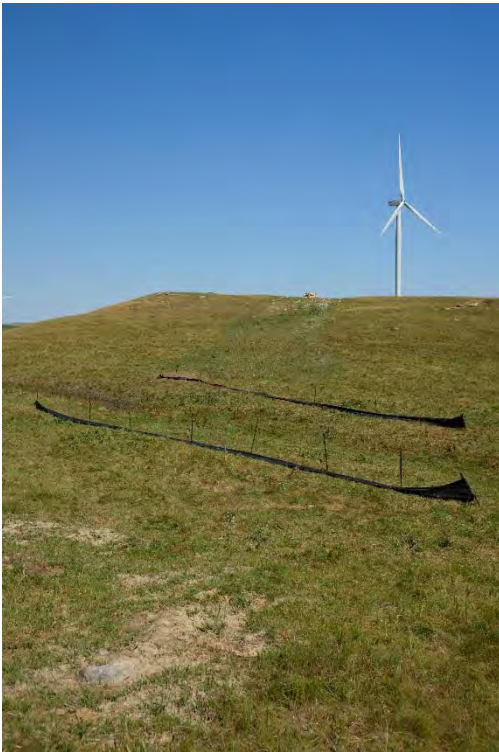
**Photo 13:** Looking east at wetland that crosses collector line right-of-way between Turbines 36 and 37.

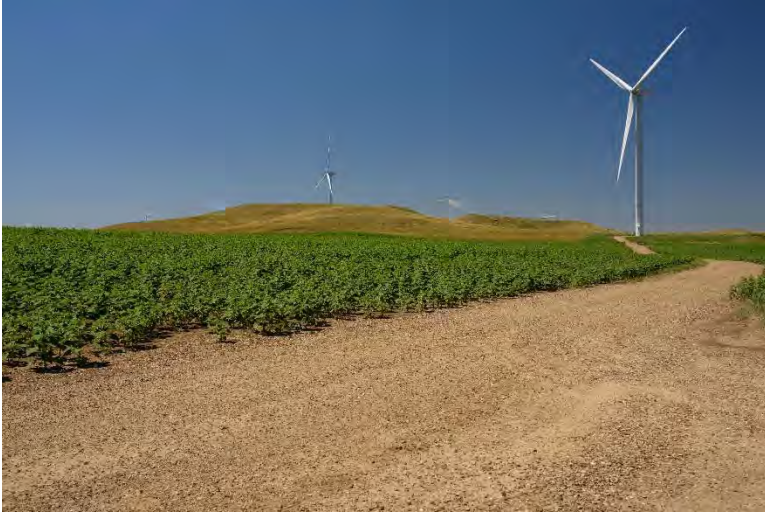
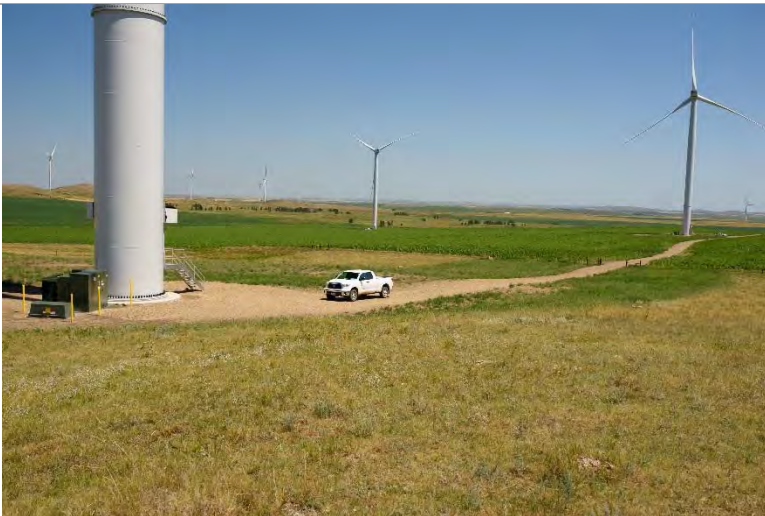
The large cultural area adjacent to Towers 18 and 19 was observed to be avoided. Tower 19 was observed to have cropland covering the cultural area; no impacts were observed.
