THUNDER SPIRIT WIND ENERGY PROJECT (PU-11-601)

Final Permit Compliance Inspection Report 2020

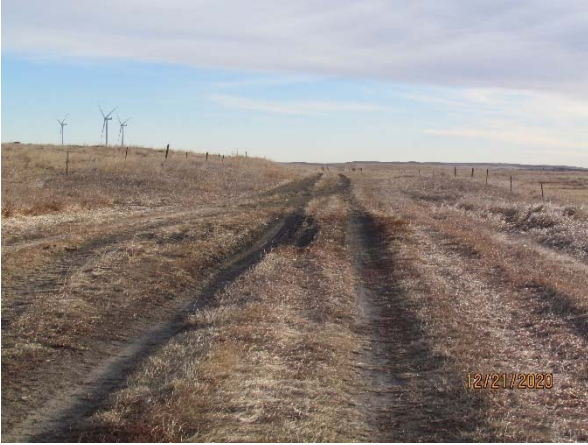
- tire rutting on public roadways (See Photos 1 – 8, 24 – 25).
- As-built documents have not yet been received by the Commission. MDU should submit As-built documentation to the Commission to be in compliance with this provision.

Photo 1: Section line (3rd Avenue NE) roadway rutting, facing east.

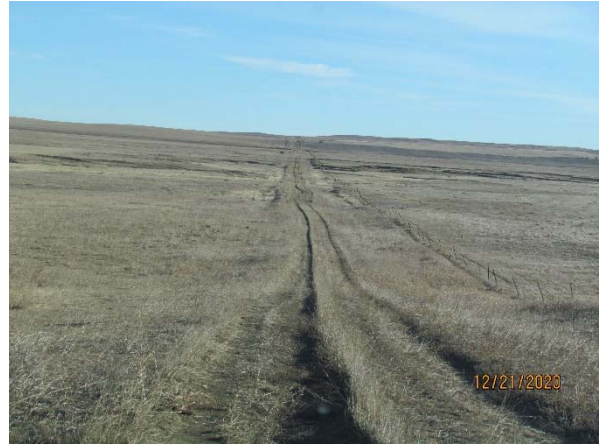
Photo 2: Section line (3rd Avenue NE) roadway rutting, facing east.

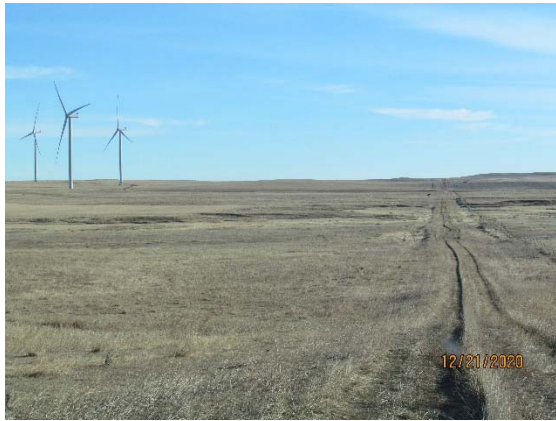
Photo 3: Section line (3rd Avenue NE) roadway rutting, facing east.

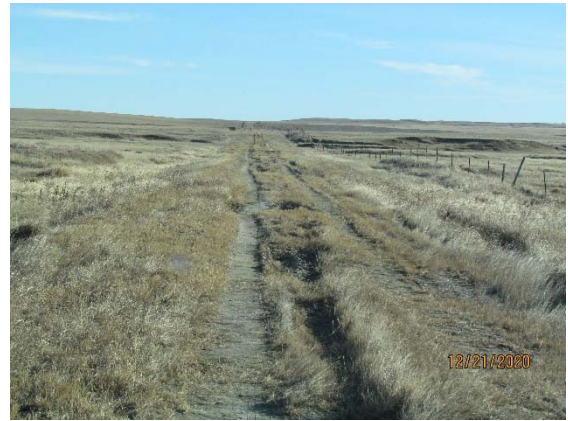
Photo 4: Section line (3rd Avenue NE) roadway rutting, facing east.

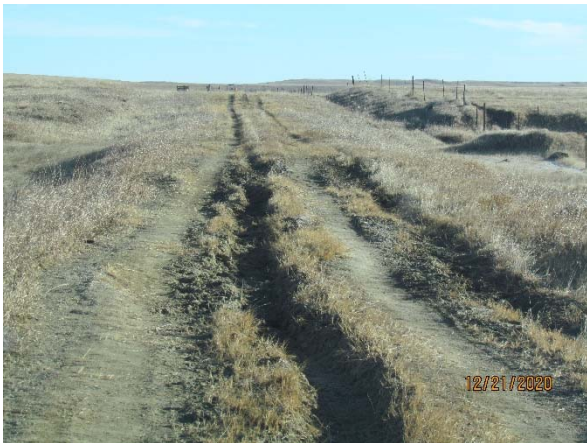
Photo 5: Section line (3rd Avenue NE) roadway rutting, facing east.

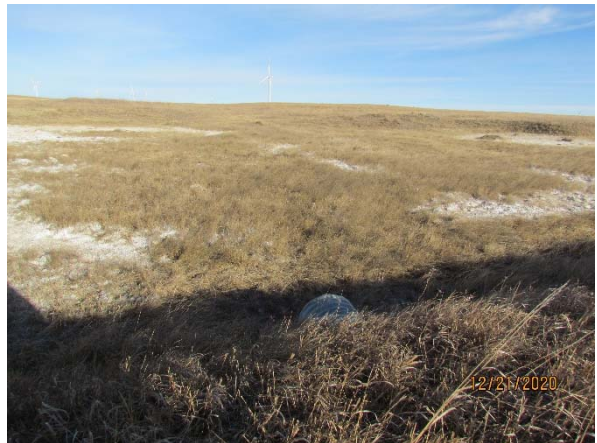
Photo 6: 3rd Avenue NE stream crossing culverts, facing north.

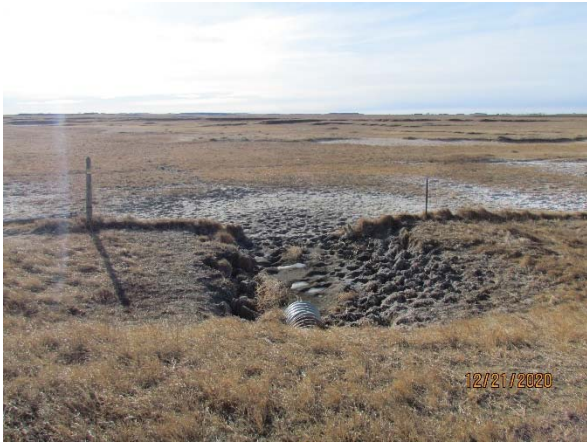
Photo 7: 3rd Avenue NE crossing culverts and erosion, facing south.

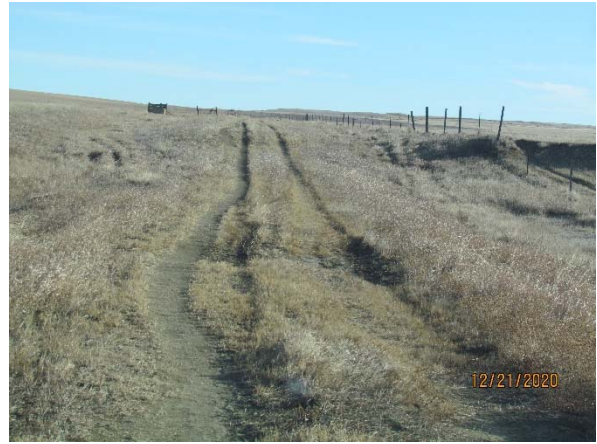
Photo 8: Section line (3rd Avenue NE) roadway rutting, facing east.

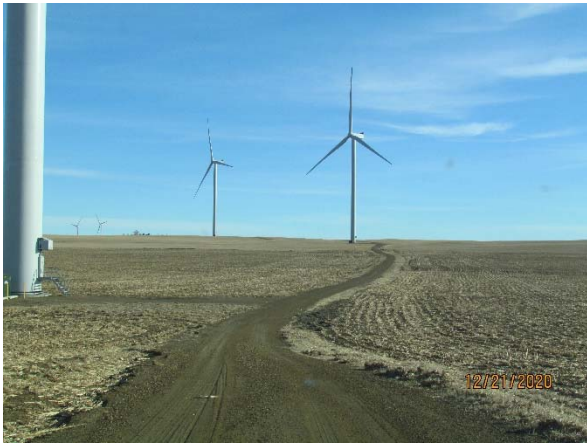
- erosion adjacent to access road for Turbine 1 (See Photos 22 – 23),
 - erosion and exposed fabric adjacent access road for Turbines 2, 3, 4 and 5 (See Photos 9 - 21),

Photo 9: Turbine 2, 3, 4, 5 access road, facing east.

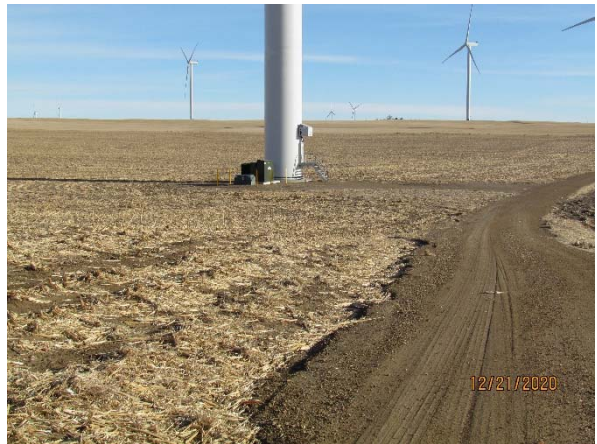
Photo 10: Minor erosion on Turbine 2, 3, 4, 5 access road, facing east.

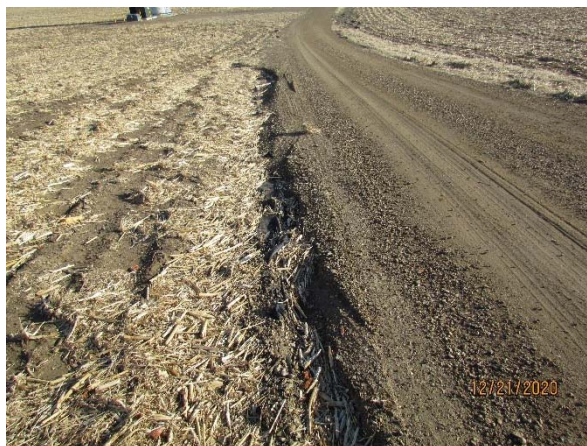
Photo 11: 10: Minor erosion on Turbine 2, 3, 4, 5 access road, facing east.

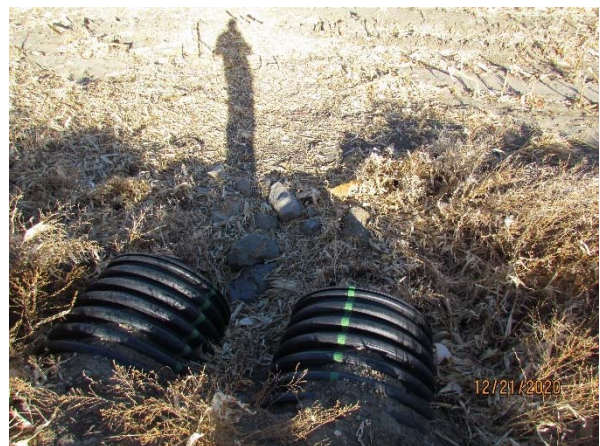
Photo 12: Waterbody crossing and minor erosion on Turbine 2, 3, 4, 5 access road, facing north.

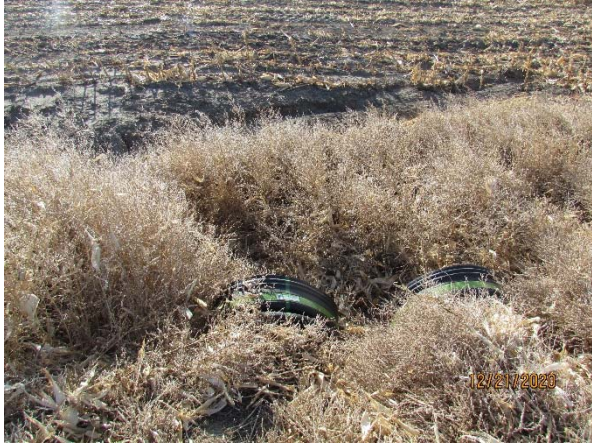
Photo 13: Waterbody crossing and minor erosion on Turbine 2, 3, 4, 5 access road, facing south.

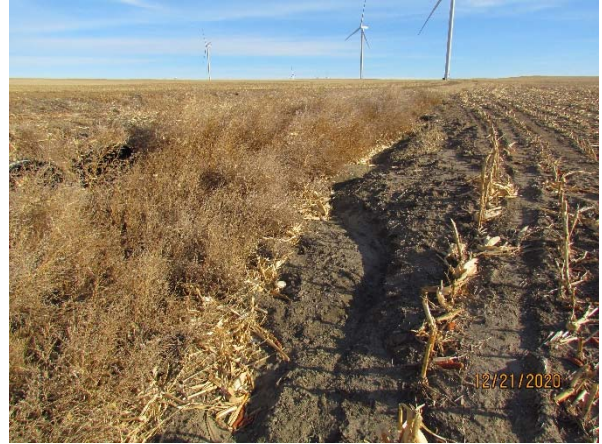
Photo 14: Erosion on Turbine 2, 3, 4, 5 access road, facing east.

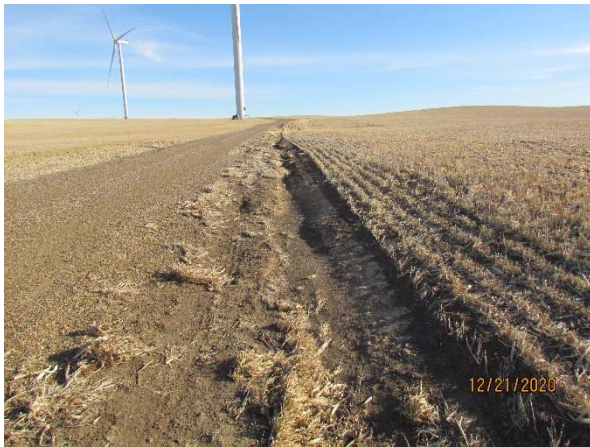
Photo 15: Erosion on Turbine 2, 3, 4, 5 access road, facing east.

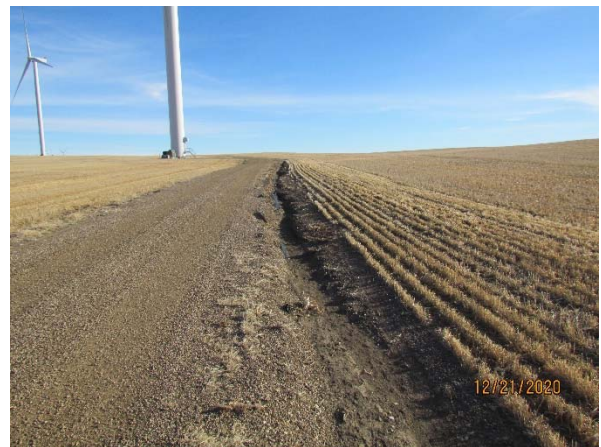
Photo 16: Erosion near Turbine 3, facing east.

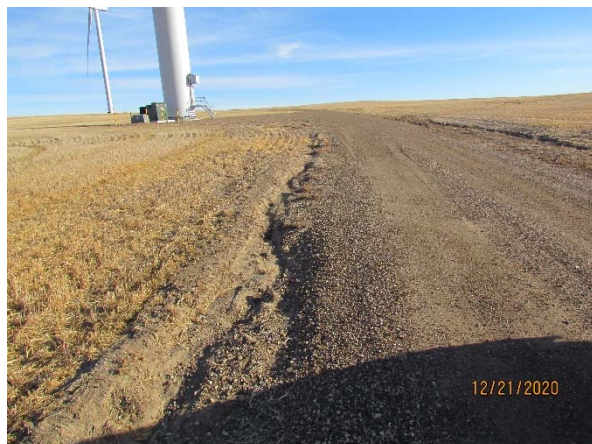
Photo 17: Erosion near Turbine 3, north side of access road, facing east.

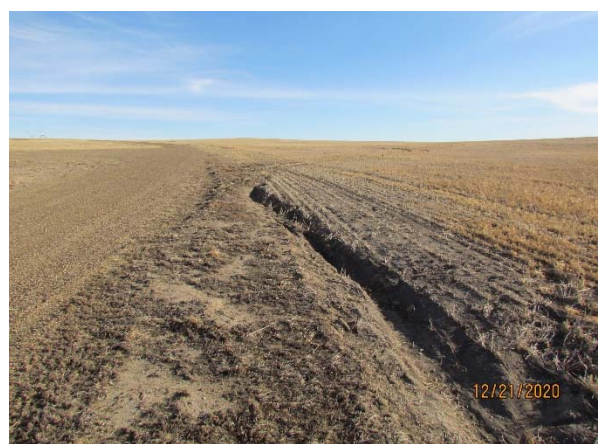
Photo 18: Erosion near Turbine 3, south side of access road facing east.

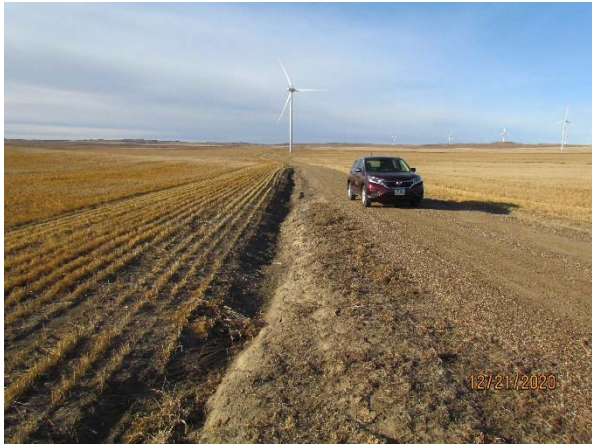
Photo 19: Erosion near Turbine 3, south side of access road, facing west.

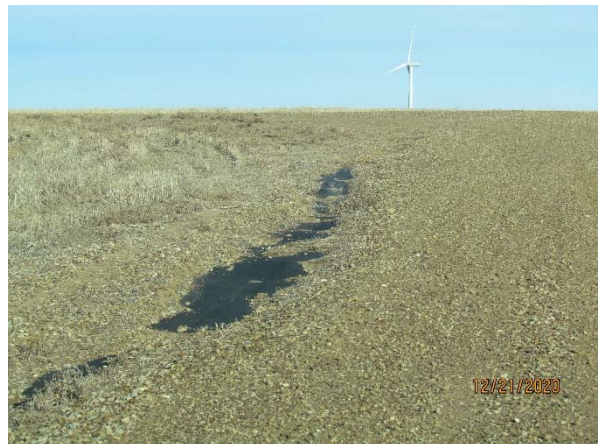
Photo 20: Exposed fabric near Turbine 5 at access road, facing north.

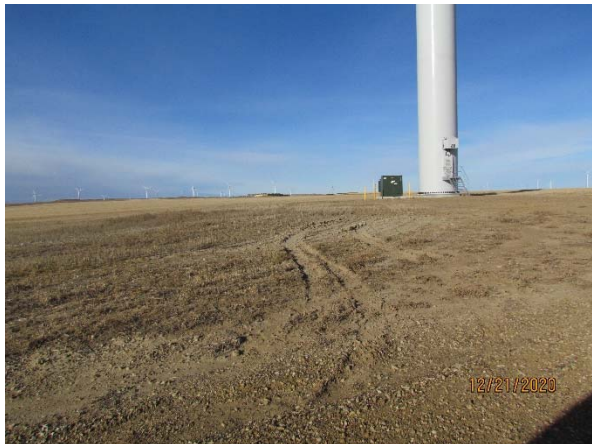
Photo 21: Tire rutting near Turbine 5.

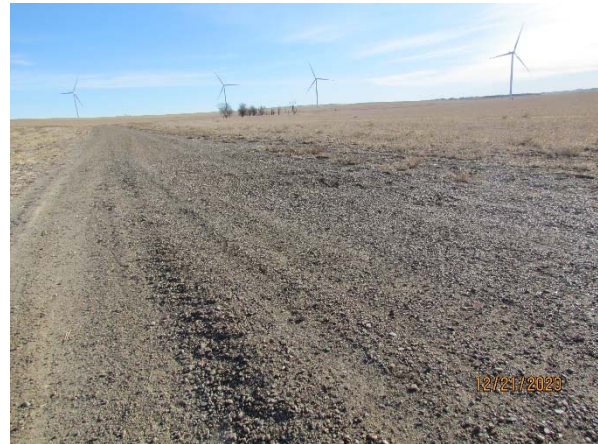
Photo 22: Settling of access road near Turbine 1, facing south.

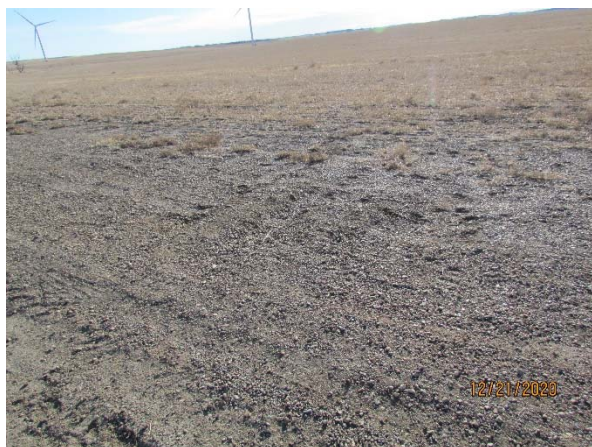
Photo 23: Settling of access road near Turbine 1, facing south.

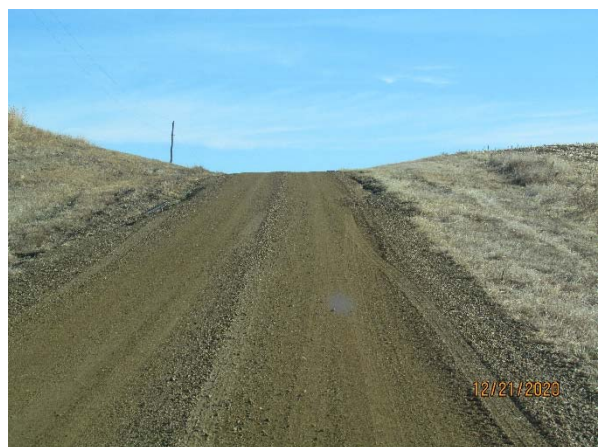
Photo 24: Minor erosion on North side of access road, facing east.

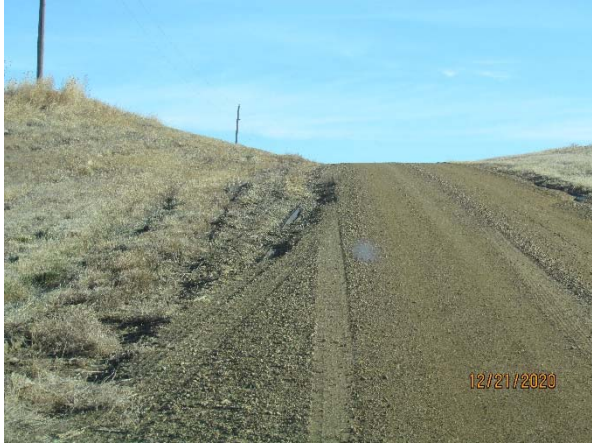
Photo 25: Minor erosion on North side of access road, facing east

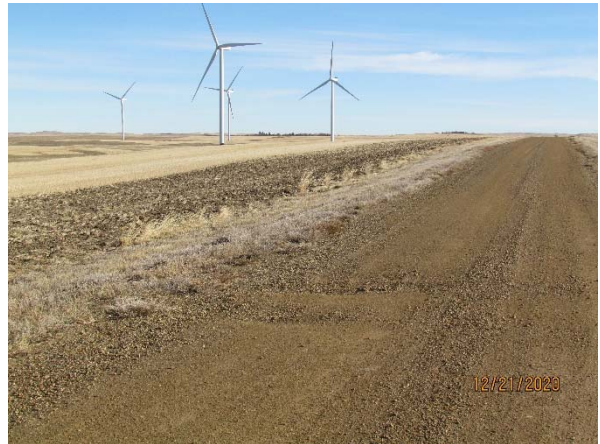
Photo 26: Settling / pothole on north side of access road, facing east.

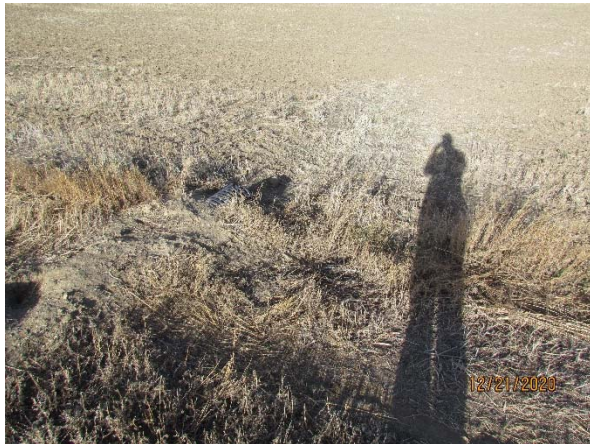
- erosion and sedimentation adjacent to access road for Turbines 6, 7, 8 and 9 (See Photos 27 - 35),
 - erosion adjacent to access road near Turbine 12 (See Photo 38),

Photo 27: Access road (Turbine 6, 7, 8, 9) culvert, minor erosion and sedimentation.

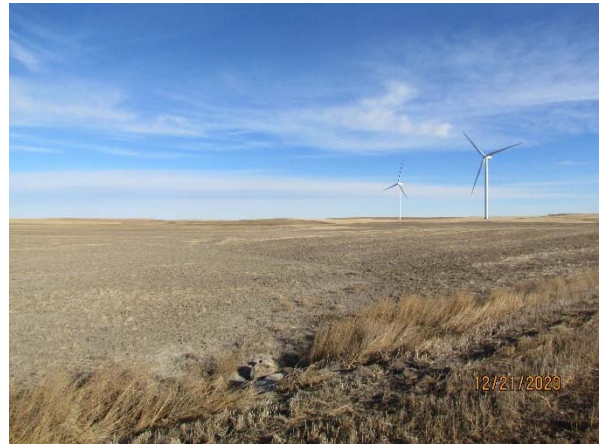
Photo 28: 7th Street NE (near Turbine 6, 7, 8, 9 access road) culvert, minor erosion and sedimentation at waterbody crossing, facing north.

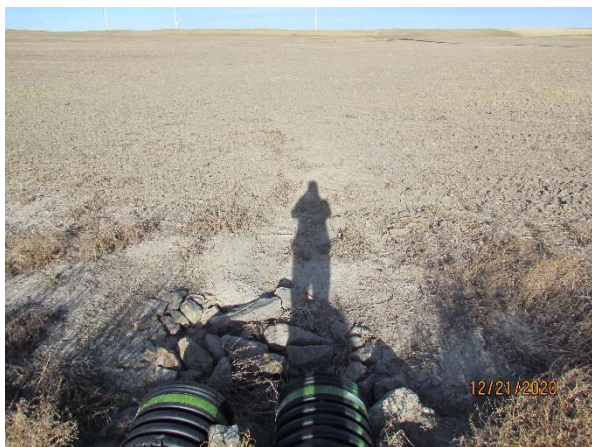
Photo 29: 7th Street NE (near Turbine 6, 7, 8, 9 access road) culvert, minor erosion and sedimentation (south)

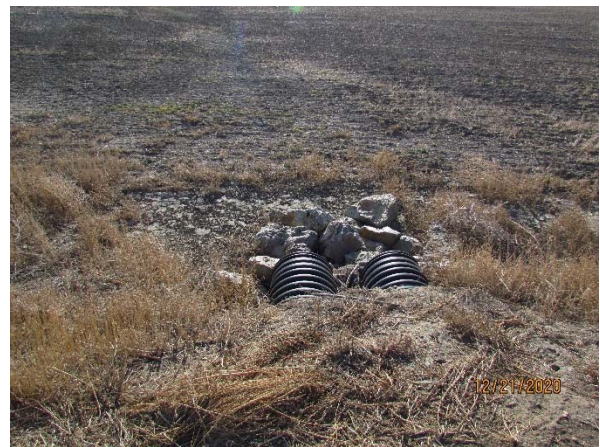
Photo 30: Access road (Turbine 6, 7, 8, 9) culvert, minor erosion and sedimentation, facing northwest.

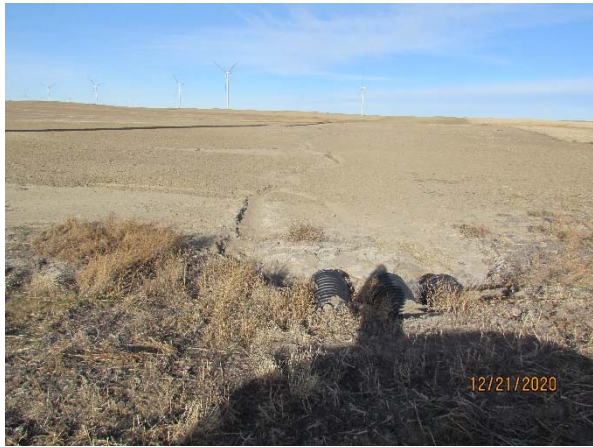
Photo 31: Access road (Turbine 6, 7, 8, 9) culvert, minor erosion and sedimentation, facing southeast.

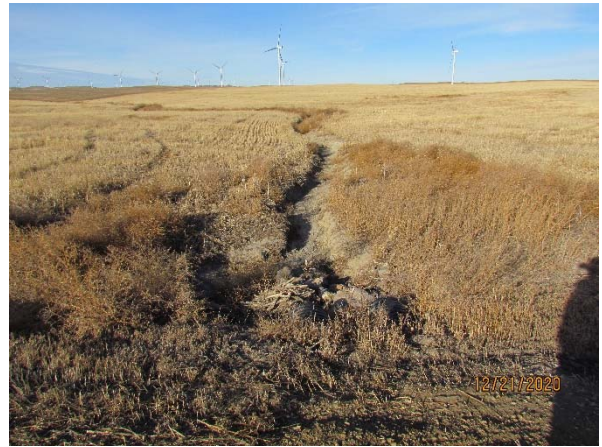
Photo 32: Access road (Turbine 6, 7, 8, 9) near Turbine 8, access road erosion, facing west.

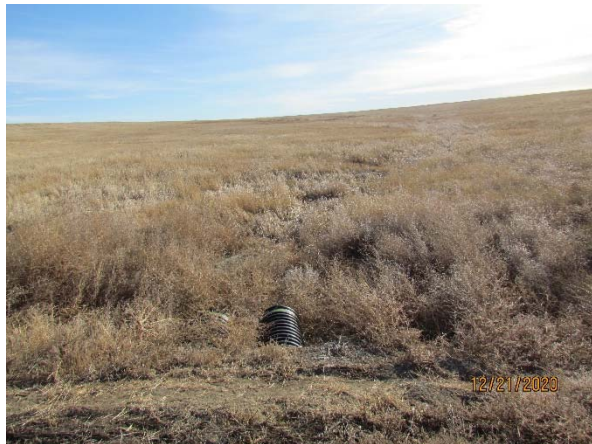
Photo 33: Access road erosion near Turbine 8, access road, facing east.

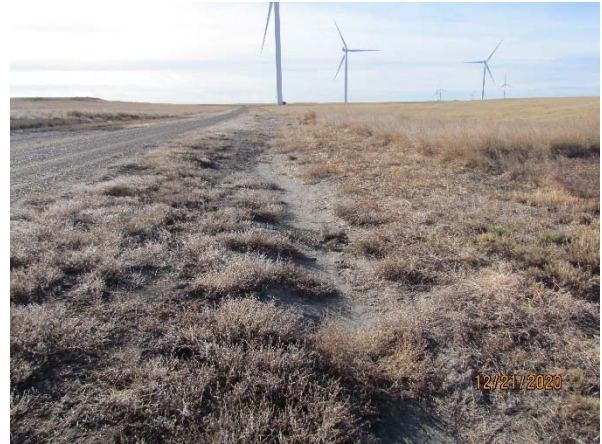
Photo 34: Minor erosion at access road near Turbine 9, facing southwest.

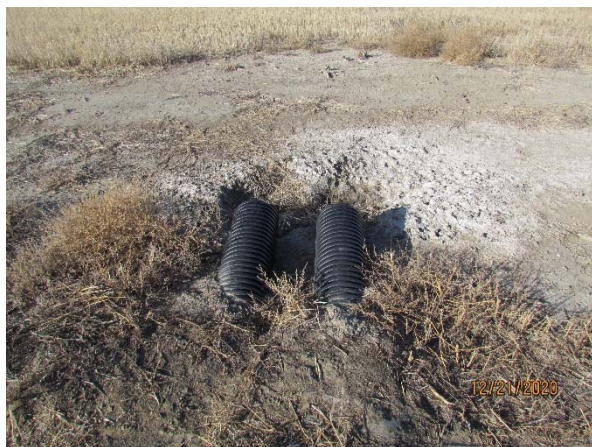
Photo 35: Access road near Turbine 9, erosion and sedimentation at culvert crossing, facing west.

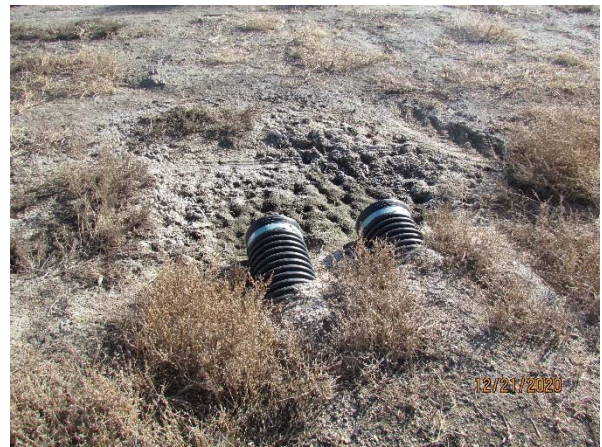
Photo 36: Access road near Turbine 9, erosion and sedimentation at culvert crossing, facing east.

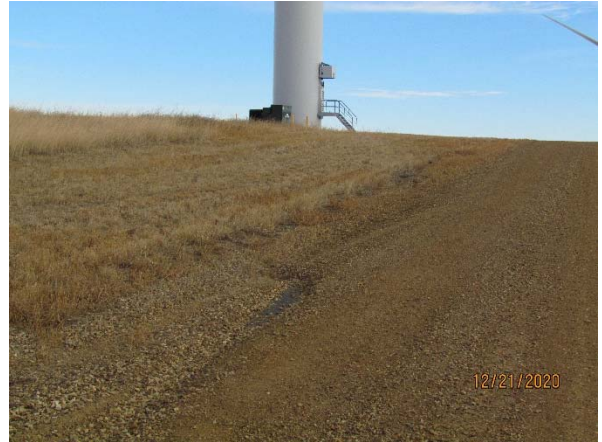
Photo 38: Minor erosion on access road near Turbine 12, facing east.

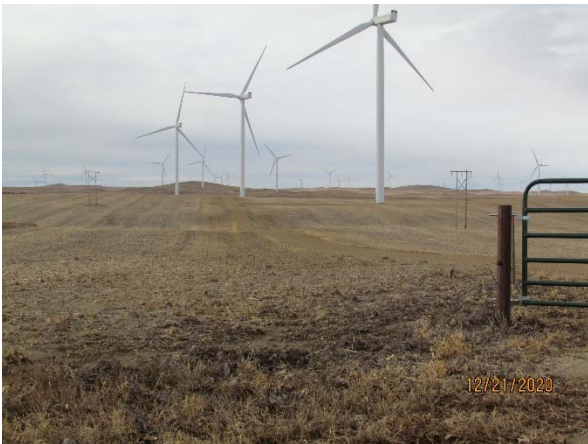
Photo 39: Turbines 14-16, no roadway access due to private property and gate.
