# Southwest Oliver Transmission Line Project Post-Construction Inspection Report **PU-11-620**

## **NORTH DAKOTA PUBLIC SERVICE COMMISSION**

## **WENCK ASSOCIATES, INC.**

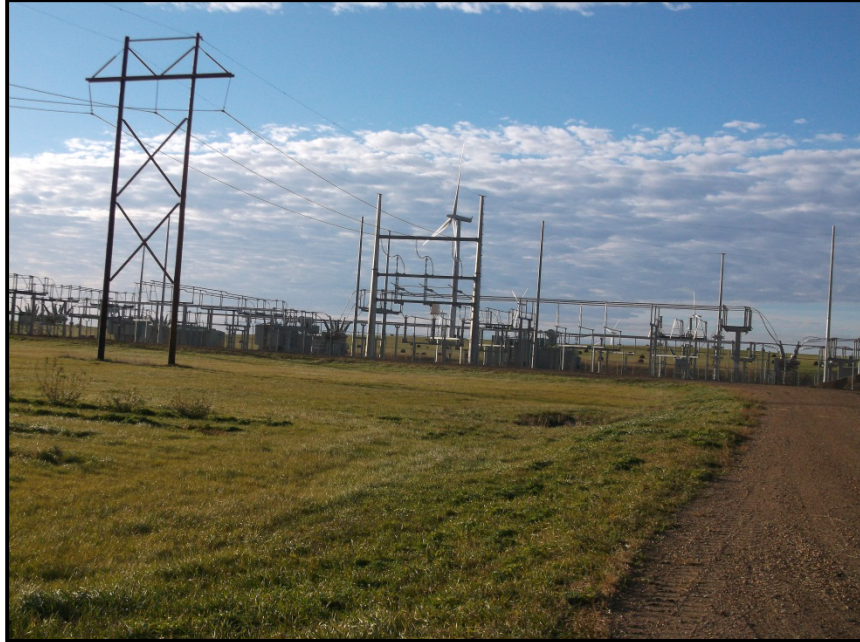
Wood H-Frame and steel monopole structures were observed along the transmission line route (**Appendix A, Photos 1-6**). Span lengths and structure heights appeared to match those specified in the Application and amendments.

**Photo 1.** Direction: South/Southeast. View of the transmission line (H-frame structures) on the east end of the route at the Bison substation.

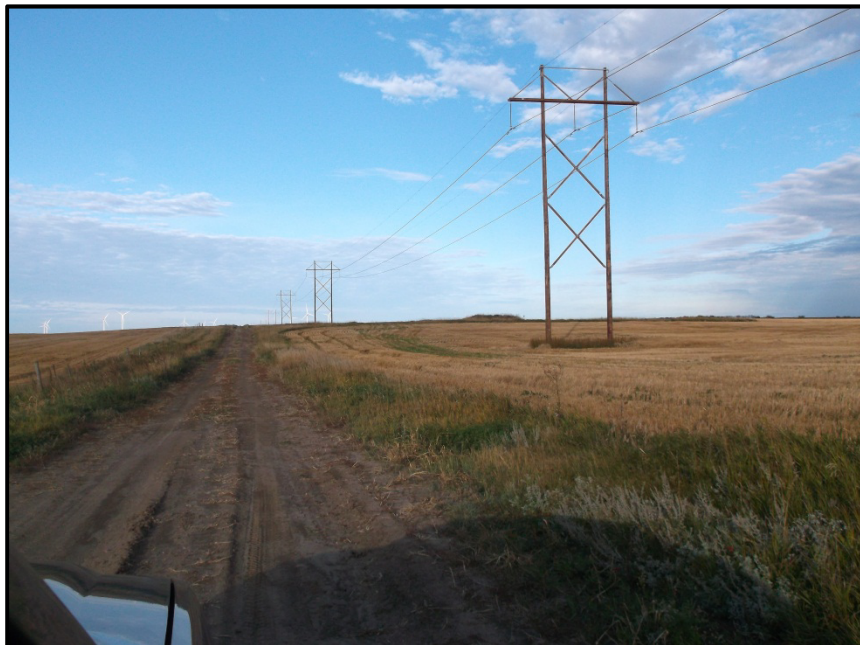
Minnesota Power representative confirmed that these measures were implemented. Bird diverters were installed as planned, and at additional areas not in the original Application.

There were several areas along the transmission line route that crossed wetland areas (**Figure 1; Appendix A, Photos 2, 7, 8**). It did not appear that vegetation along wetland margins had been disturbed. There were no poles/structures within wetland vegetation. No copies of the U.S. Army Corps of Engineers permits were on file; however, no impacts were observed to surface drainage or groundwater flow patterns. It did not appear that any machine clearing or disturbance of vegetation occurred near rivers or streams. No Waterfowl Production Areas were located within the project corridor. It appeared that construction of the Project avoided impacts to wetland areas as specified in the Application.

Most of the transmission line was in cultivated lands. Some of the transmission line did cross native prairie currently used for grazing. Wenck observed that disturbance in these areas was kept to a minimum and revegetation appeared satisfactory (**Appendix A, Photos 2,9**).

Preexisting roads appeared to have been restored and appeared in good condition (**Appendix A, Photos 2, 7**). There was no evidence of temporary roads used during construction, so presumably none were needed or they had been restored. Fences and gates removed during construction had been replaced or repaired.

**Photo 2.** Direction: West. View of the transmission line with bird diverters installed on the transmission line around the wetland. Section line road is also visible.

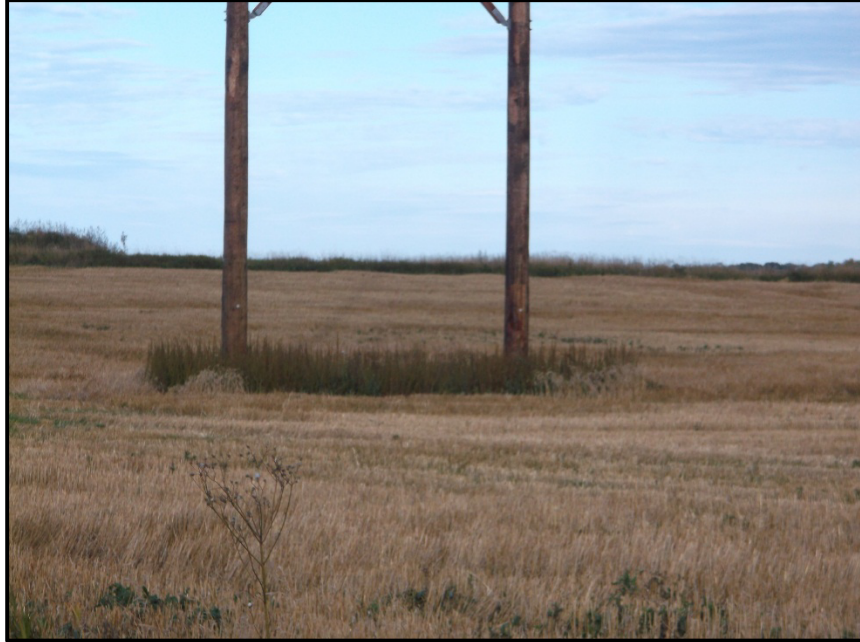
Construction activities appeared to have had minimal disturbance; only minor reclamation would have been necessary around structure bases. It was not clear if reseeded had occurred following construction because most of the poles were in agricultural land. However, in non-agricultural areas, it appeared that vegetation surrounding poles matched that of the surrounding area (**Appendix A, Photos 2-5, 9**).

**Photo 3.** Direction: Northwest. View of base of transmission H-frame structure where reclamation is complete and re-vegetation has occurred.

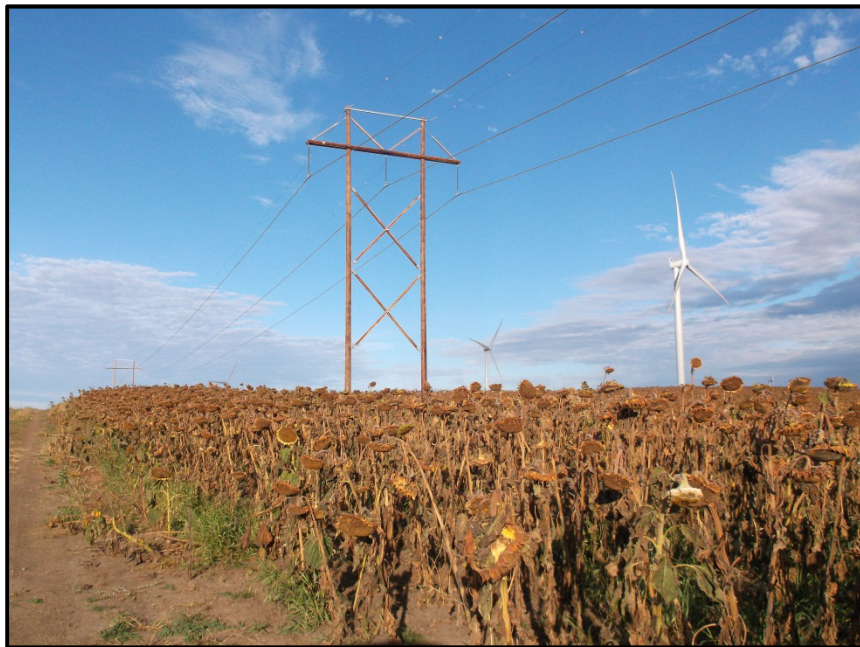
**Photo 4.** Direction: West. View of the transmission line as it spanned an agricultural area. No construction-related disturbance to the agricultural area was noted.

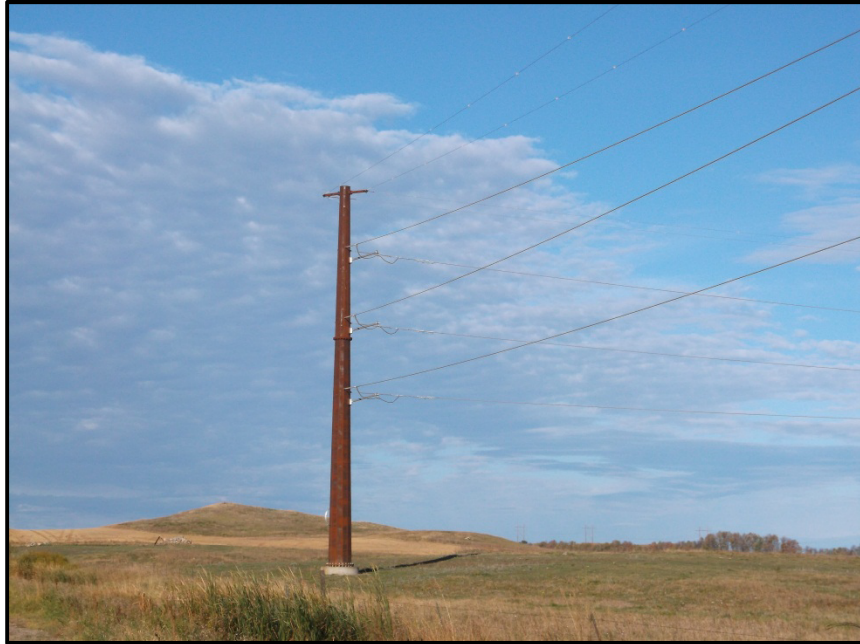
**Photo 5.** Direction: Northwest. View of a single steel pole structure that changes direction of the transmission line to the north.

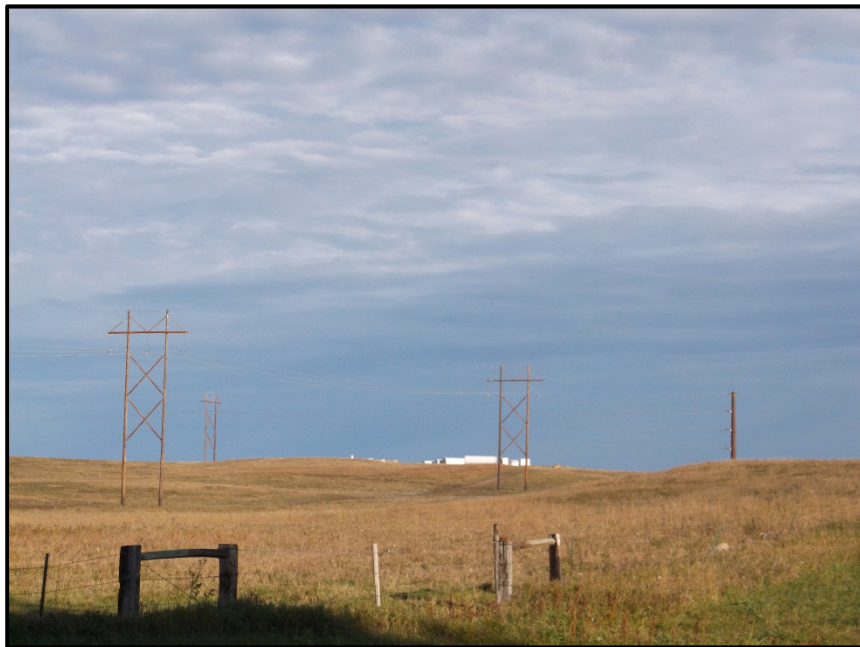
**Photo 6.** Direction: West. View of a single steel pole structure that changes direction of transmission line to the west.

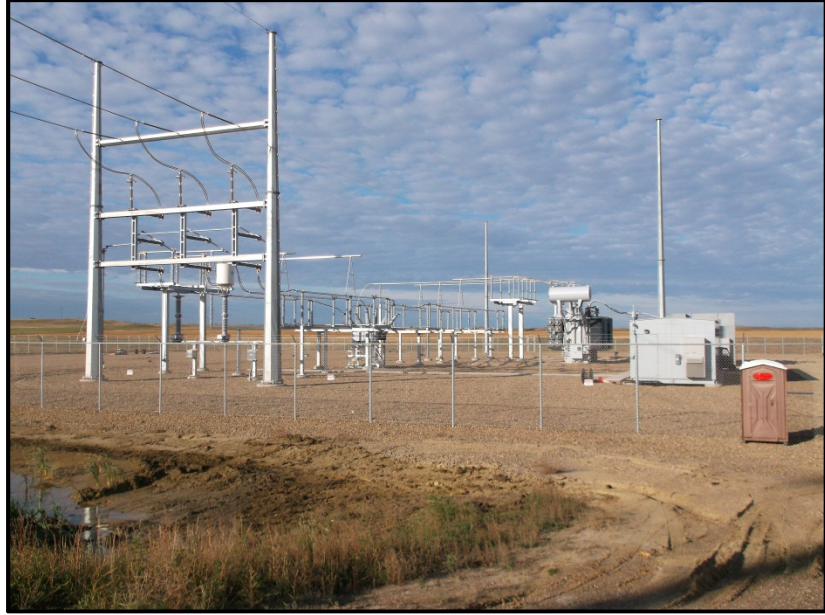
**Photo 7.** Direction: Southwest. View of the Tri-County substation and wetland that experienced no construction-related disturbance.

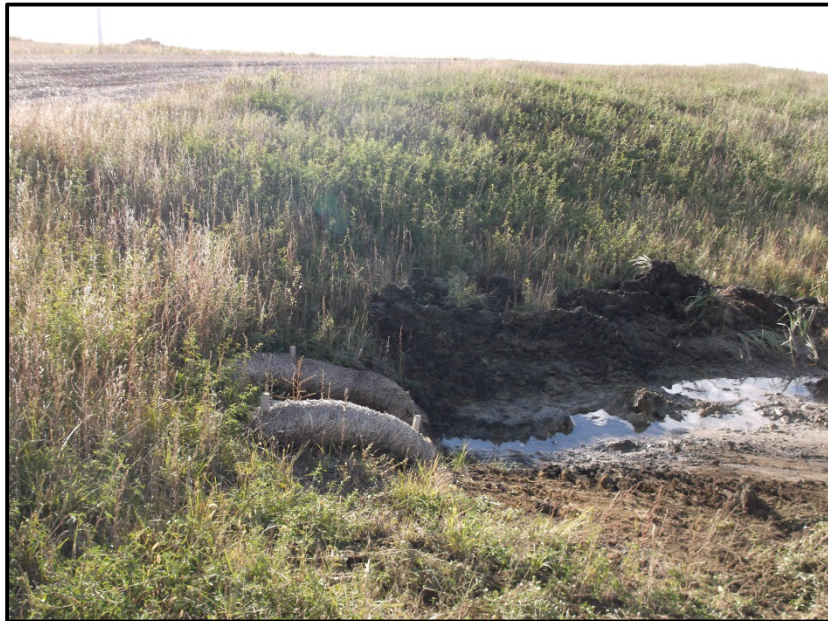
**Photo 8.** Direction: South/Southwest. View of stormwater straw waddles being utilized to prevent sediment from leaving construction area.

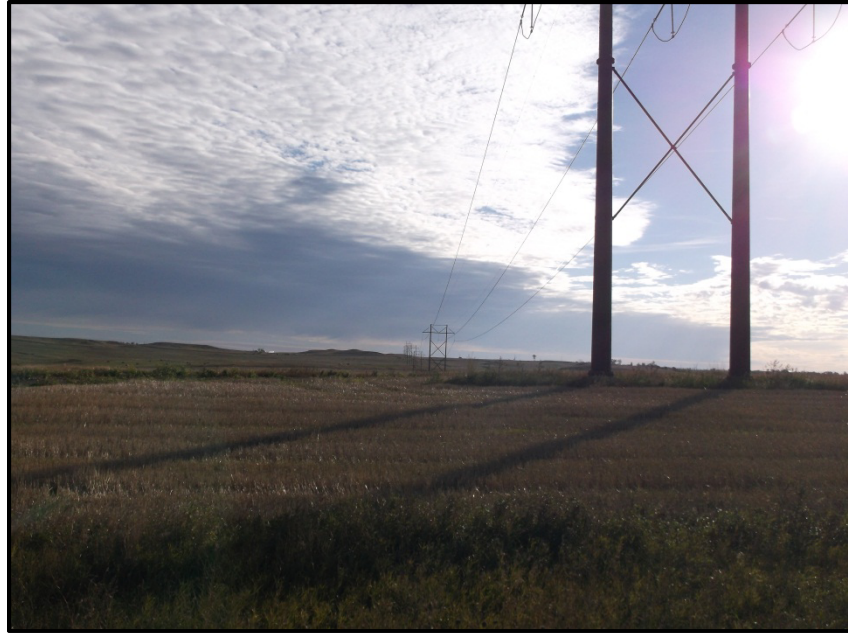
**Photo 9.** Direction: East. View of native prairie that was not impacted by construction-related disturbance.
