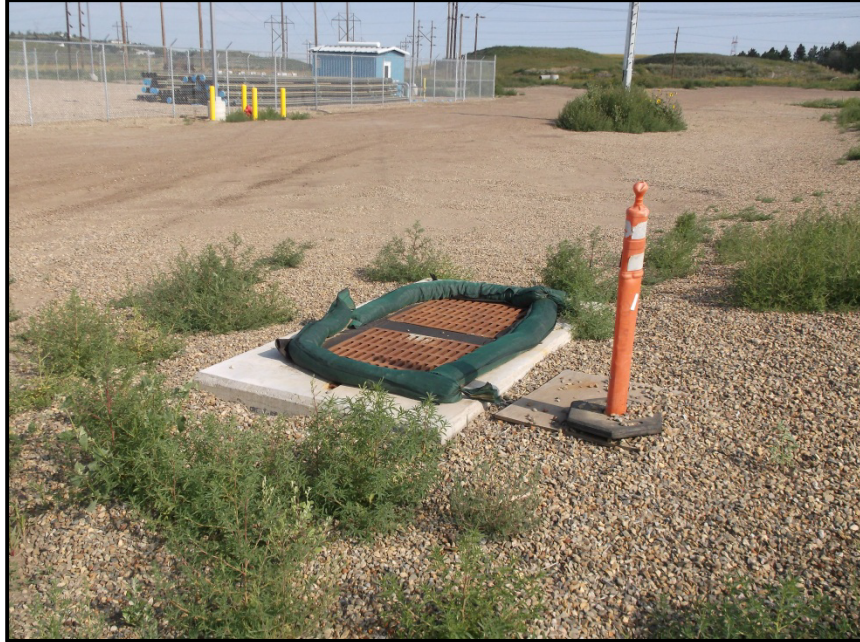
**Photo 1.** Direction: North. View of the stormwater inlet protection.

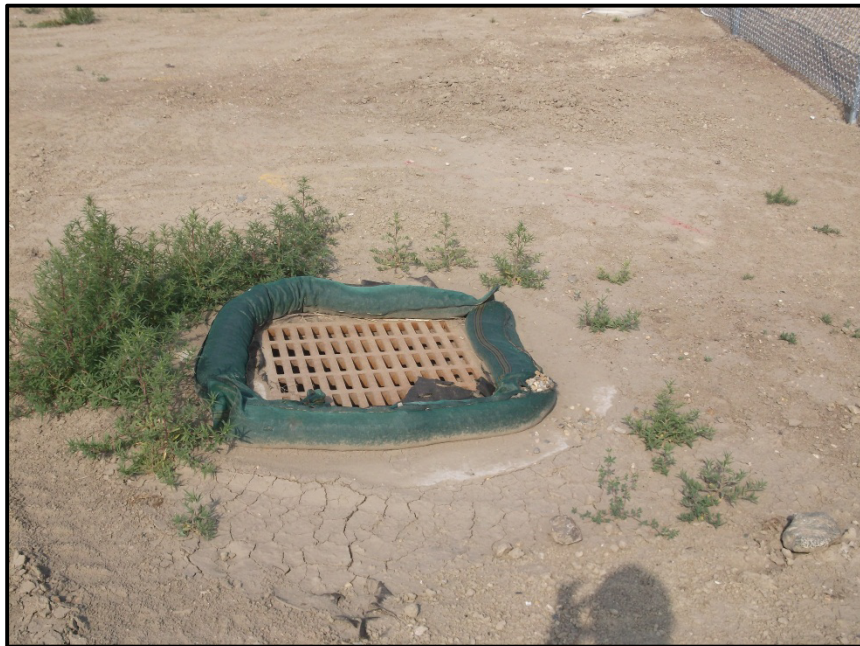
**Photo 2.** Direction: West. Additional view of stormwater inlet protection on the project site.

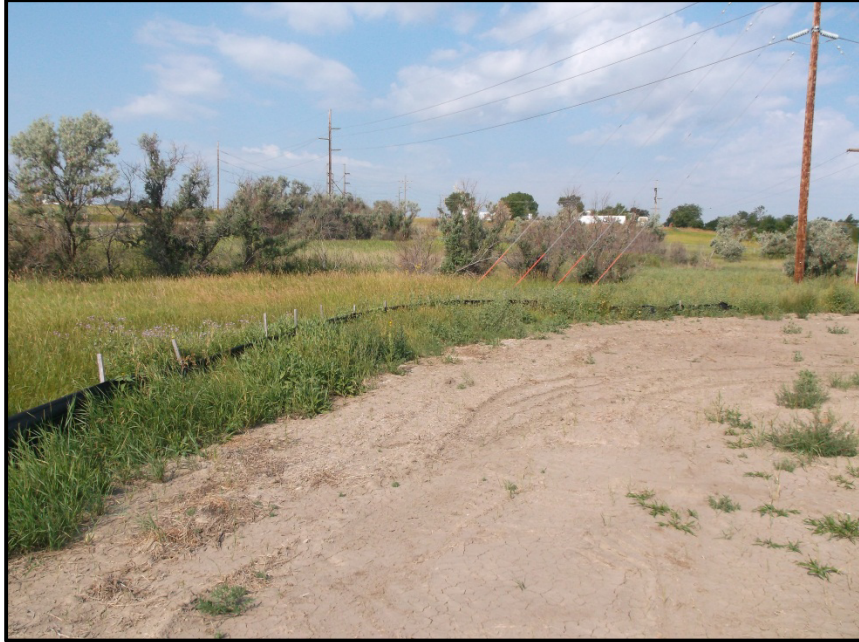
**Photo 3.** Direction: Northwest. View of silt fence along the project site boundary.

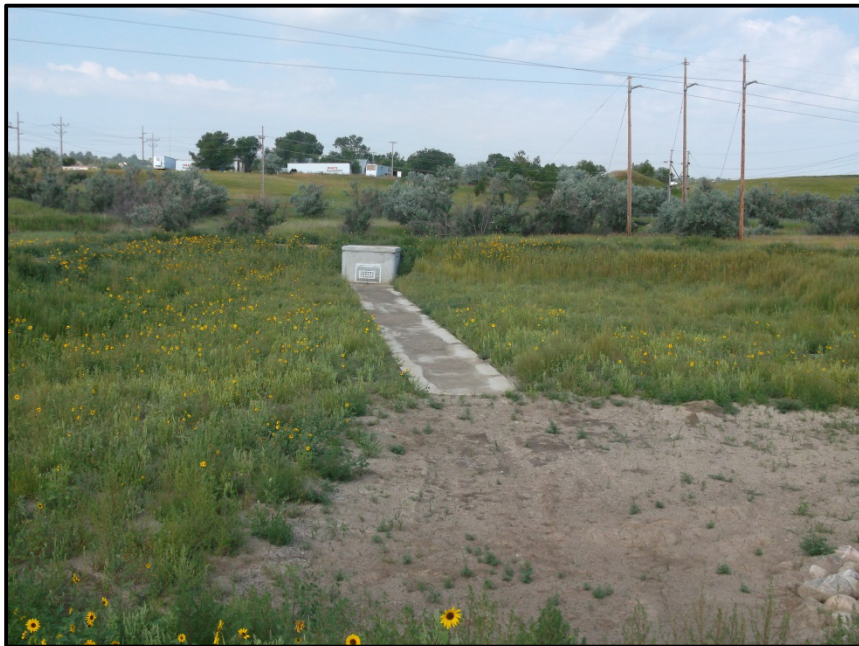
**Photo 4.** Direction: West. View of the drainage basin and valley gutter. Also pictured is the part of the finished stormwater pond.

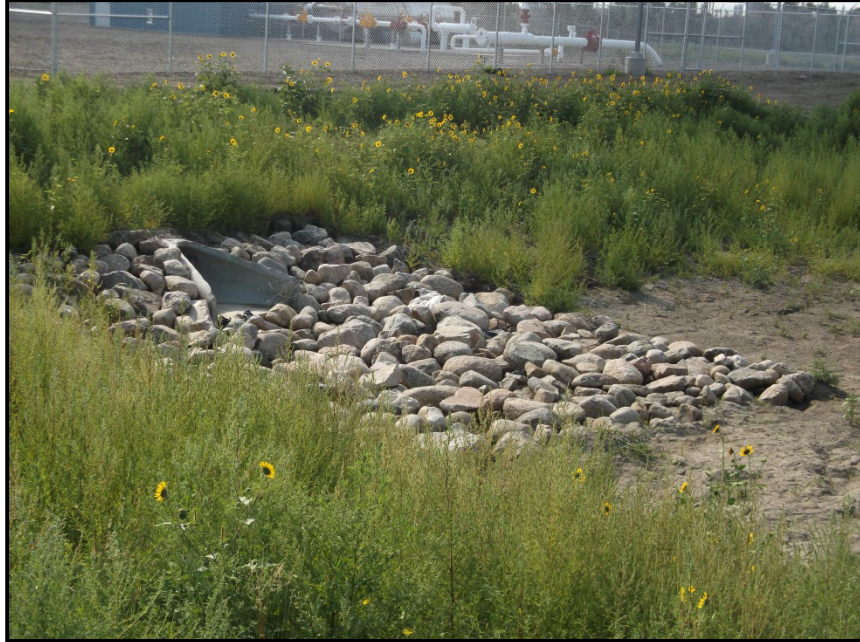
**Photo 5.** Direction: Southwest. View of stormwater drainage outlet surrounded by riprap and reclamation growth.

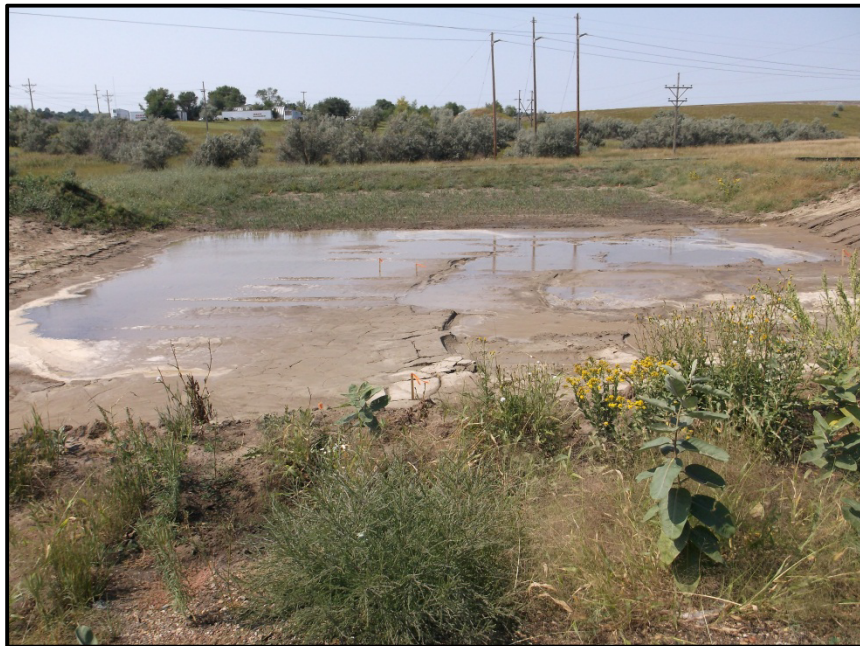
**Photo 6.** Direction: West. View of future stormwater pond. At the time of this photo it was under construction.

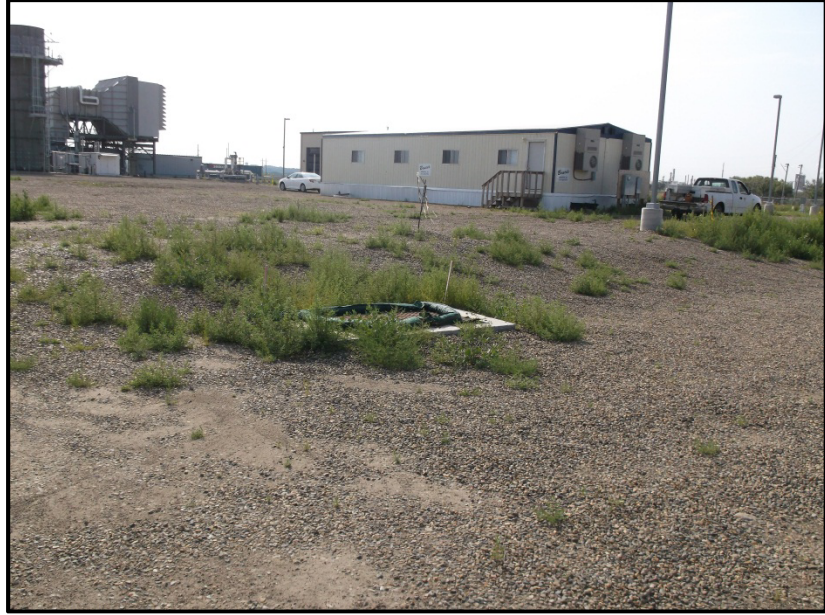
**Photo 7.** Direction: Southeast. View of the project trailer and MDU 88 MW turbine (on left).

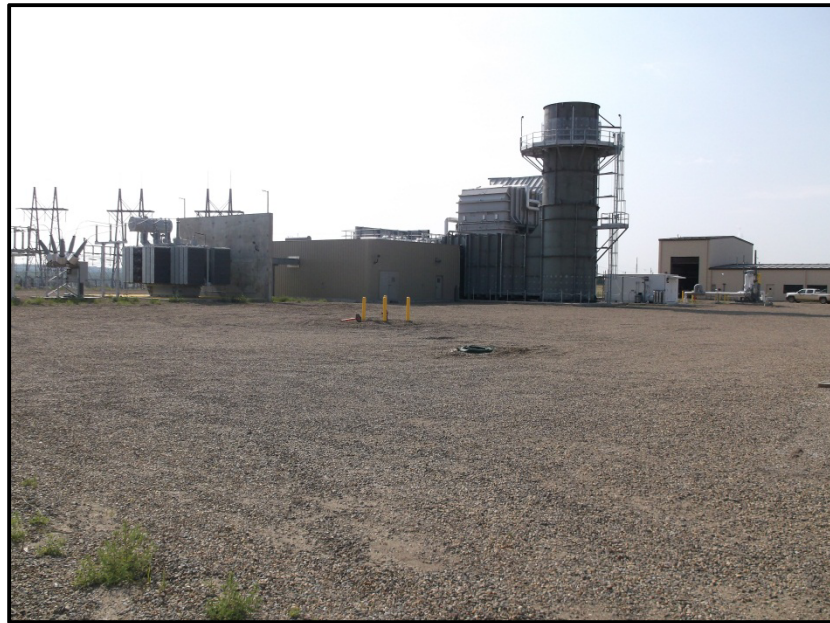
**Photo 8.** Direction: Northwest. View of stormwater inlet protection (in foreground) and MDU 88 MW turbine. Note the grading and surface gravel of the project site.

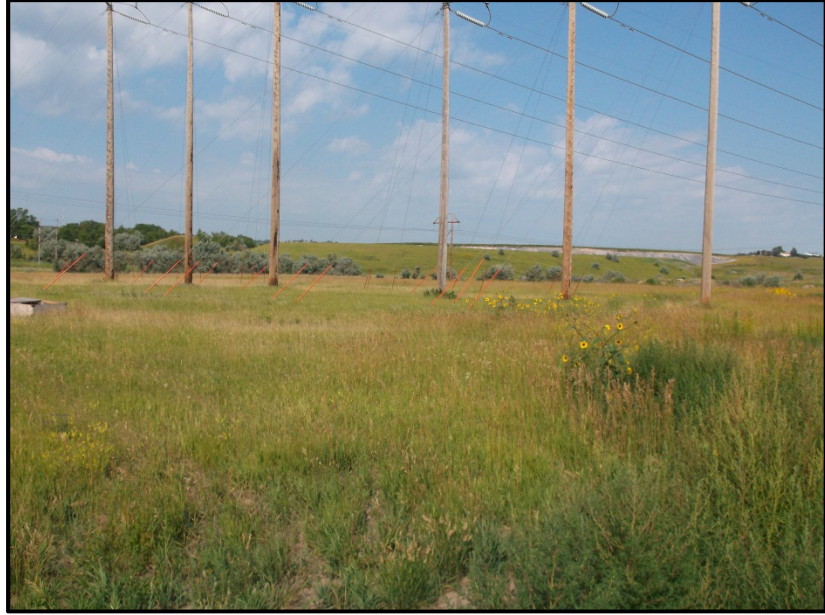
**Photo 9.** Direction: North. View of reclaimed prairie area and future site of tree mitigation.

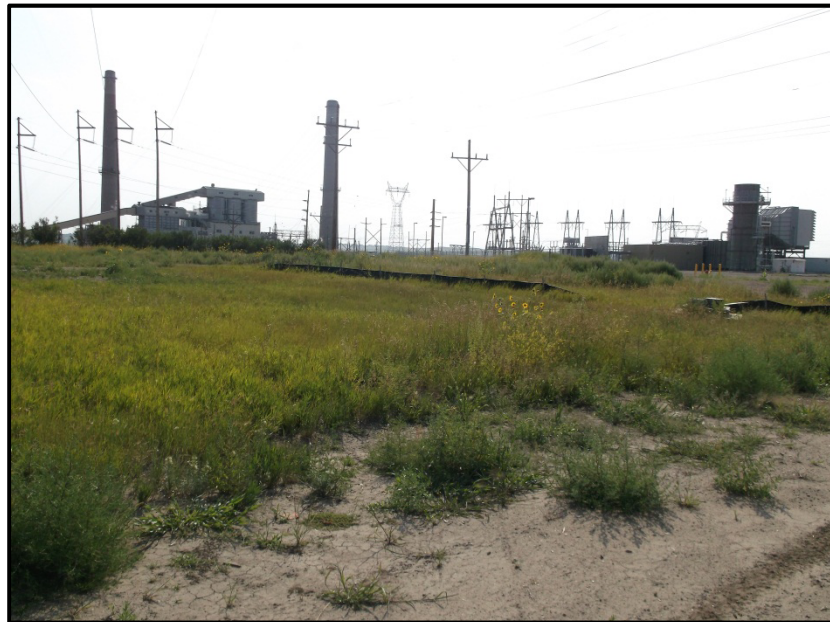
**Photo 10.** Direction: East. View of project site from the east. Also pictured are the reclaimed prairie area and silt fence.

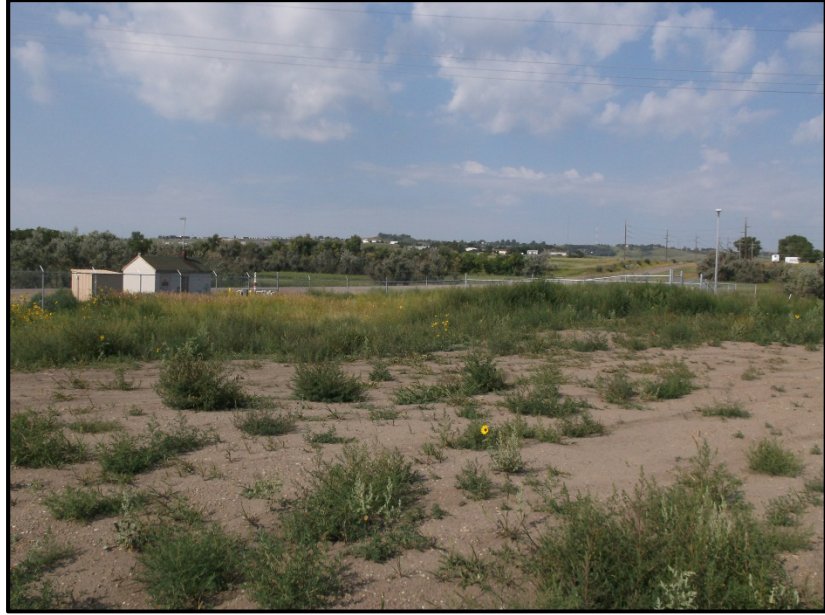
**Photo 11.** Direction: South. View of project area that will be seeded in the future and main entrance access road (visible in mid-ground of photo).

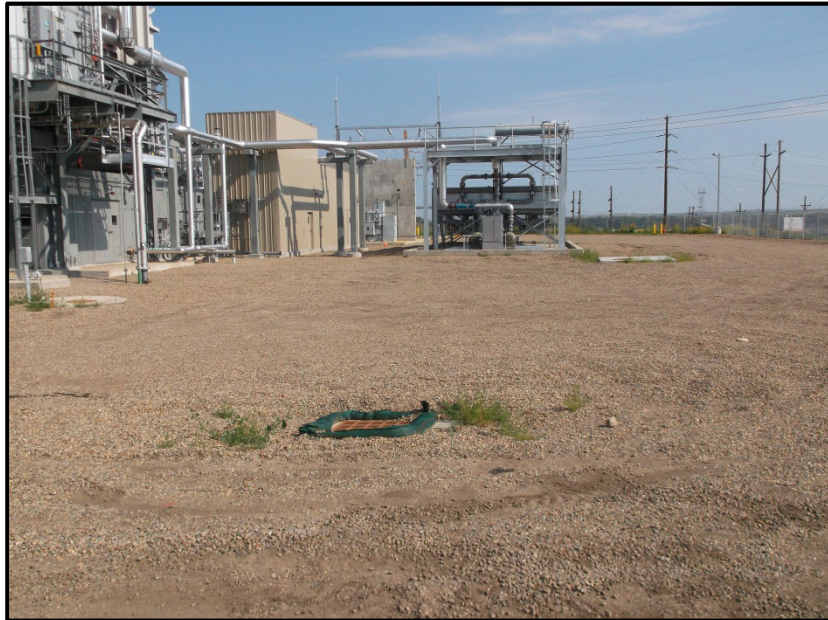
**Photo 12.** Direction: North. View of MDU 88 MW Combustion Turbine and stormwater inlet protection.

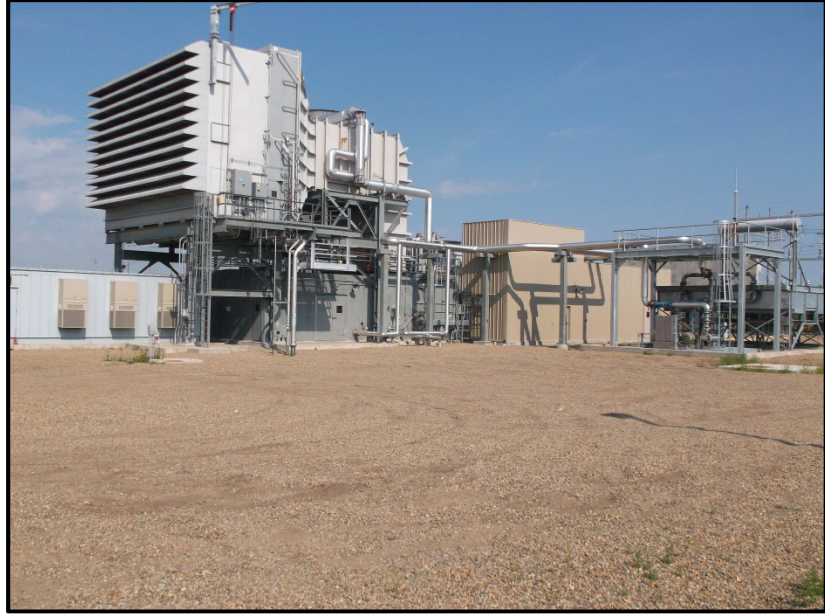
**Photo 13.** Direction: Northwest. View of the MDU 88 MW combustion turbine and graded project area.

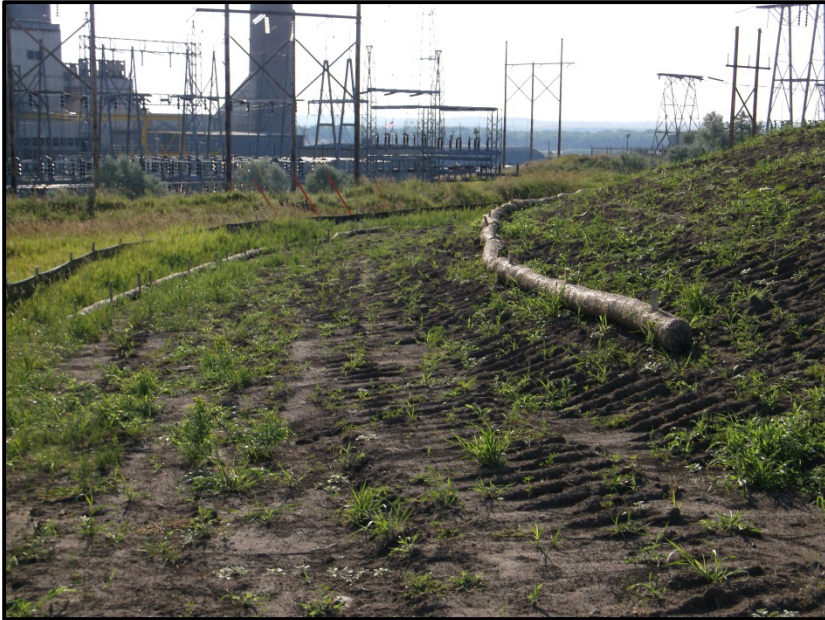
**Photo 14.** Direction: East. View of stormwater straw waddles being utilized to prevent sediment from leaving construction area.

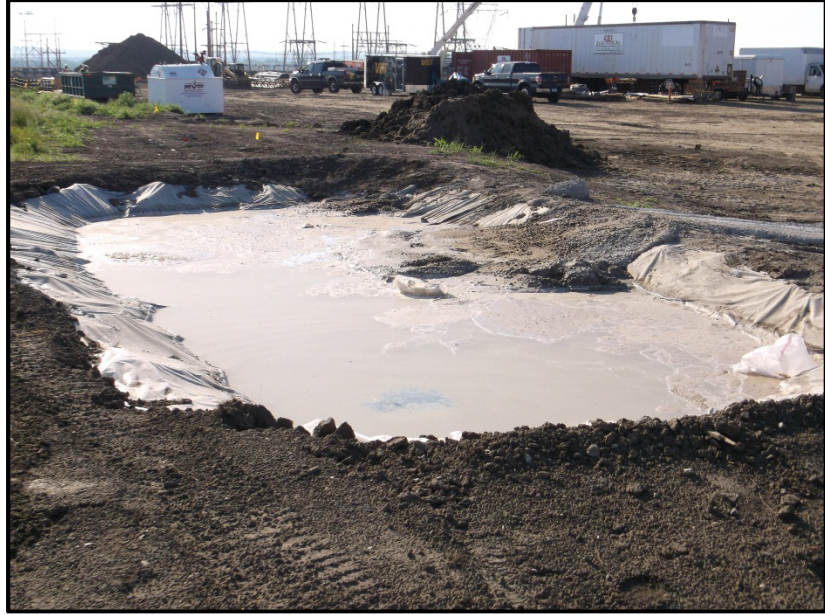
**Photo 15.** Direction: East. View of concrete washout pit, with liner, during construction.

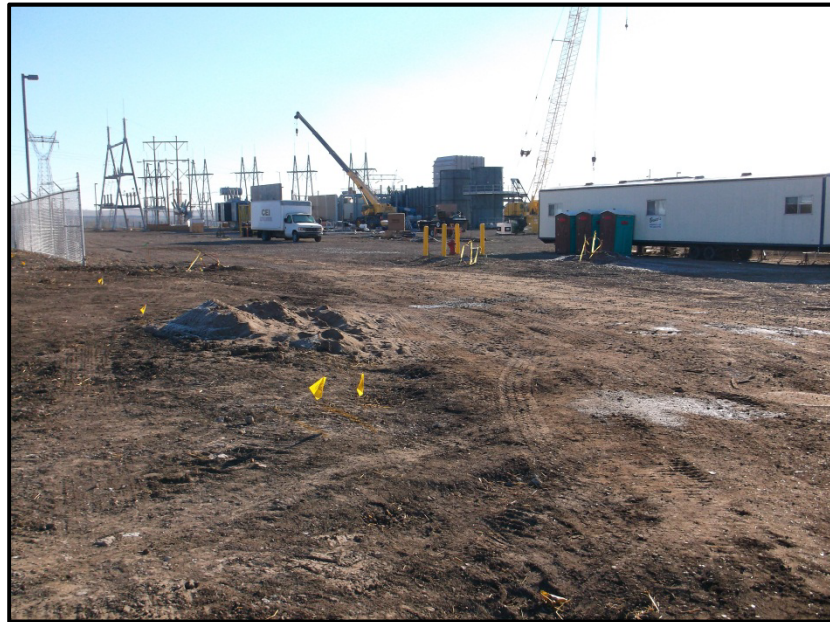
**Photo 16.** Direction: South/Southeast. Overall view of entire project site, during construction of the 88 MW turbine. Note that the site and working area is clear of debris and trash.
