# Reclamation and Revegetation

## Inspection Report

Clean Energy #1 Wind Project

ND PSC Case No. PU-11-662

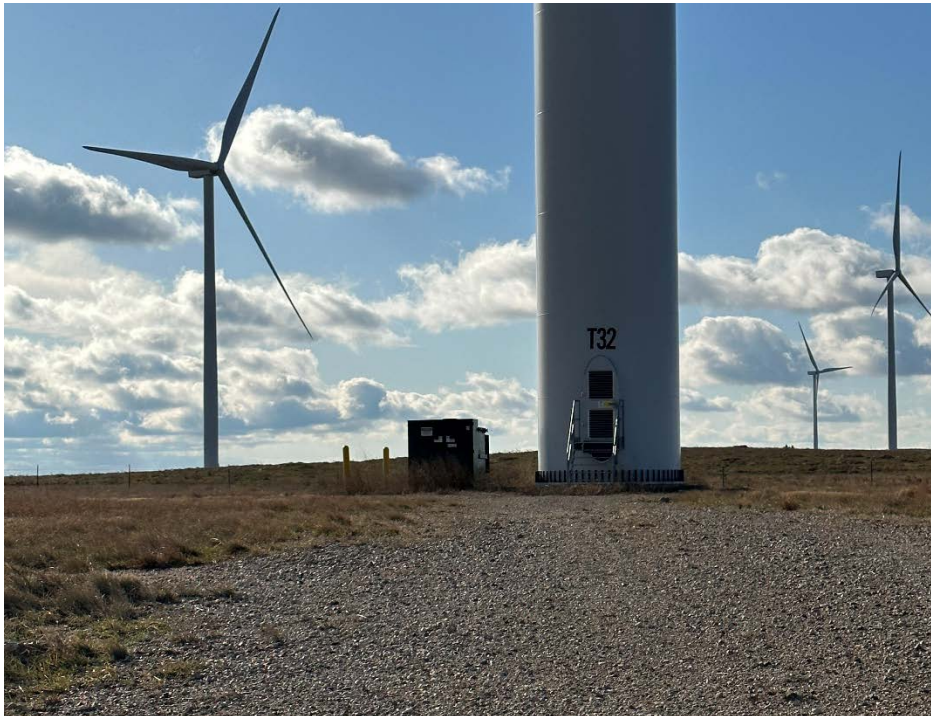
Project areas occurring in crop lands appeared to be returned to pre-construction conditions at the time of visit. Crop density appeared to be similar to areas adjacent to the Project area. Portions of the Project occurring in range or pasture land had approximately 80-100% ground cover, but were mostly weeds and nonnative species. Even though they were undesirable species, the disturbed areas appeared to be stabilized.

**Report Photo #2:** Some Weedy Vegetation at T32

1. Continual maintenance should be done to encourage the revegetation of desirable species.
2. Any areas of erosion noted during routine maintenance or visits should be noted and corrected.

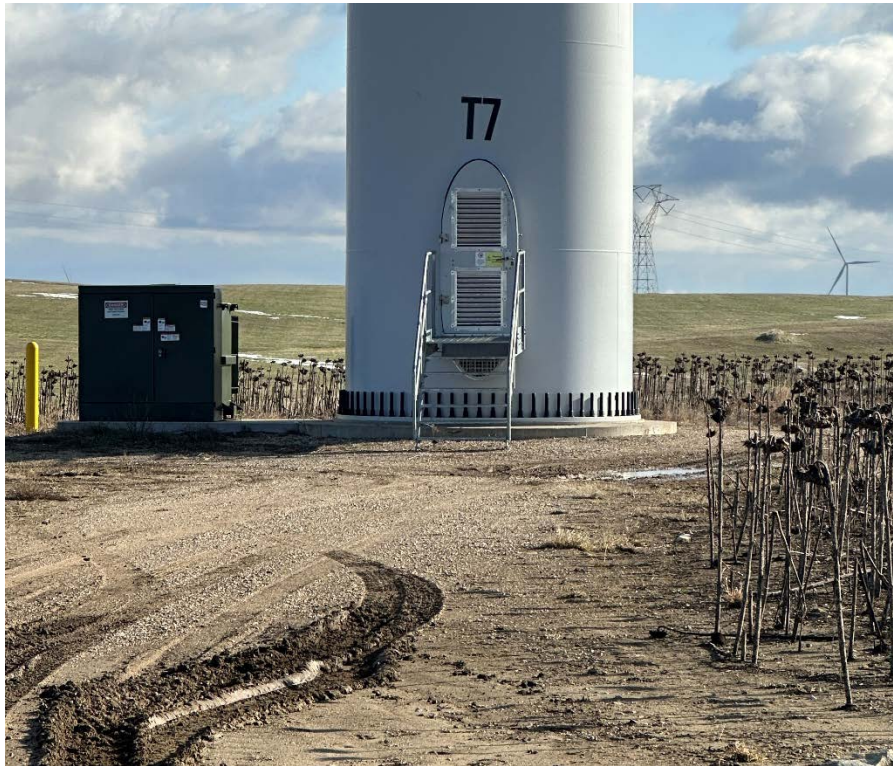
**Report Photo #3:** Established in Cropland at T7

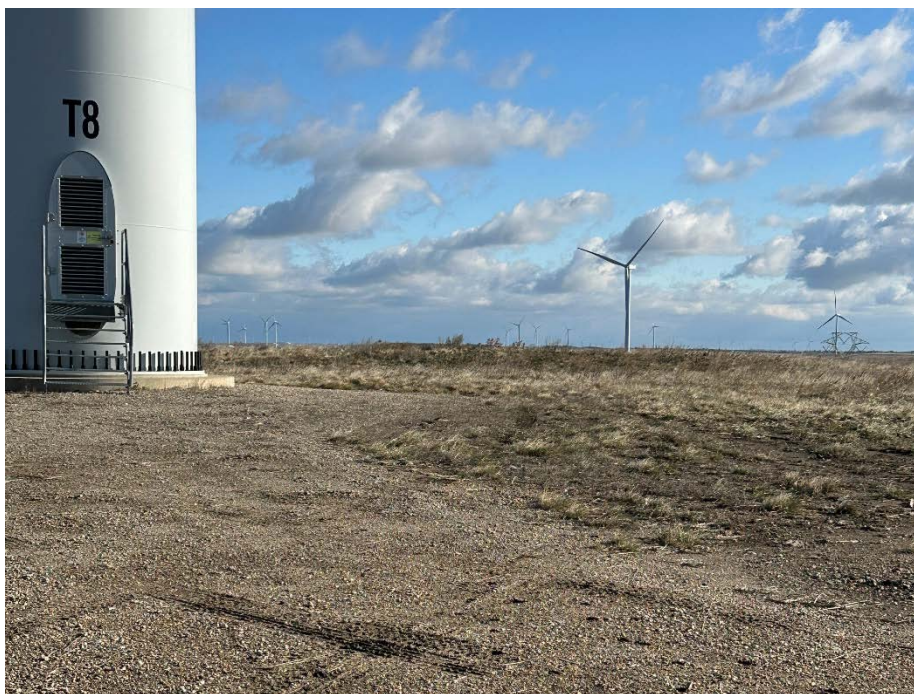
**Report Photo #4:** Some Undesirable Vegetation at T8

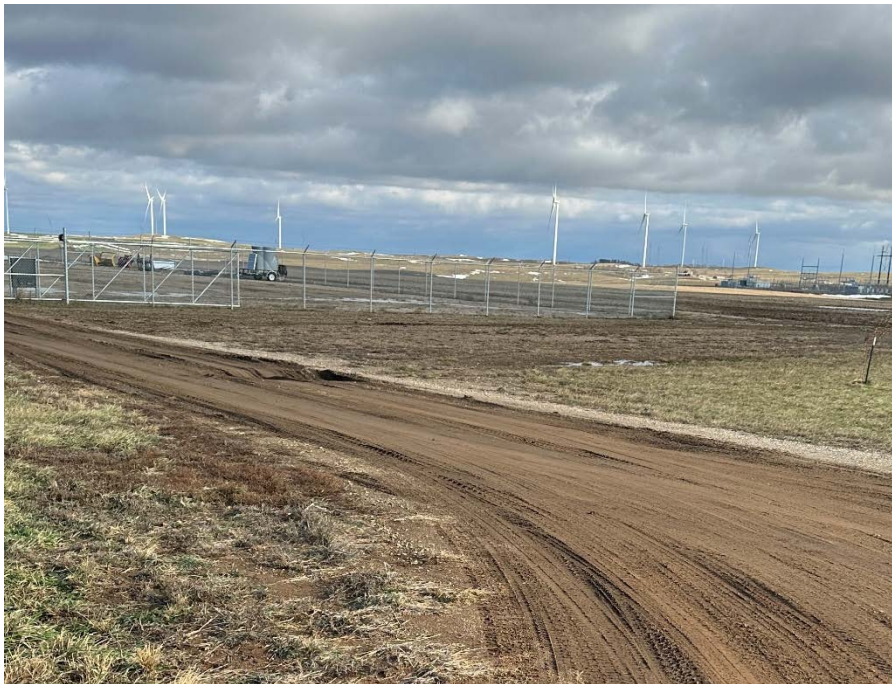
Erosion was noticeable on some of the access roads.

**Report Photo #6:** Road Erosion Example
