MONTANA-DAKOTA

Re: Case No. PU-11-680
Post Construction Inspection

Montana-Dakota Utilities Co. (Montana-Dakota), a Division of MDU Resources Group, Inc., herewith submits the original and two (2) copies of its responses to the list of actions recommended in the post construction inspection report issued by Wenck Associates, Inc on December 10, 2014 (Wenck Report) and staff questions submitted on September 10, 2015.

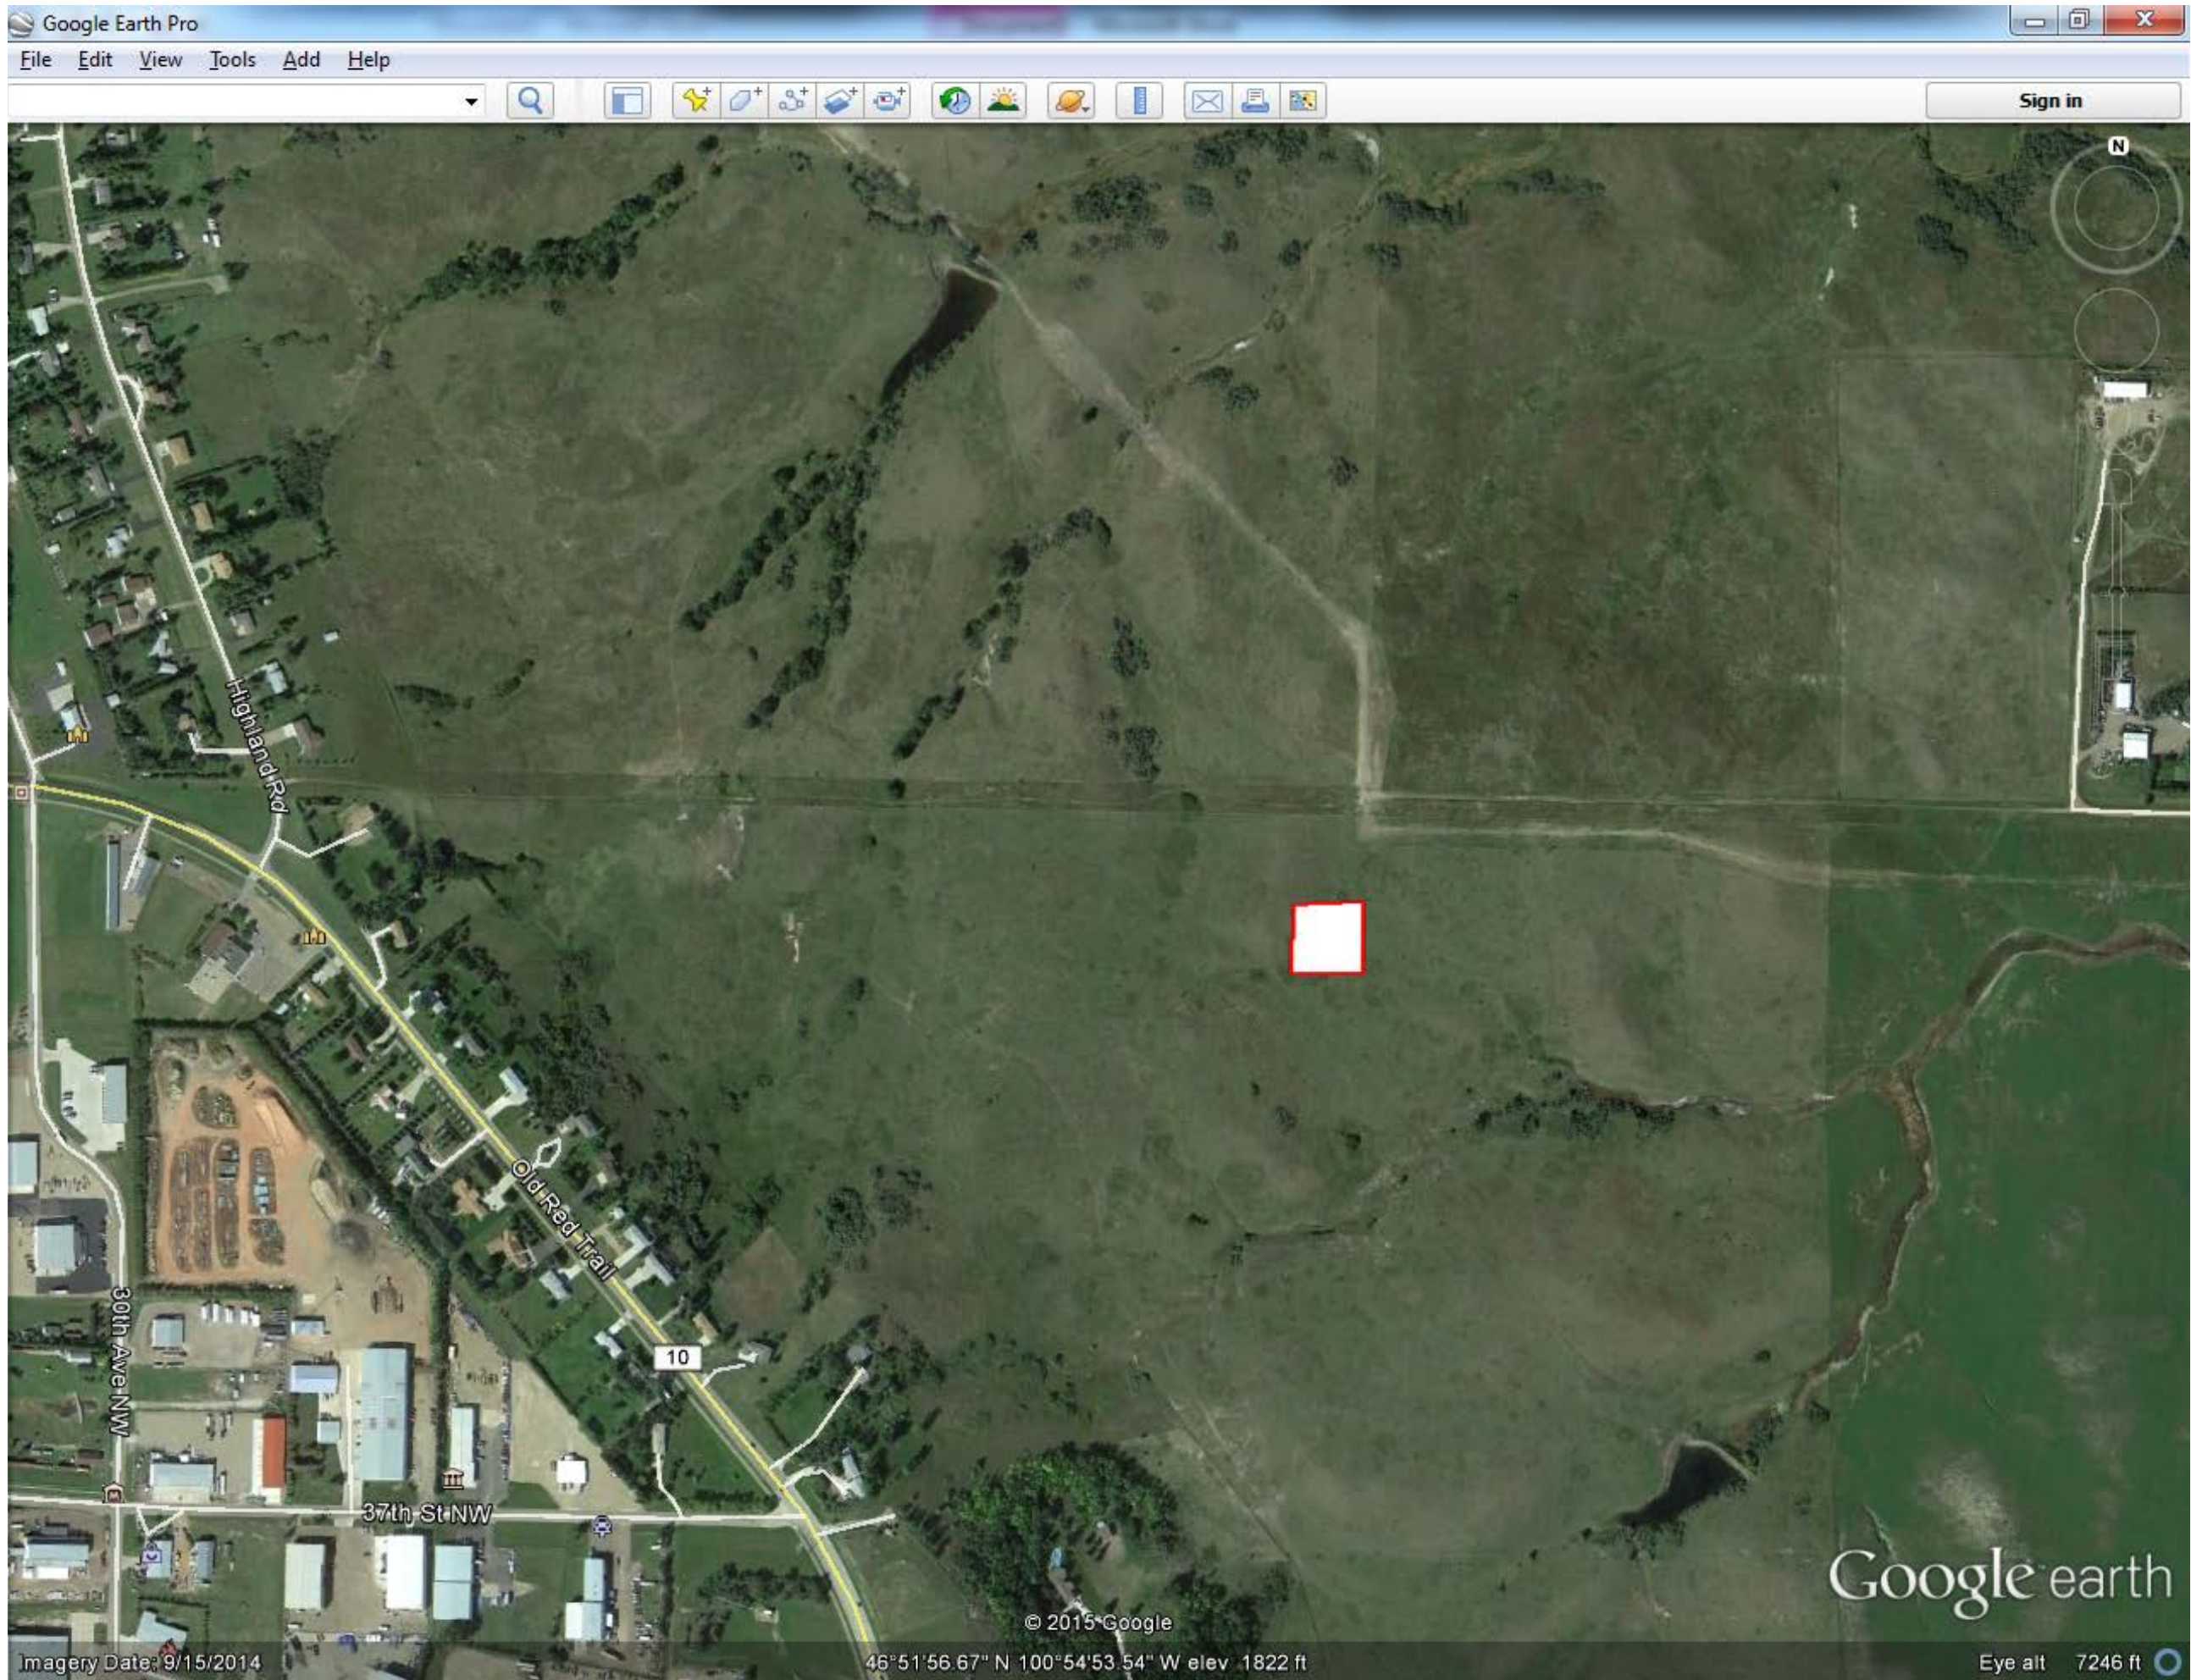
The defined Native Prairie Areas were determined by Section 4.1.1 and Appendix G of the Biological Resources Survey and identified in Section 3.5.3 Native Prairie in the Wenck Report. Attached are Attachment A, "Remnant Prairie #1" and Attachment B, "Remnant Prairie #2" providing aerial overviews of the Native Prairie Remnant Areas (areas shaded white) and the actual construction scar showing the location of the actual transmission line route as built. The Natural Prairie Remnant Areas were avoided during the actual construction to eliminate issues of disturbance or narrowing of the ROW in these identified areas.

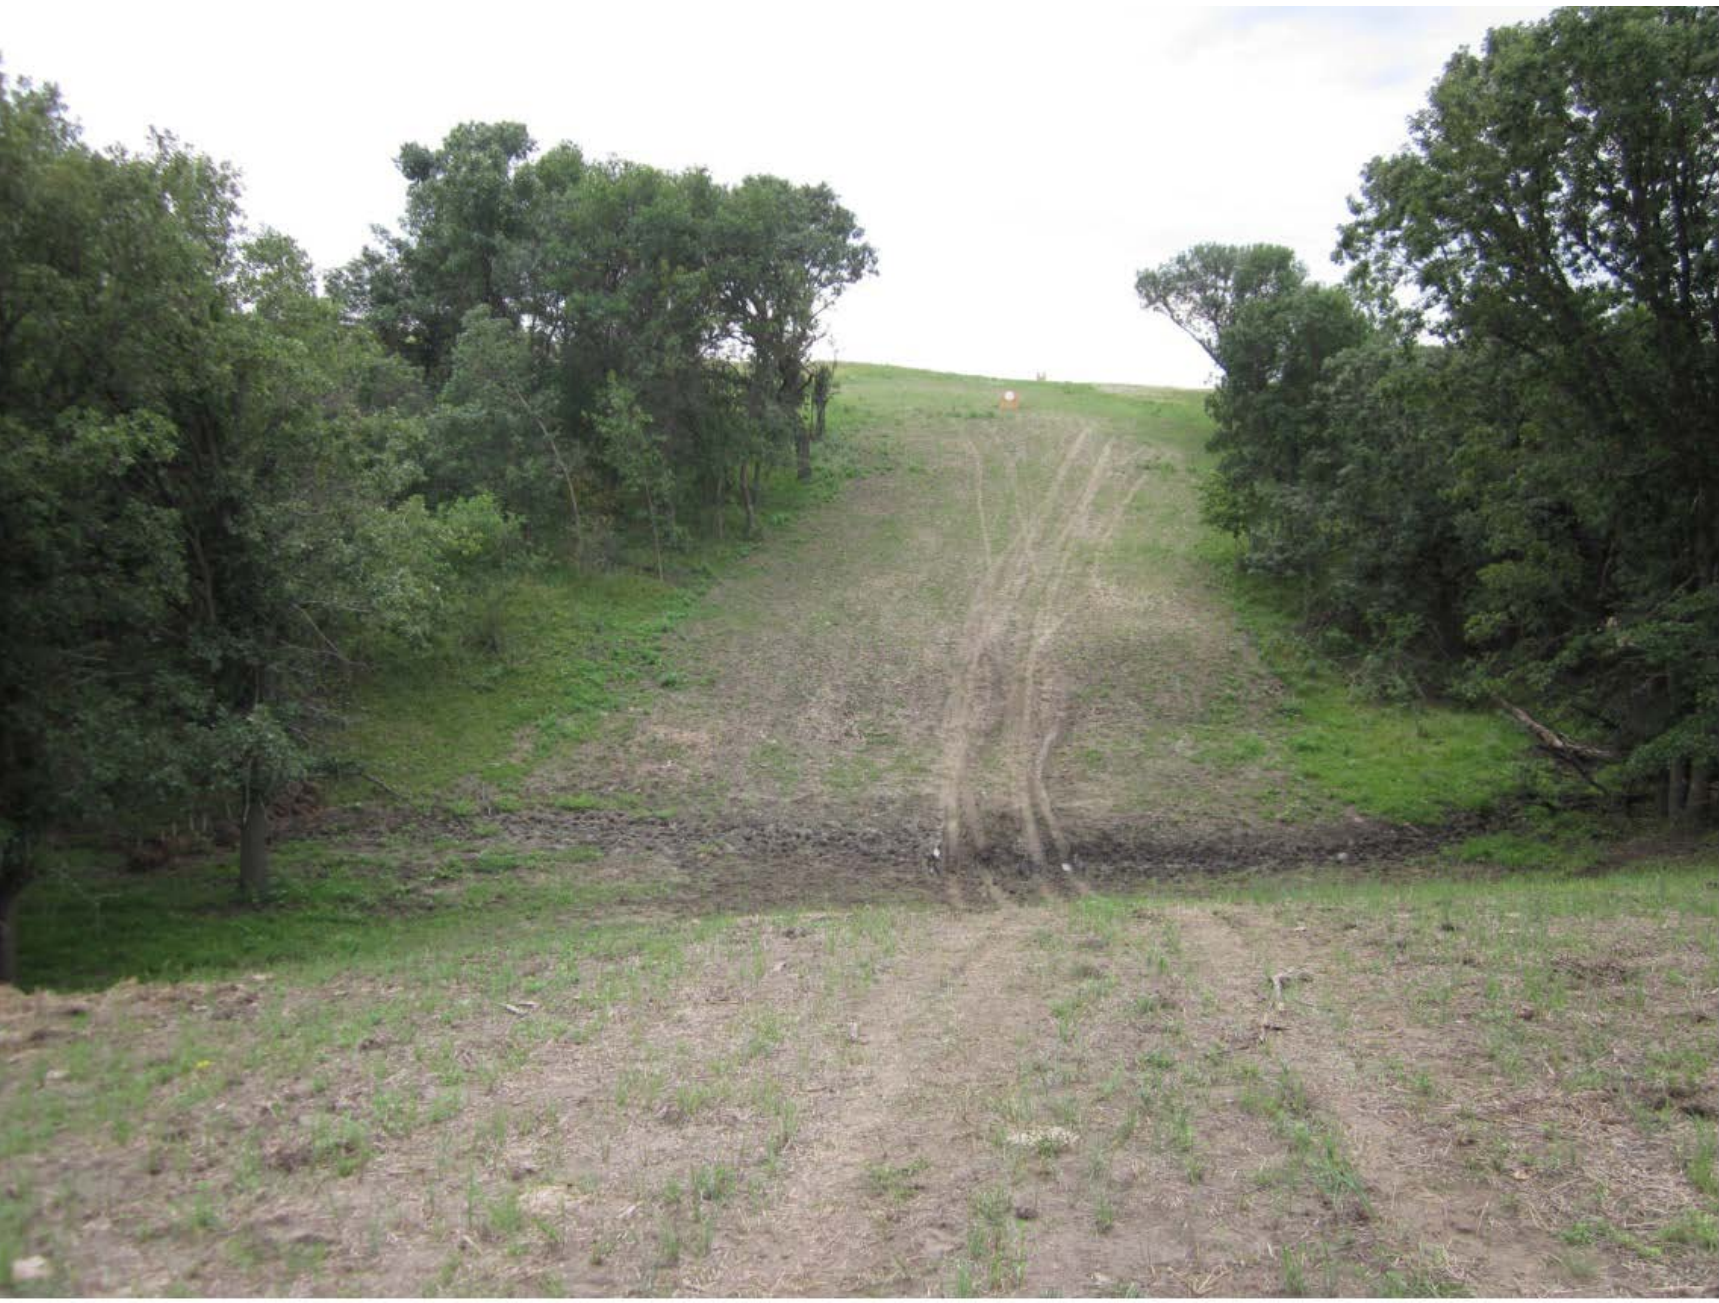
Area 1 – a hill with evidence of heavy livestock travel and some vehicle travel attributed to local residents. The photo taken of this area from the Report is attached here as Attachment C Page 1, "PHOTO 20 – AREA OF CONCERN". For review, Montana Dakota submits additional photos taken in

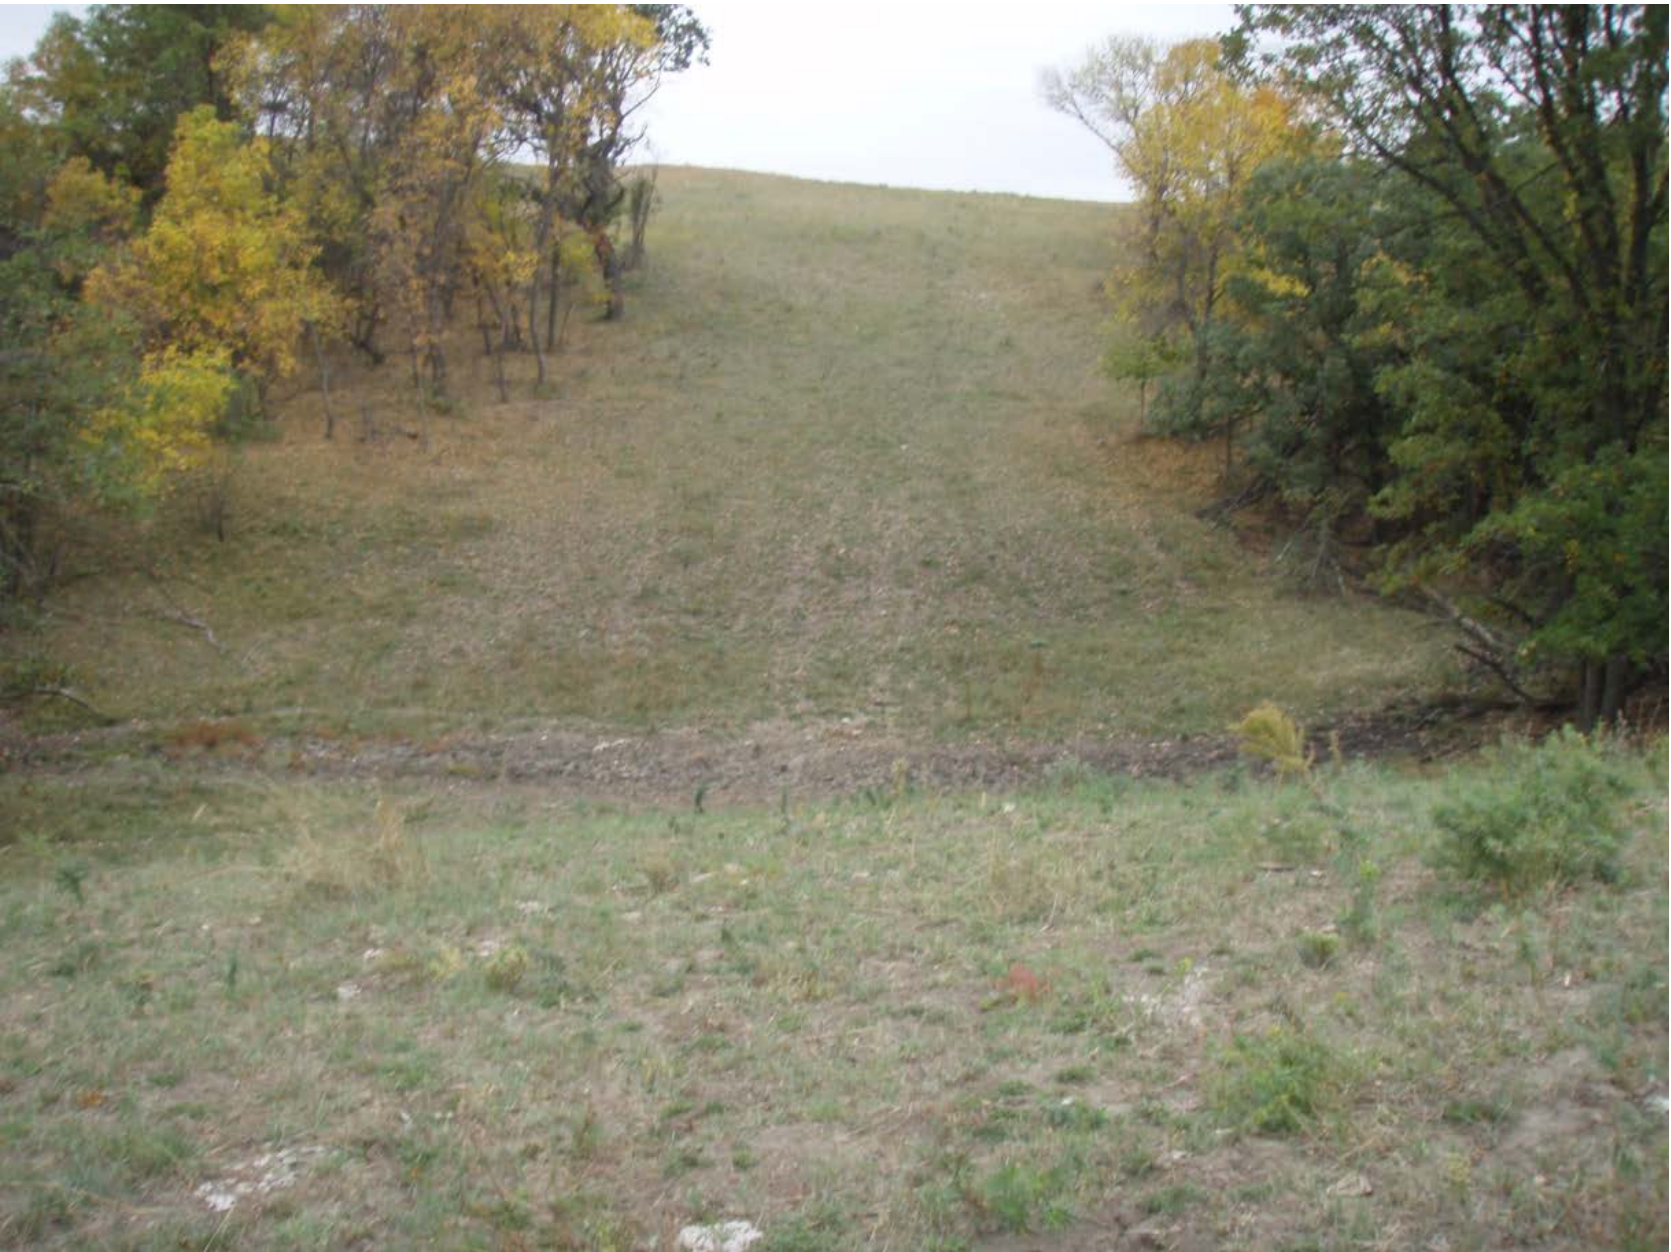
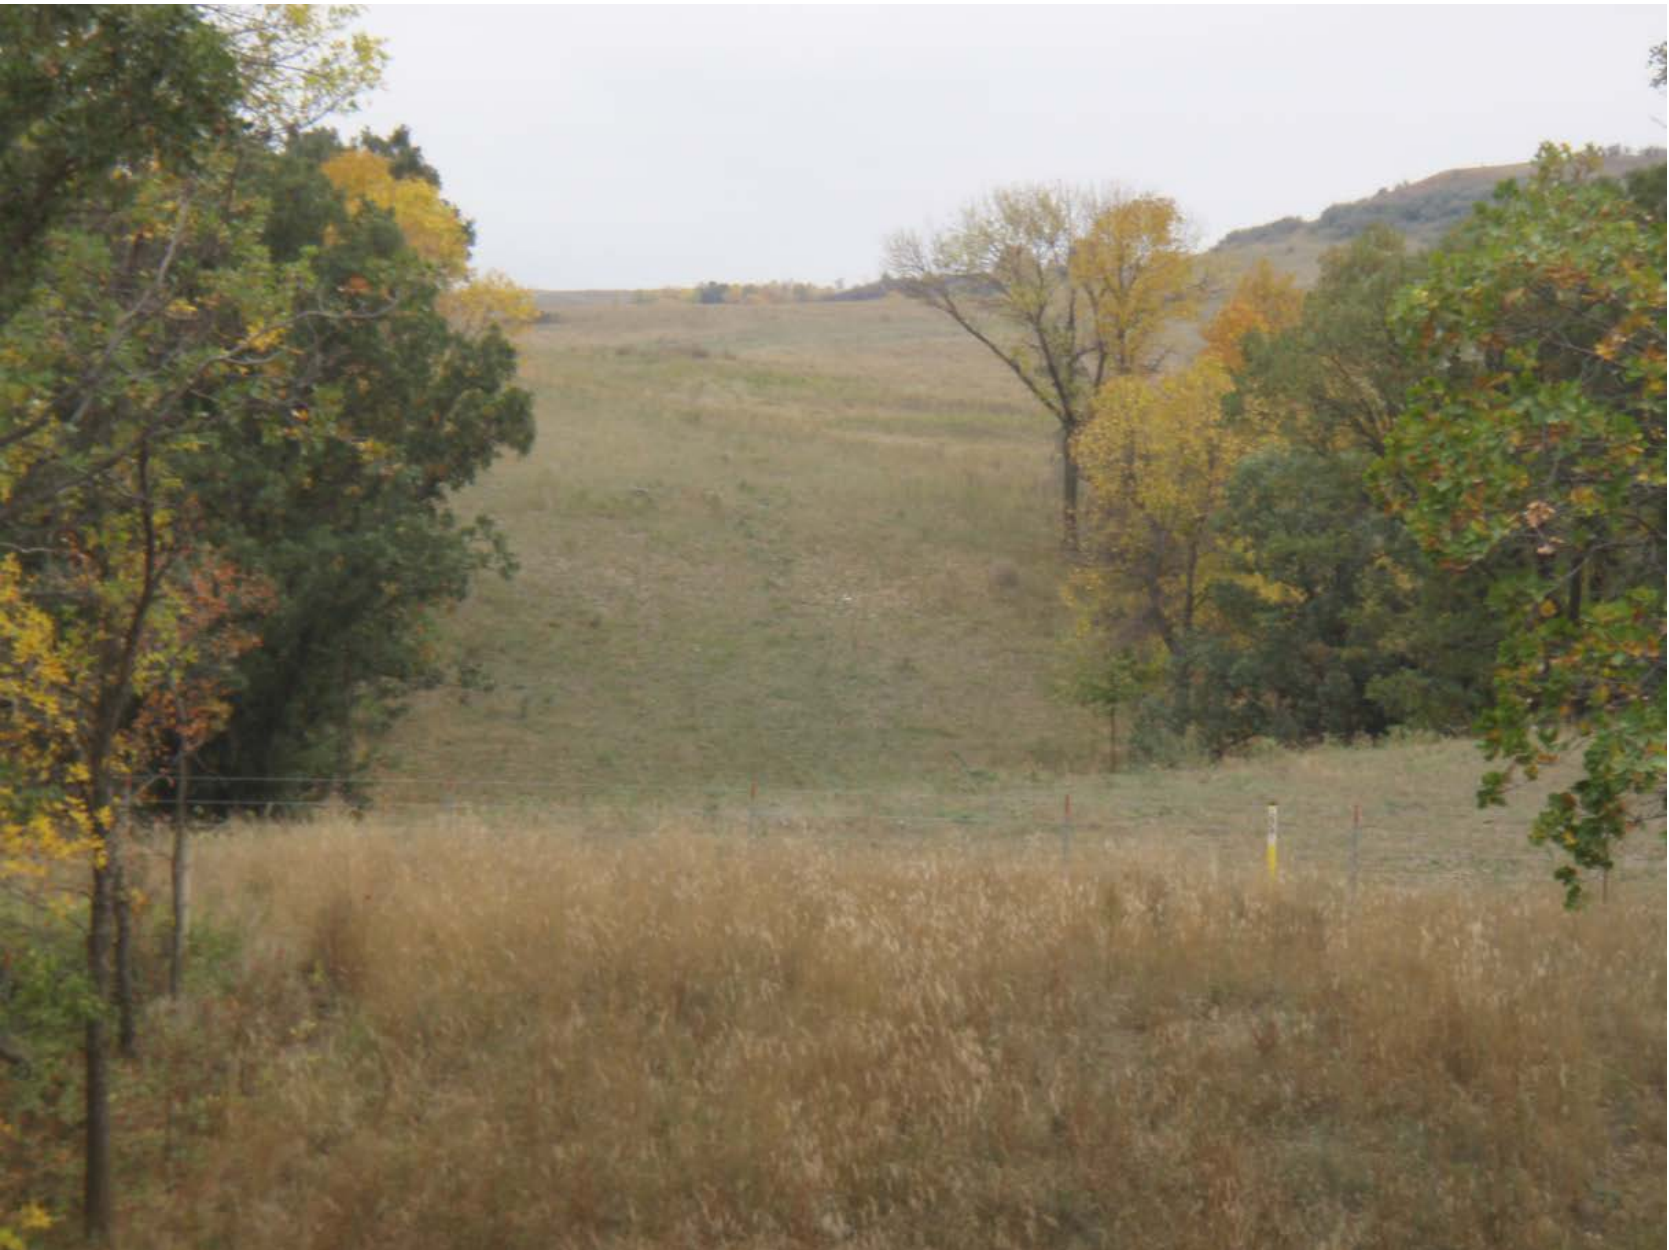
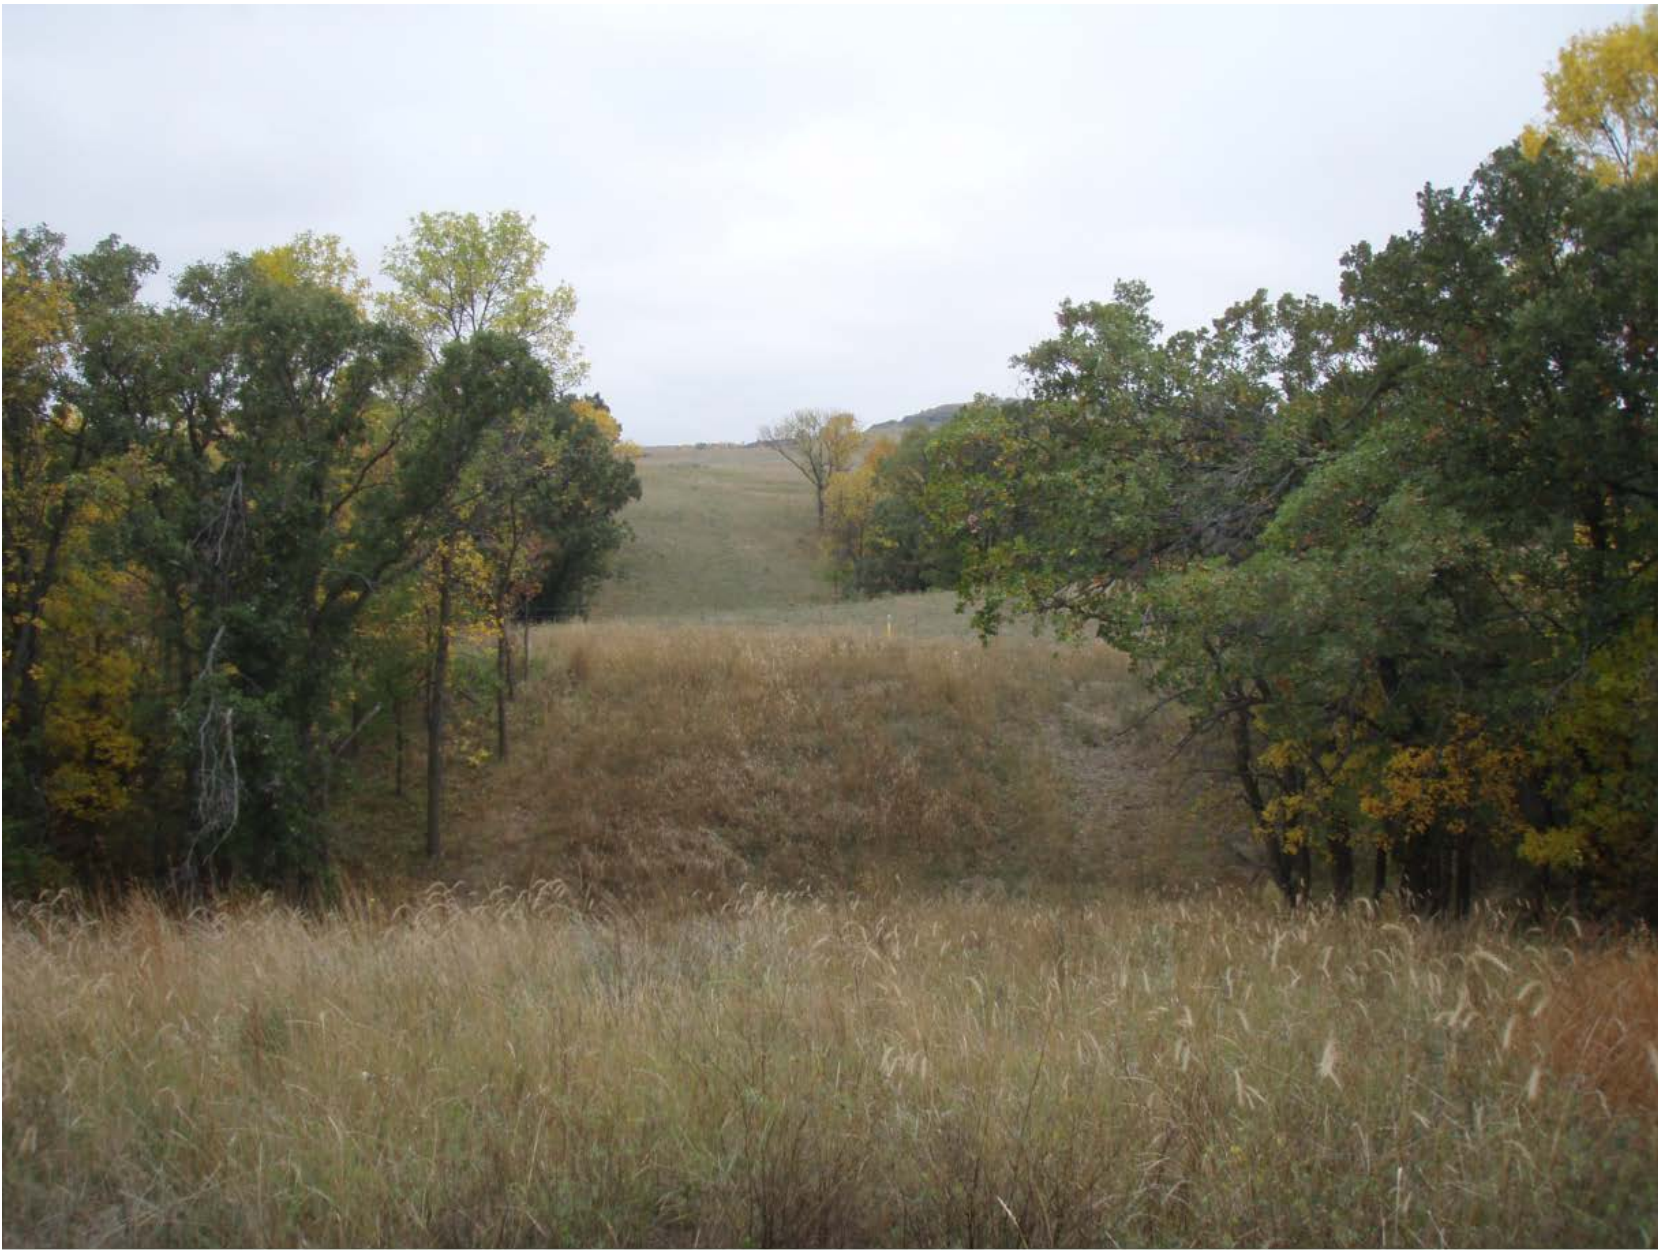
September 2015 entitled Attachment C Pages 2-4 "Area of Photo 20(1)-Sept 2015"; "Area of Photo 20(2)-Sept 2015" and "Area of Photo 20(3)-Sept 2015".

A review of these two areas of concern, shown in the pictures taken in September 2015, provide evidence that the vegetation has been restored to a condition that is equal to or better than the condition prior to the construction of the transmission facility and that the condition of the land will accommodate the previous use of the land.

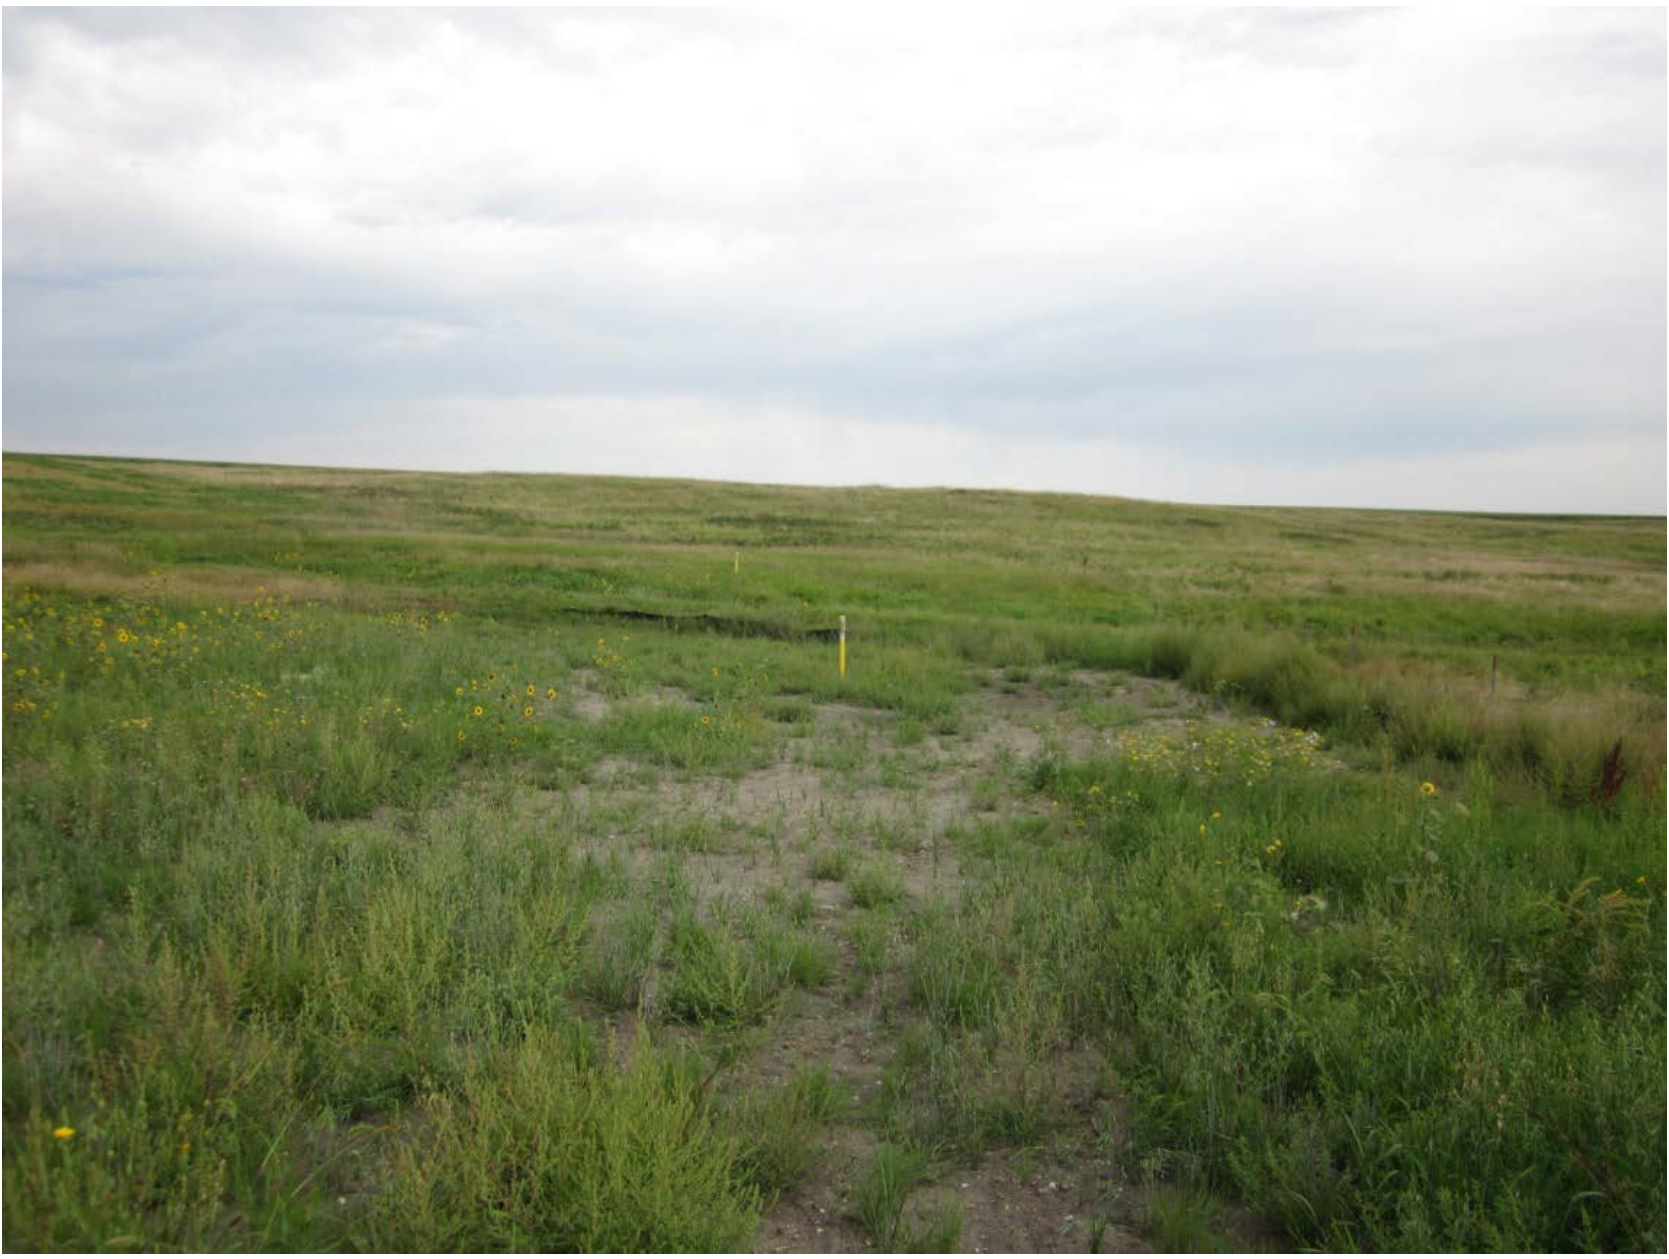
Attachment D
PHOTO 8 - AREA OF CONCERN
Page 1 of 4

Area 2 – is an area of poor vegetation growth near Pipeline Marker N:388012.25 E:1847743.82. The Photo taken of this area from the Wenck Report is attached here as Attachment D Page 1 "PHOTO 8 – AREA OF CONCERN" and looking the other direction, Attachment D Page 2 "PHOTO 19 – AREA OF CONCERN". For Review Montana Dakota submits additional pictures taken in September 2015 entitled Attachment D Page 3 "Area of Photo 8 – Sept 2015" and Attachment D Page 4 "Area of Photo 19 – Sept 2015".
