# Basin Electric Power Cooperative

## 345 kV Electrical Transmission Line

#### Construction Inspection Report - Judson Electrical Substation

ND PSC Case No. PU-11-696

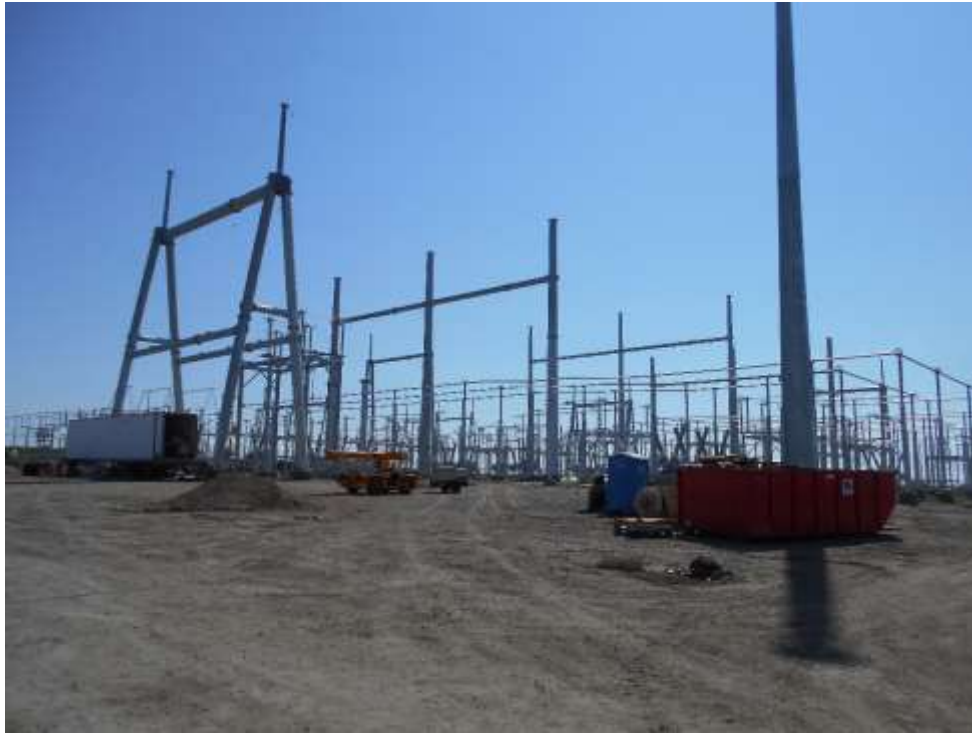
Photo 1 –Overall site picture looking southeast.

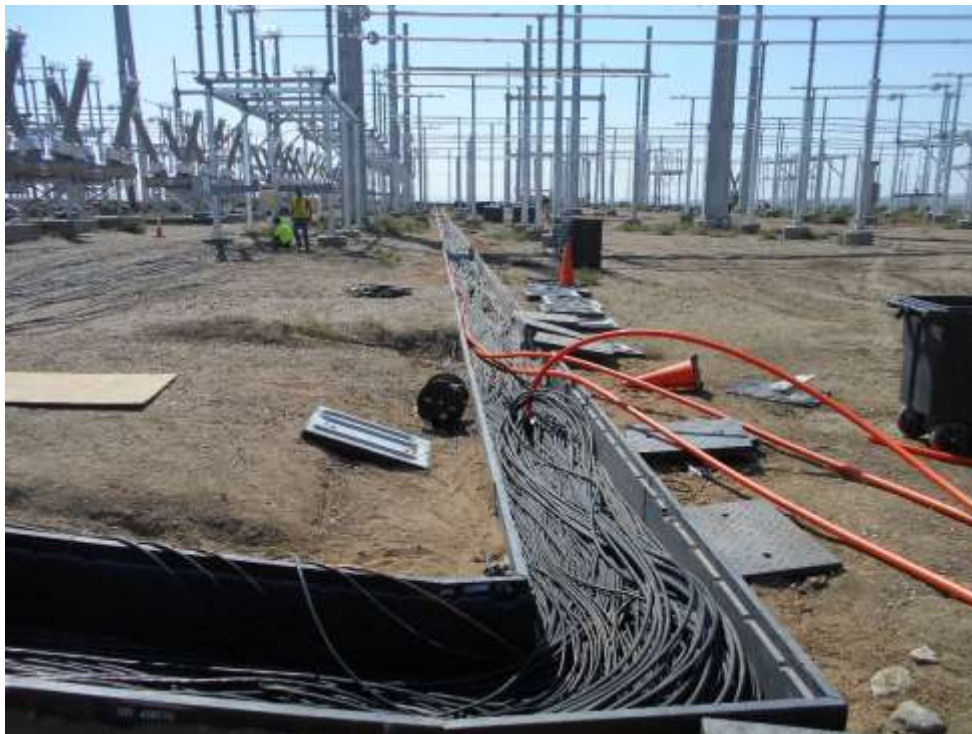
The electrical wiring duct enclosures are subsurface mounted and include both the electrical wiring and fiber optic cable. The fiber optic cable is housed in highly visible orange conduit. In order to disperse of any possible precipitation making its way into the enclosures, they are tied into a French drain system which is then attached to the site's storm water drainage system. The storm water drainage systems drain directly to a storm water retention pond located to the west of the site.

Photo 2 – Electrical wiring enclosure. Fiber optic cabling located in orange conduit.

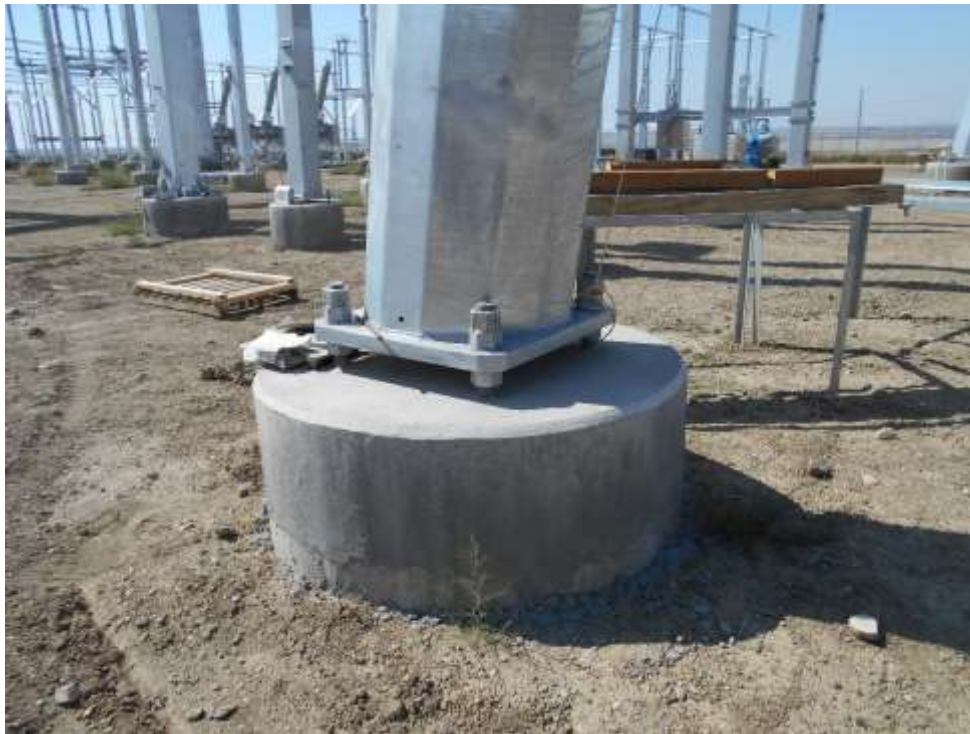
Picture 3 – Typical structural pier and mounting bolts.

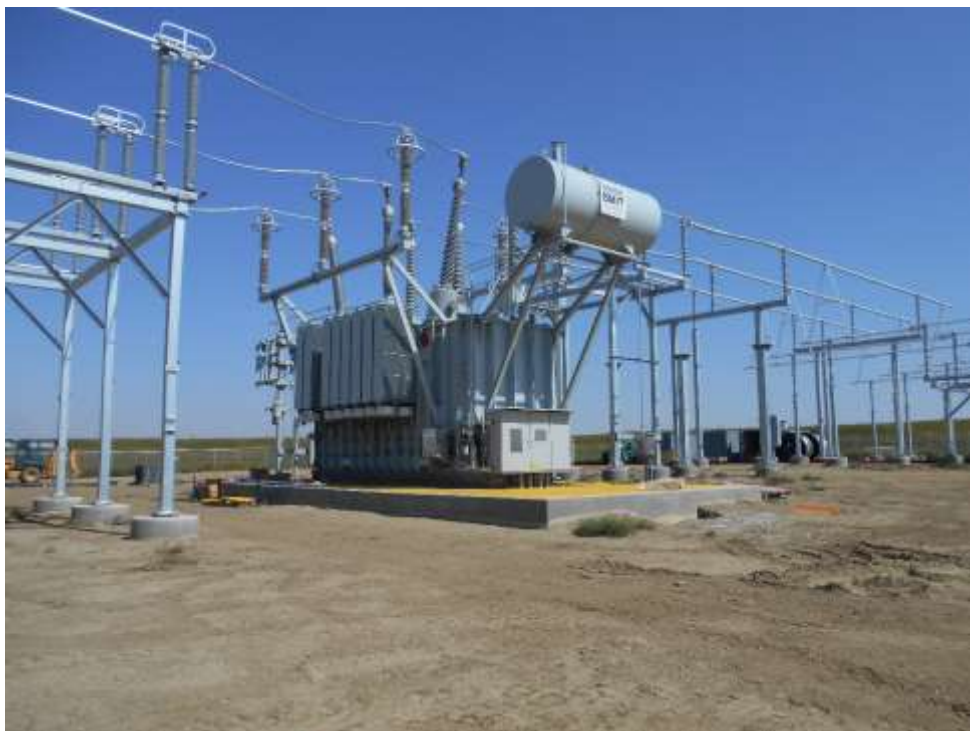
Picture 4 – Electrical transformer looking northeast.

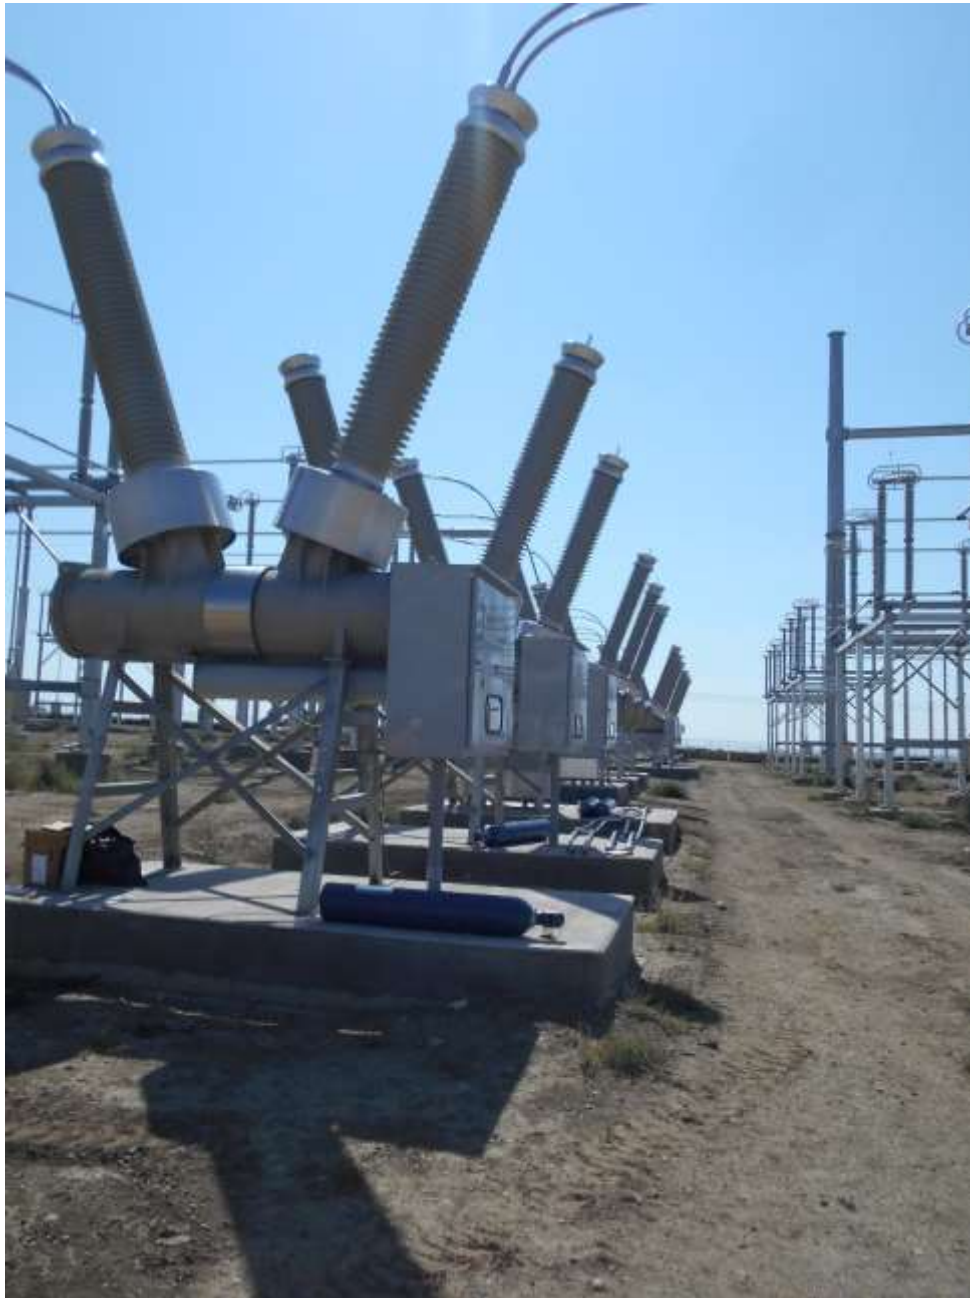
Picture 5 – Electrical breakers looking south.
