**Construction Inspection Report - Judson Substation to Neseet Substation
Basin Electric Power Cooperative
345 kV Electrical Transmission Line
Williams County, ND
ND PSC Case No. PU-11-696
Keitu Project No. 569-213**

**345 kV Electrical Transmission Line
Construction Inspection Report
Judson Substation to Neseet Substation**

Basin Electric Power Cooperative

ND PSC Case No. PU-11-696

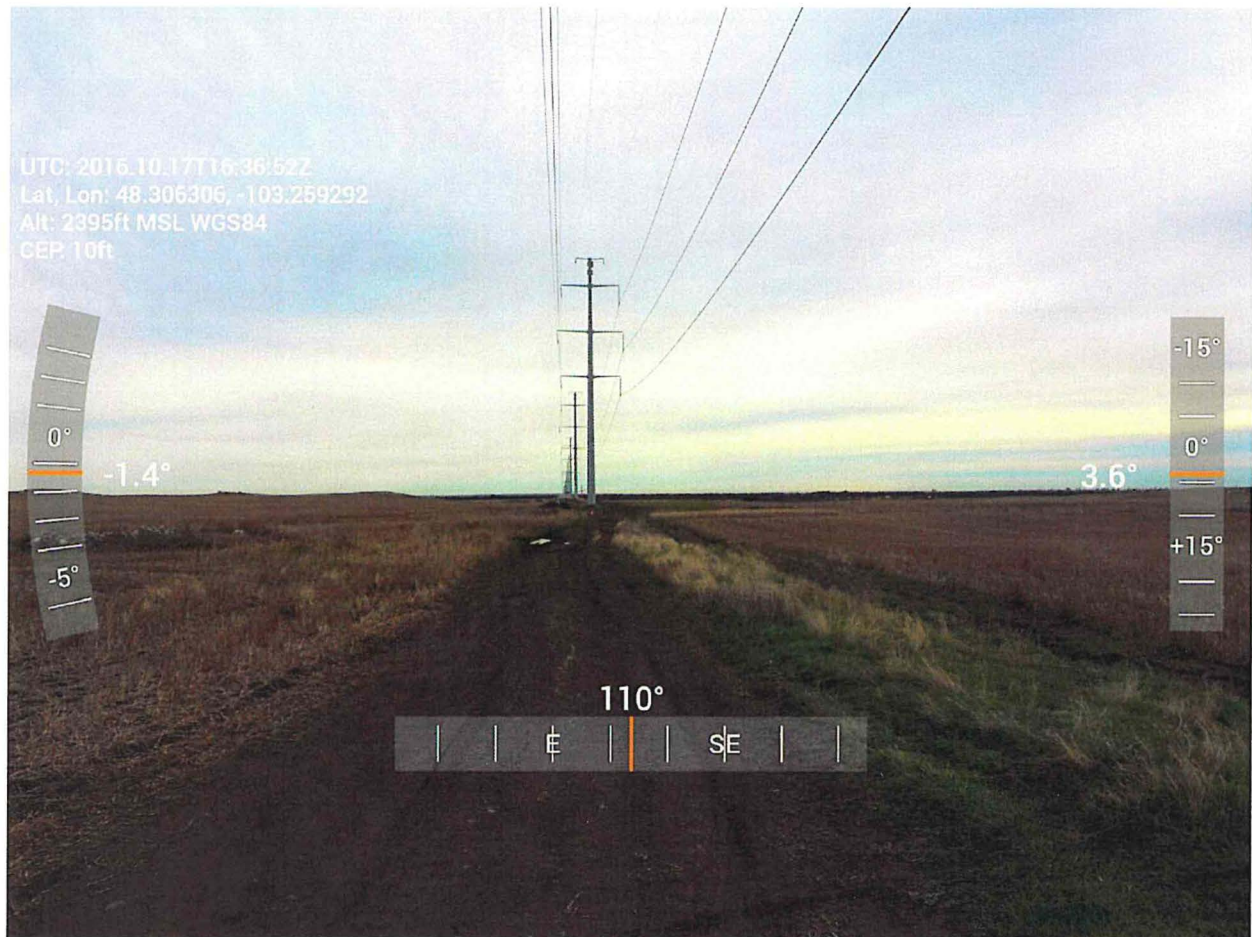
Photo 1 -Typical view of corridor.

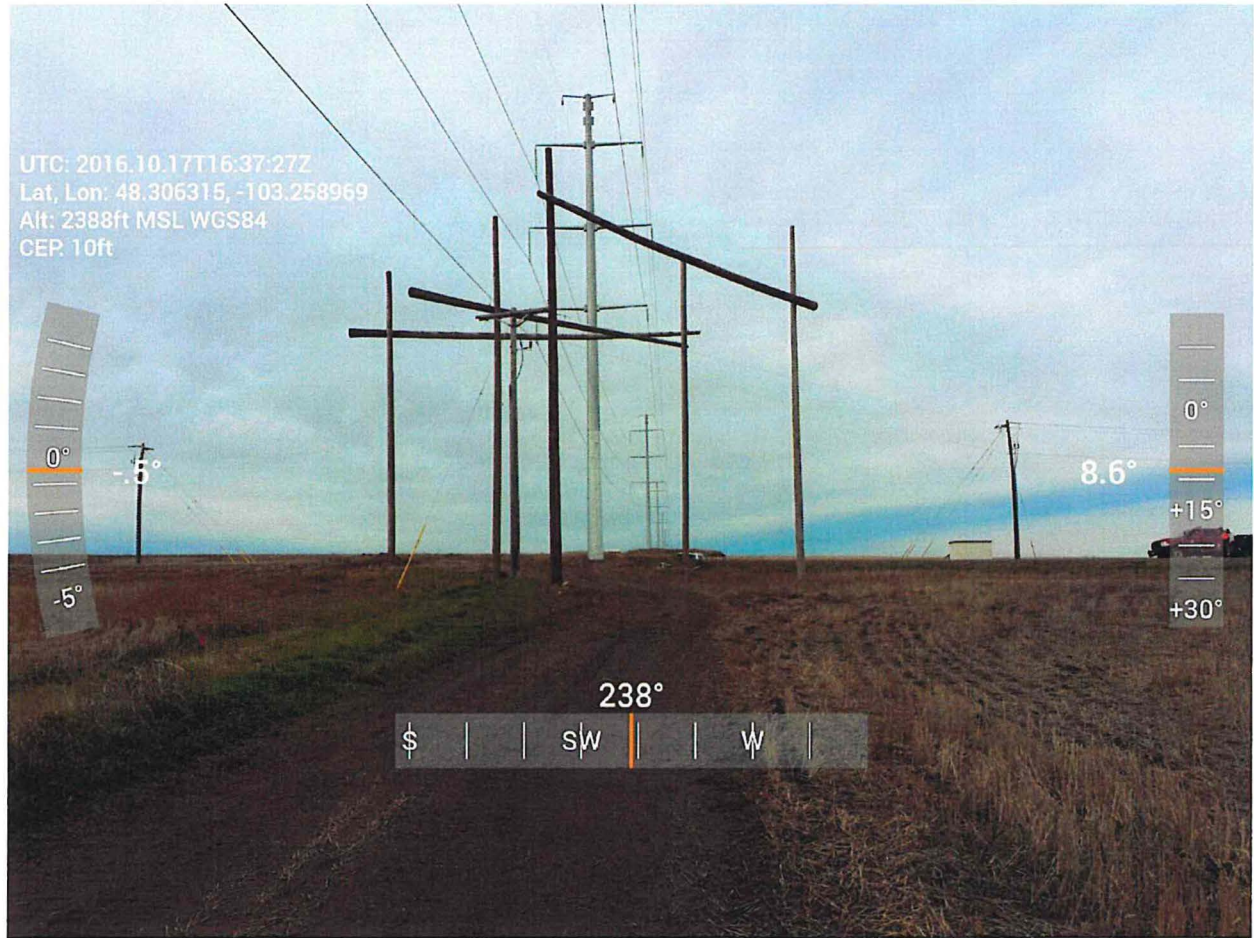
Red flags were observed to mark the boundaries of wetlands and cultural resources along the ROW so construction crews knew to stay outside of those areas. Blue flags were observed along the edges of the ROW so workers can stay within the approved corridor. Utility work that was happening above roadways was accompanied by workers signaling traffic to slow in the construction area.

Photo 2 – Transmission Line crossing road with powerline goalposts.

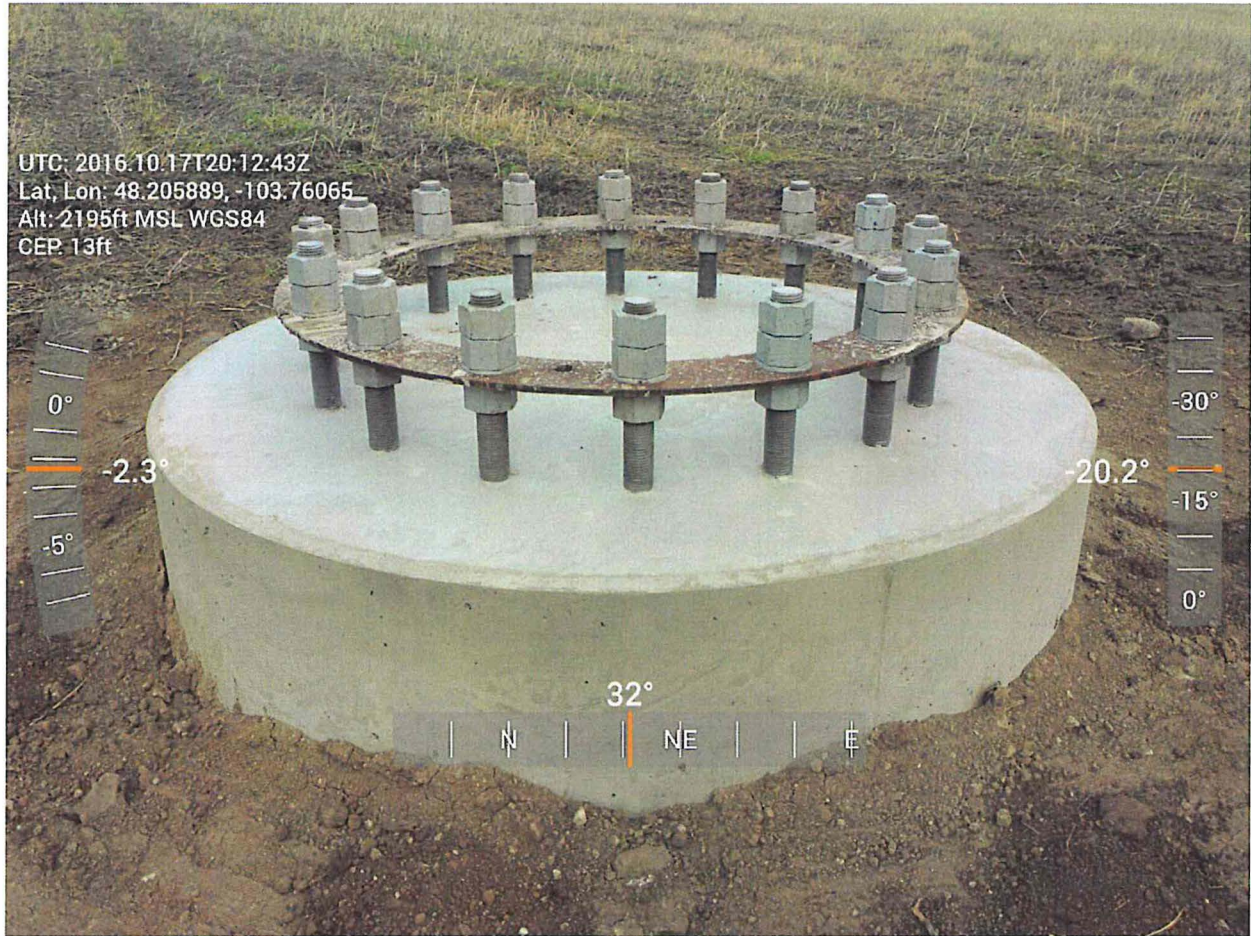
Concrete foundations were observed for the structures throughout the Project. For the concrete foundations, 4,000 psi concrete was used.

Photo 3 -Typical concrete type structural base.

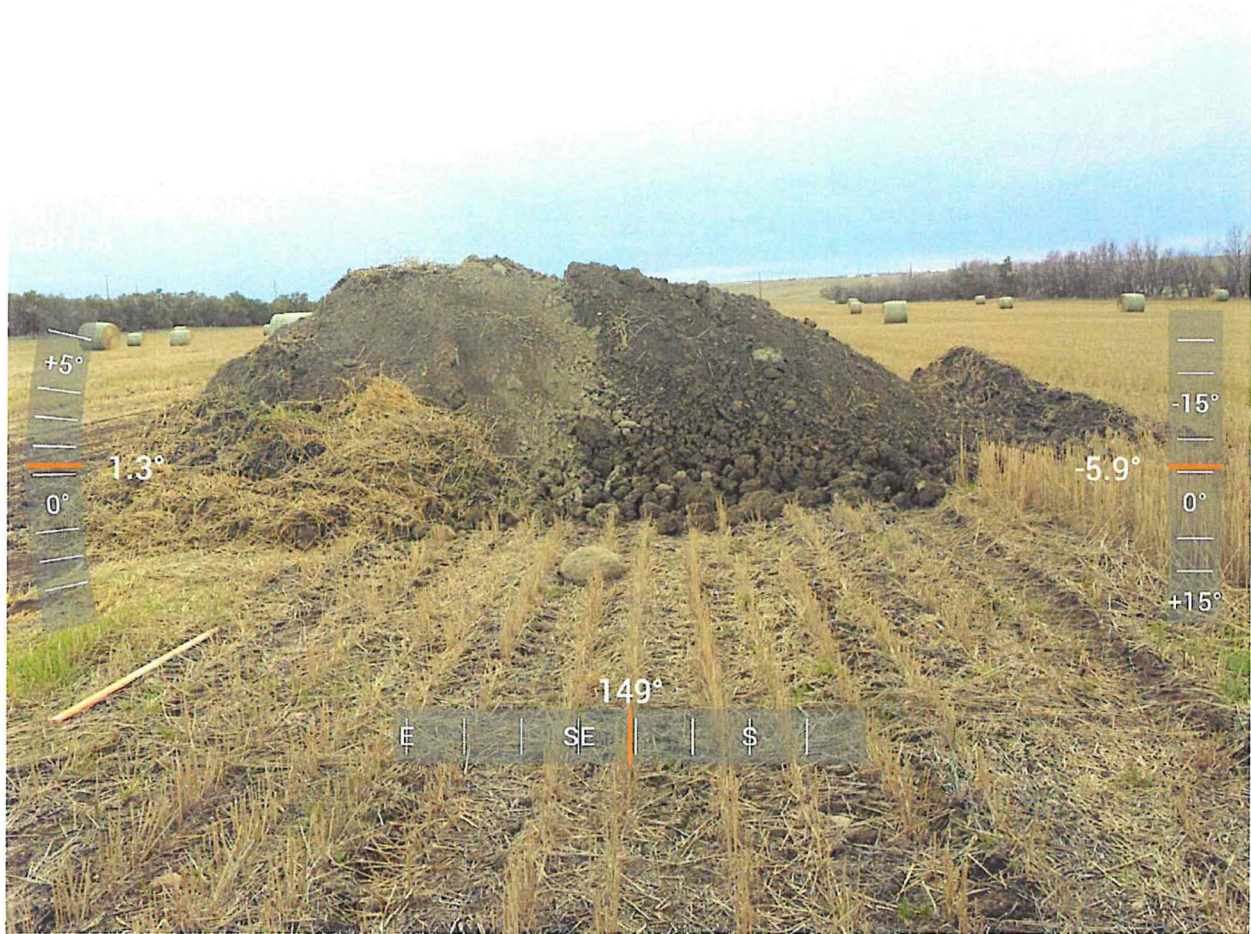
Soil piles were observed near the foundations. These piles contained topsoil, subsoil, vegetation and concrete. BEPC communicated to Keitu that many local contractors and farmers accepted the soil as a use for fill on their projects.

Photo 5 – Soil pile from foundation construction to be used for fill.

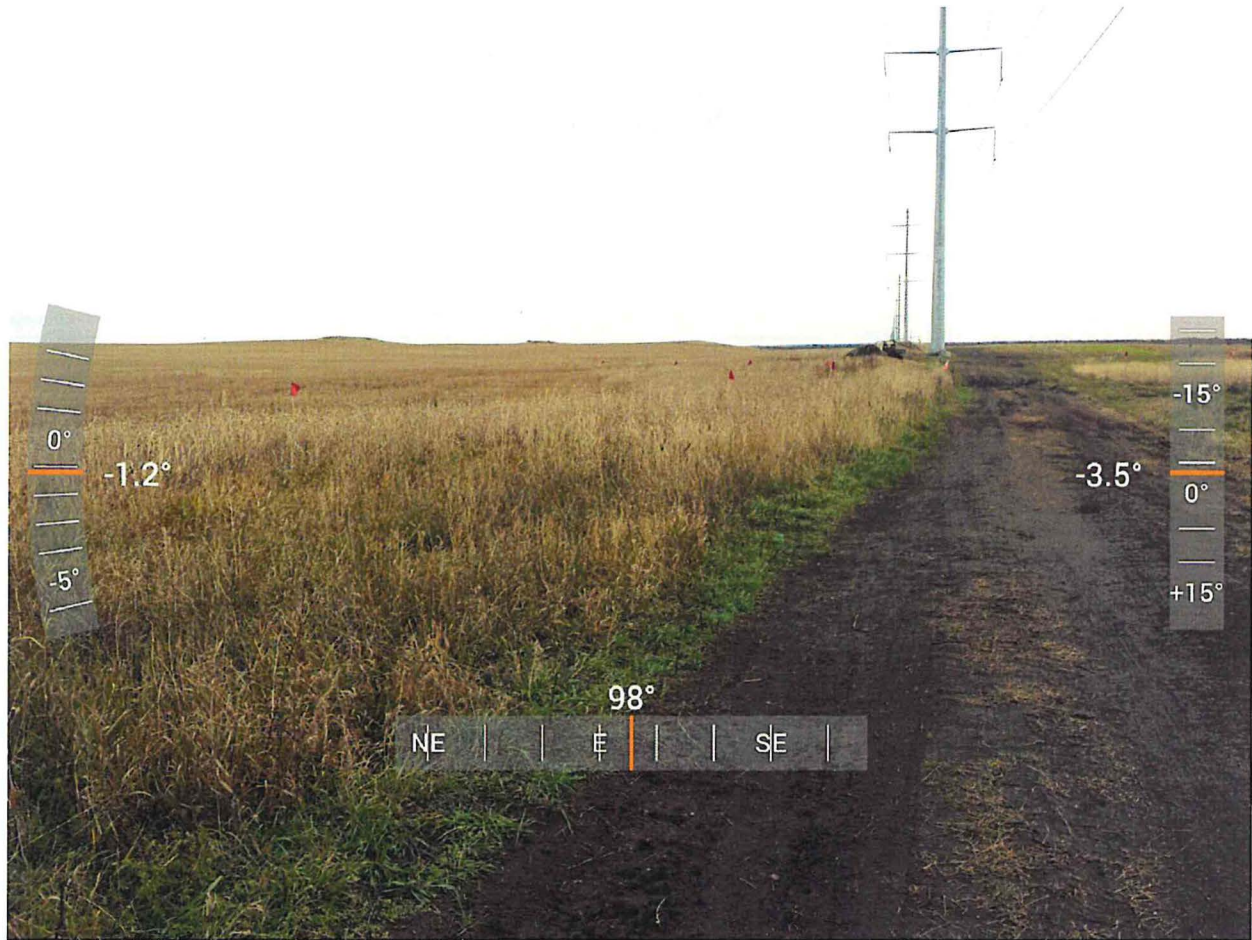
Photo 6 - Red flags used to delineate the wetland boundaries.
