RE: SHERBURNE COUNTY GENERATING STATION UNIT 3
RESTORATION UPDATE (CASE NO. PU-12-12)

Xcel Energy
 SHERCO 3
 Restoration Project
 Update: Feb. 12, 2013

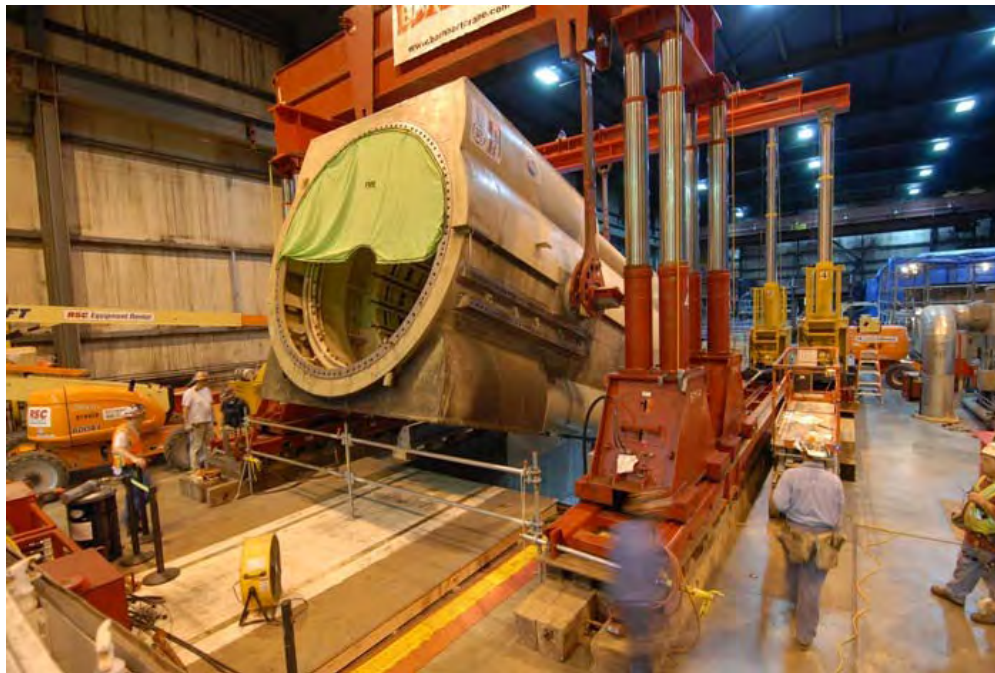
Repair of the generator stator (see Picture 1) was completed at the end of January 2013, which was later than the October 2012 date originally anticipated.

We had to complete significant portions of the process twice due to alignment issues that occurred during the first restack. This restacking and alignment work was challenging due to the limited industry experience for generators of similar design and size, or extent of damage as Sherco 3.

Restacking the generator stator required first lifting and rotating the generator from its usual horizontal position to a vertical position. It took several weeks of planning and preparation and about two weeks to set up the equipment necessary for the lifting process. The actual lift took about two days.

Picture 1: The generator stator being lifted to a vertical position for restacking.

Once the generator was in its vertical position, there were two shifts of workers inside the generator each day for approximately seven weeks, rebuilding the core of the machine by stacking approximately 400,000 thin pieces of steel plate segments by hand one on top of another like bricks in a circle.

After restacking of the steel plates was complete, the generator (now weighing about 390 tons) was lifted and rotated back to the horizontal position. Then, copper stator bars were slid into the 24-foot long by 1³/₄-inch wide slots formed by the steel plates.

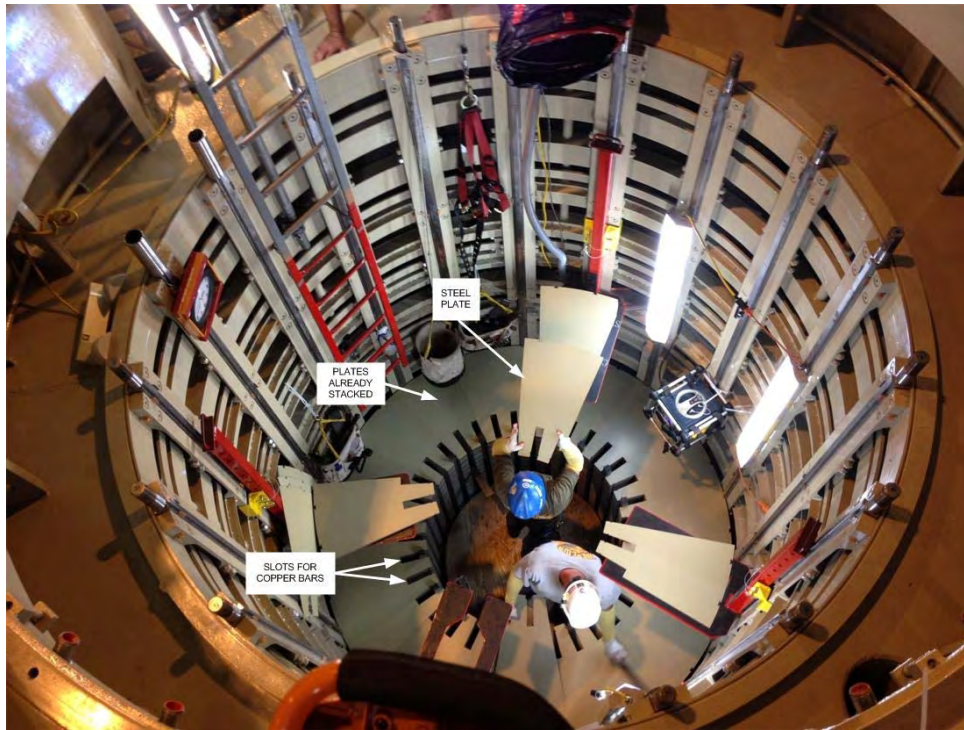
Picture 2: Internal stacking of the generator stator, and the slots where the copper bars need to fit.

After we completed our initial restacking process, we determined there was an alignment problem between the stator bars and the steel plates. Although there were alignment checks performed throughout the entire restacking process, the room for error was approximately 1/32 inch, and the contractor was unable to get the proper fit needed to complete the reassembly process.

As a result, we again lifted and rotated the generator back to the vertical position, removed the majority of the steel plates, and repeated the restack, performing additional alignment checks throughout the process. At the conclusion of this second stacking process, the stator bars fit into the slots with the proper clearances and tolerances.

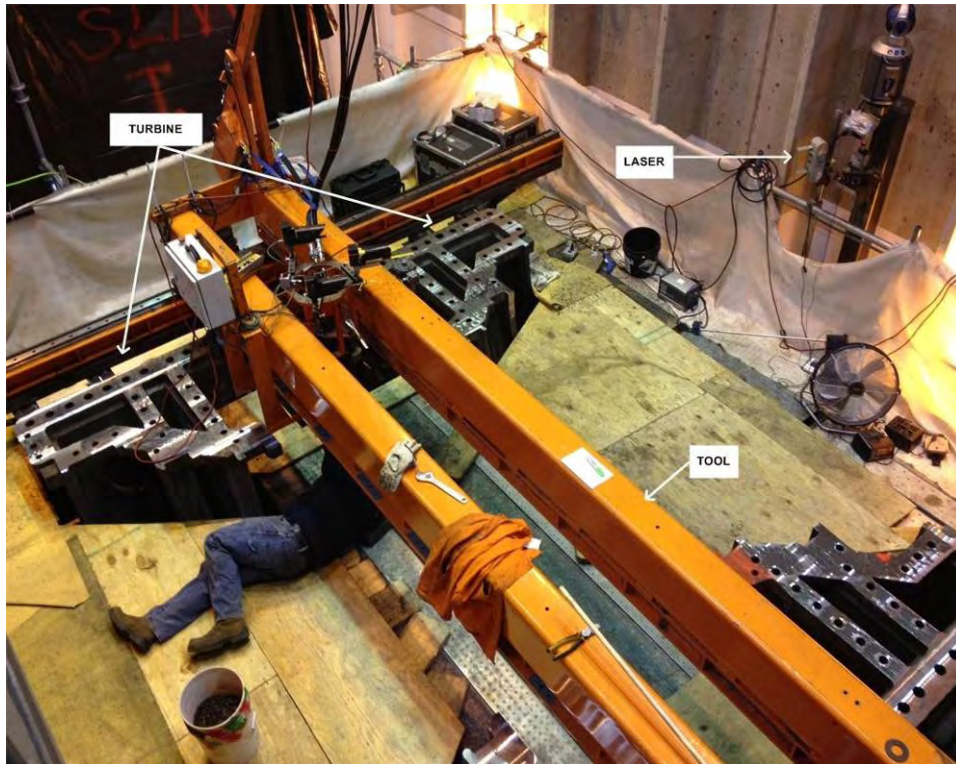
The onsite turbine repairs consist of detailed visual non-destructive examinations, dimensional inspections, engineering assessments, detailed repair plans, welding, and machining. The type of damage on the turbines was more severe and went deeper than expected, and thus required considerably more time to perform each of the activities than anticipated. For example, one type of damage observed on the equipment was machine surface self-welding. This phenomenon occurred on many flat and curved surfaces where machine parts are in contact with each other. The horizontal joining surfaces are the most obvious location where this phenomenon was observed, but it was also found under the feet of the turbine after the turbines had been completely lifted from their foundations to replace the damaged foundation system, which was not expected. This damage required repairs to restore the machined surfaces to their proper form, fit, and function, and the additional damage found meant additional time was required to complete the work.

Picture 3: A laser-guided specialty tool brought in to repair the surfaces of the turbines.

In addition, this was not routine maintenance type work, but instead required innovative engineering and technology development and specialized repair technique creation as the details of the damage were discovered. One of the techniques used to repair the damage to the machined horizontal joint surfaces of the LP turbines required the use of large laser guided machine tools that were custom designed and fitted for the Sherco 3 turbines (see Picture 3). The installation of these tools and procedures to apply them required extensive engineering and set-up time that occurred as the work progressed.

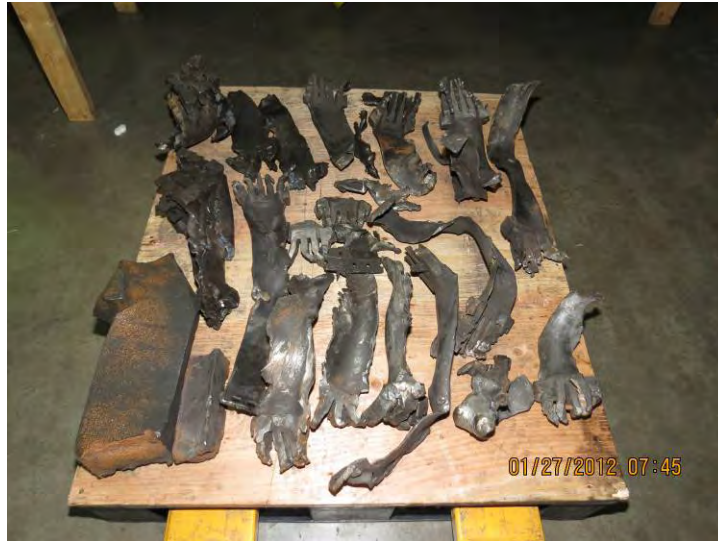
The low pressure turbines sustained substantially more damage than the other turbine sections during the event. Similar to the other turbine sections, some major components of these turbines were repaired on site while some were sent offsite for repairs.

Picture 4: Damaged LP turbine blades.

The onsite repairs are nearing completion. However, due to the extent of the damage to the LP turbine components there was additional repair time required. Repairs for these components are anticipated to be completed in April 2013. Minor onsite repairs will continue through unit assembly as additional necessary work is identified as the parts are fully assembled with each other.

The offsite repairs are also nearing completion and most critical turbine parts are expected to be returned to the site in April. The low pressure rotors are the most

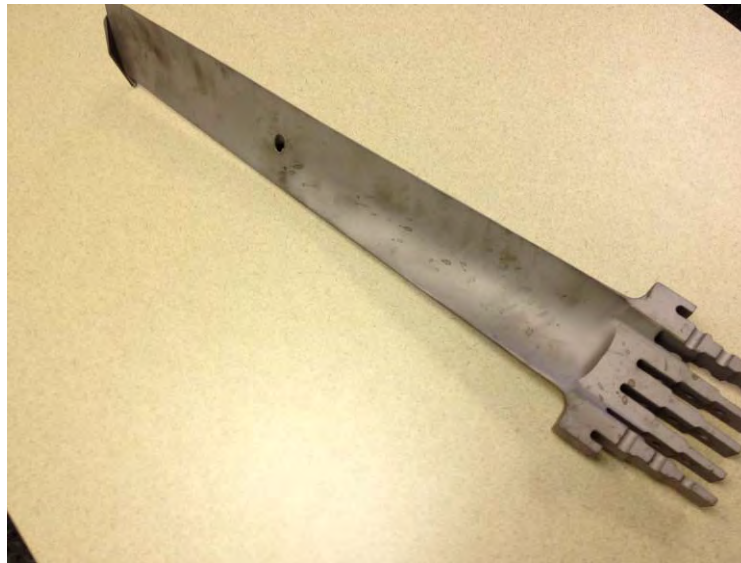
Picture 5: A new LP turbine blade.
