April 15, 2013

RE: SHERBURNE COUNTY GENERATING STATION UNIT 3
RESTORATION UPDATE (CASE NO. PU-12-12)

Xcel Energy
 SHERCO 3
 Restoration Project
 Update: Apr. 10, 2013

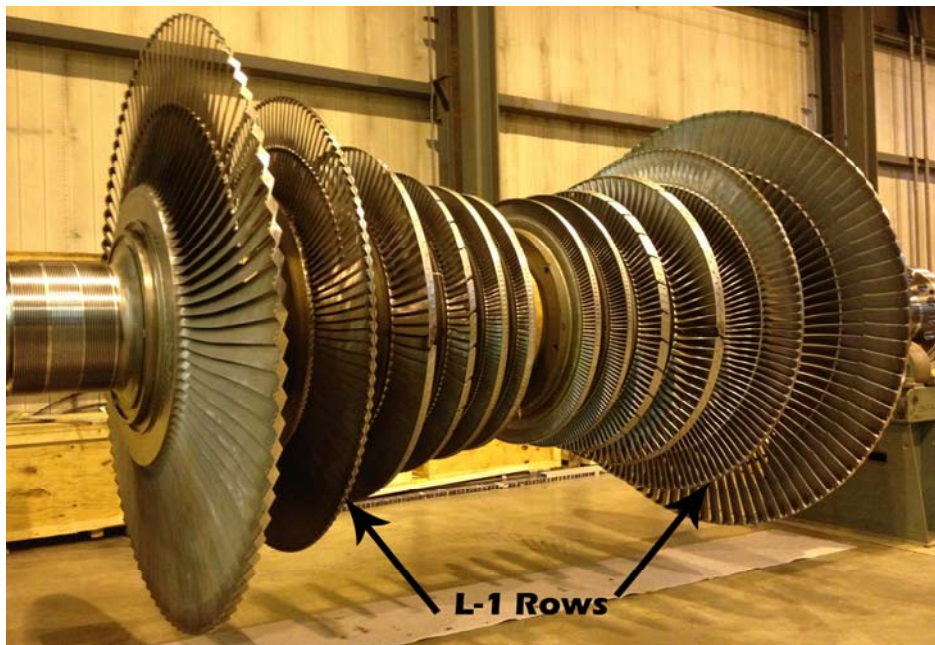
- The failure event originated in the low pressure (LP) “B” turbine at the attachment location of the next to last row of turbine blades – known as the L-1 stage. The Sherco 3 steam turbine has four identical L-1 rows, one of which failed, resulting in the loss of significant mass from the rotor and subsequently creating a large imbalance. Image 1 shows one of the two LP turbine rotors and identifies the L-1 rows.

Image 1: One of the two LP turbine rotors.

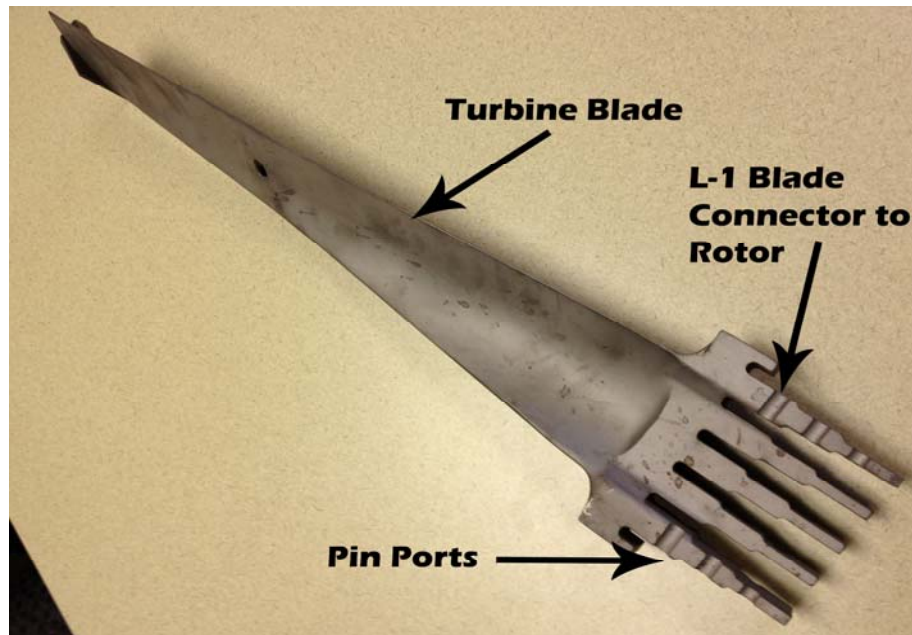
- Extensive cracking in the root area of the attachment location where the L-1 blades connect with the rotor disc caused the failure. Similar cracking was detected in the other L-1 stage attachments. Image 2 shows the L-1 turbine blade and pin ports where pins are inserted to “pin” the turbine blade to the turbine rotor disc. Extensive cracking was found in the inside “fingers” of the connector adjacent to the pin ports.

Image 2: L-1 turbine blade, disconnected from the turbine rotor disc.

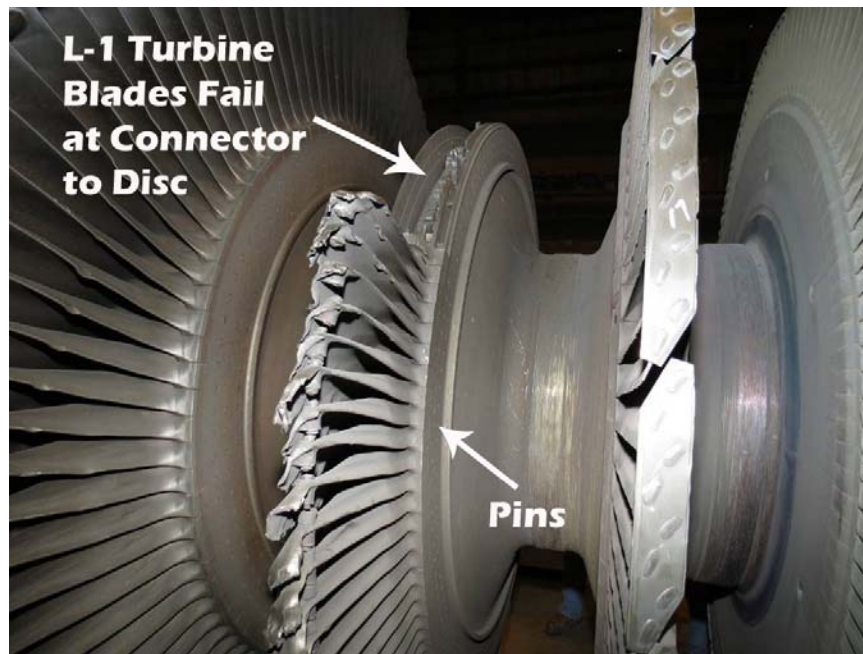
- Metallurgical examination (including analysis of the fracture surface by a scanning electron microscope) determined the failure to be the result of what is commonly known as stress corrosion cracking. Image 3 shows the L-1 turbine blades that failed at the root connector to the turbine rotor disc. Image 1 and Image 3 are the same component- with Image 3 being before repairs.

Image 3: L-1 turbine blades that failed, connected to turbine disc.

- The unit was operated normally and no anomalies (indications/warnings/alarms) were noted before the failure event.
- A review of the water chemistry operating history confirms that Sherco 3 has been operated in accordance with industry norms since the unit was commissioned in 1987.
- A review of the operations and maintenance procedures and history confirms that the unit has been operated and maintained in accordance with industry norms since the unit was commissioned in 1987.
- The primary causal factor responsible for the stress corrosion cracking of the low pressure turbine L-1 disks was the high static stresses generated during normal operation at the pin holes, ledges and at the base of the fingers of the finger pinned blade attachments in the low pressure turbine L-1 stage disks. The high stresses in the finger pinned blade attachments are a function of the original design.
