October 2, 2013

Jerry Lein
Public Utility Analyst
North Dakota Public Service Commission
600 East Boulevard Avenue, Dept. 408
Bismarck, ND 58505-0480

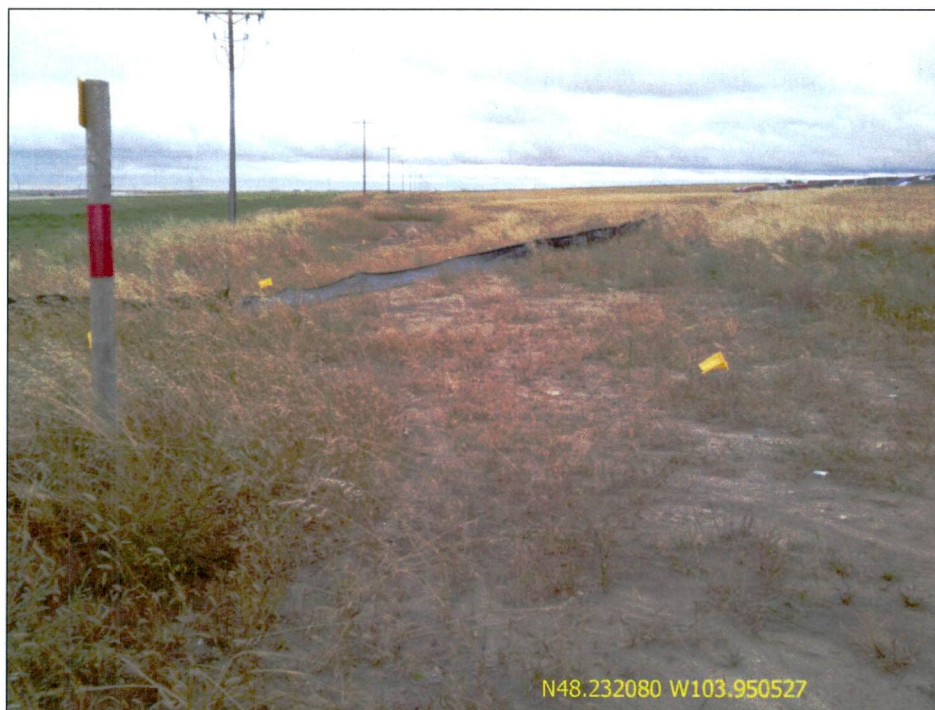
Figure 2. Photo of silt fence and cover crop south of Site. Silt fence in need of minor maintenance but was still working effectively. TIC committed to repairing it immediately.

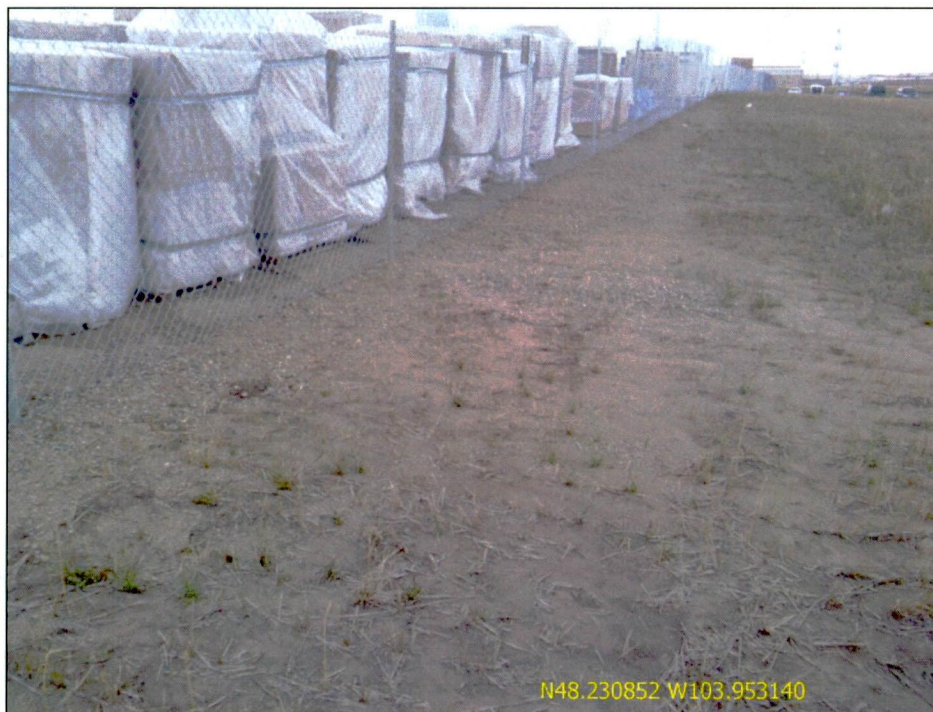
Figure 3. Photo of south side of the temporary construction work site storage area. Surface runoff has washed sand/gravel from under pallets to outside of fenced area. Recommendation was to install silt fence and remove gravel.

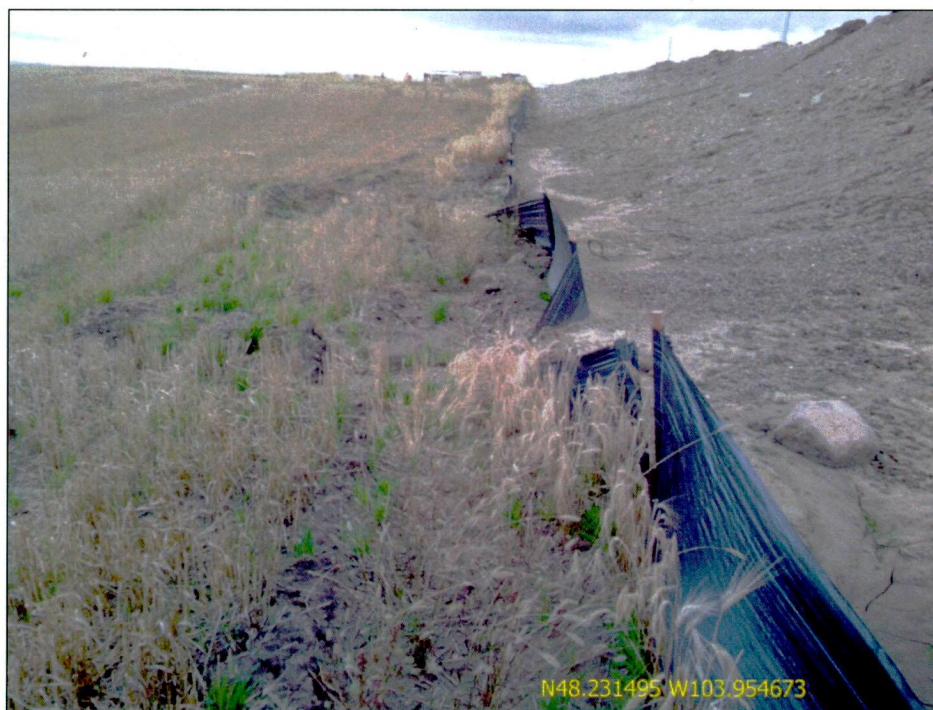
Figure 4. Recent activity on the soil storage piles and recent rain showers has filled the backside of the ECD. The silt fence effectively contained the soil subsidence. TIC committed to maintenance immediately.
