ONEOK Garden Creek II & III

Second Construction Inspection – 8/06/2013

PCS Case No. PU-12-656

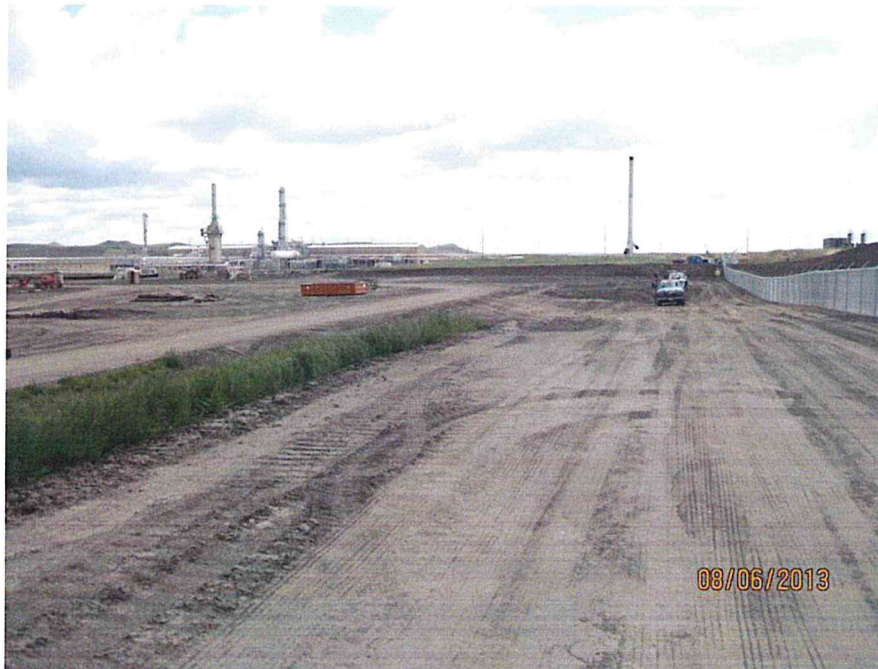
Figure 1. View from the western edge of Garden Creek II looking south

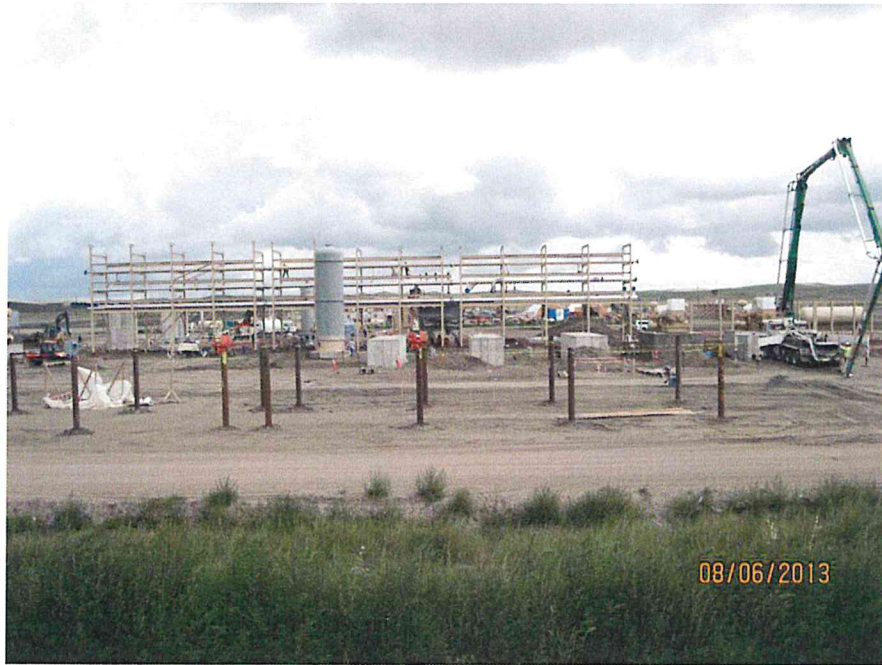
Figure 2. View from the western edge of Garden Creek II looking east

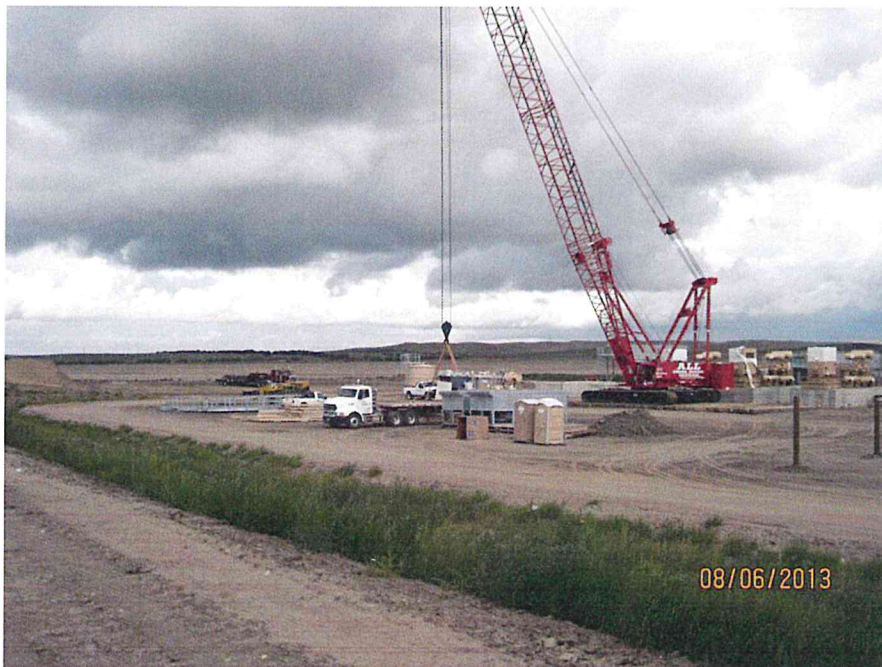
Figure 3. View from the western edge of Garden Creek II looking northeast

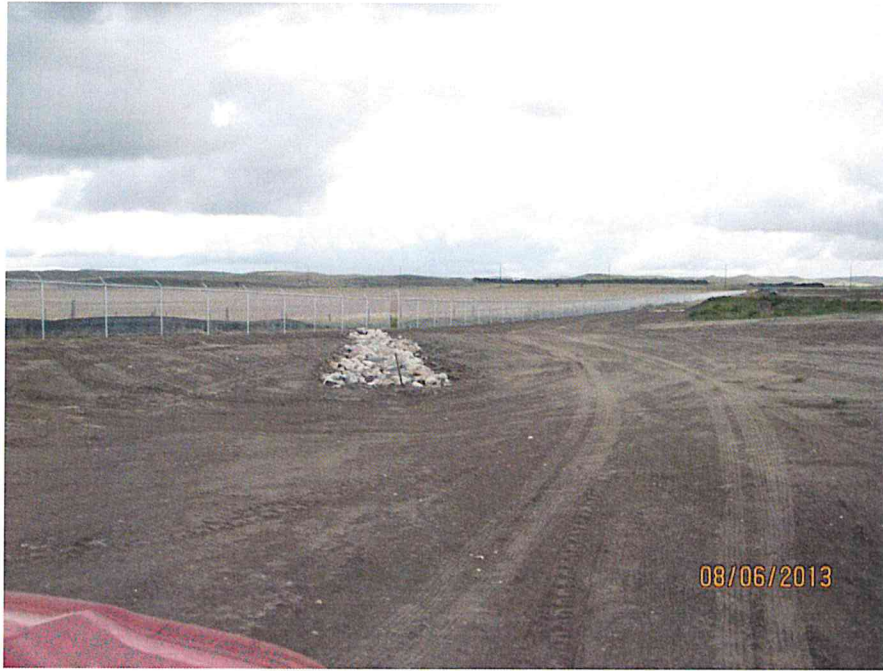
Figure 4. View from the northern edge of Garden Creek II looking east. Riprap installation to control drainage is seen.

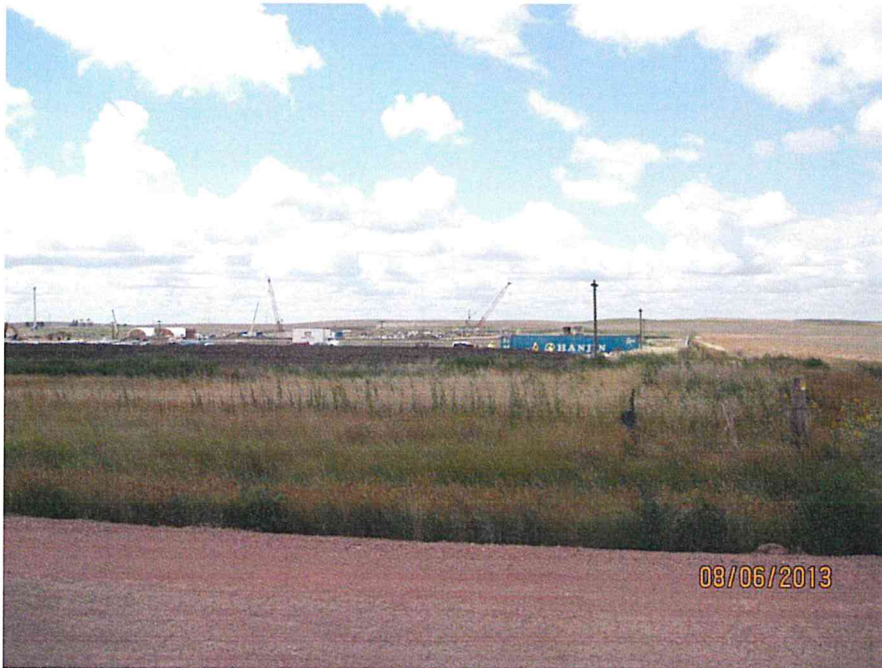
Figure 5. View from the northeastern corner of Garden Creek III looking west

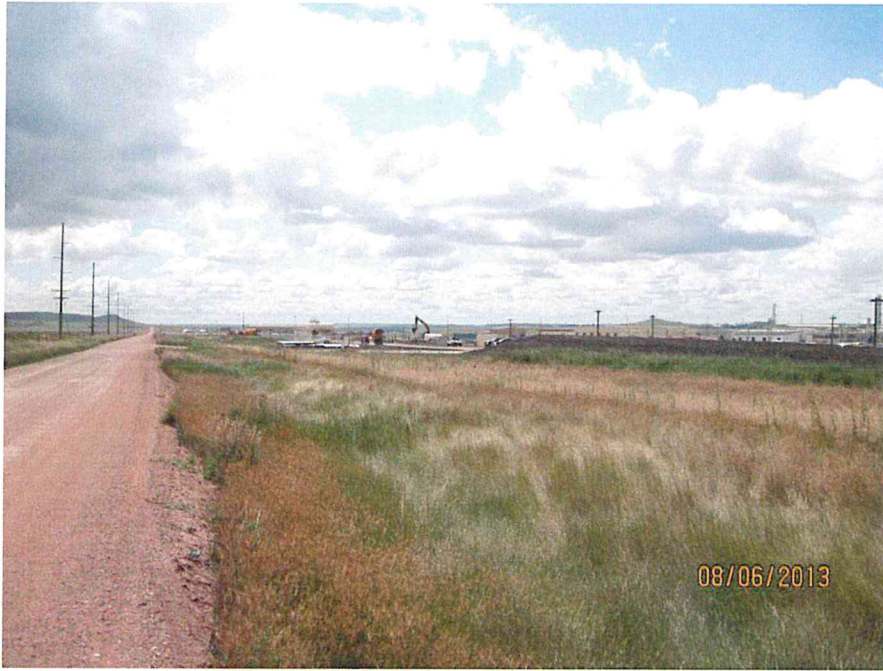
Figure 6. View from the northeastern corner of Garden Creek III looking south

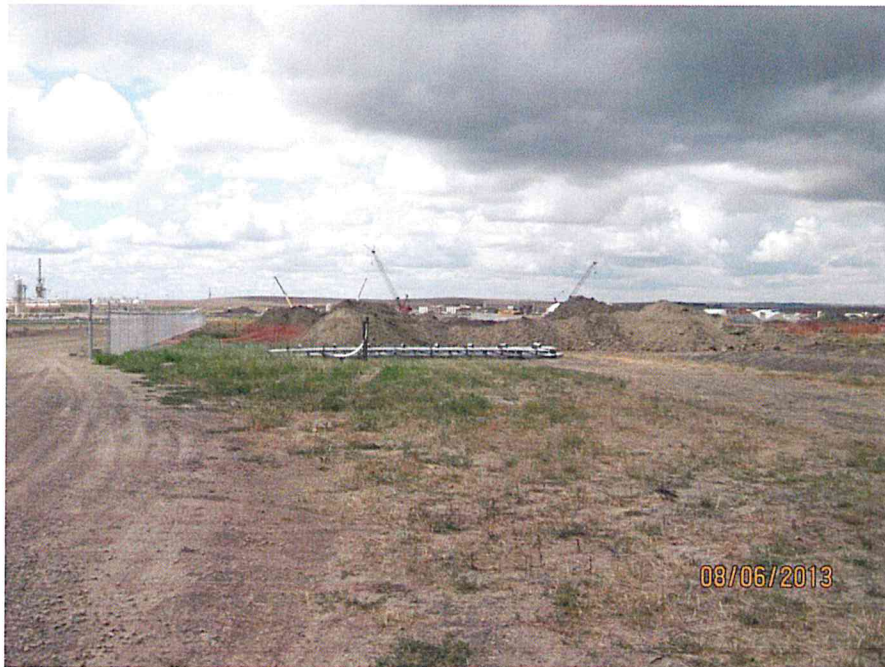
Figure 7. View from the southeastern corner of Garden Creek III looking west

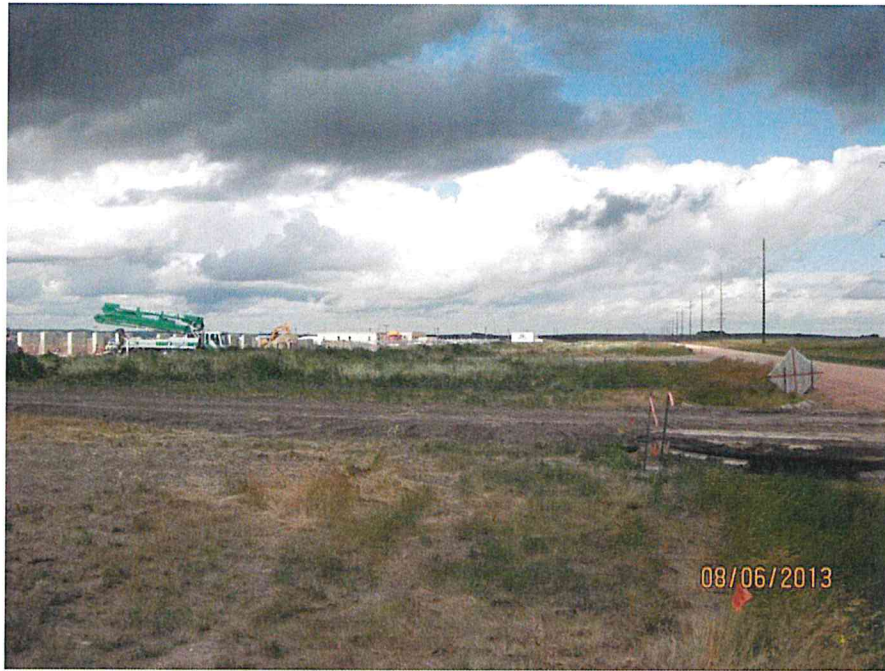
Figure 8. View from the southeastern corner of Garden Creek III looking north
