ONEOK Garden Creek II & III

Third Construction Inspection – 04/22/2014

PCS Case No. PU-12-656

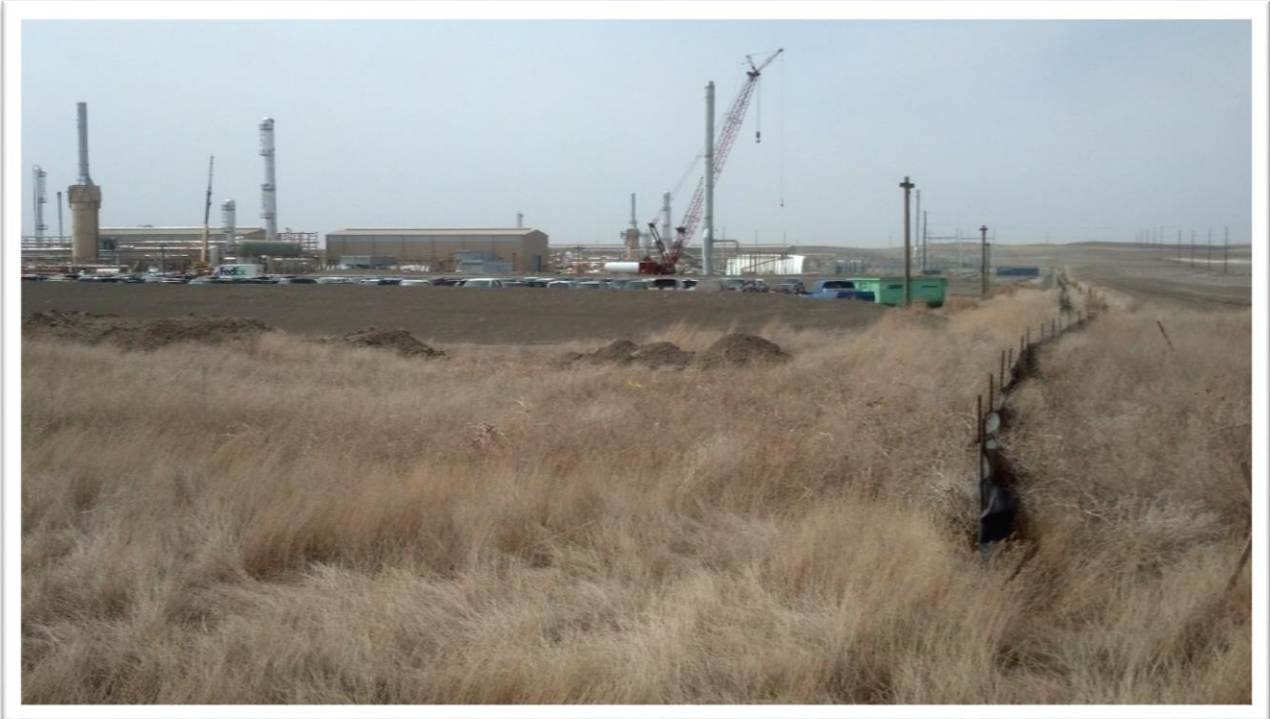
Figure 1. View from the northeast corner of Garden Creek II looking west

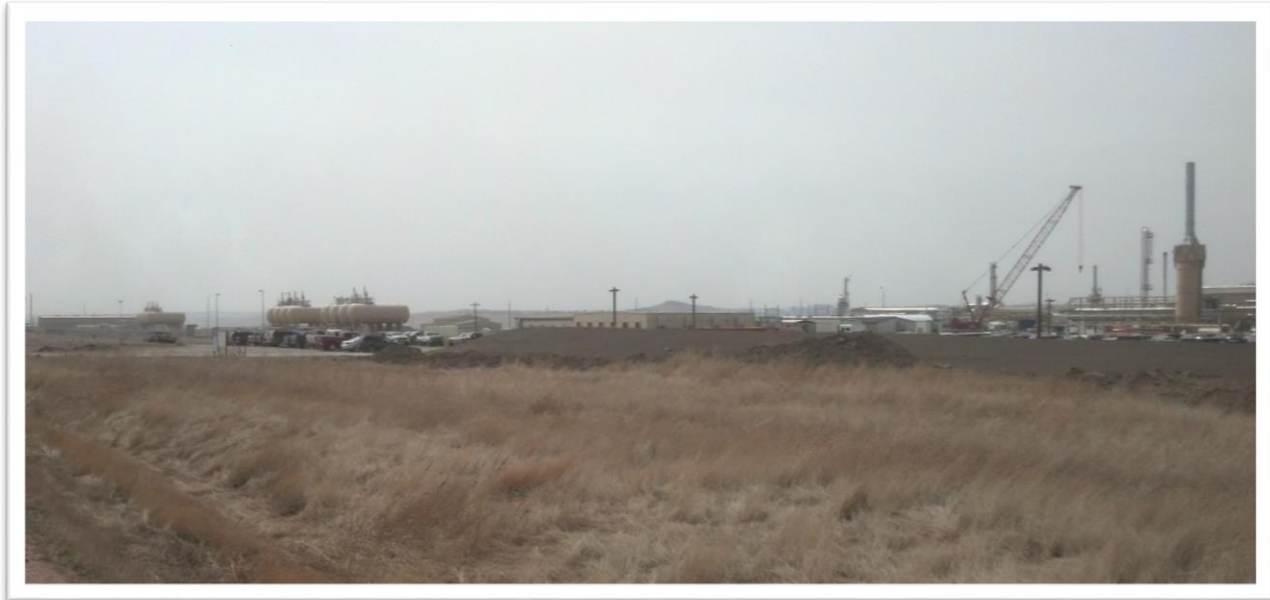
Figure 2. View from the northeast corner of Garden Creek II looking southeast

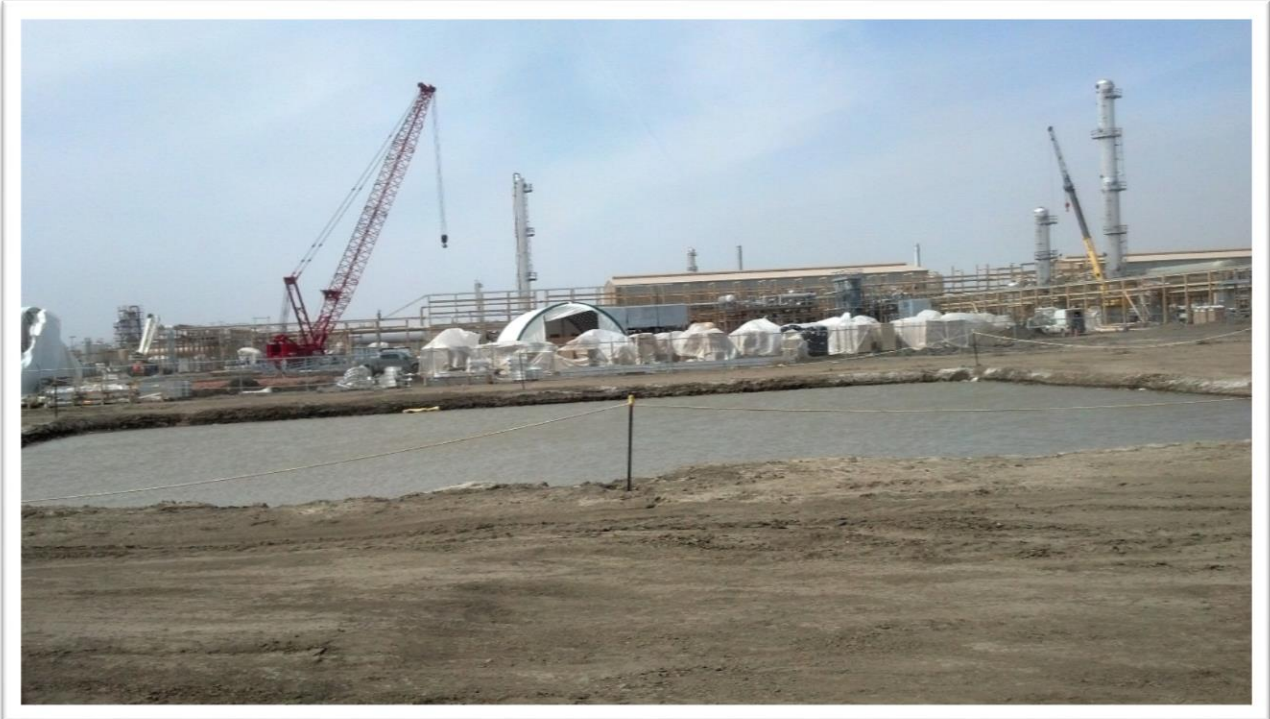
Figure 3. View of a retention pond along the eastern edge of Garden Creek II looking west

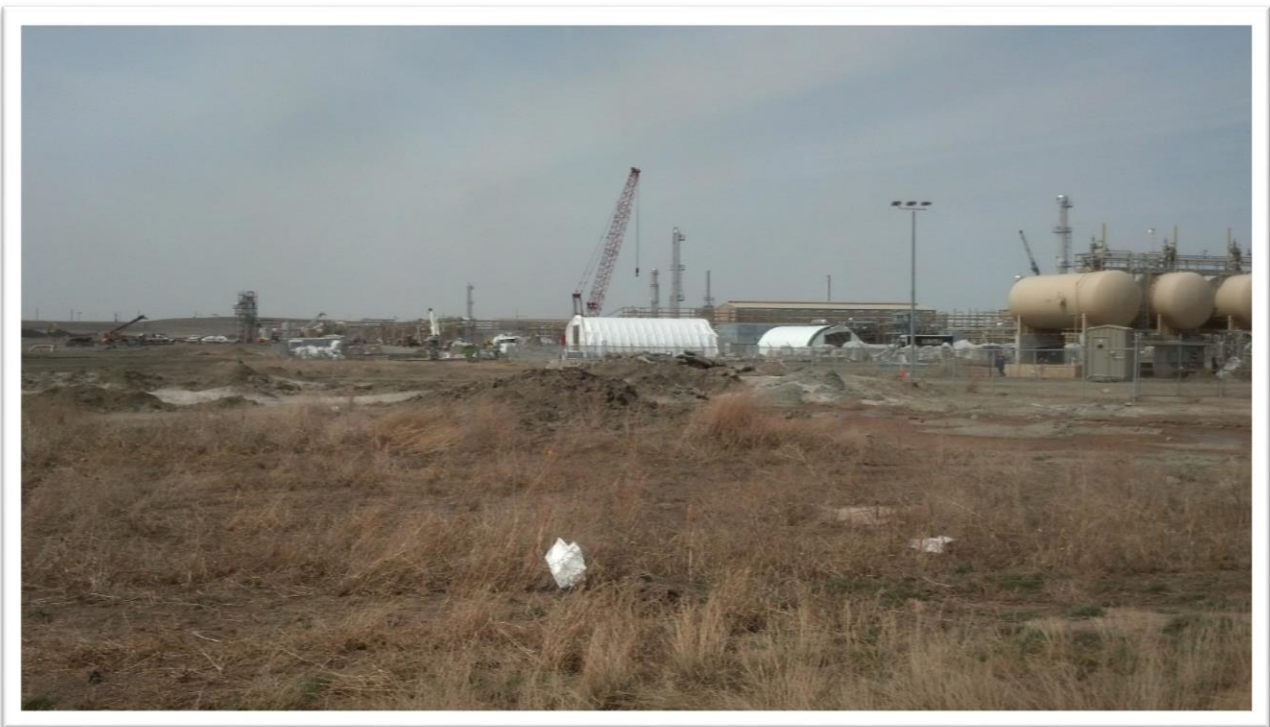
Figure 4. View from the southeast corner of Garden Creek II looking west

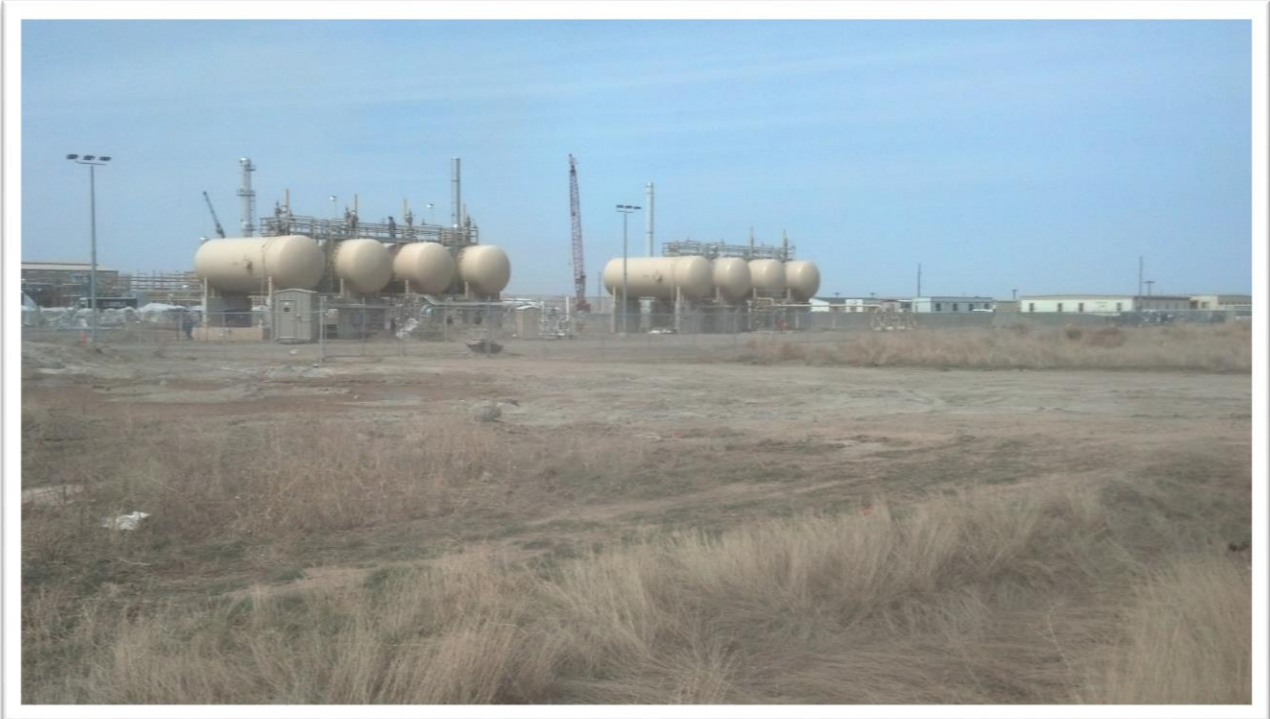
Figure 5. View from the southeast corner of Garden Creek II looking northwest

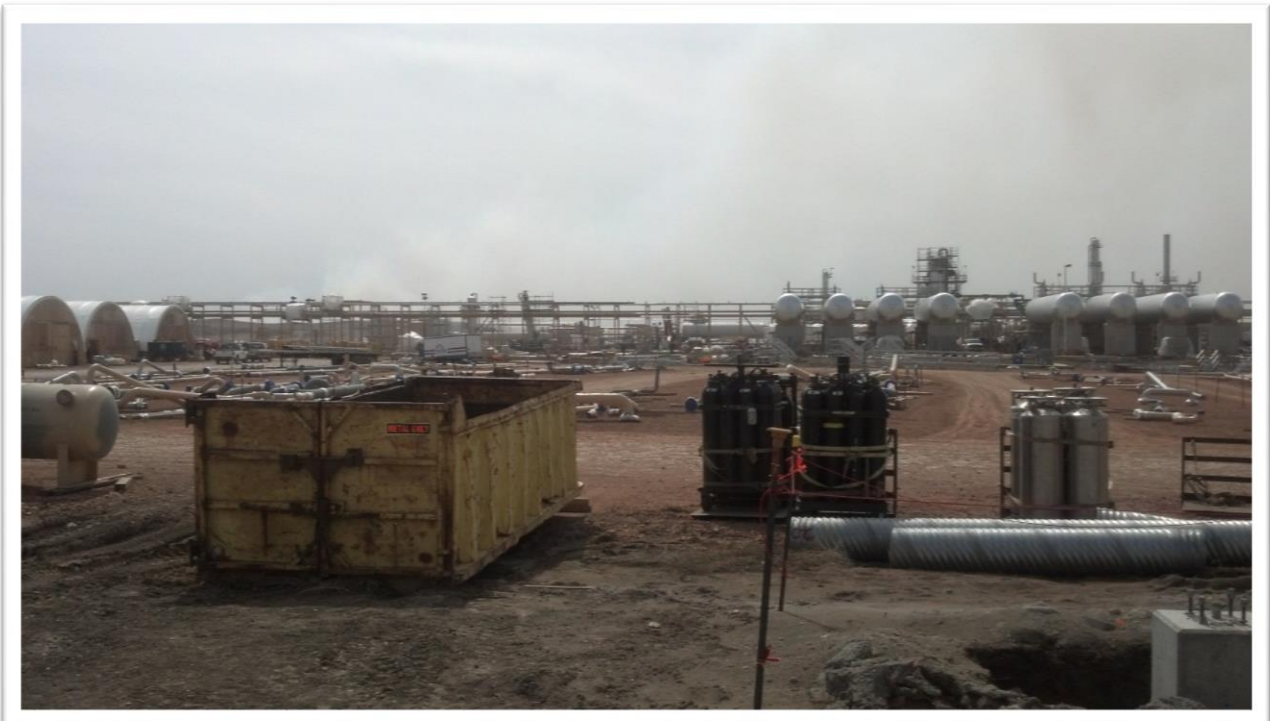
Figure 6. View looking south at the dividing point between Garden Creek II and III. The center of the 8 elevated tanks seen above is the dividing point, with Garden Creek II being the east (left) side and Garden Creek III being the west (right) side

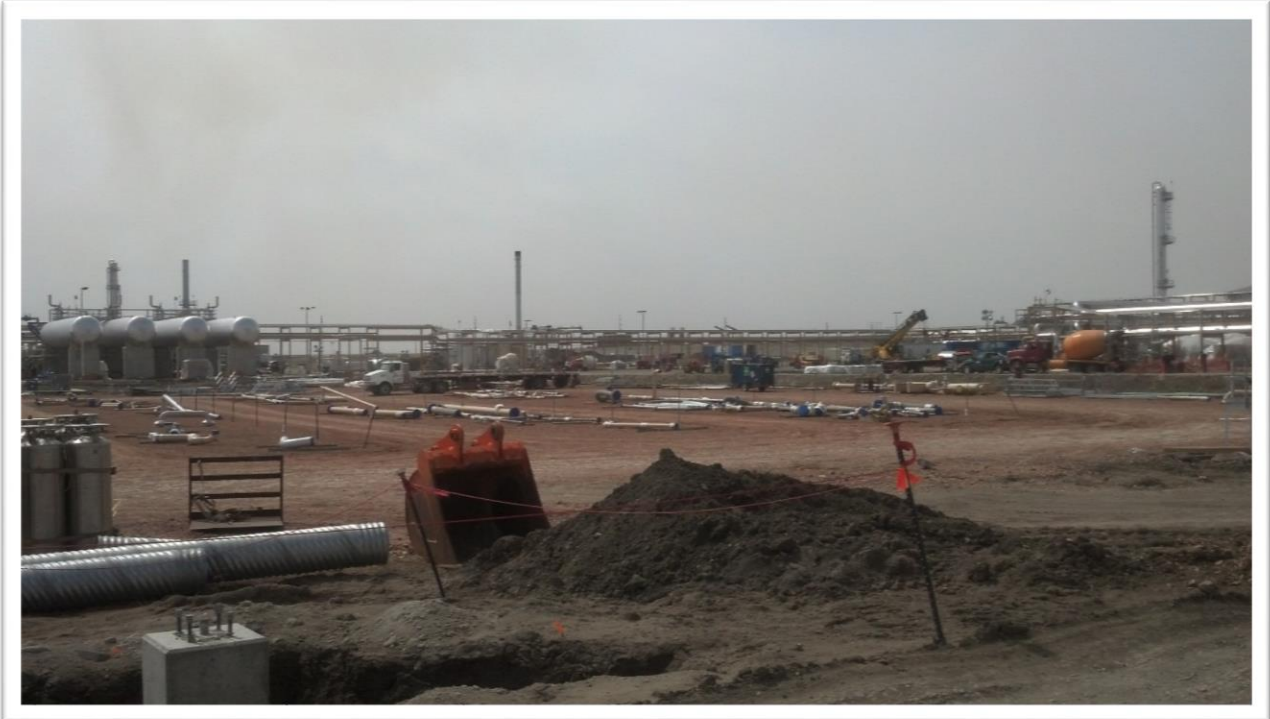
Figure 7. View of Garden Creek III from the dividing line looking southwest

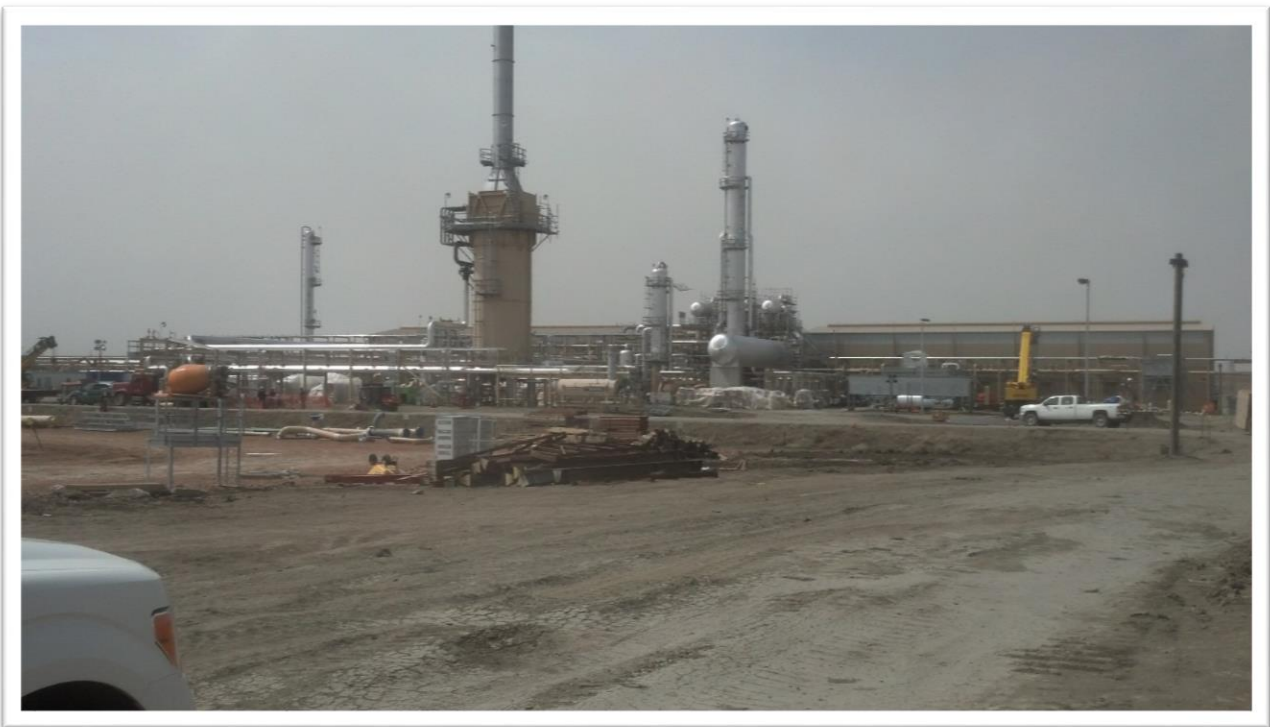
Figure 8. View of Garden Creek III from the dividing line looking west
