**Basin Transload, LLC Crude Oil Pipeline, Burke County, ND. (PSC Case No. PU-12-675)**

Permit Compliance Review

NDPUC Contract No.: PU-686-005

Reporting Period: September 30<sup>th</sup>, 2014 - June 8<sup>th</sup>, 2015

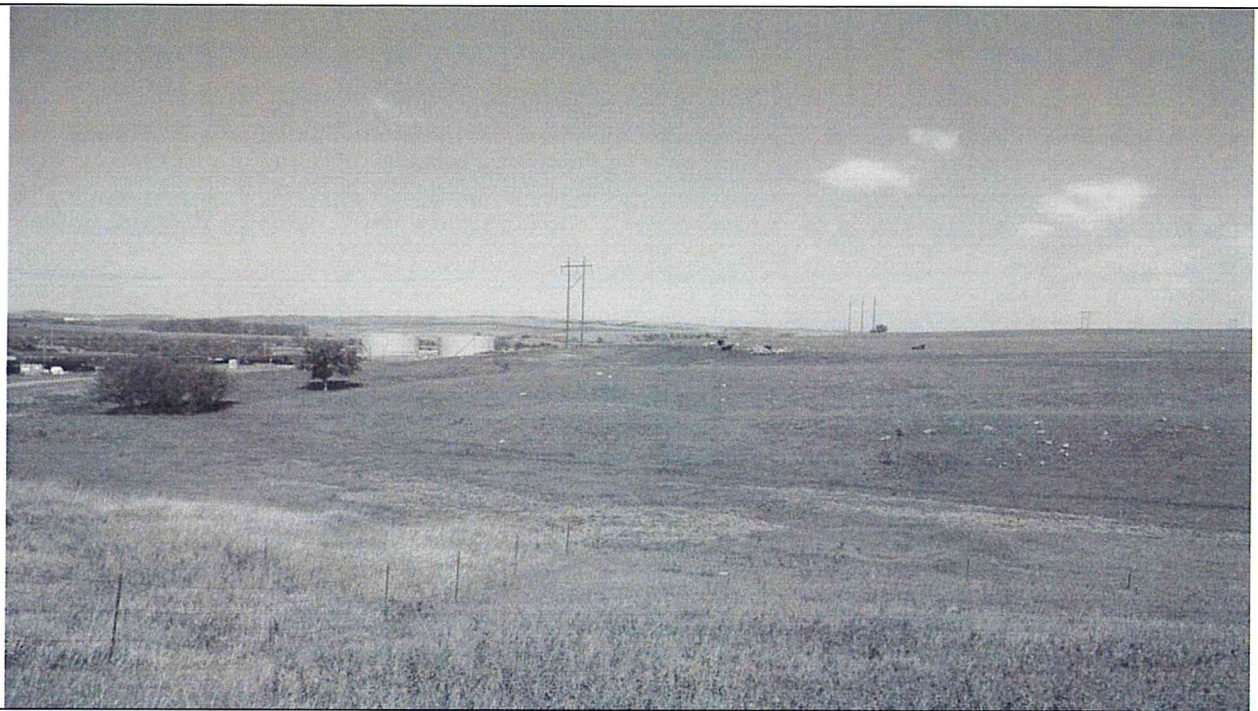
Photo 1: North end of pipeline ROW.

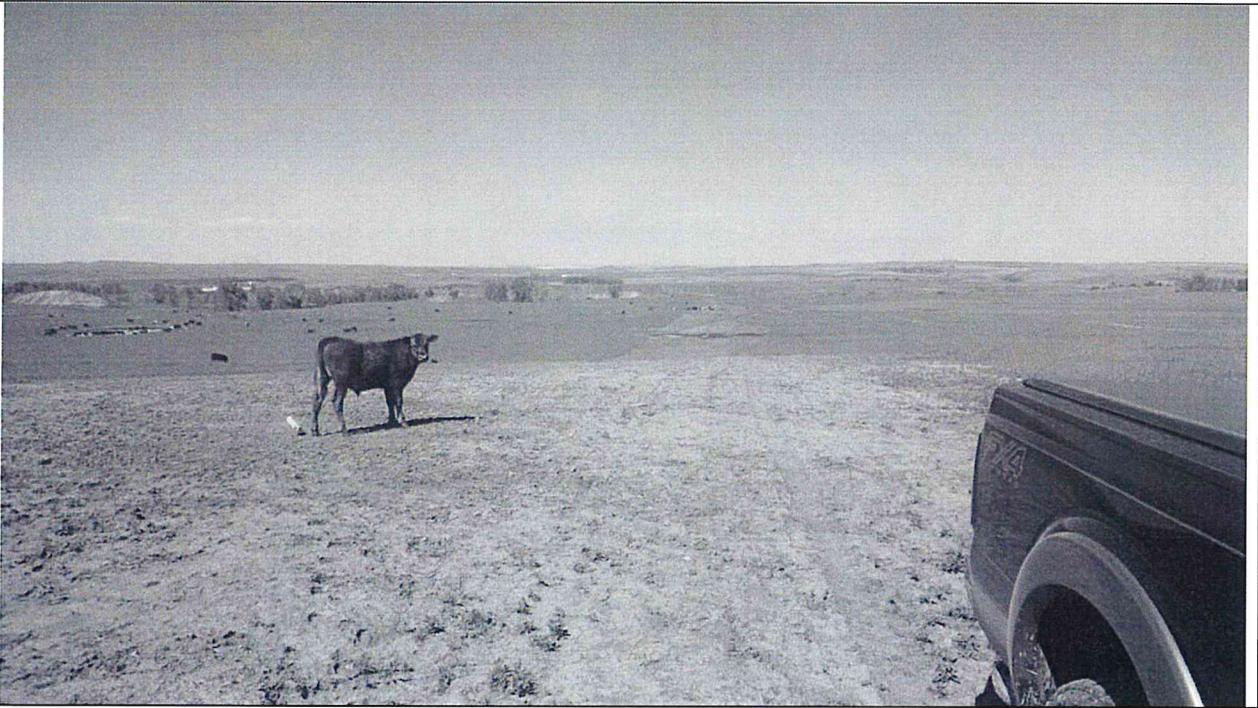
Photo 2: Livestock grazing over existing ROW.

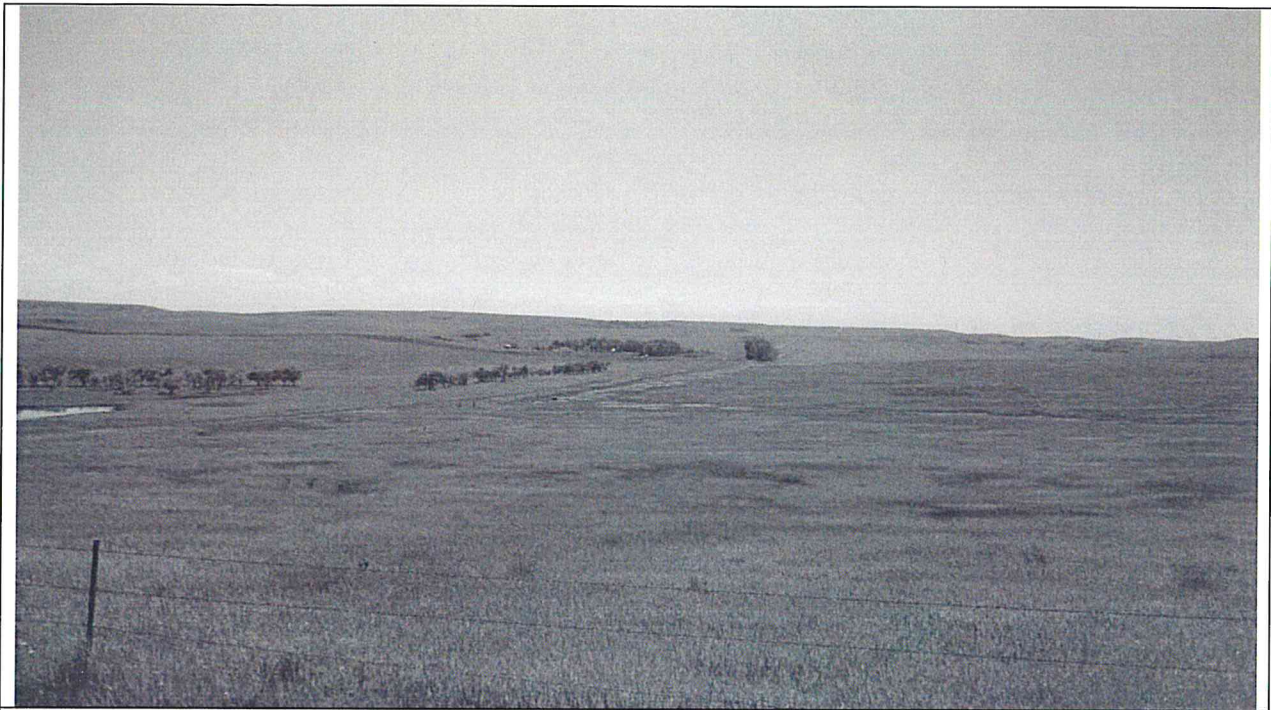
Photo 3: Pipeline ROW in the distance.

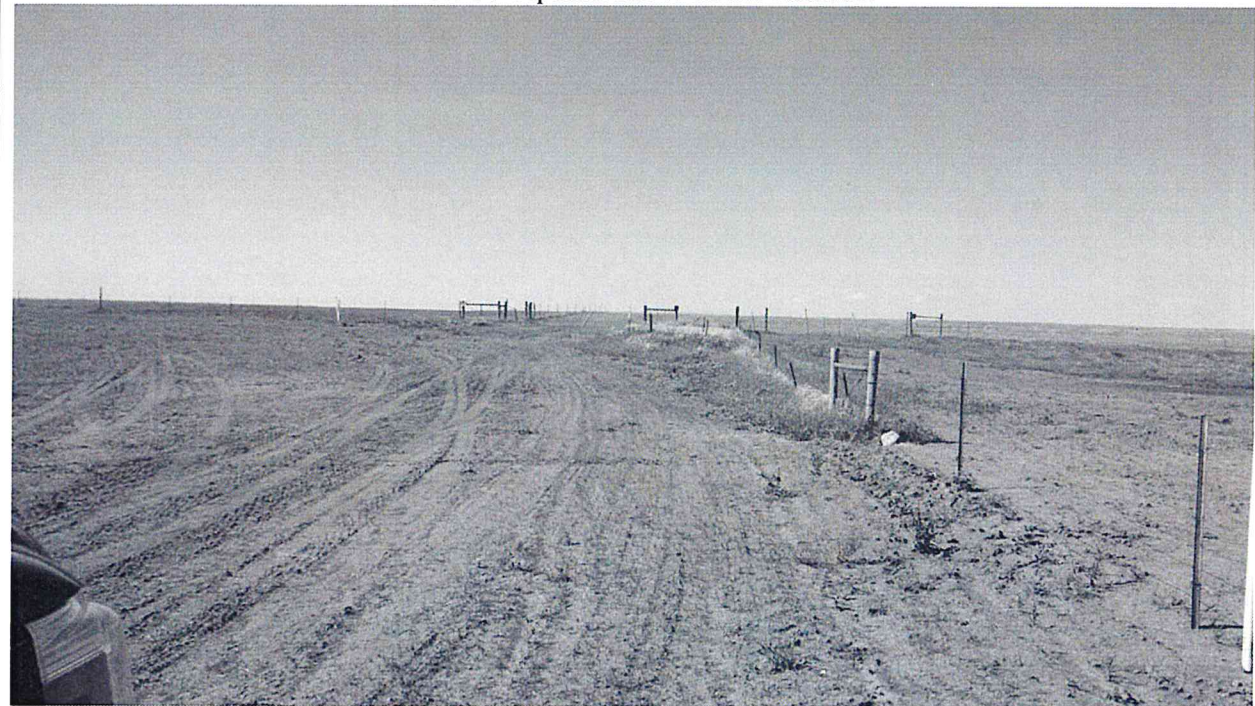
Photo 4: Intermittent revegetation.

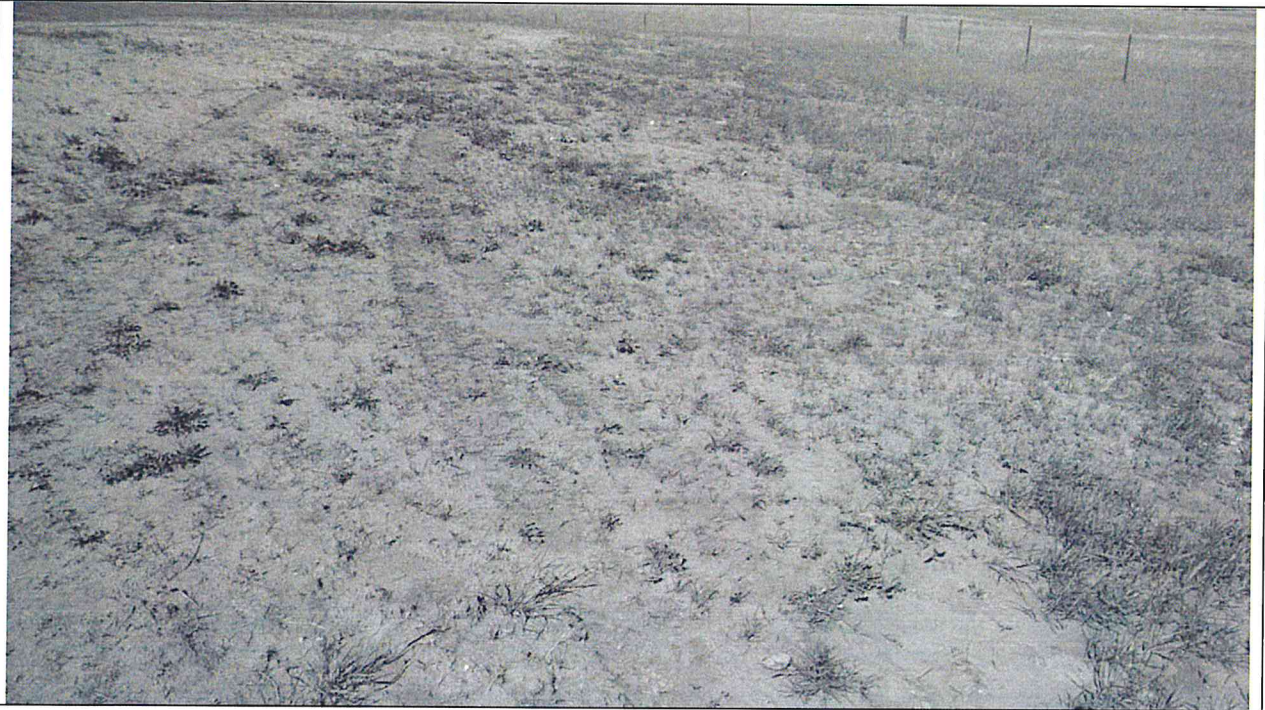
Photo 5: Intermittent revegetation.

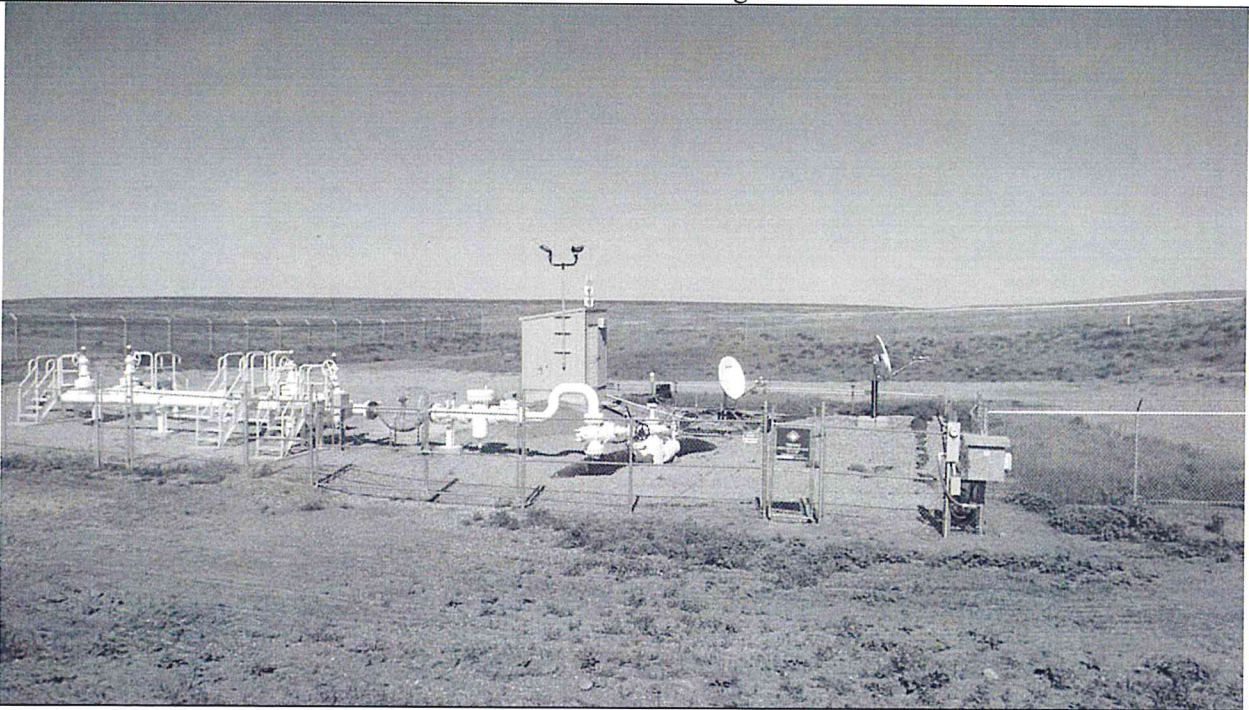
Photo 6: Valve station at south end of the project.
