**Re: Permit Compliance Inspections for Basin Transload Crude Oil Pipeline
HEi Project Number: 6077-005
Contract No. PU-686-005**

**Basin Transload, LLC Crude Oil Pipeline, Burke County, ND.
(PSC Case No. PU-12-675)**

Prepared By: Houston Engineering, Inc. / Emmy Baskerville, Environmental Scientist and
Bart Schultz, Project Manager

Permit Compliance Review

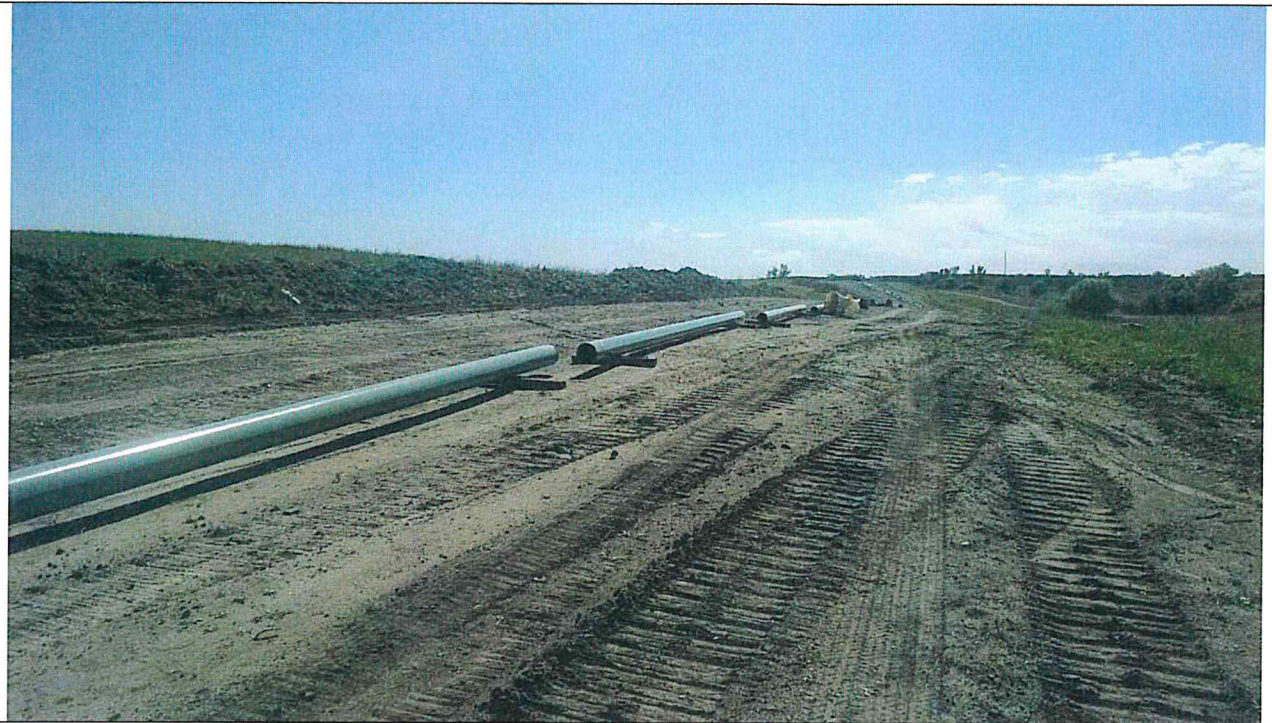
- Reviewed with construction managers, several wetlands that were to be avoided according to the permit, and one that will require directional boring to avoid wetland impacts. Pipeline corridor is currently laid out on the surface, and the placement indicates wetland avoidance and future directional boring, which is in compliance with the permit.

Photo 1: Pipeline laid out, Pipeline laid out, ready for permanent placement.

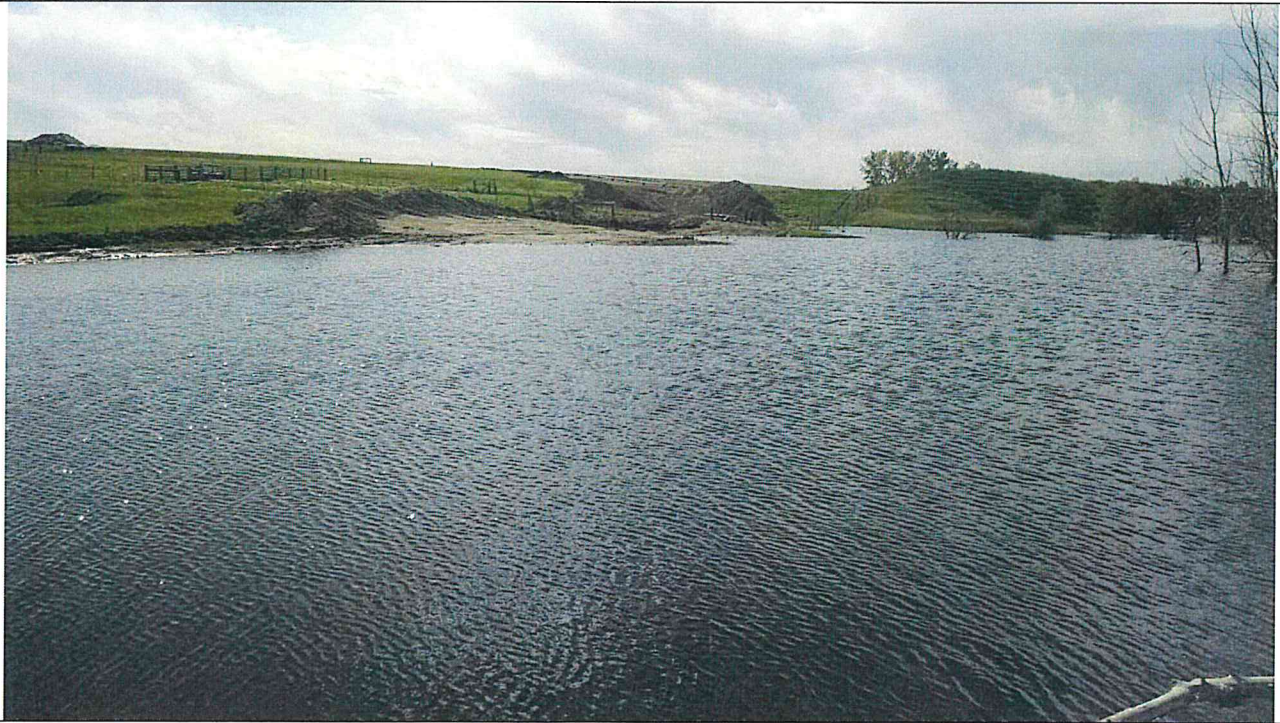
Photo 2: Livestock pond to be avoided by directional boring.

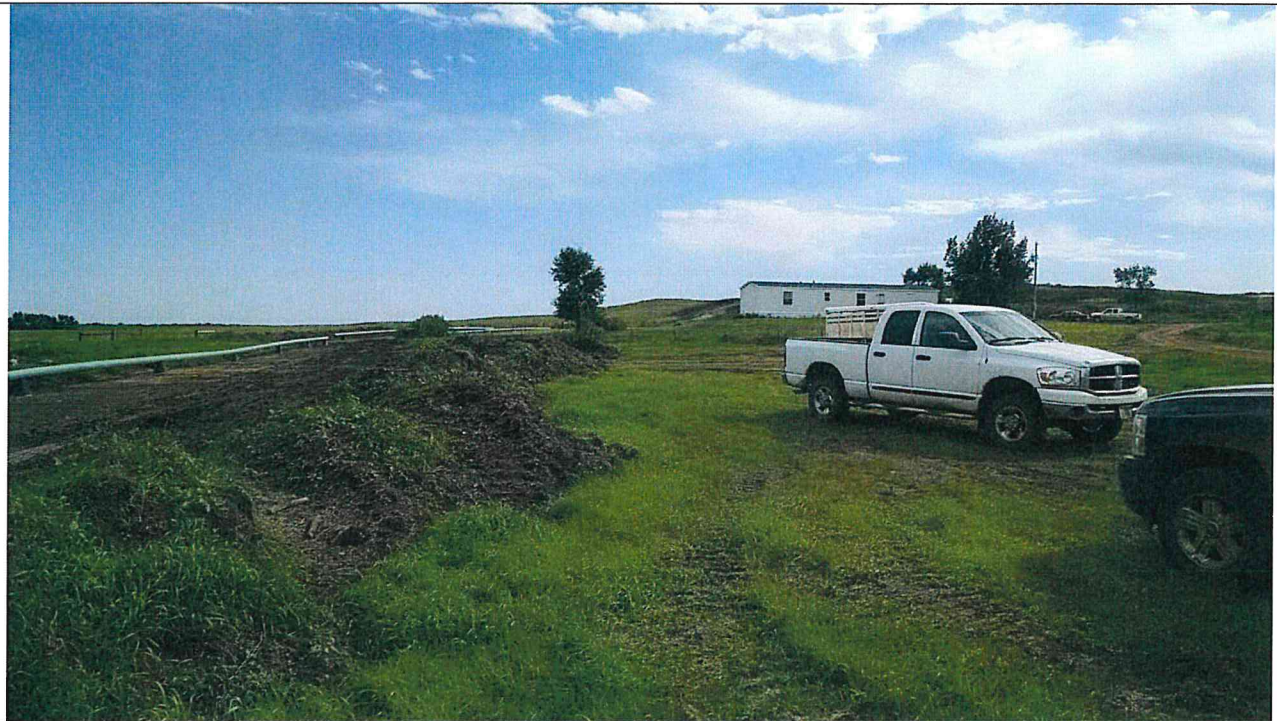
- The Field Superintendent of TRE Constructors explained that an adjacent resident has placed a mobile home and completed some tree leveling activities adjacent to the right-of-way (ROW) since the ROW purchase activities had been completed. The pipeline has already been laid out to avoid this group of trees, so it appears that the landowner has indeed completed additional tree removal.

Photo 3: Mobile home adjacent to right-of-way. Cleared trees are to the left of the photo.

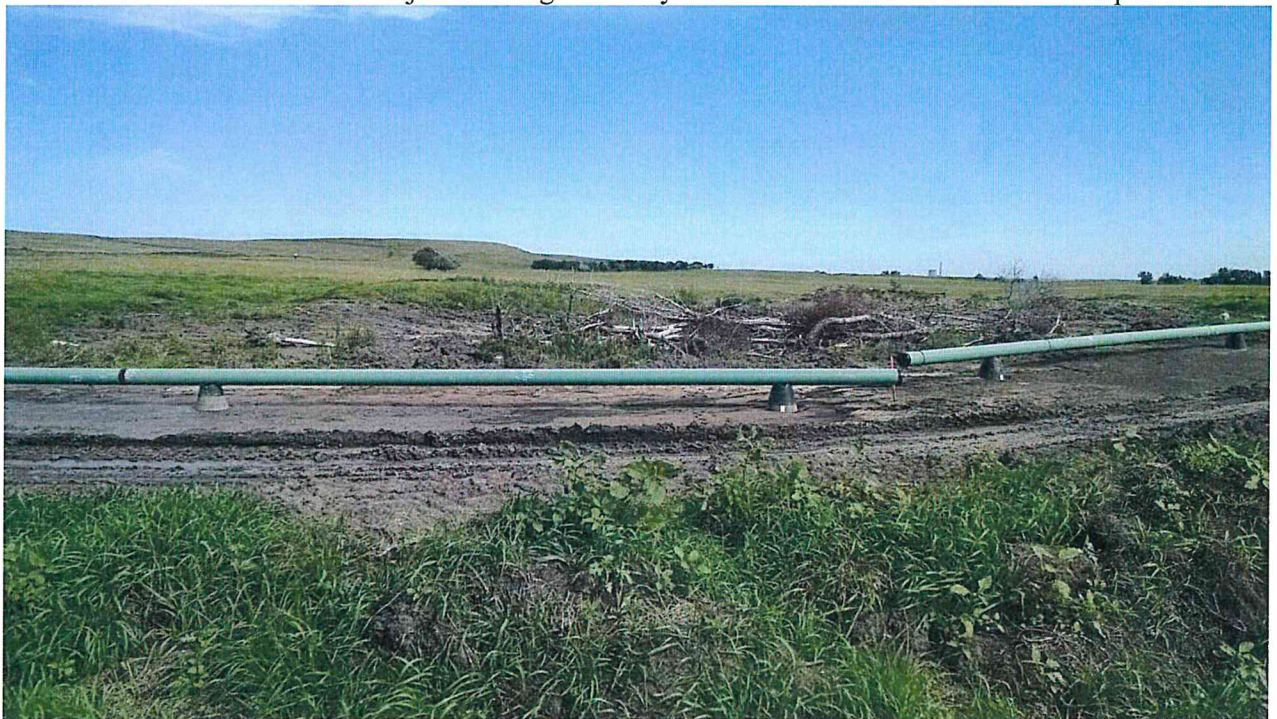
Photo 4: Remains of trees cleared by adjacent resident.

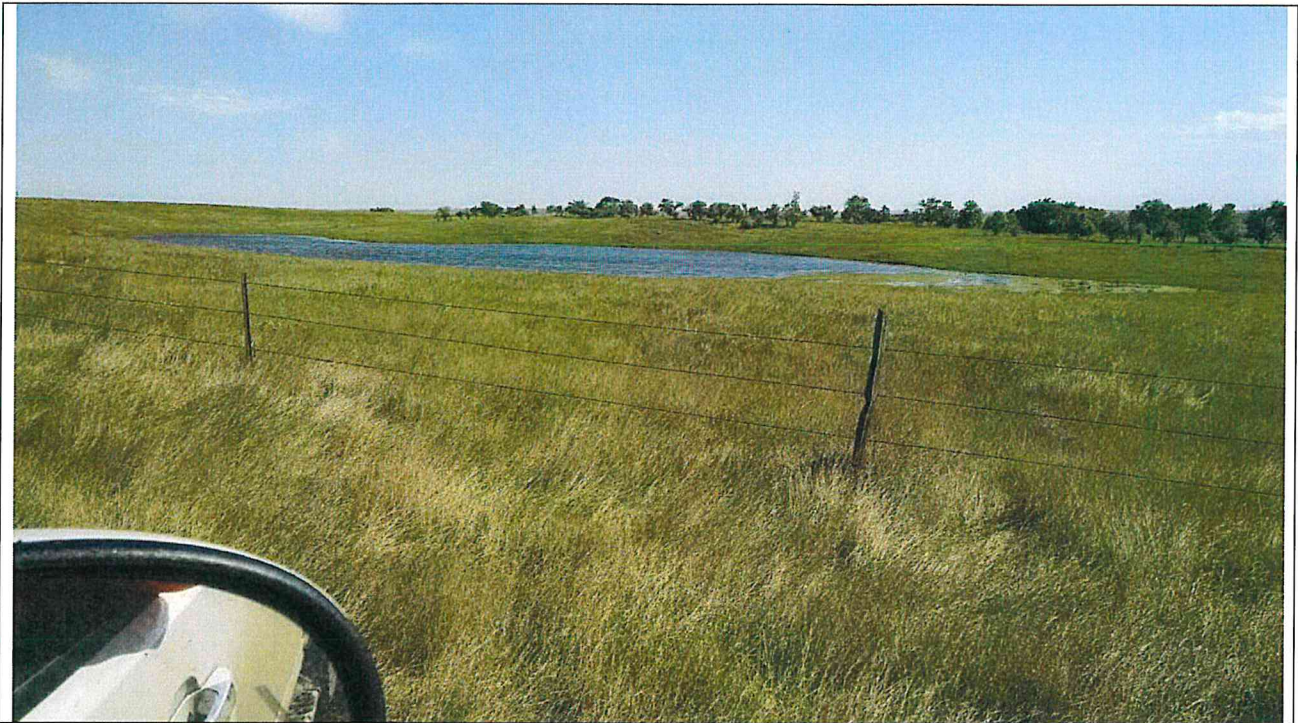
Photo 5: Wetland avoidance.

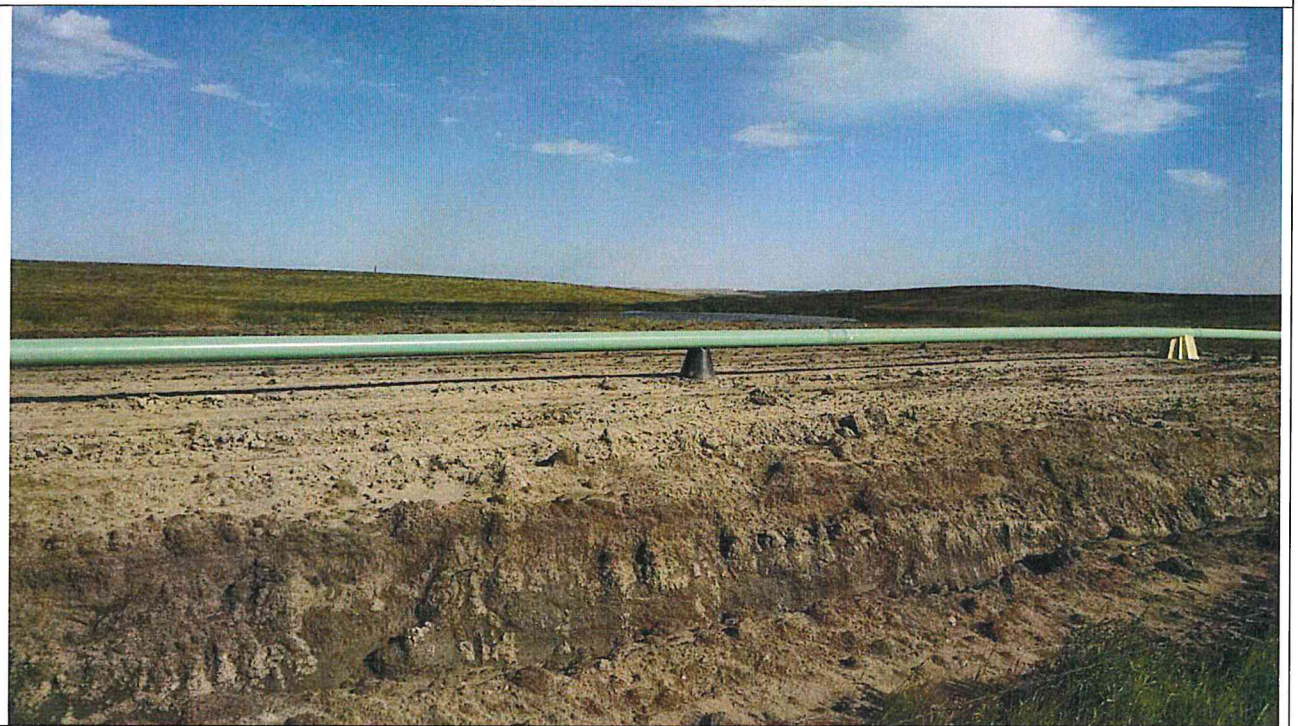
Photo 6: Pipeline laid out, ready for permanent placement.

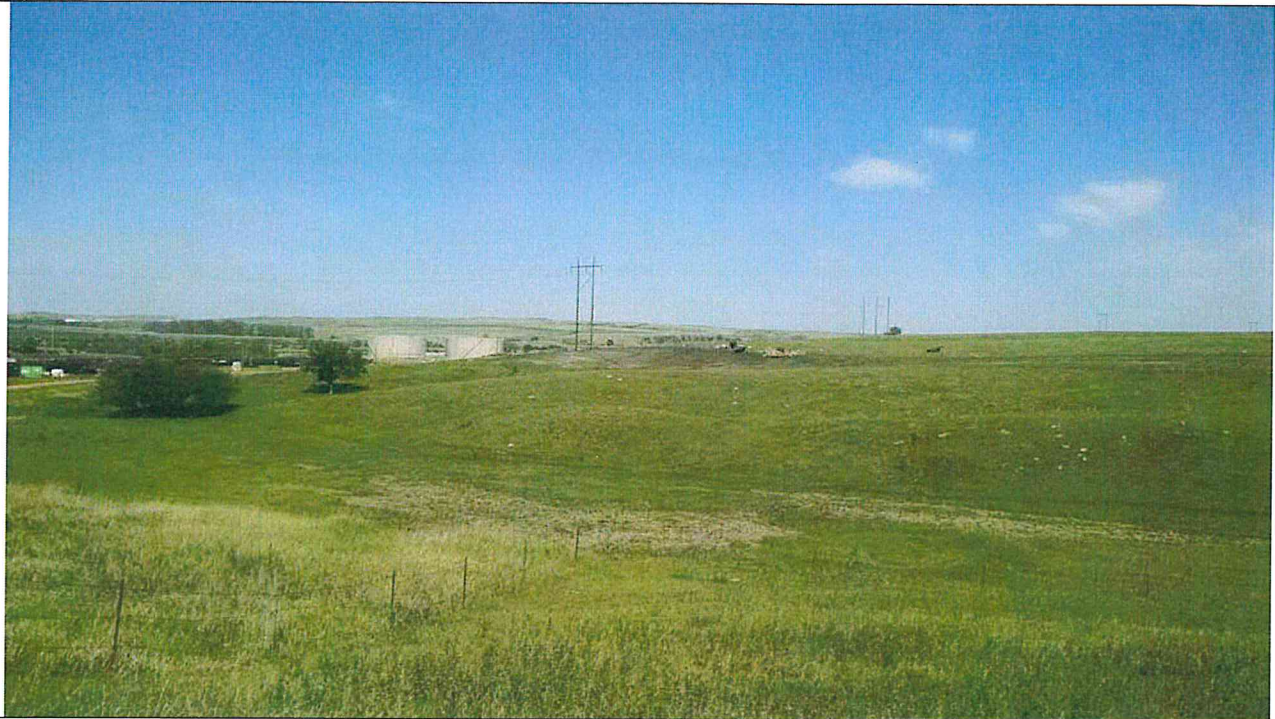
Photo 1: North end of pipeline ROW.

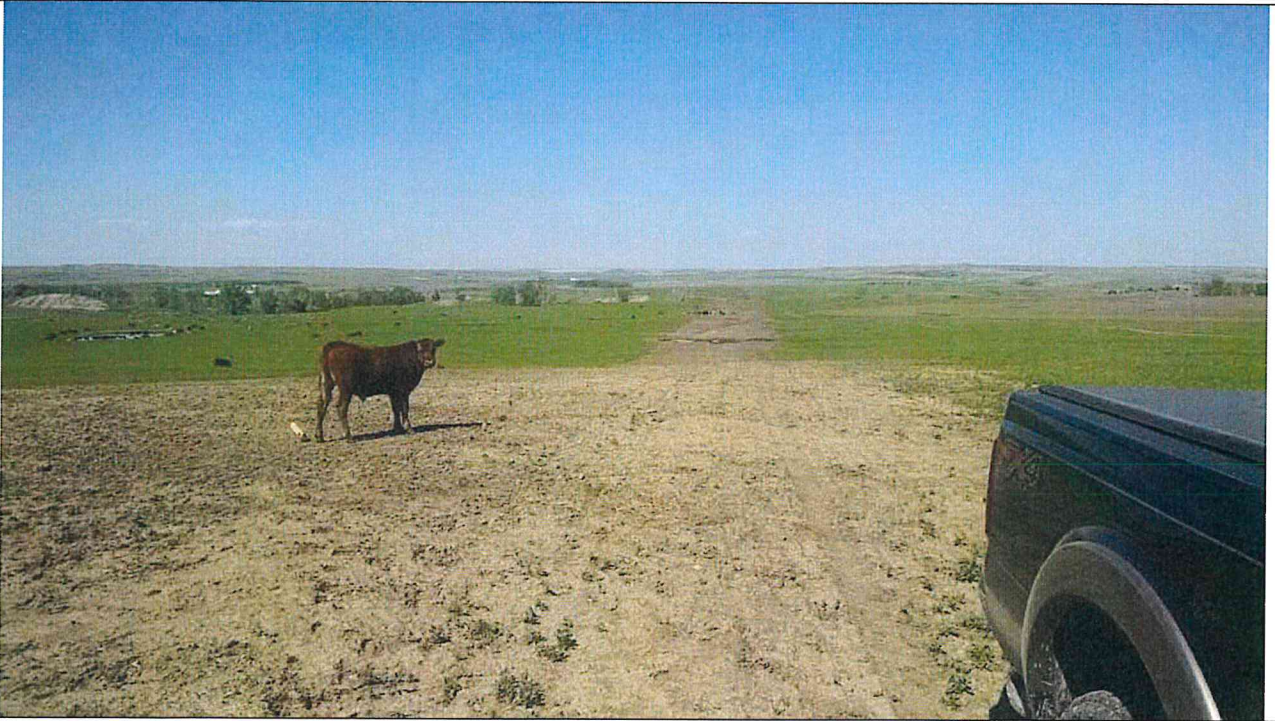
Photo 2: Livestock grazing over existing ROW.

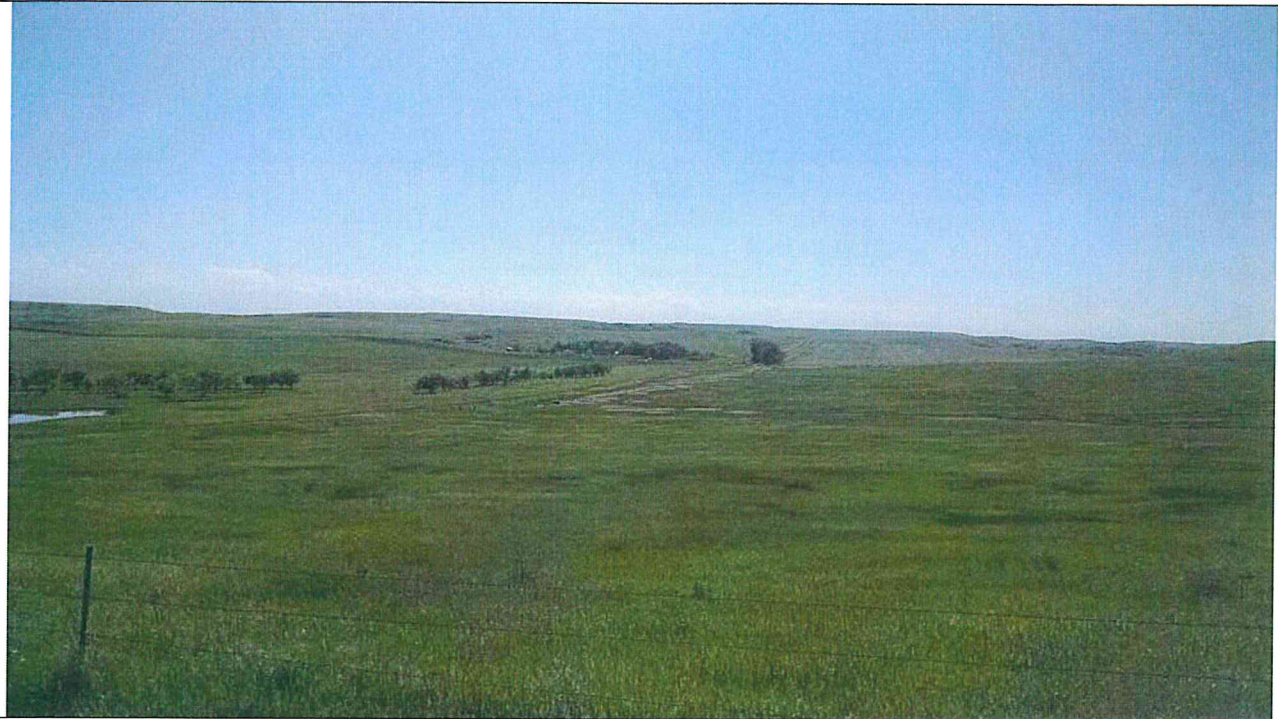
Photo 3: Pipeline ROW in the distance.

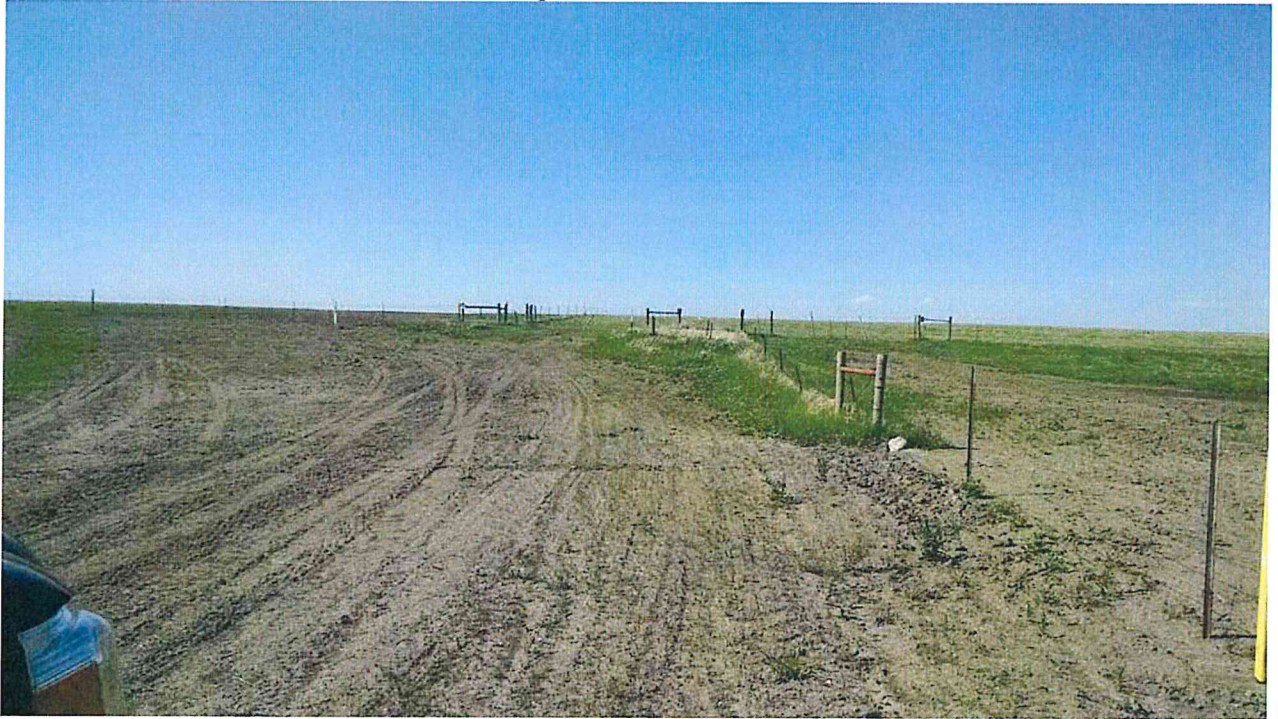
Photo 4: Intermittent revegetation.

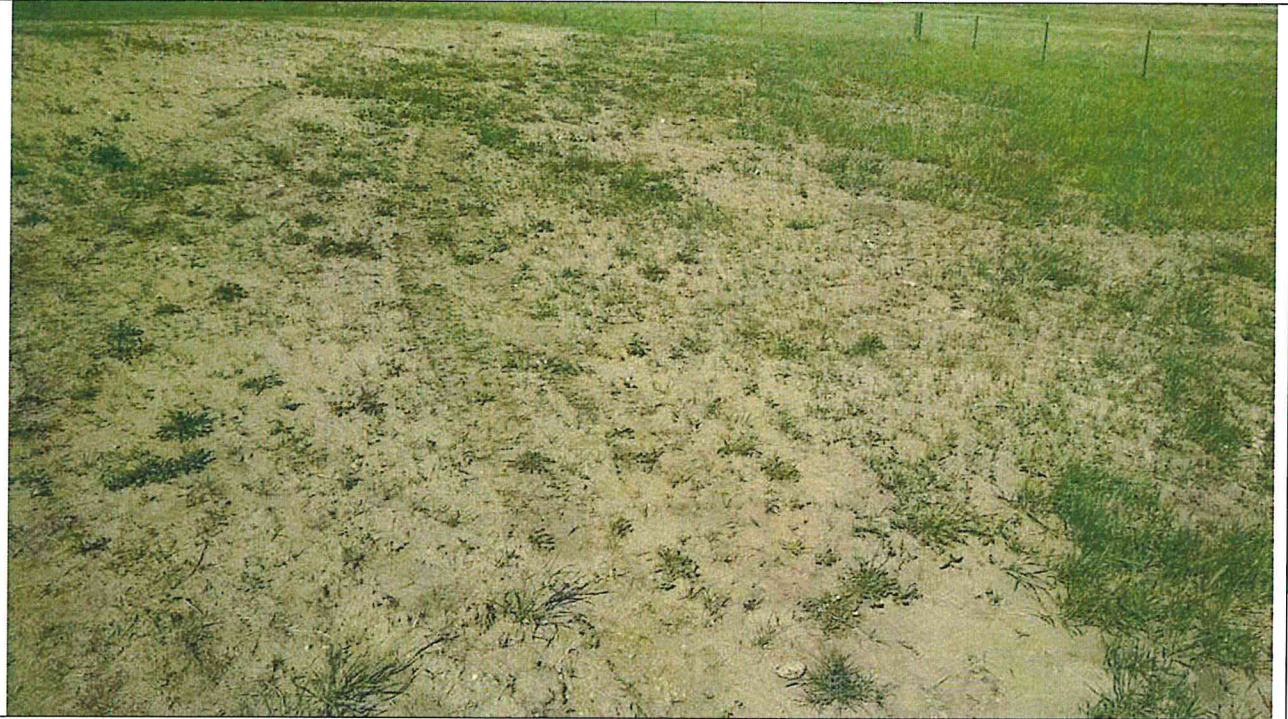
Photo 5: Intermittent revegetation.

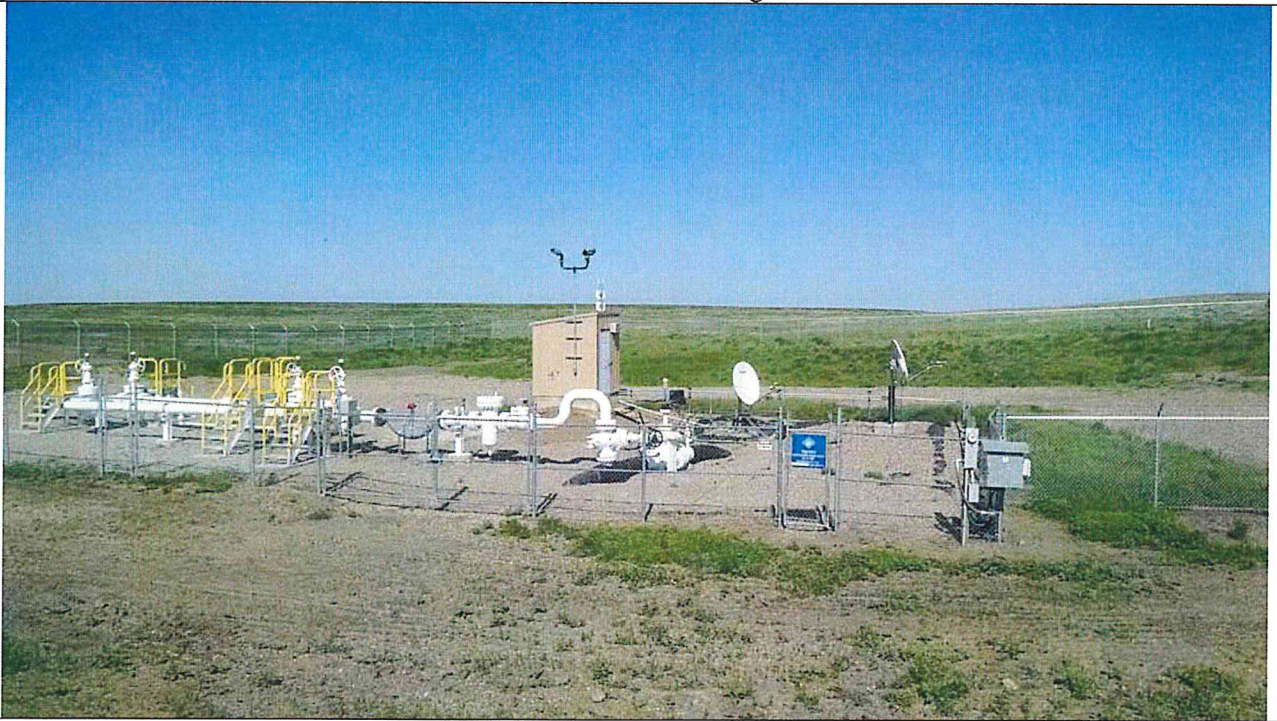
Photo 6: Valve station at south end of the project.
