## Project Inspection Report

**Project Name:** Basin Transload Lignite Pipeline Project 10" Crude Line, Burke County ND

**PSC Case Number:** PU-12-775

**Inspector:** Greg Underwood, E3 Environmental, LLC      **Date:** May 16, 2013      **Time:** 8:00 am

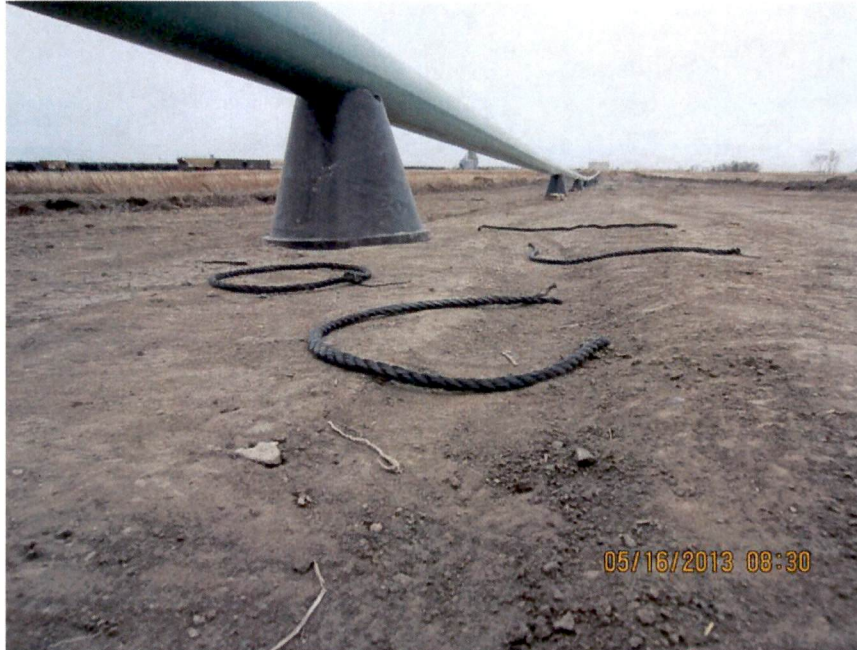
Photo: 1: Construction Debris on ROW

1. Implement Housekeeping Measures (pick up trash, construction debris along ROW); Photos 1.
2. Erosion and sediment control (ESC) measures missing at wetland/waterway crossings. Stabilization and ESC measures should be placed ASAP to prevent sediment from entering these features as required by the NPDES regulations; Photos 2-4 provide examples, it is recommended that all crossings be inspected for proper placement/use of these measures.
3. Secondary containment is missing around pumping equipment; containment is required per SPCC regulations; Photo 5.
4. Filtration and energy dissipation measures not being utilized to filter surface water being pumped from wetland located east of 89<sup>th</sup> Ave NW; use of these devices was identified as a mitigation measure in PSC filing. Photo 6.

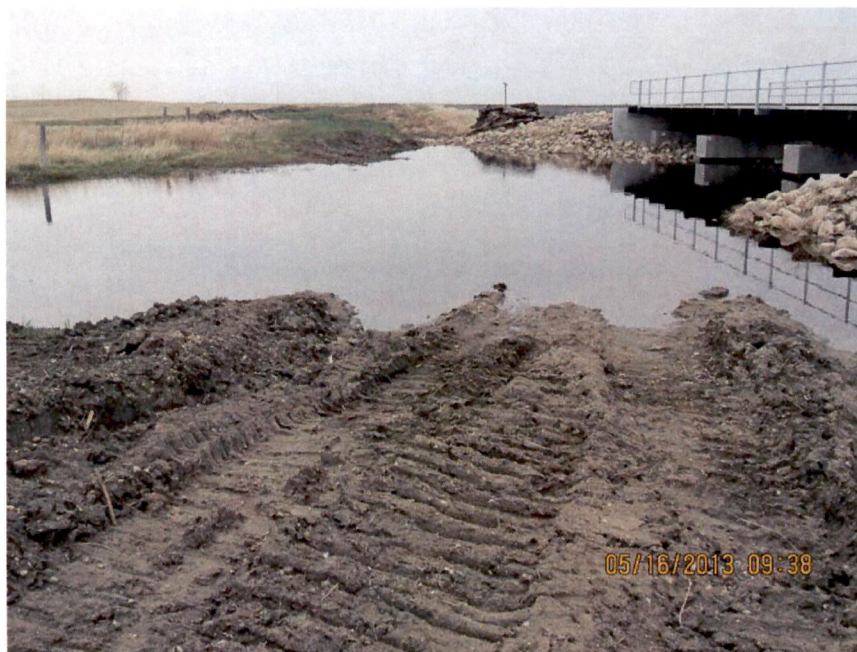
Photo: 2: Pipeline installation was done via HDD, equipment travel appears to have occurred through waterway without the placement/ use of erosion/sediment control measure to protect waterway. Also stabilization of disturbed banks has not been initiated.

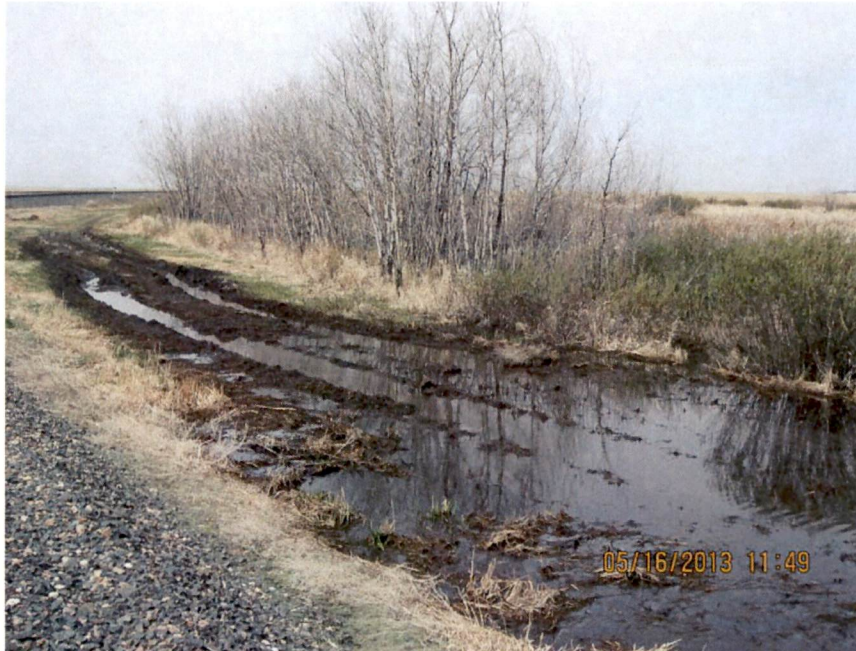
**Photo: 3: No erosion or sediment control devices in place to protect wetland in the background.**

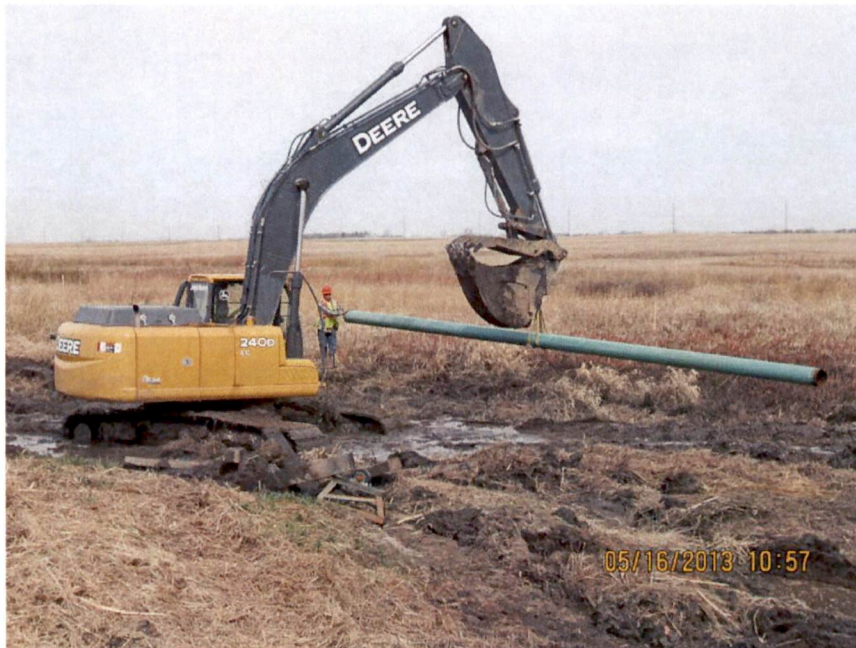
**Photo: 4: No erosion or sediment control devices in place to protect wetland in the background.**

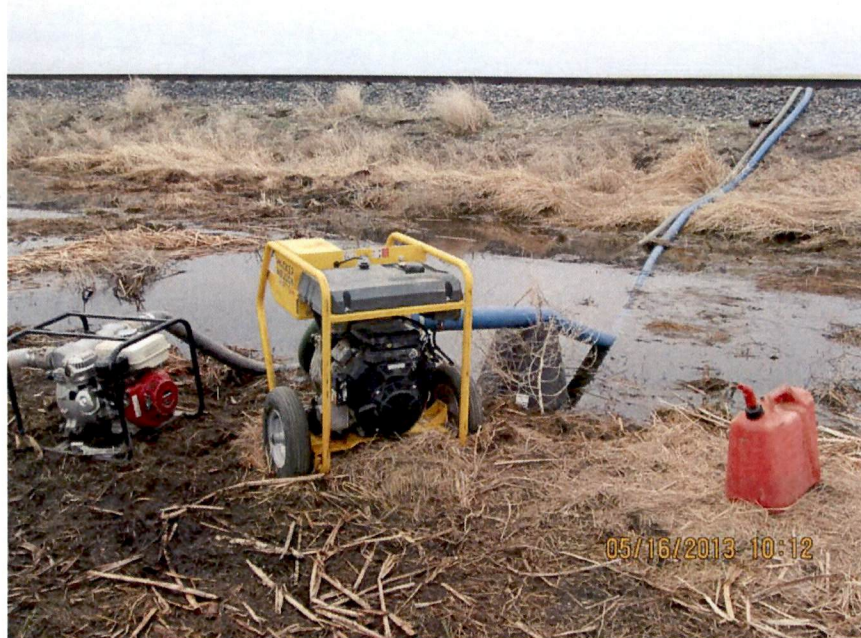
**Photo: 5: Use of pumps and gas can within mapped wetland; no secondary containment or spill measures in place. Taken to the east of 89<sup>th</sup> Ave. NW where pumping activities were occurring at time of inspection.**

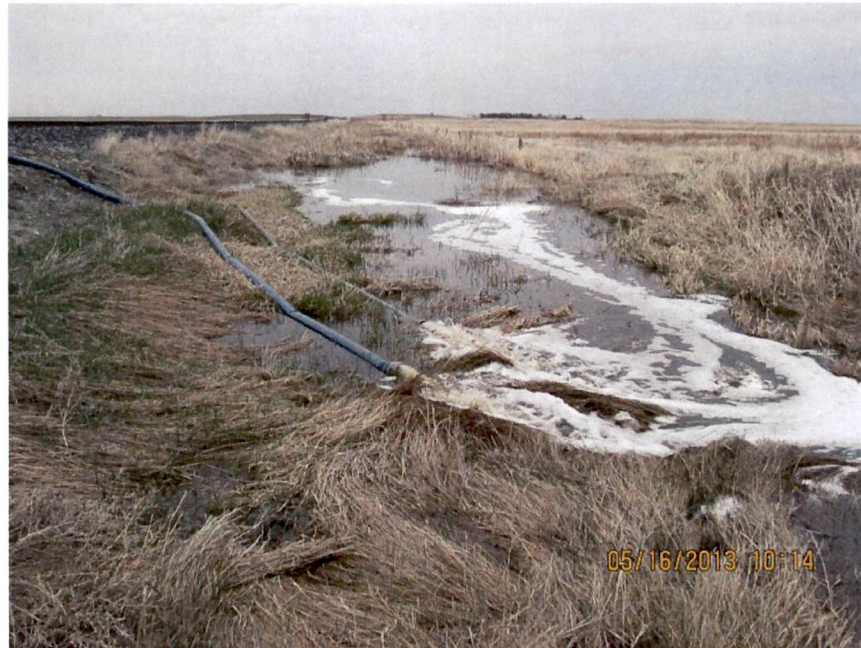
**Photo: 6: Water being discharged to wetland without use of filtration or energy dissipation to prevent sediment from entering waterway, scouring or erosion.**
