## Project Inspection Report

**Project Name:** Basin Transload Lignite Pipeline Project 10" Crude Line, Burke County ND

**PSC Case Number:** PU-12-775

**Inspector:** Tony Ross, E3 Environmental, LLC    **Date:** November 13, 2013

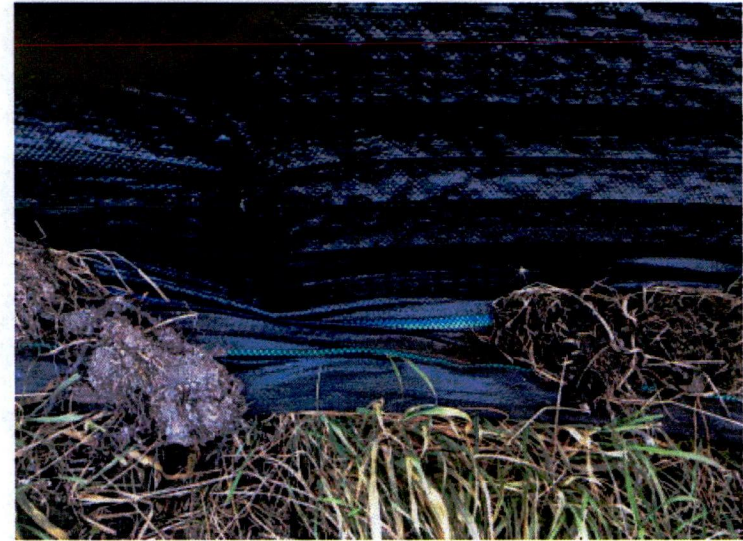
Image 2:

11/13/2013	37	Rutted Row	N48 53 15.40 W102 36 45.40	Regrade	Yes	No
11/13/2013	39	Contractor drove through a wetland and there is no evidence of matting boards being used; rutted	N48 53 15.04 W102 37 3.58			No
11/13/2013	40	Subsidence	N48 53 14.90 W102 36 43.22	Regrade	Yes	No
<b>SECTION D: ECDs</b>						
11/13/2013	2	Improperly installed silt fence	N48 53 18.81 W102 44 9.30	Remove silt fence and install straw waddle	Yes	No
11/13/2013	3	Improperly installed silt fence	N48 53 19.08 W102 44 2.87	Remove silt fence and install straw waddle	Yes	No
11/13/2013	10	No ECD in place at wetland edge	N48 53 15.05 W102 43 9.07	Install straw waddle	Yes	No
11/13/2013	16	Improperly installed silt fence	N48 53 16.01 W102 41 38.13	Remove silt fence and install straw waddle	Yes	No
11/13/2013	19	No ECD in place at natural drainage edge	N48 53 15.44 W102 39 27.56	Install straw wattles on both sides of ROW	Yes	No
11/13/2013	21	Improperly installed silt fence	N48 53 15.29 W102 39 8.39	Remove silt fence and install straw waddle	Yes	No

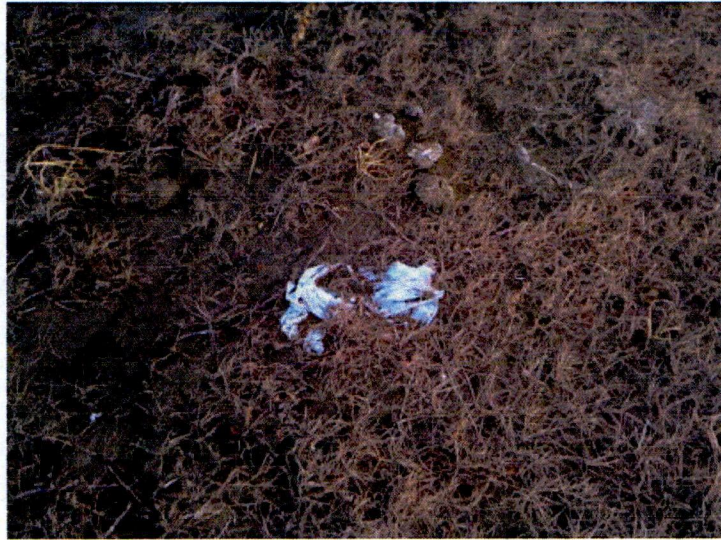
Image 5:

Inspection Date	Image Reference No.	ROW Condition	Photo Location	Recommendation	Continued Work Needed	Final Stabilization Achieved
<b>SECTION B: CONSTRUCTION DEBRIS/TRASH</b>						
11/13/2013	5	Trash on ROW	N48 53 19.09 W102 44 2.43	Properly dispose of	Yes	No
11/13/2013	9	Trash on ROW	N48 53 14.97 W102 43 9.21	Properly dispose of	Yes	No
11/13/2013	11	Partially buried metal strap	N48 53 15.17 W102 43 14.81	Properly dispose of	Yes	No
11/13/2013	12	Inspector collected and piled trash	N48 53 15.42 W120 41 57.06	Properly dispose of	Yes	No
11/13/2013	13	Partially buried barbed wire fencing	N48 53 15.24 W102 41 55.01	Properly dispose of	Yes	No
11/13/2013	14	Partially buried barbed wire fencing	N48 53 15.90 W102 41 45.16	Properly dispose of	Yes	No
11/13/2013	18	Partially buried barbed wire fencing	N48 53 15.29 W102 40 33.95	Properly dispose of	Yes	No
11/13/2013	27	Inspector collected and piled trash	N48 53 15.53 W102 39 20.38	Properly dispose of	Yes	No

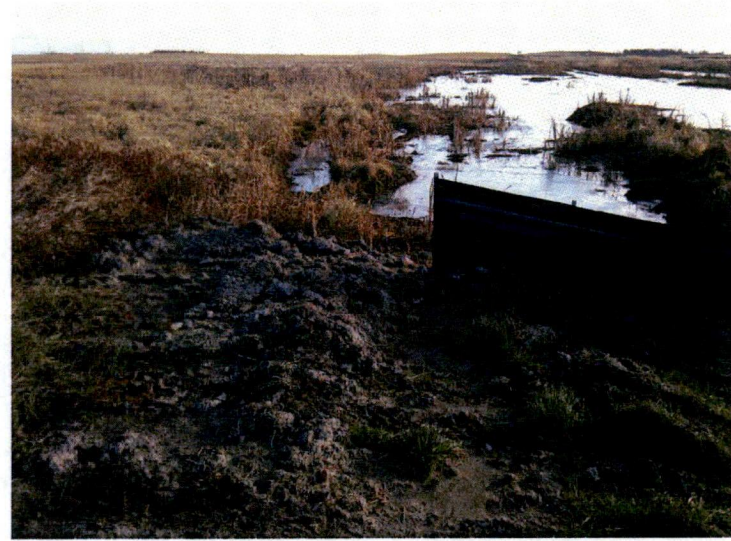
Image 20:

11/13/2013	32	Partially buried railroad tie	N48 53 19.11 W102 36 6.12	Properly dispose of	Yes	No
11/13/2013	33	Partially buried railroad tie	N48 53 18.12 W102 36 7.22	Properly dispose of	Yes	No
11/13/2013	38	Partially buried railroad tie	N48 53 15.27 W102 37 2.38	Properly dispose of	Yes	No
<b>SECTION C: NOTED ANOMOLIES</b>						
11/13/2013	1	Rough ROW	N48 53 18.90 W102 44 10.35	Regrade	Yes	No
11/13/2013	4	Rough ROW	N48 53 19.12 W102 44 2.58	Regrade	Yes	No
11/13/2013	6	Rough ROW	N48 53 19.06 W102 43 52.49	Regrade	Yes	No
11/13/2013	7	Rough ROW	N48 53 18.83 W102 43 37.87	Regrade	Yes	No
11/13/2013	8	Rough ROW	N48 53 15.53 W102 43 9.97	Regrade	Yes	No
11/13/2013	15	Rough ROW	N48 53 15.90 W102 41 37.96	Regrade	Yes	No
11/13/2013	17	Contractor drove through a perennial creek and there is no evidence of matting boards being used; rutted	N48 53 15.16 W102 41 36.20			No
11/13/2013	20	Rough ROW	N48 53 15.83 W102 39 8.30	Regrade	Yes	No

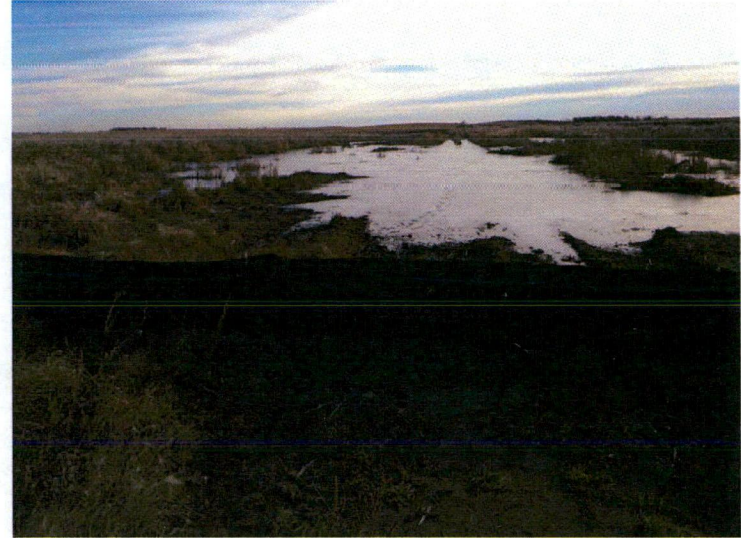
Image 22:

11/13/2013	22	Contractor drove through a wetland and there is no evidence of matting boards being used; extremely rutted	N48 53 15.47 W102 39 8.52			No
11/13/2013	23	Contractor drove through a wetland and there is no evidence of matting boards being used; extremely rutted	N48 53 15.21 W102 39 6.10			No
11/13/2013	24	Rutted ROW/wetland edge	N48 53 15.33 W102 39 3.20	Regrade	Yes	No
11/13/2013	25	Rutted ROW/wetland edge	N48 53 15.50 W102 39 1.75	Regrade	Yes	No
11/13/2013	29	Contractor drove through a wetland and there is no evidence of matting boards being used; rutted	N48 53 14.98 W102 38 41.26			No
11/13/2013	30	Rough ROW	N48 53 14.81 W102 38 1.63	Regrade	Yes	No
11/13/2013	31	Rough ROW	N48 53 19.17 W102 36 6.05	Regrade	Yes	No
11/13/2013	34	Contractor drove through a wetland and there is no evidence of matting boards being used; extremely rutted	N48 53 17.09 W102 36 8.59			No
11/13/2013	36	Rough ROW	N48 53 14.32 W12 36 24.22	Regrade	Yes	No

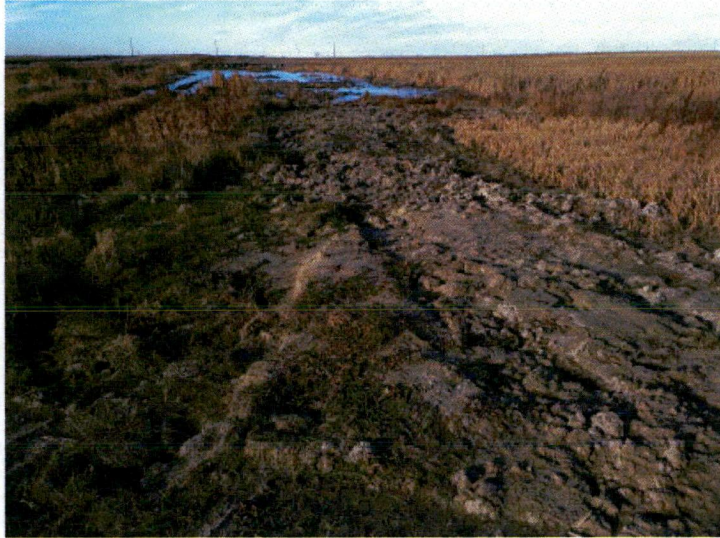
Image 25:

11/13/2013	25	No ECD in place at wetland edge	N48 53 15.50 W102 39 1.75	Install straw waddle	Yes	No
11/13/2013	26	Improperly installed silt fence	N48 53 15.27 W102 39 8.36	Remove silt fence and install straw waddle	Yes	No
11/13/2013	28	No ECD in place at wetland edge	N48 53 15.03 W102 38 40.79	Install straw wattles on both edges of wetland	Yes	No
