## Project Inspection Report

**Project Name:** Basin Transload Lignite Pipeline Project 10" Crude Line, Burke County ND

**PSC Case Number:** PU-12-775

**Inspector:** Tony Ross, E3 Environmental, LLC    **Date:** November 13, 2013

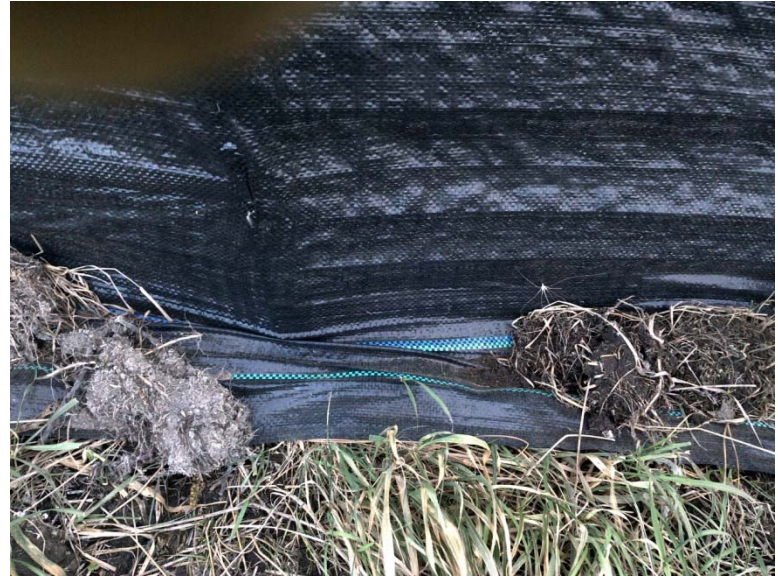
Image 2:

11/13/2013	37	Rutted Row	N48 53 15.40 W102 36 45.40	Regrade	Yes	No
11/13/2013	39	Contractor drove through a wetland and there is no evidence of matting boards being used; rutted	N48 53 15.04 W102 37 3.58			No
11/13/2013	40	Subsidence	N48 53 14.90 W102 36 43.22	Regrade	Yes	No
<b>SECTION D: ECDs</b>						
11/13/2013	2	Improperly installed silt fence	N48 53 18.81 W102 44 9.30	Remove silt fence and install straw waddle	Yes	No
11/13/2013	3	Improperly installed silt fence	N48 53 19.08 W102 44 2.87	Remove silt fence and install straw waddle	Yes	No
11/13/2013	10	No ECD in place at wetland edge	N48 53 15.05 W102 43 9.07	Install straw waddle	Yes	No
11/13/2013	16	Improperly installed silt fence	N48 53 16.01 W102 41 38.13	Remove silt fence and install straw waddle	Yes	No
11/13/2013	19	No ECD in place at natural drainage edge	N48 53 15.44 W102 39 27.56	Install straw wattles on both sides of ROW	Yes	No
11/13/2013	21	Improperly installed silt fence	N48 53 15.29 W102 39 8.39	Remove silt fence and install straw waddle	Yes	No

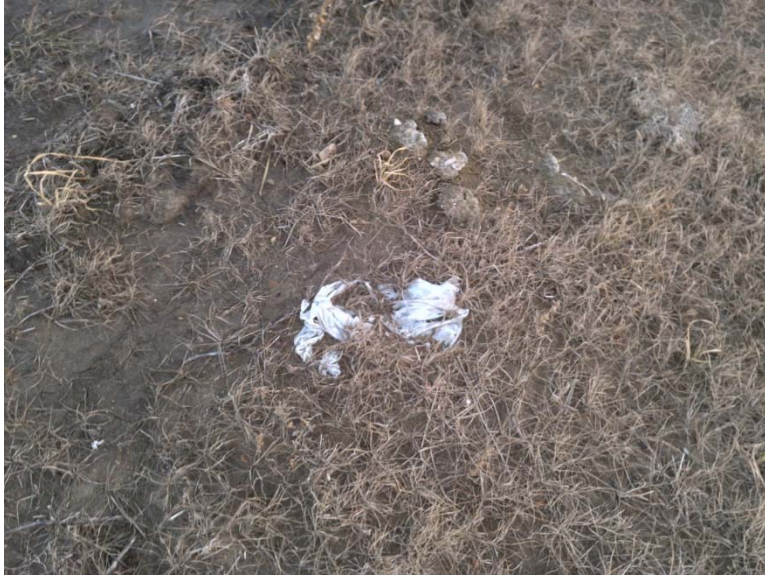
Image 5:

Inspection Date	Image Reference No.	ROW Condition	Photo Location	Recommendation	Continued Work Needed	Final Stabilization Achieved
<b>SECTION B: CONSTRUCTION DEBRIS/TRASH</b>						
11/13/2013	5	Trash on ROW	N48 53 19.09 W102 44 2.43	Properly dispose of	Yes	No
11/13/2013	9	Trash on ROW	N48 53 14.97 W102 43 9.21	Properly dispose of	Yes	No
11/13/2013	11	Partially buried metal strap	N48 53 15.17 W102 43 14.81	Properly dispose of	Yes	No
11/13/2013	12	Inspector collected and piled trash	N48 53 15.42 W120 41 57.06	Properly dispose of	Yes	No
11/13/2013	13	Partially buried barbed wire fencing	N48 53 15.24 W102 41 55.01	Properly dispose of	Yes	No
11/13/2013	14	Partially buried barbed wire fencing	N48 53 15.30 W102 41 45.16	Properly dispose of	Yes	No
11/13/2013	18	Partially buried barbed wire fencing	N48 53 15.29 W102 40 33.95	Properly dispose of	Yes	No
11/13/2013	27	Inspector collected and piled trash	N48 53 15.53 W102 39 20.38	Properly dispose of	Yes	No

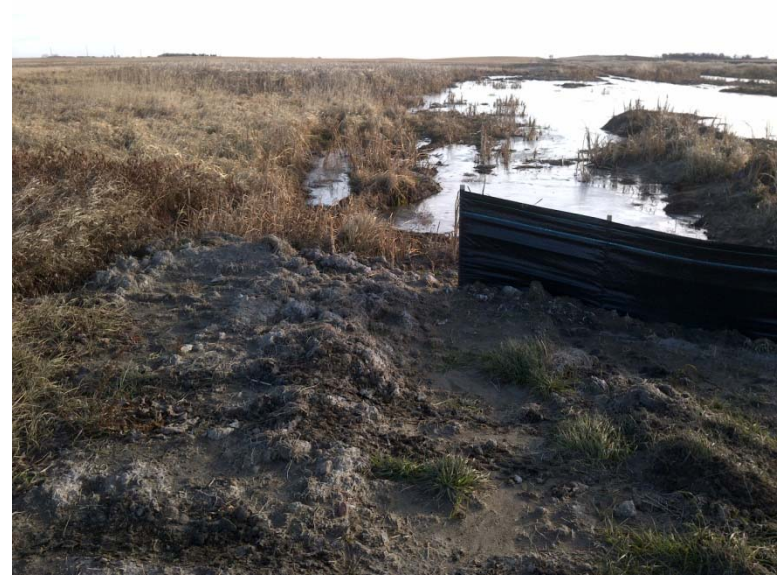
Image 20:

11/13/2013	32	Partially buried railroad tie	N48 53 19.11 W102 36 6.12	Properly dispose of	Yes	No
11/13/2013	33	Partially buried railroad tie	N48 53 18.12 W102 36 7.22	Properly dispose of	Yes	No
11/13/2013	38	Partially buried railroad tie	N48 53 15.27 W102 37 2.38	Properly dispose of	Yes	No
<b>SECTION C: NOTED ANOMOLIES</b>						
11/13/2013	1	Rough ROW	N48 53 18.90 W102 44 10.35	Regrade	Yes	No
11/13/2013	4	Rough ROW	N48 53 19.12 W102 44 2.58	Regrade	Yes	No
11/13/2013	6	Rough ROW	N48 53 19.06 W102 43 52.49	Regrade	Yes	No
11/13/2013	7	Rough ROW	N48 53 18.83 W102 43 37.87	Regrade	Yes	No
11/13/2013	8	Rough ROW	N48 53 15.53 W102 43 9.97	Regrade	Yes	No
11/13/2013	15	Rough ROW	N48 53 15.50 W102 41 37.96	Regrade	Yes	No
11/13/2013	17	Contractor drove through a perennial creek and there is no evidence of matting boards being used; rutted	N48 53 15.16 W102 41 36.20			No
11/13/2013	20	Rough ROW	N48 53 15.83 W102 39 8.30	Regrade	Yes	No

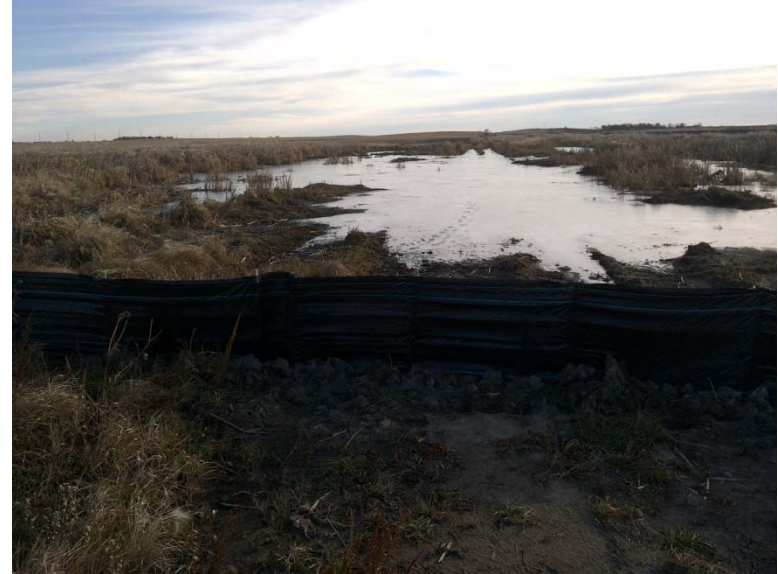
Image 22:

11/13/2013	22	Contractor drove through a wetland and there is no evidence of matting boards being used; extremely rutted	N48 53 15.47 W102 39 8.52			No
11/13/2013	23	Contractor drove through a wetland and there is no evidence of matting boards being used; extremely rutted	N48 53 15.21 W102 39 6.40			No
11/13/2013	24	Rutted ROW/wetland edge	N48 53 15.33 W102 39 3.20	Regrade	Yes	No
11/13/2013	25	Rutted ROW/wetland edge	N48 53 15.50 W102 39 1.75	Regrade	Yes	No
11/13/2013	29	Contractor drove through a wetland and there is no evidence of matting boards being used; rutted	N48 53 14.98 W102 38 41.26			No
11/13/2013	30	Rough ROW	N48 53 14.81 W102 38 1.63	Regrade	Yes	No
11/13/2013	31	Rough ROW	N48 53 19.17 W102 36 6.05	Regrade	Yes	No
11/13/2013	34	Contractor drove through a wetland and there is no evidence of matting boards being used; extremely rutted	N48 53 17.09 W102 36 8.59			No
11/13/2013	36	Rough ROW	N48 53 14.32 W12 36 24.22	Regrade	Yes	No

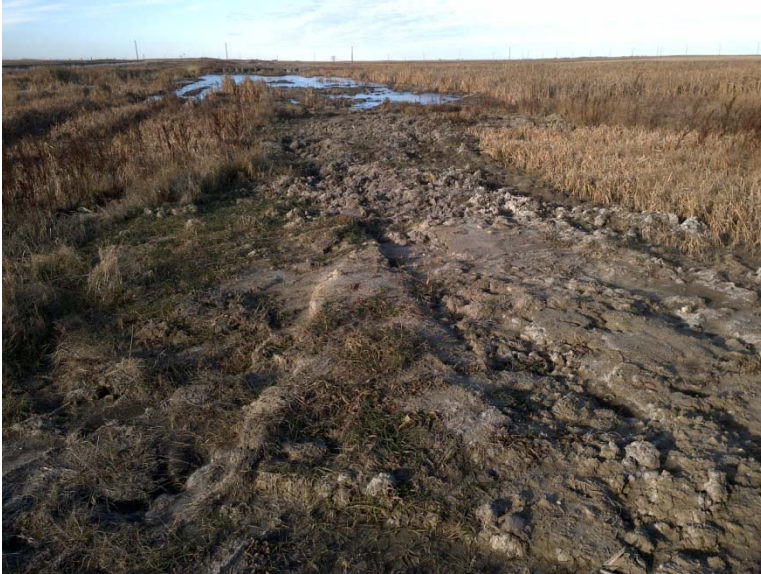
Image 25:

11/13/2013	25	No ECD in place at wetland edge	N48 53 15.50 W102 39 1.75	Install straw waddle	Yes	No
11/13/2013	26	Improperly installed silt fence	N48 53 15.27 W102 39 8.36	Remove silt fence and install straw waddle	Yes	No
11/13/2013	28	No ECD in place at wetland edge	N48 53 15.03 W102 38 40.79	Install straw wattles on both edges of wetland	Yes	No
