## Project Inspection Report

**Project Name:** Basin Transload Lignite Pipeline Project 10" Crude Line, Burke County ND

**PSC Case Number:** PU-12-775

**Inspector:** Greg Underwood, E3 Environmental, LLC      **Date:** May 16, 2013      **Time:** 8:00 am

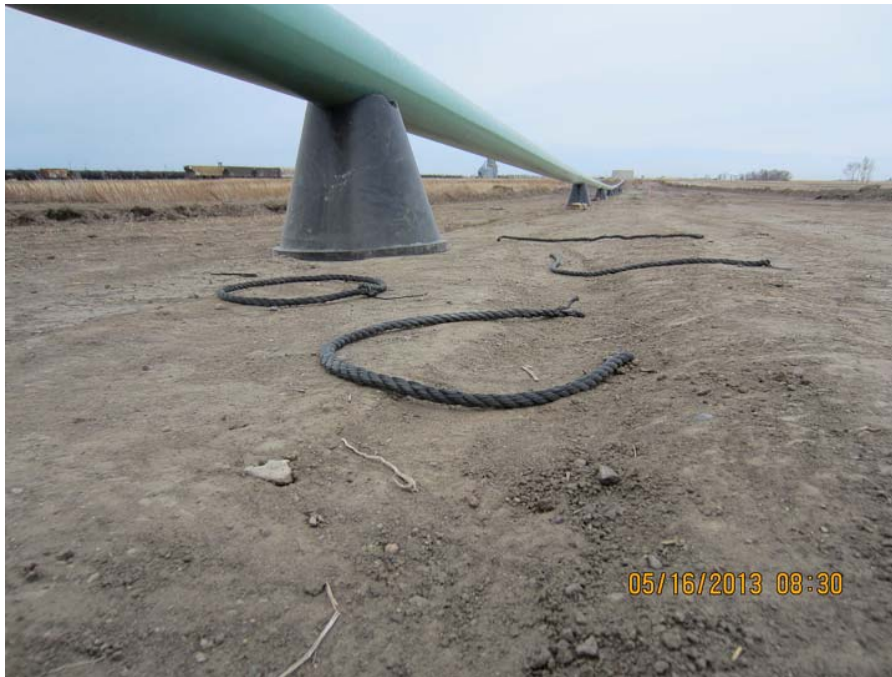
**Photo: 1: Construction Debris on ROW**

1. Implement Housekeeping Measures (pick up trash, construction debris along ROW); Photos 1.
2. Erosion and sediment control (ESC) measures missing at wetland/waterway crossings. Stabilization and ESC measures should be placed ASAP to prevent sediment from entering these features as required by the NPDES regulations; Photos 2-4 provide examples, it is recommended that all crossings be inspected for proper placement/use of these measures.
3. Secondary containment is missing around pumping equipment; containment is required per SPCC regulations; Photo 5.
4. Filtration and energy dissipation measures not being utilized to filter surface water being pumped from wetland located east of 89<sup>th</sup> Ave NW; use of these devices was identified as a mitigation measure in PSC filing. Photo 6.

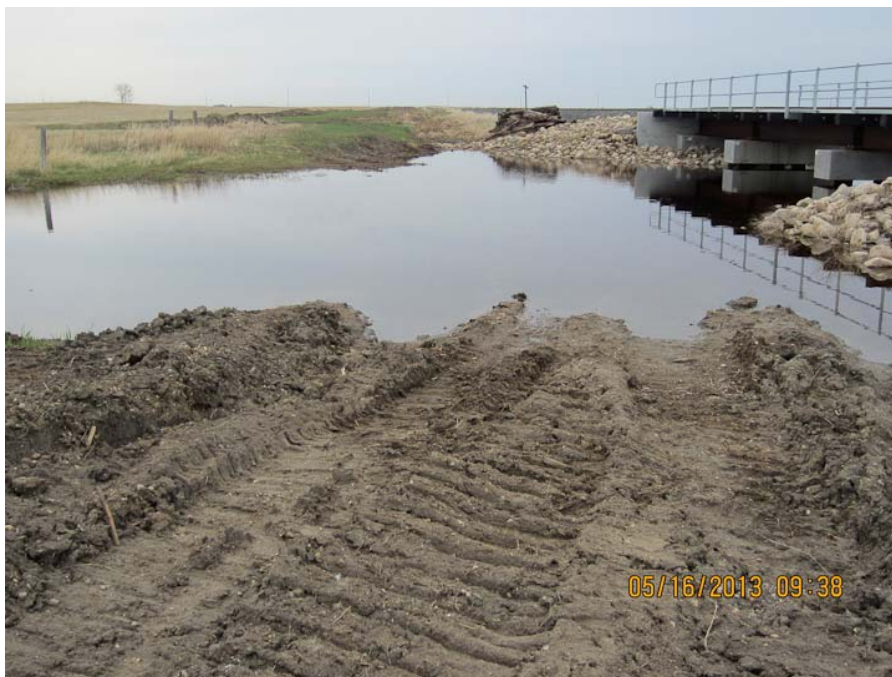
**Photo: 2: Pipeline installation was done via HDD, equipment travel appears to have occurred through waterway without the placement/ use of erosion/sediment control measure to protect waterway. Also stabilization of disturbed banks has not been initiated.**

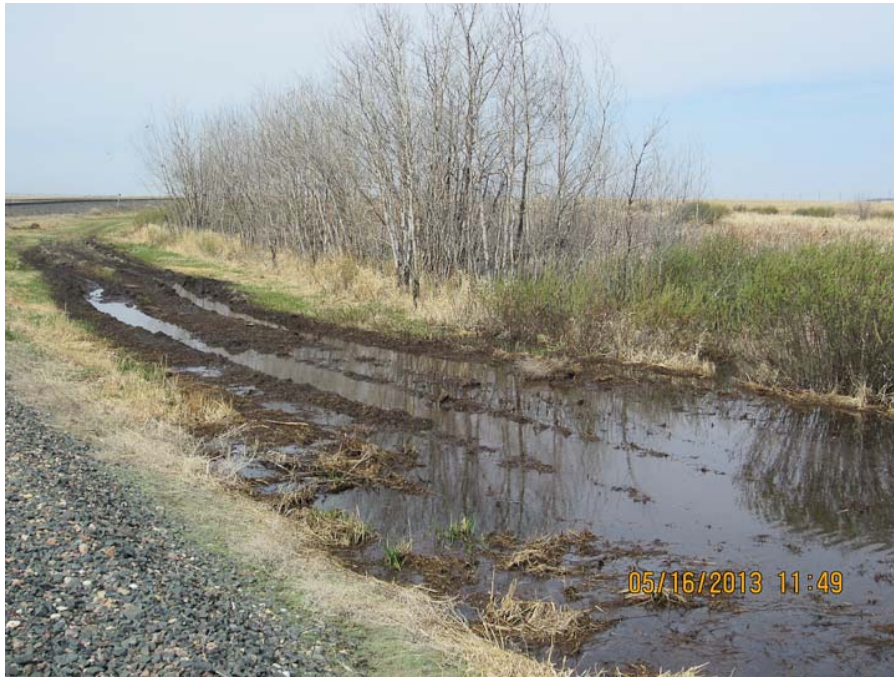
**Photo: 3: No erosion or sediment control devices in place to protect wetland in the background.**

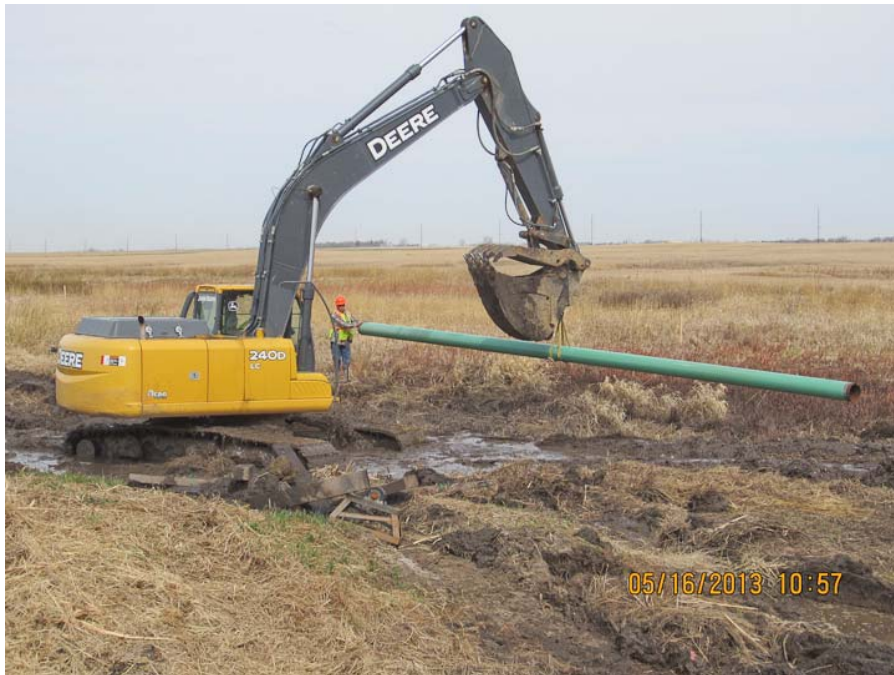
**Photo: 4: No erosion or sediment control devices in place to protect wetland in the background.**

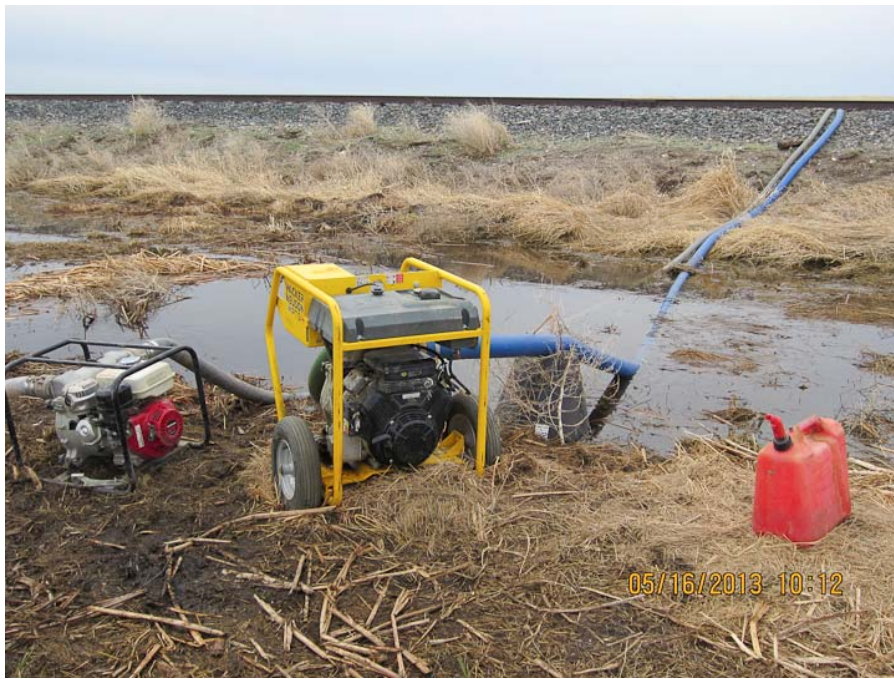
**Photo: 5: Use of pumps and gas can within mapped wetland; no secondary containment or spill measures in place. Taken to the east of 89<sup>th</sup> Ave. NW where pumping activities were occurring at time of inspection.**

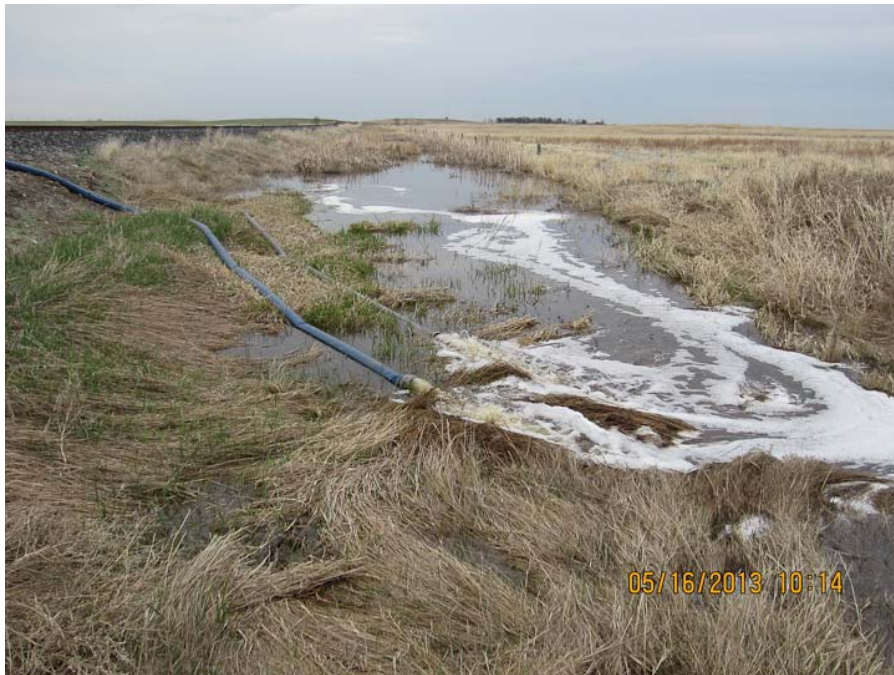
**Photo: 6: Water being discharged to wetland without use of filtration or energy dissipation to prevent sediment from entering waterway, scouring or erosion.**
