September 15, 2014

Carlson McCain Inc, (CMI) performed a construction inspection applying engineering and science principles for the purpose of ensuring that PSC Case No. PU-12-790, Basin Electric Power Cooperative's (BEPC) two natural gas simple cycle electric generators (Lonesome Creek Station - Phase II) totaling 90 MW located approximately 14 miles west of Watford City in McKenzie County, North Dakota., is being constructed in compliance with the siting laws (N.D.C.C. 49-22) and rules (N.D. Administrative Code Article 69-09) and applicable Commission orders.

Construction Inspection Summary
BEPC Lonesome Creek Station - Phase II - Williams County
Case No. PU-12-790

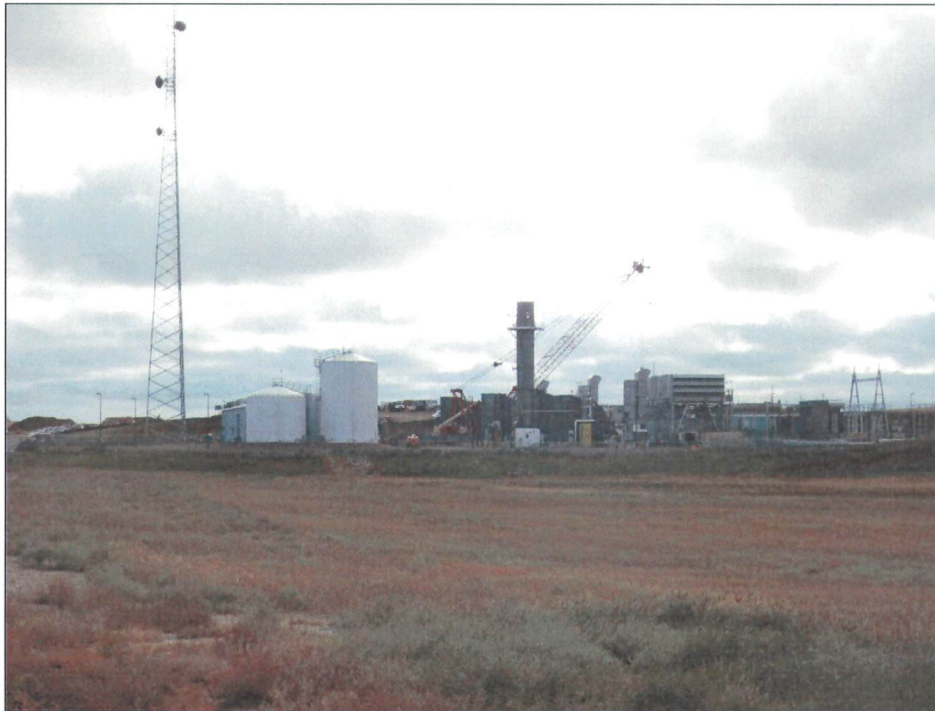
Figure 1. Overview of BEPC Lonesome Creek Station. Phase I turbine is operating while Phase II construction is in progress.

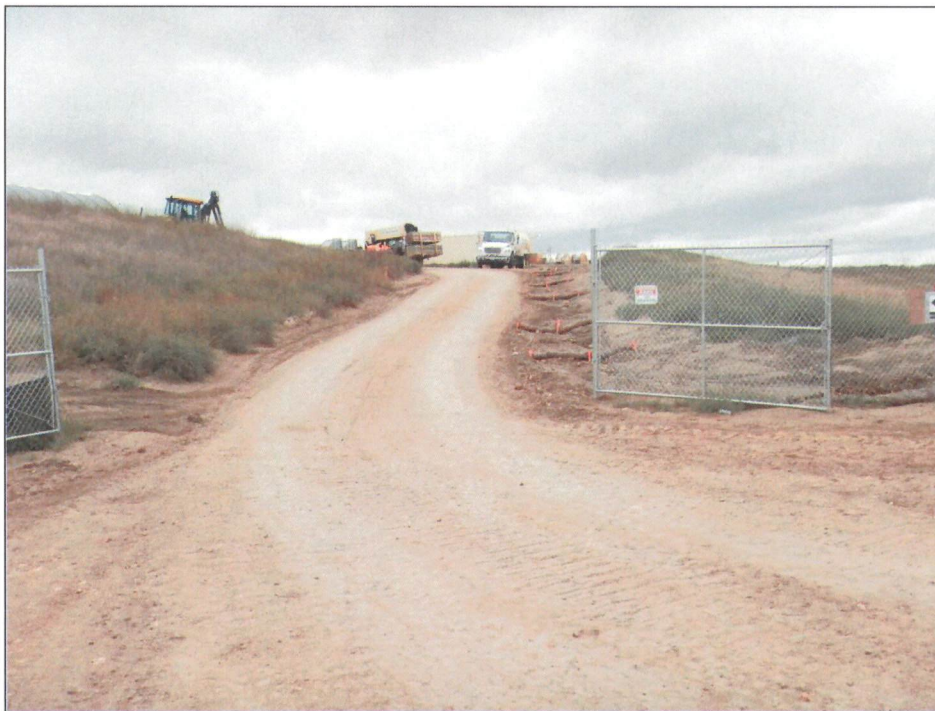
Figure 2. Photo of the access road to temporary construction site. Straw waddles are seen in shallow ditch which slow water flow and reduce soil erosion. Sediment from these ECD's are routinely cleaned out and repaired.

- 1) Continue to ensure ECDs are being inspected, maintained and reported on as needed (at a minimum biweekly or immediately after >0.5 inches of rainfall)
- 2) Notify the North Dakota Public Service Commission and the inspector of construction completion and reclamation timing (expected to occur spring 2015)
- 3) Continue spraying and/or mow weedy species to help in grass reestablishment

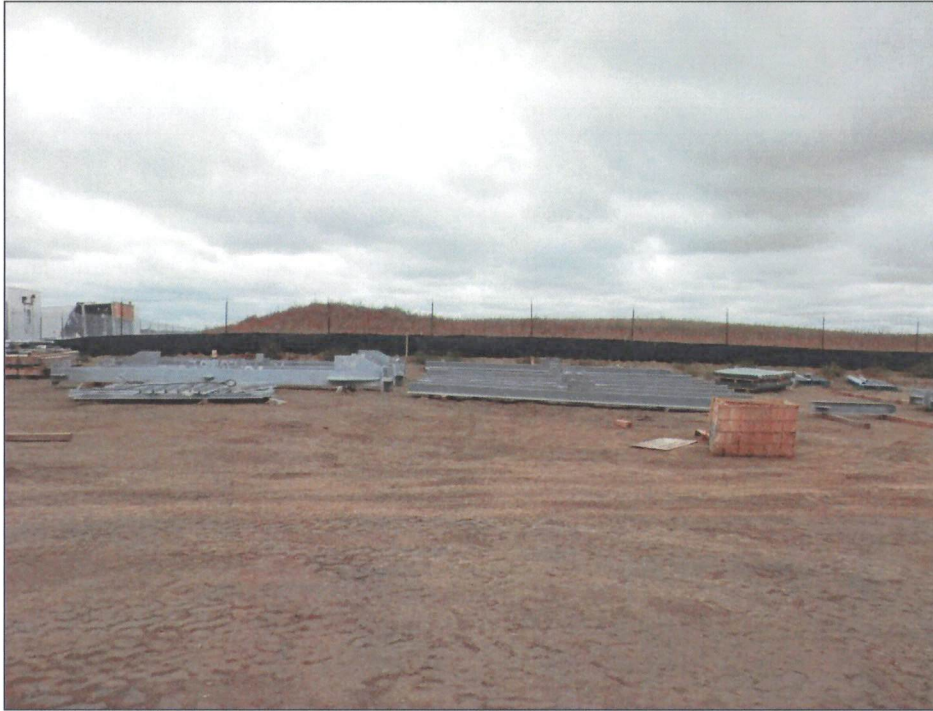
Figure 3. Photo taken from within the temporary construction site facing the south perimeter fence. Silt fencing was installed and working effectively around the site.

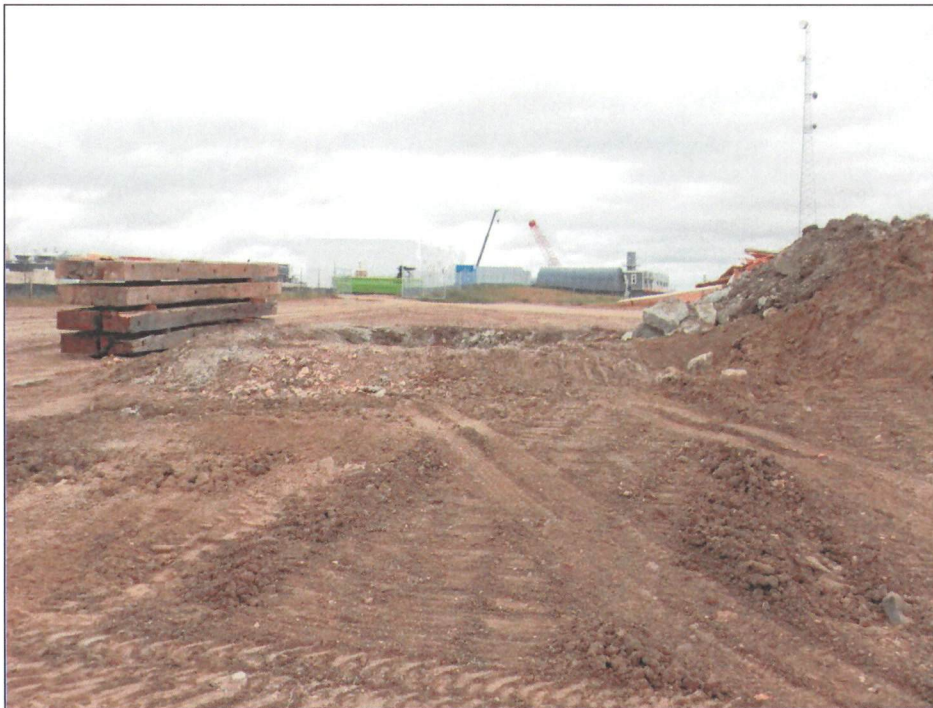
There was one concrete washout basin within the fenced temporary work area. The shallow basin had containment berms established around the perimeters and no issues with erosion or leaching were observed. Mr. Johnson indicated that in the same area there were other concrete washout basins that had been removed and cleaned up. The construction plans were reviewed with Mr. Johnson and

Figure 4. Concrete washout area. The basin was recently cleaned out and berms reconstructed.

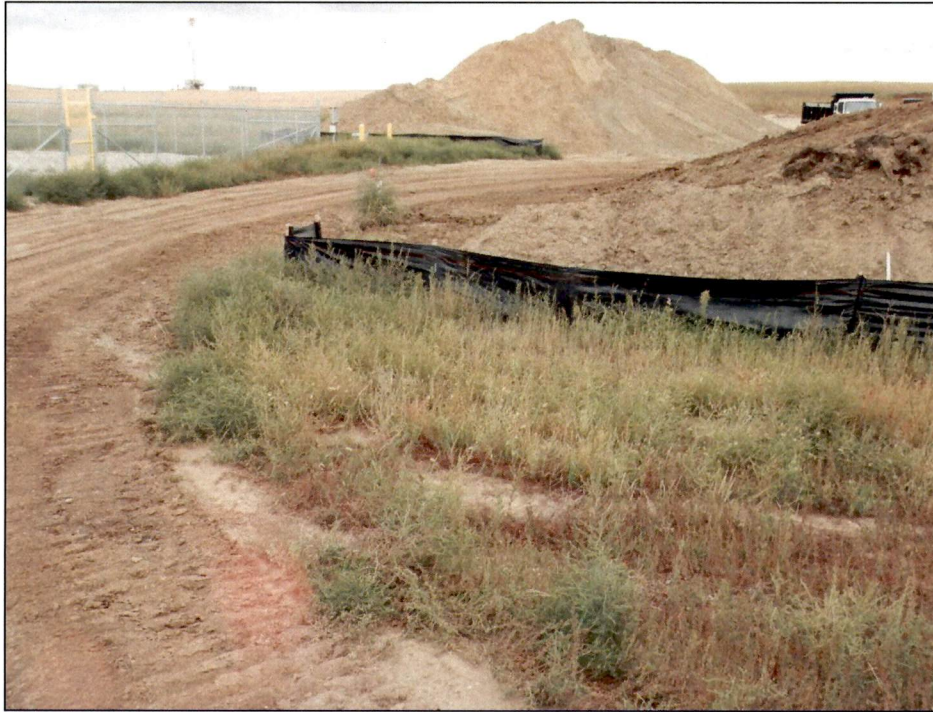
Figure 5. Photo of the northeast corner of the temporary construction site and soil storage piles. Silt fencing is in place and working properly to contain the soils on-site.

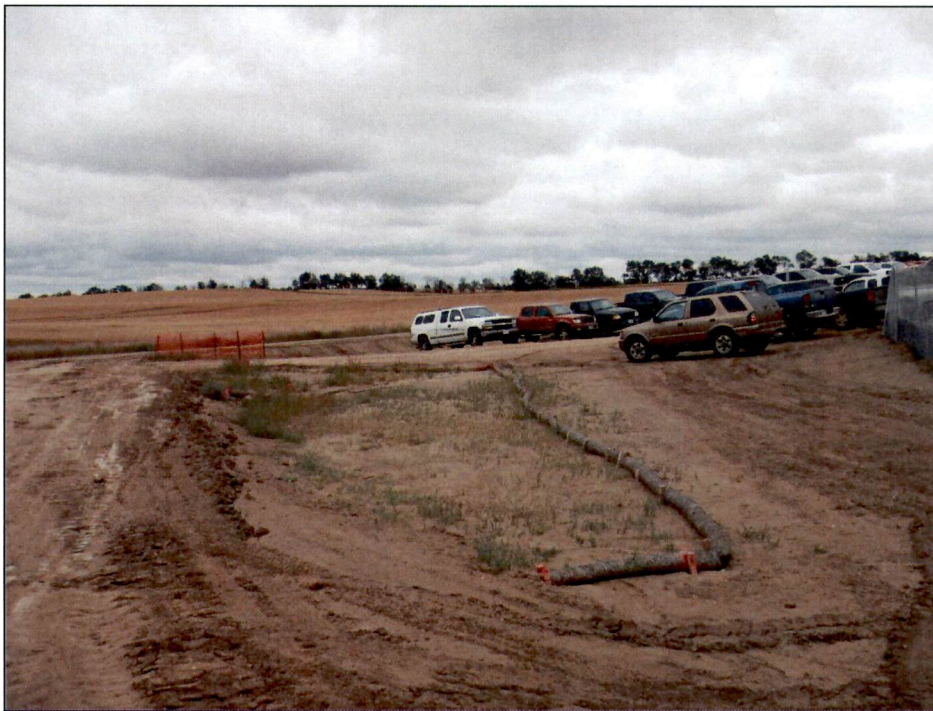
Figure 6. Straw wattles in place to reduce erosion of sandy soils into culvert.

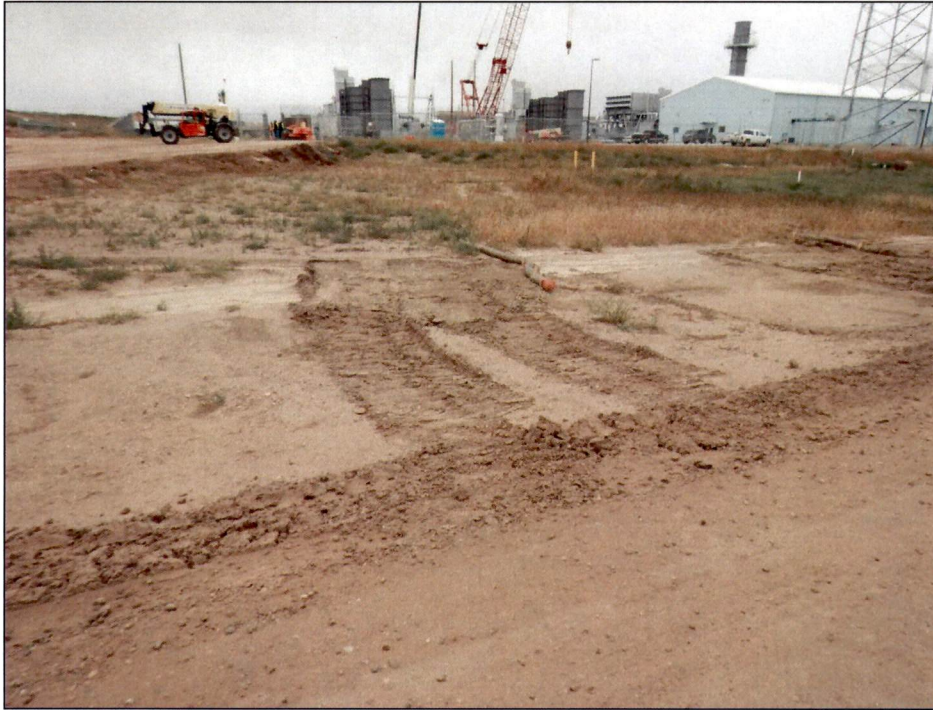
Figure 7. Straw waddles placed to contain sediments in a shallow ditch on-site. Sediment was recently removed from behind the waddles.

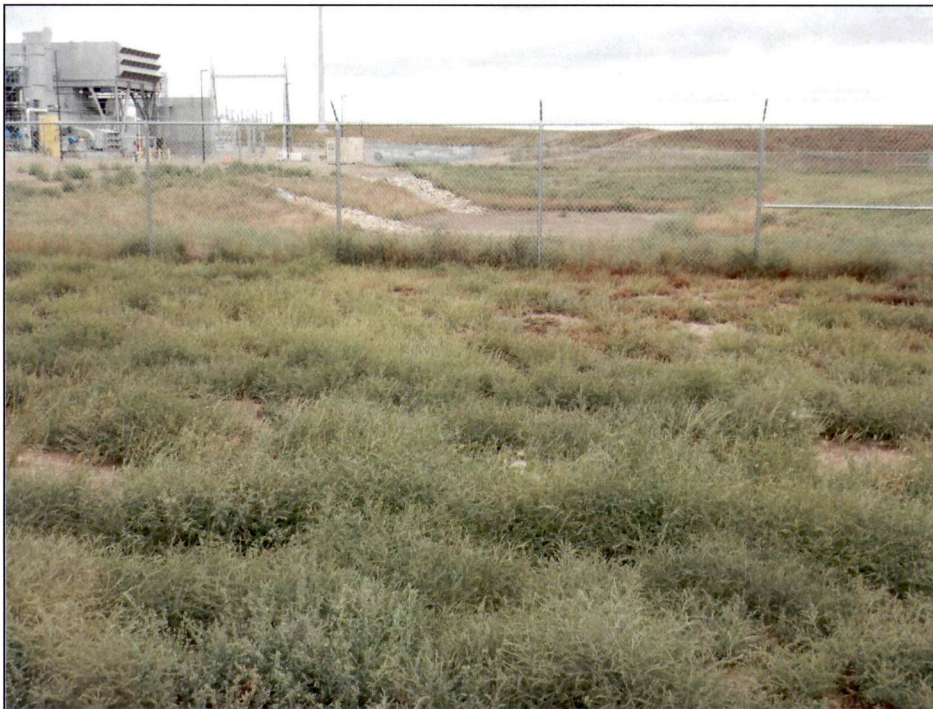
Figure 8. Permanent stormwater pond located west side of the permanent station. Inlets and outlets are rock rip-rapped and appeared to be in good condition. Any stored water has evaporated leaving a small amount of sediment in the bottom.
