210 MW Bison 4 Wind Project, Minnesota Power (PSC Case No. PU-13-127)

Permit Compliance Review

NDPSC Contract No.: PU-688-13-EE

Reporting Period: August 1st, 2014 -- November 21st, 2014Prepared By: Houston Engineering, Inc. / Emmy Baskerville, Environmental Scientist and Bart Schultz, Project Manager

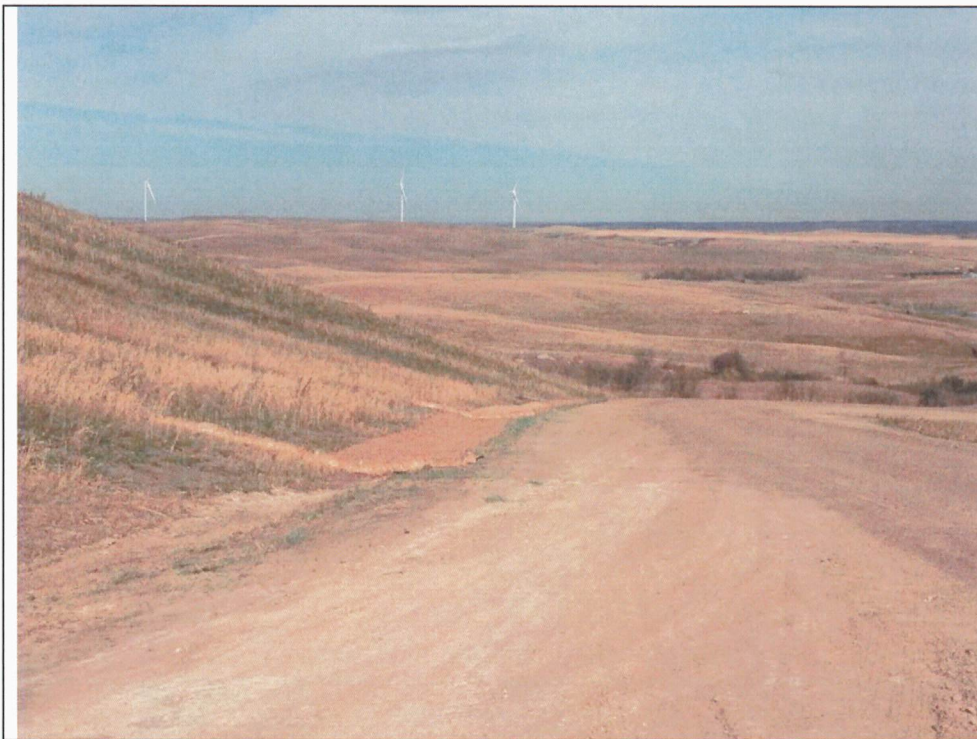
Photo 1: Site 421, showing erosion control measures.

421: biorolls, erosion control in place

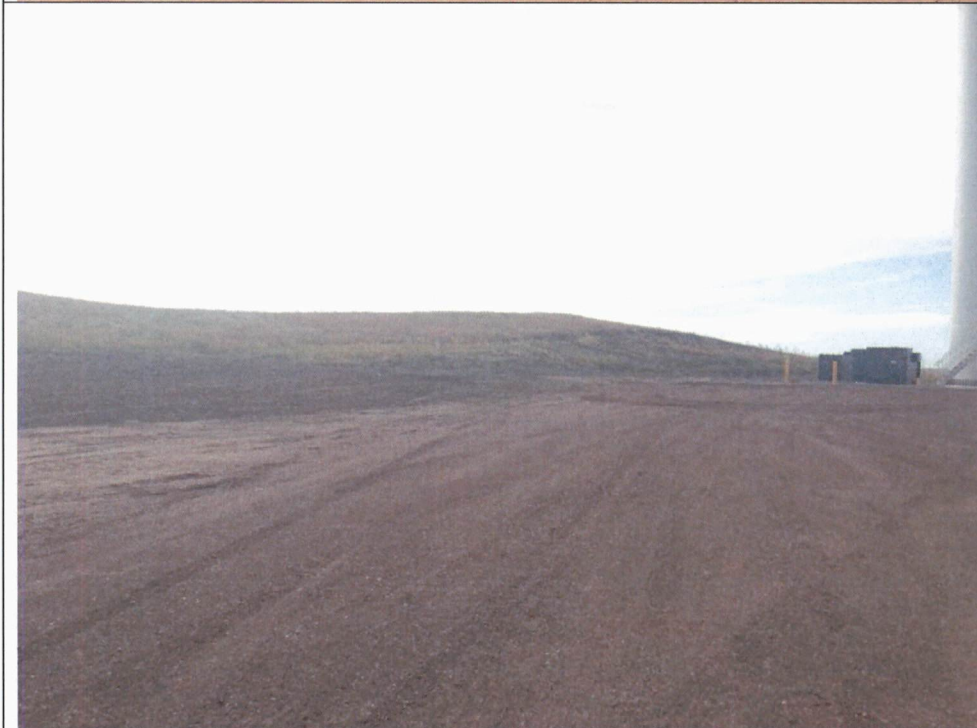
Photo 2: Site 408, showing avoidance of significant archaeological site.

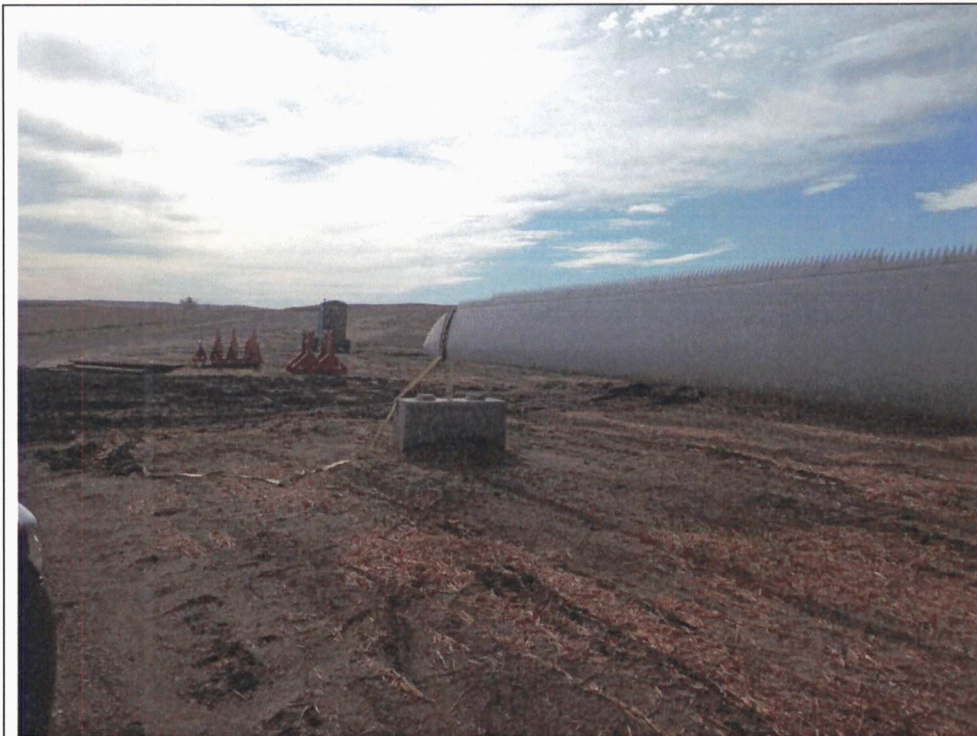
Photo 3: Site 457, showing turbine laydown area.

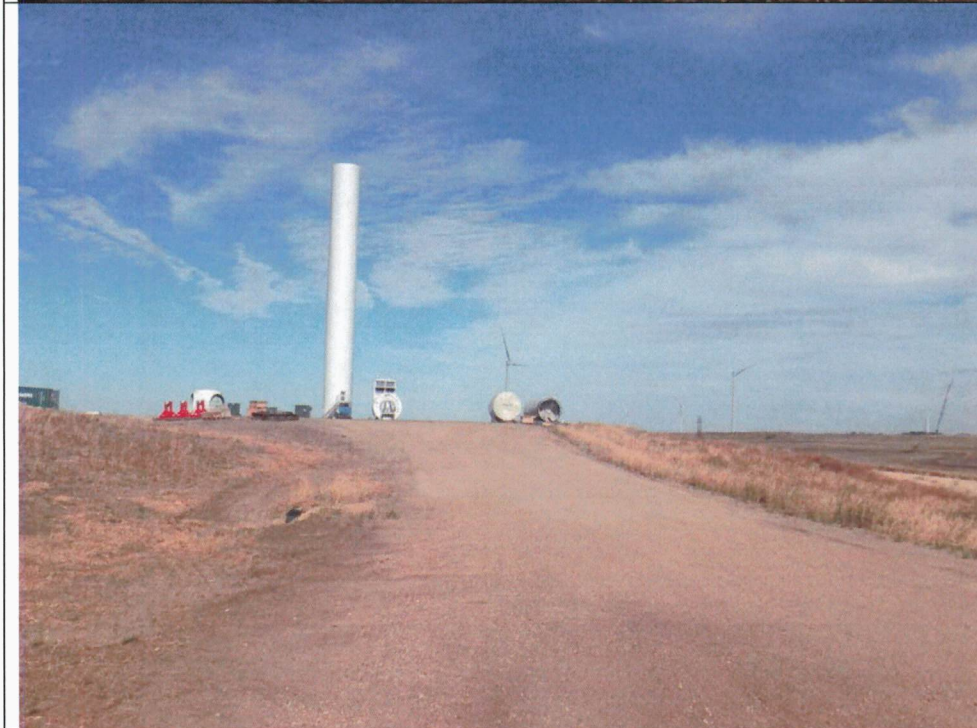
Photo 4: Site 433, actively under construction.

433: under const - pic

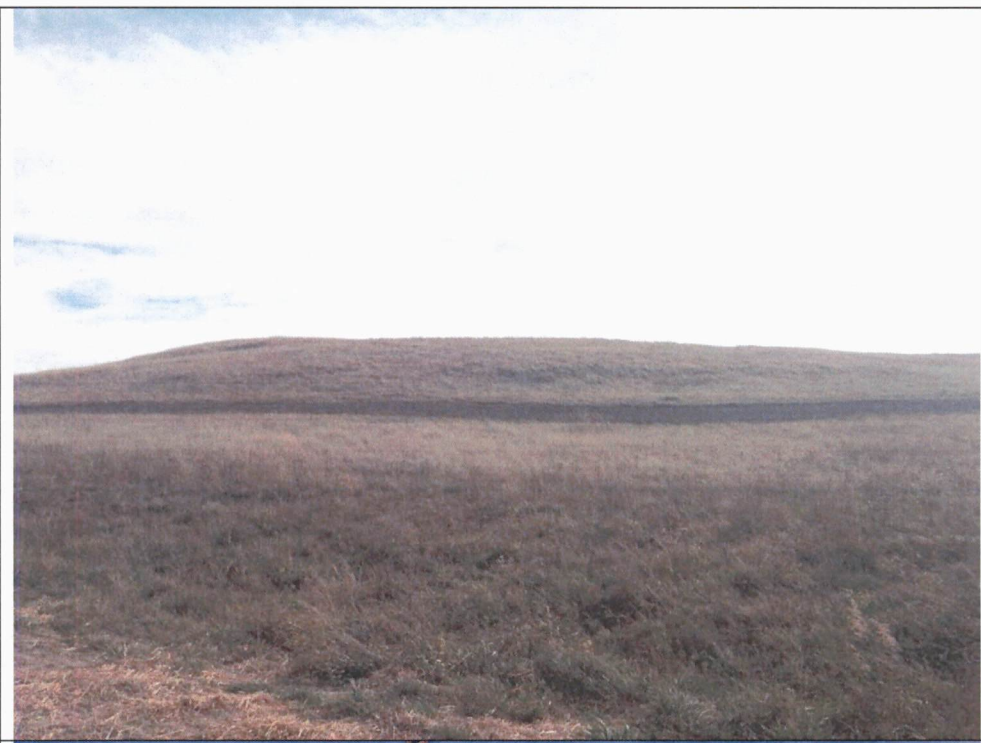
Photo 5: Site 434, showing avoidance of significant archaeological site.

434: ~~at~~ major archaeological site.
Avoided

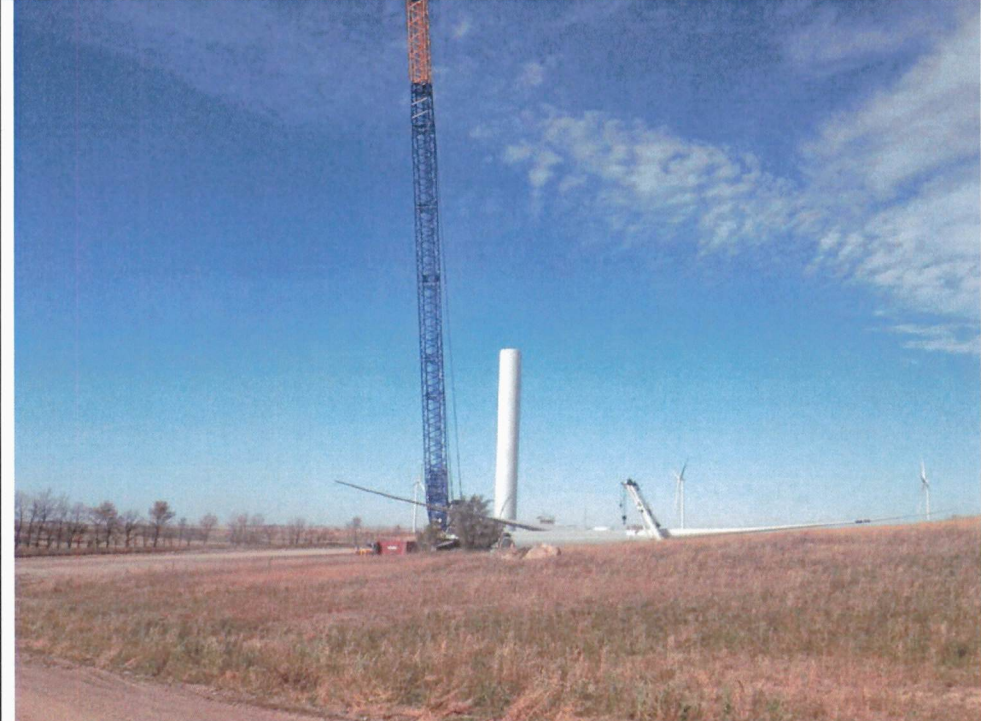
Photo 6: Active construction on pad for turbine 452.

452: under const. crane on site

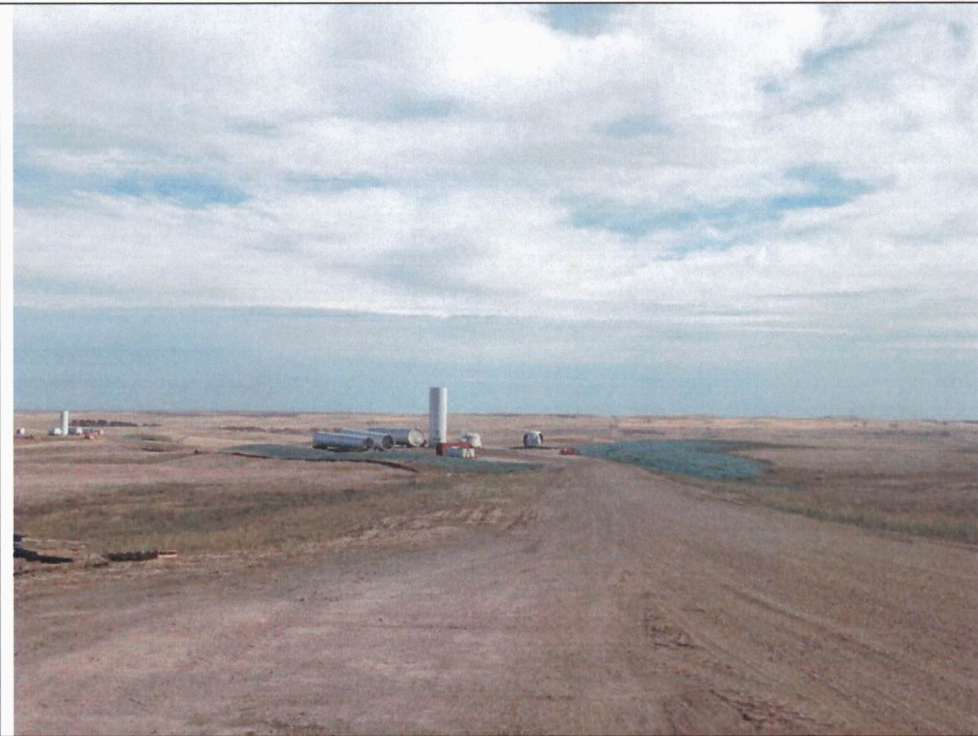
Photo 7: Site 439, recent hydroseeding.

439: ~~by~~ recent hydro SEED - PIC
silt fence observed

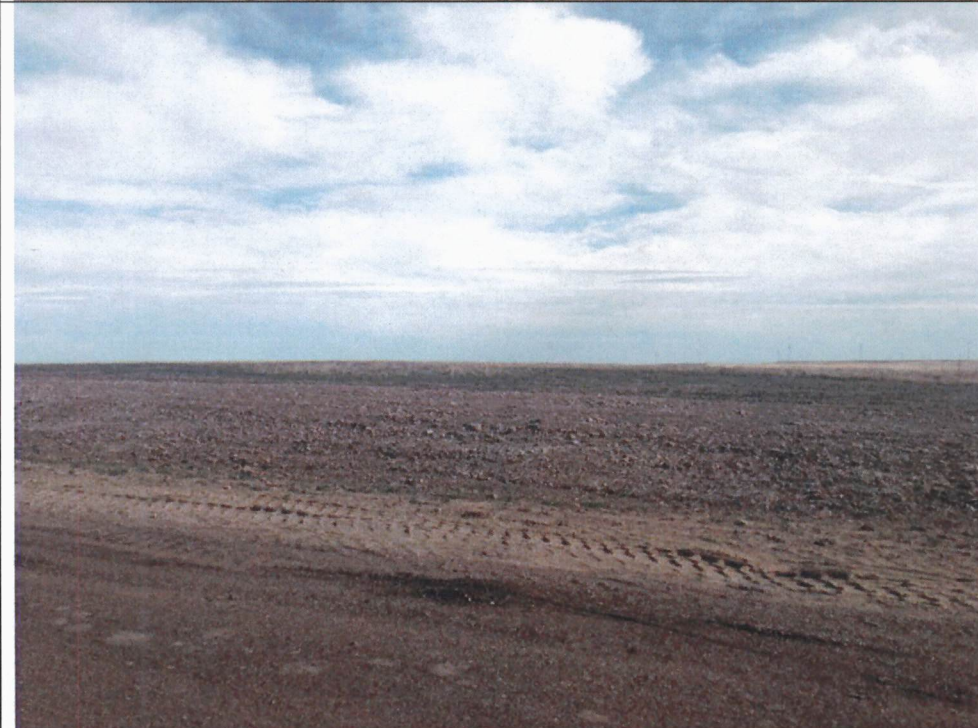
Photo 8: Site 440, recent seeding.
