**Re: Permit Compliance Inspections for Bison 4 Wind Project, Minnesota Power
HEi Project Number: 6077-004
Contract No. PU-668-13-EE**

210 MW Bison 4 Wind Project, Minnesota Power (PSC Case No. PU-13-127)

Permit Compliance Review

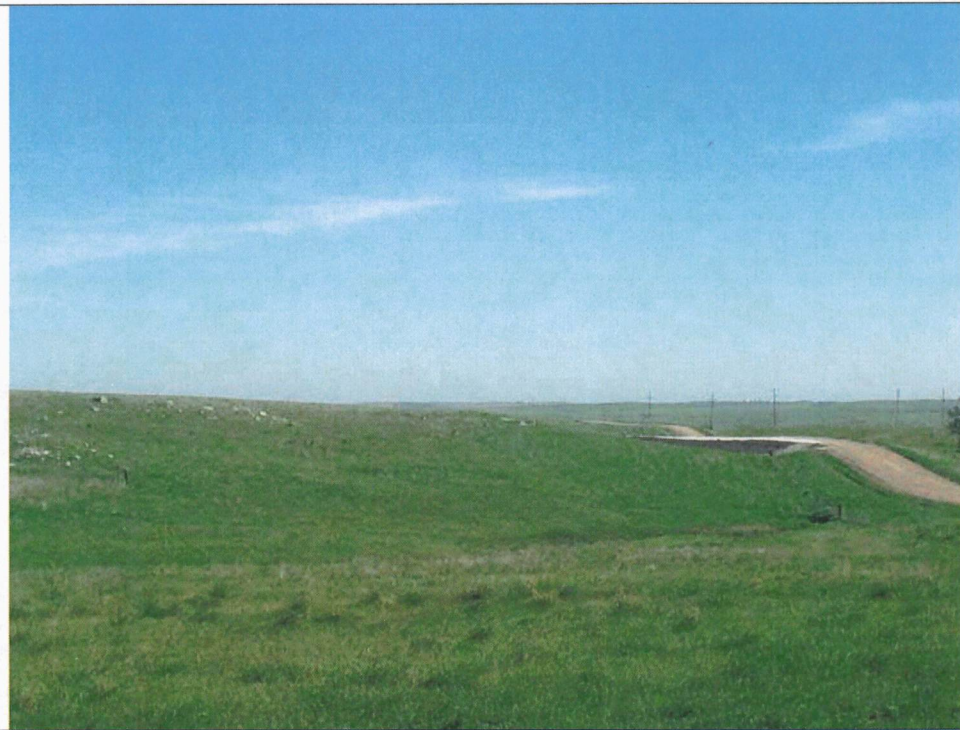
Photo 1: Access road for Turbine 463, from the south facing north. The staked archaeological / historic area can be seen in the foreground, and the access road construction avoids this identified area.

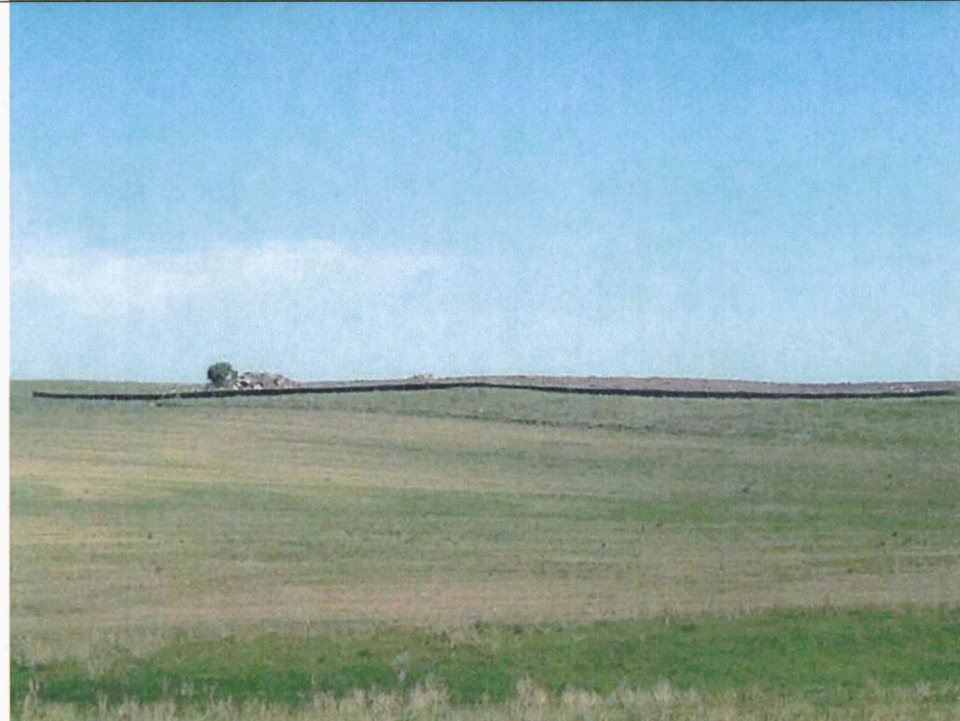
Photo 2: Silt fencing surrounding the pad for turbine 463. From the southeast facing northwest from 28th street.

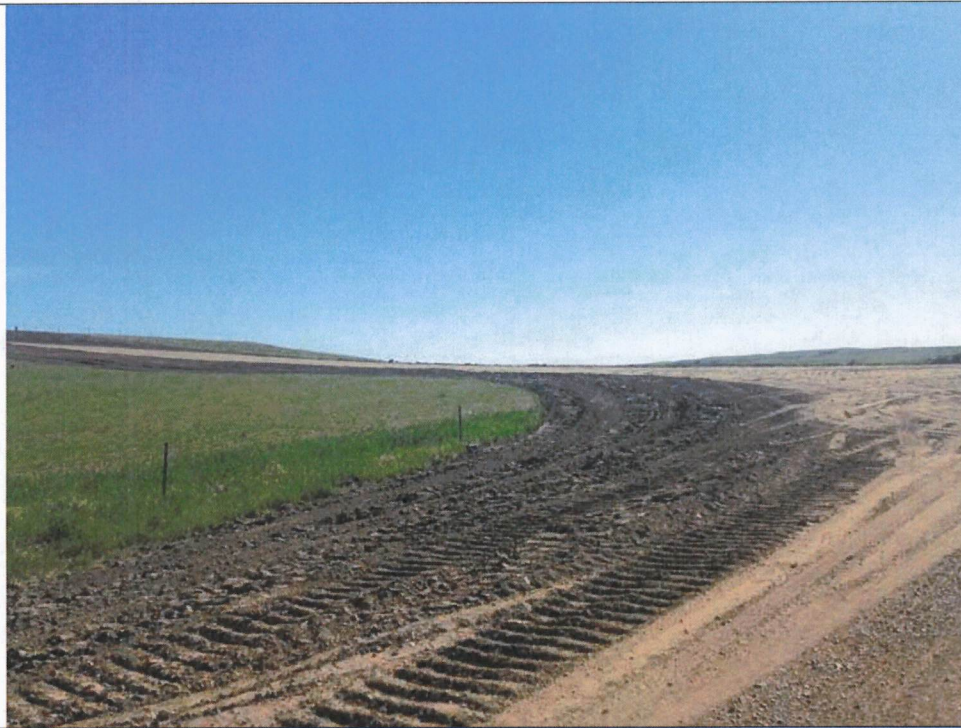
All areas observed under construction had appropriately placed erosion control (silt fencing). In addition, appropriate construction signage along public roads was observed within the heavy equipment areas. Tree removal activities had occurred and the debris had been removed from the site (no debris was observed). One archaeological / historic area adjacent to turbine 463 was identified. HEI observed that the access road construction had completely avoided this area, complying with the permit stipulations. Rough road rutting was noted along 59th Avenue, adjacent to turbine 463. The road near turbine 463 will require some restoration.

Photo 3: Access road for turbine 462. The county road conditions in this area were relatively rough, however active construction equipment was in the area. This roadway will need to be restored to the original condition.

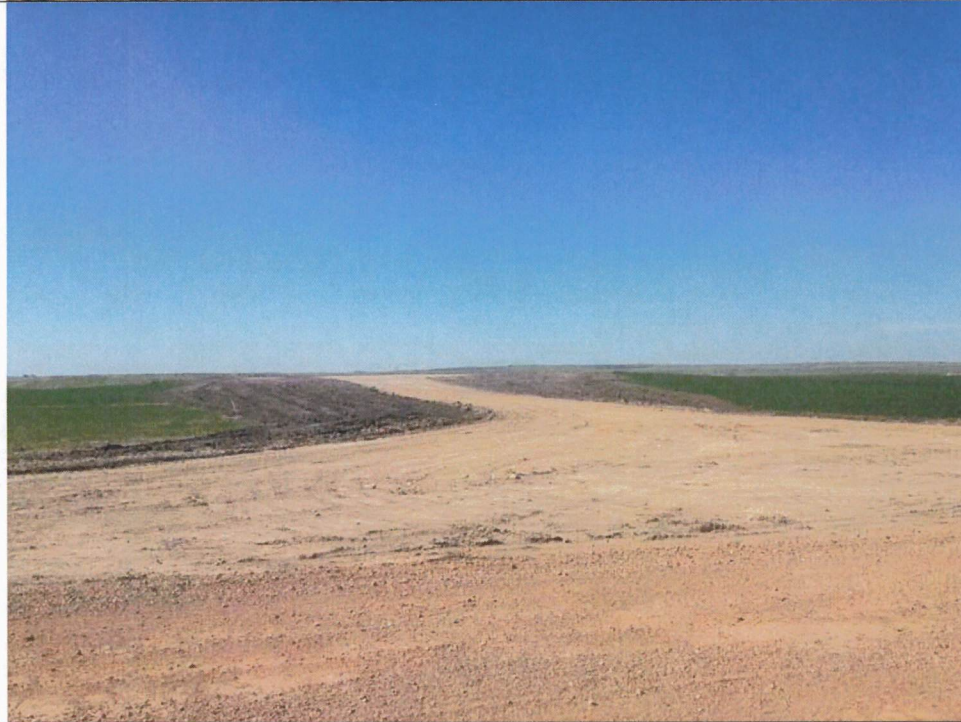
Photo 4: Access road (foreground) and pad (background) for turbine 461. Silt fencing was observed surrounding the pad.

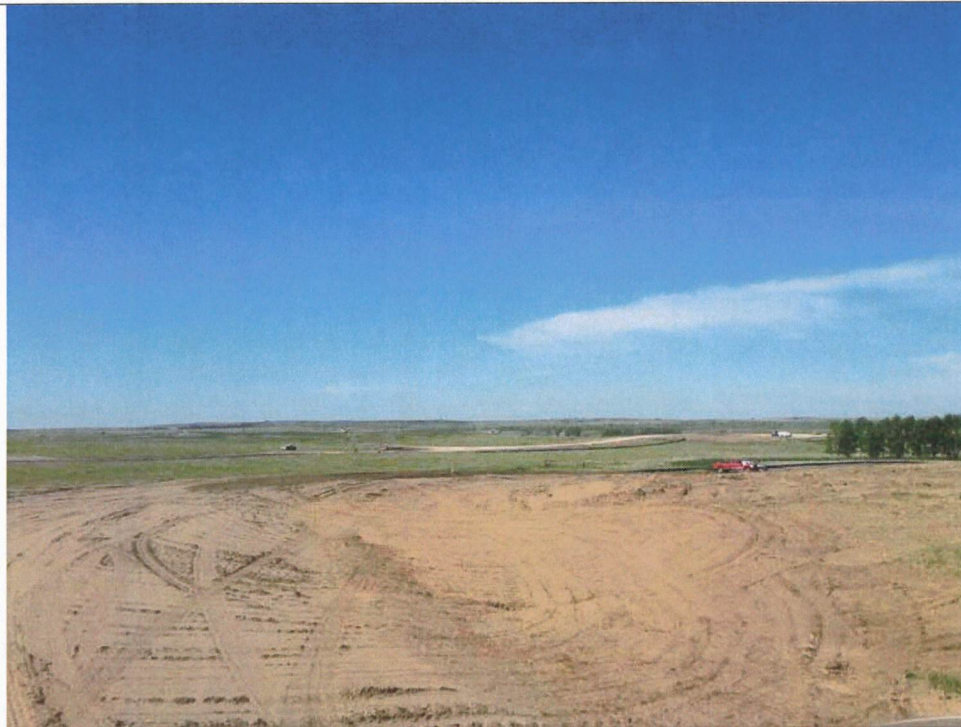
Photo 5: Access road and pad construction for turbines 452 (foreground) and 459 (background). Silt fencing observed.

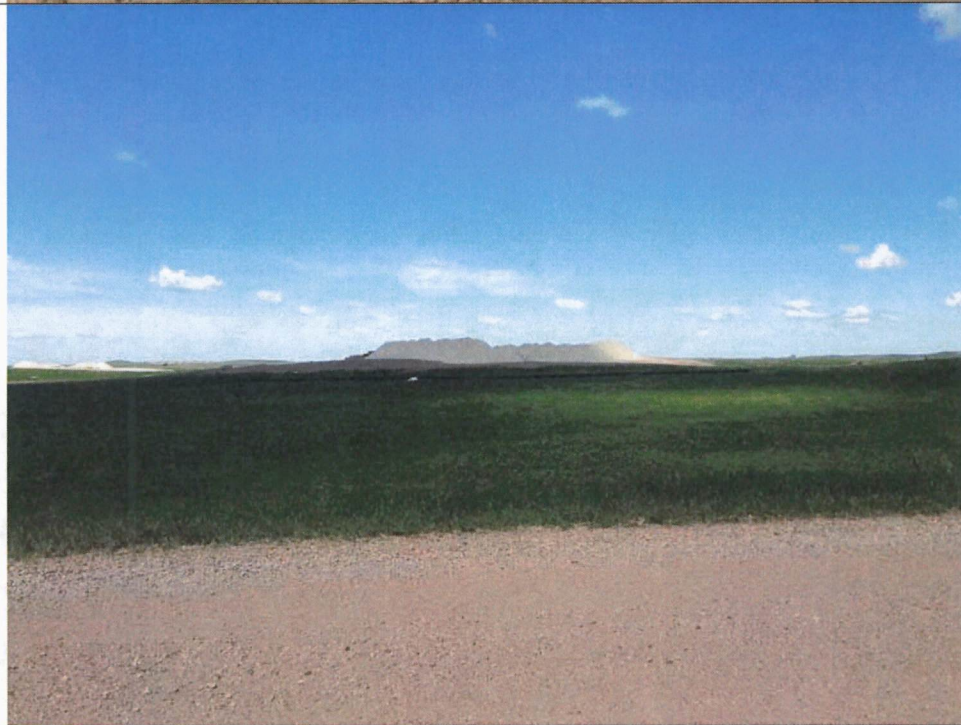
Photo 6: Active construction on pad for turbine 420. Silt fencing observed surrounding pad.

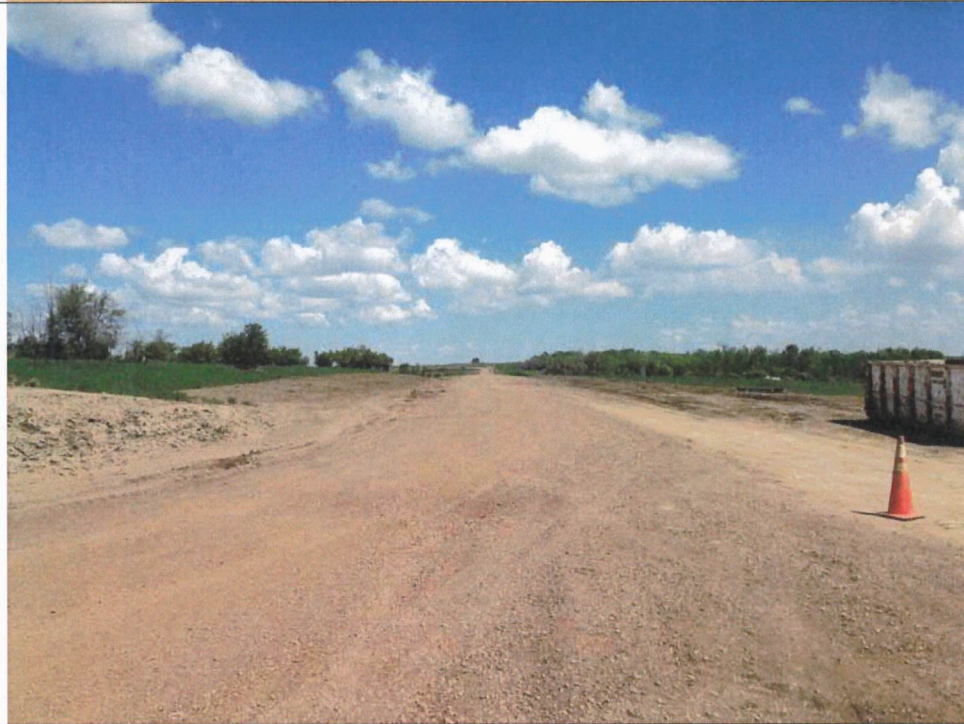
Photo 8:
Completed
access road for
turbine 421,
from the south
facing north.

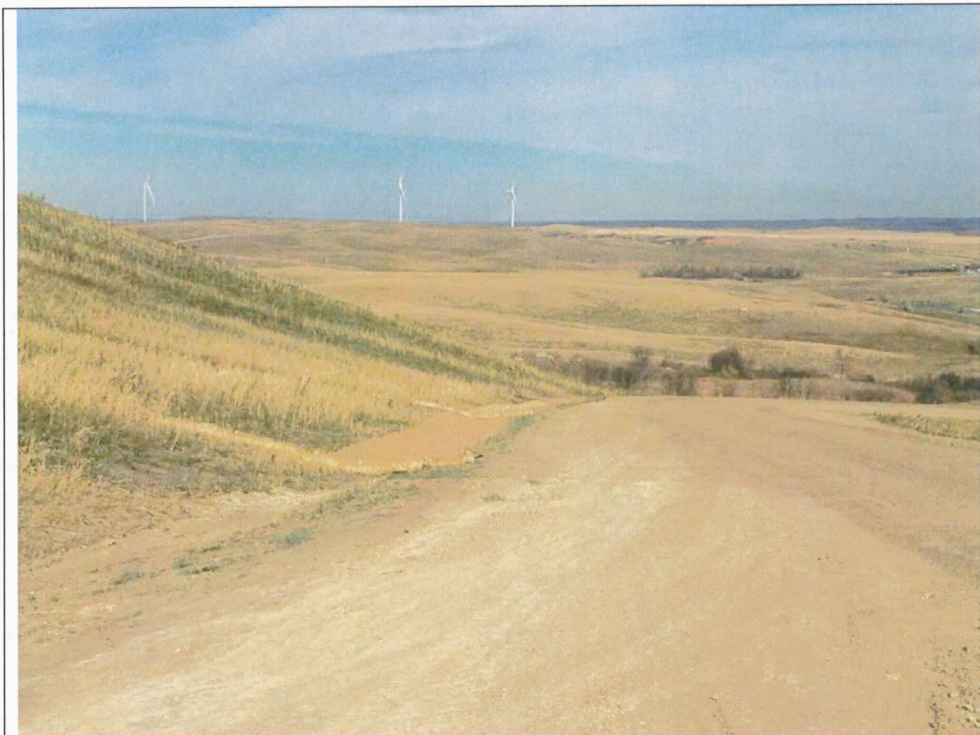
Photo 1: Site 421, showing erosion control measures.

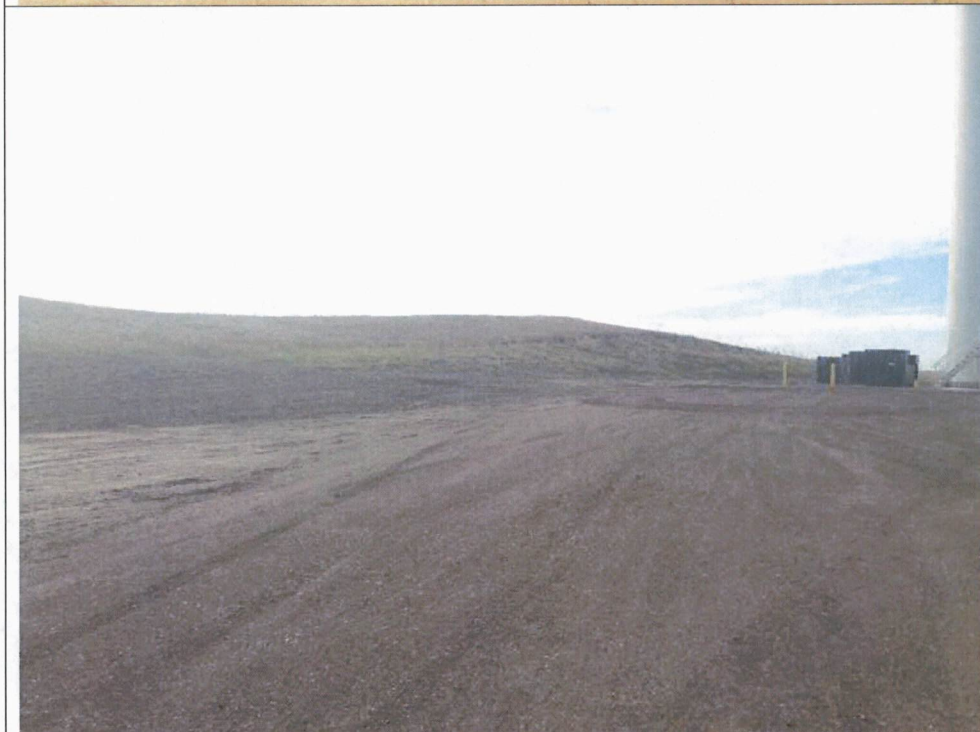
Photo 2: Site 408, showing avoidance of significant archaeological site.

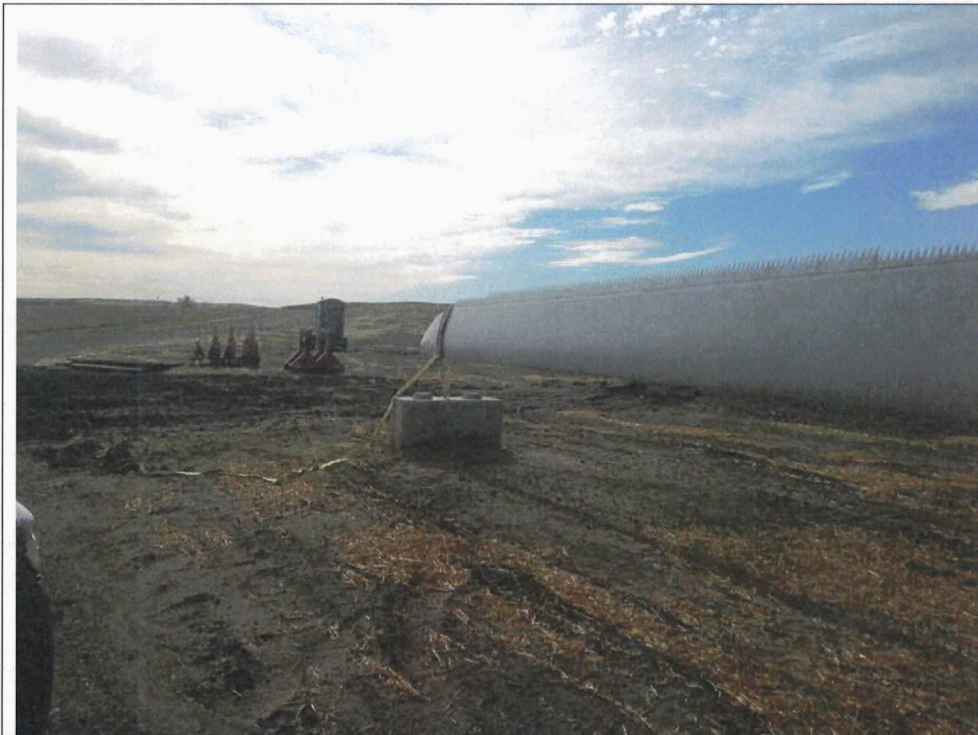
Photo 3: Site 457, showing turbine laydown area.

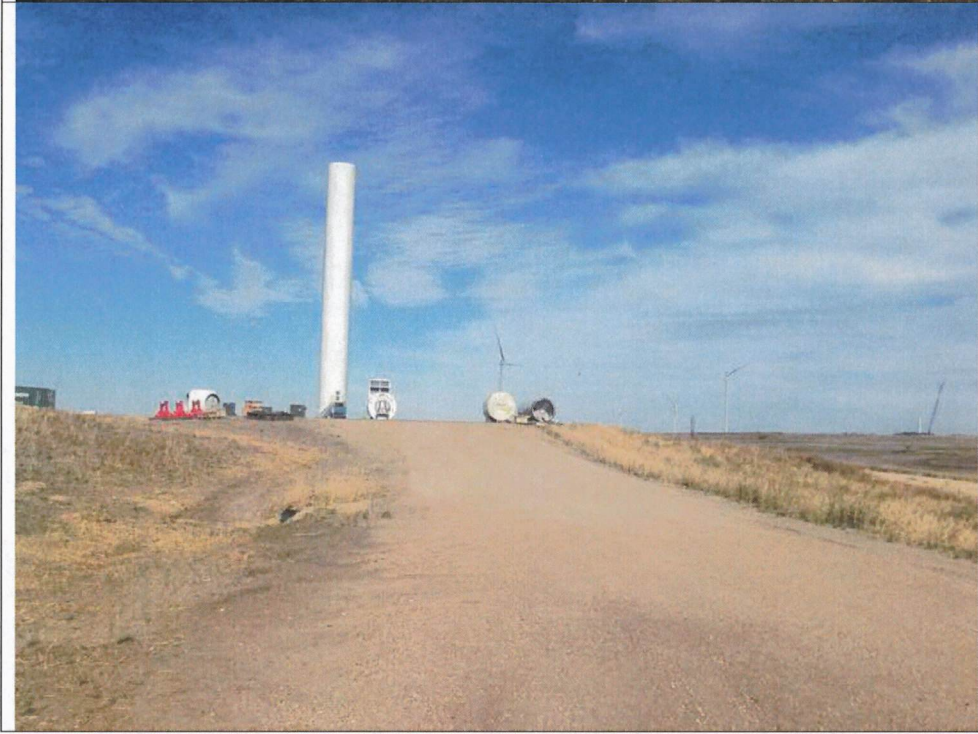
Photo 4: Site 433, actively under construction.

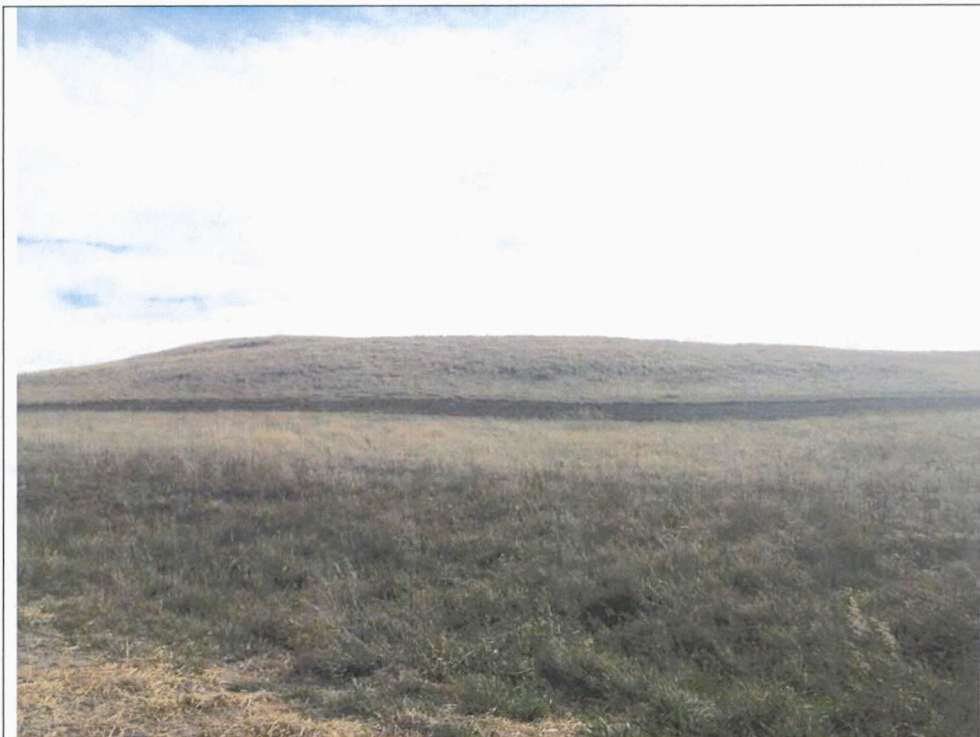
Photo 5: Site 434, showing avoidance of significant archaeological site.

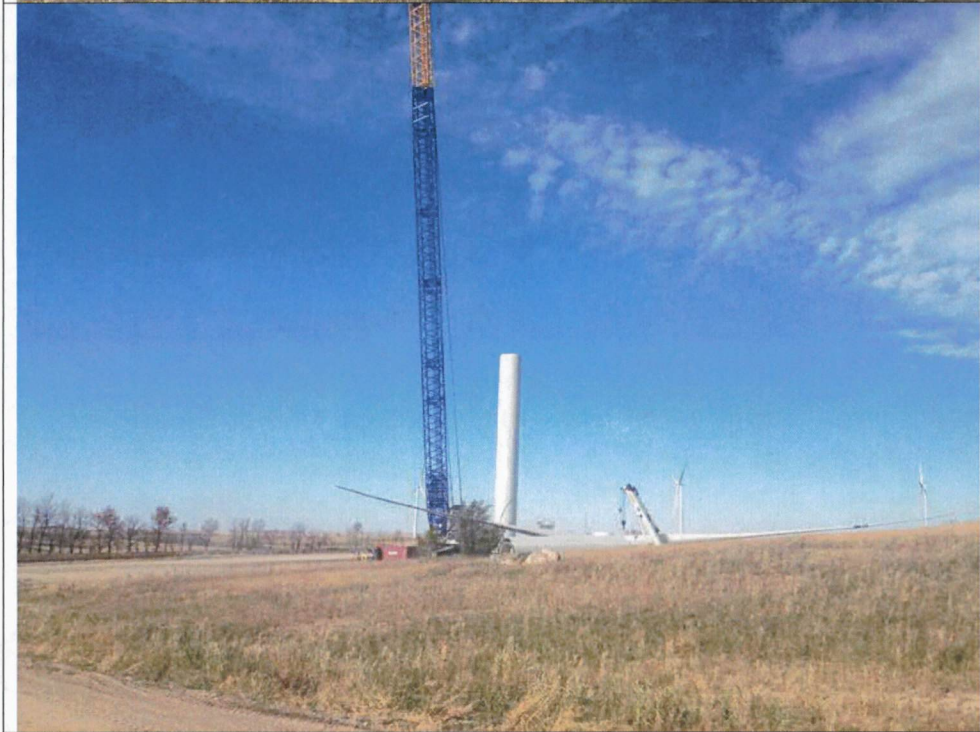
Photo 6: Active construction on pad for turbine 452.

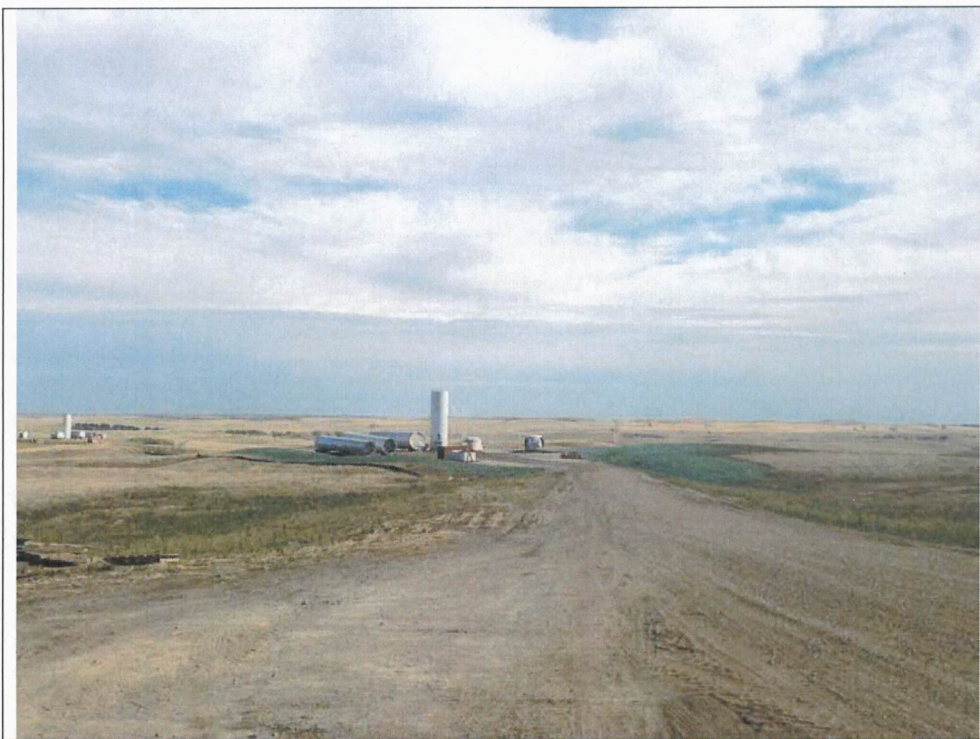
Photo 7: Site 439, recent hydroseeding.

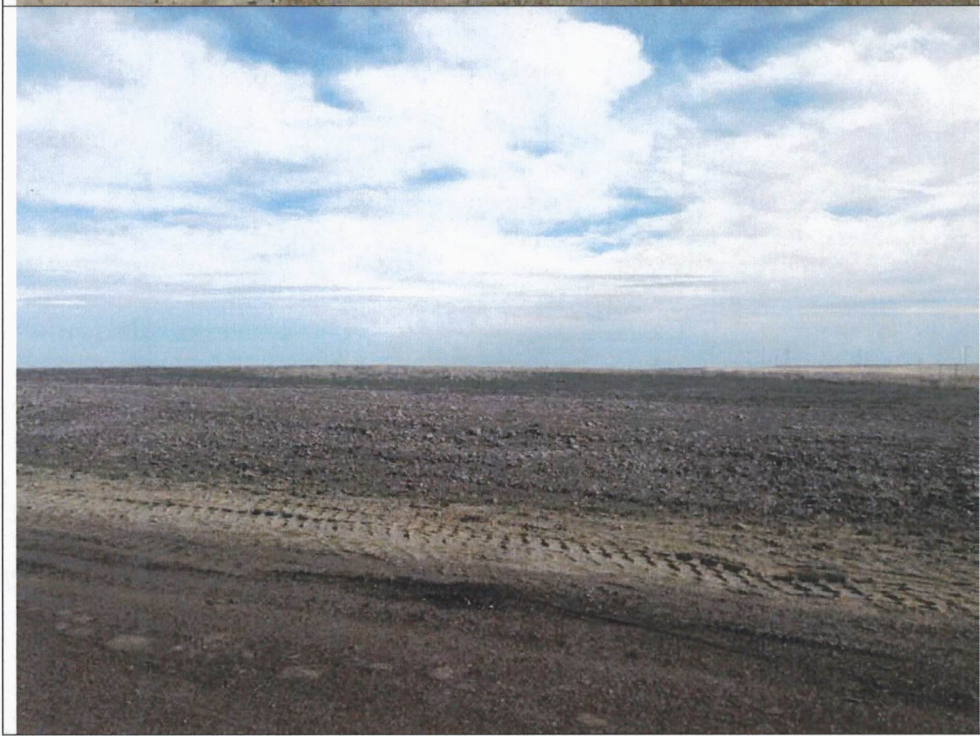
Photo 8: Site 440, recent seeding.

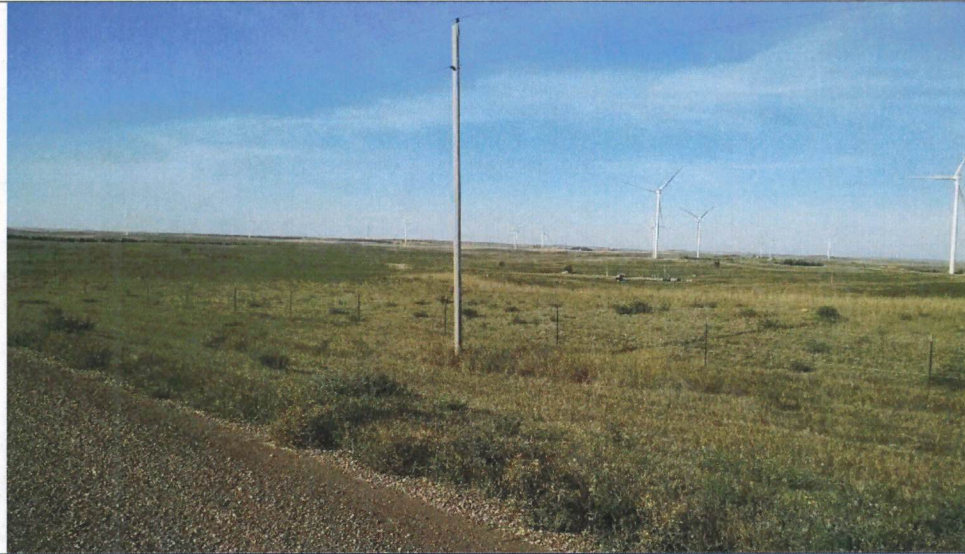
Photo 1:
Looking west
from 57th Ave at
Collector line
crossing.
Turbine 451 is
on the right of
the photo.

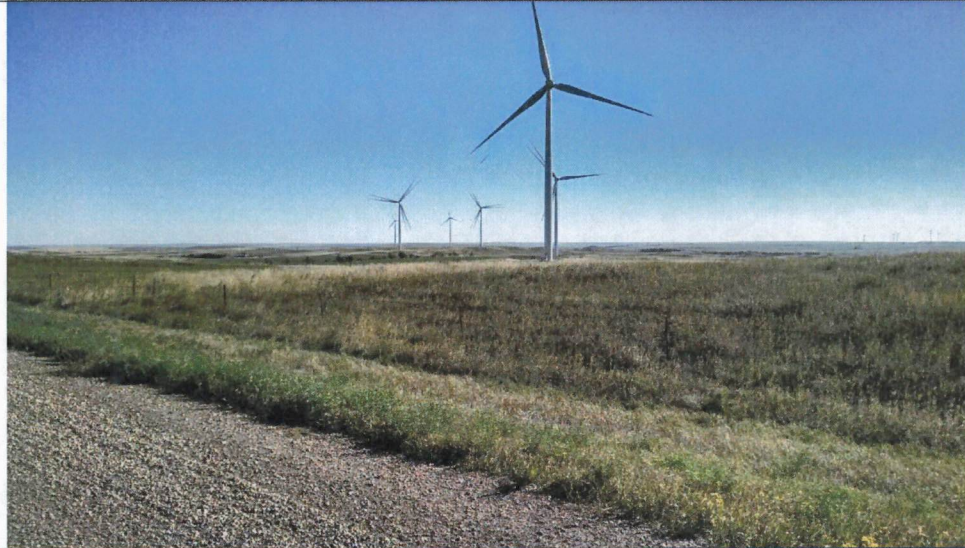
Photo 2:
Looking east
from 57th Ave at
Collector line
crossing.
Turbine 439 is
the closest one in
view.

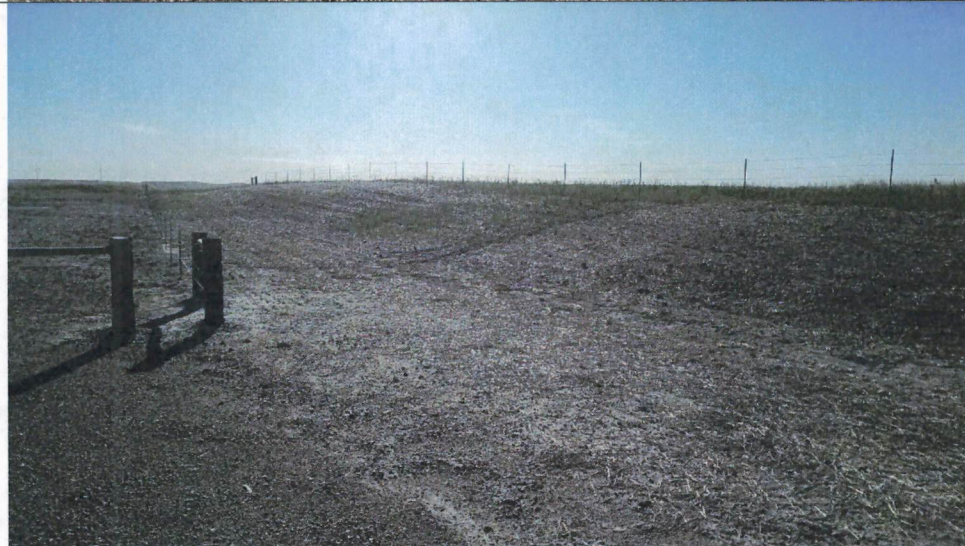
Photo 3: Partial
revegetation of
area near
Turbine 441

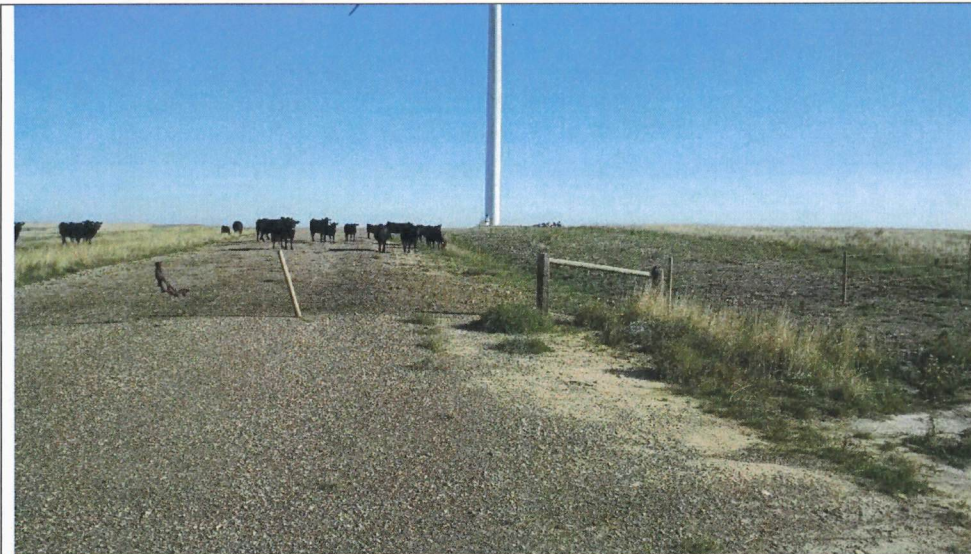
Photo 4: Cattle grazing the new vegetation near Turbine 444.

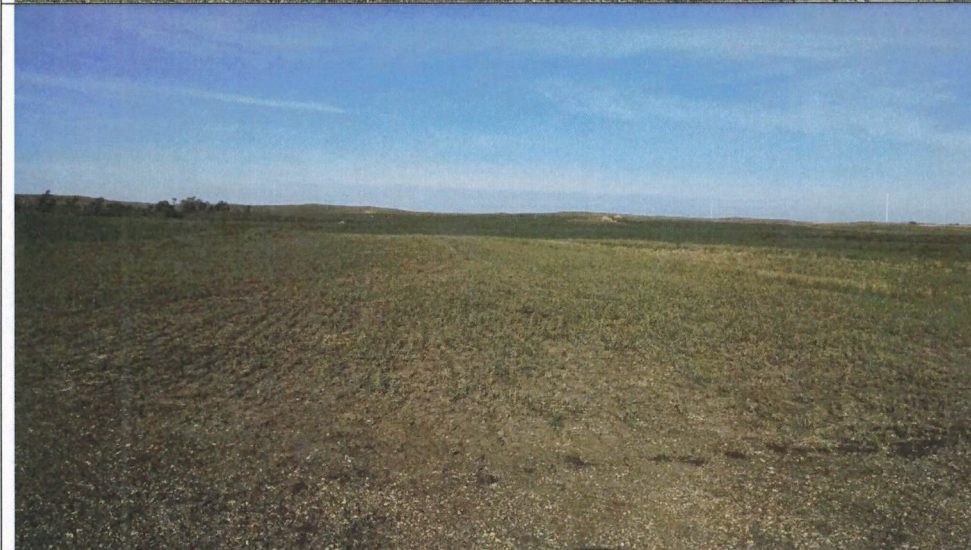
Photo 5: revegetation progress near Turbine 441.

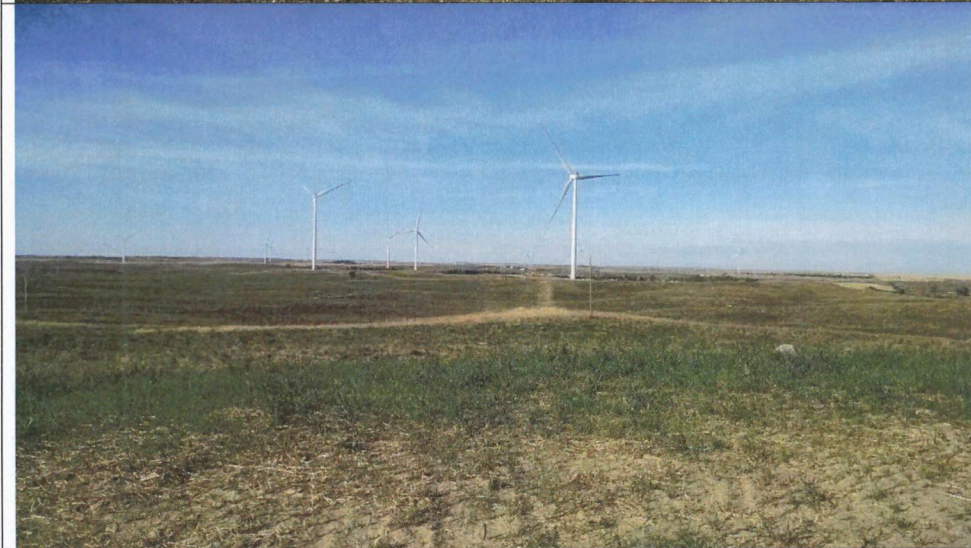
Photo 6: revegetated collector line ROW.

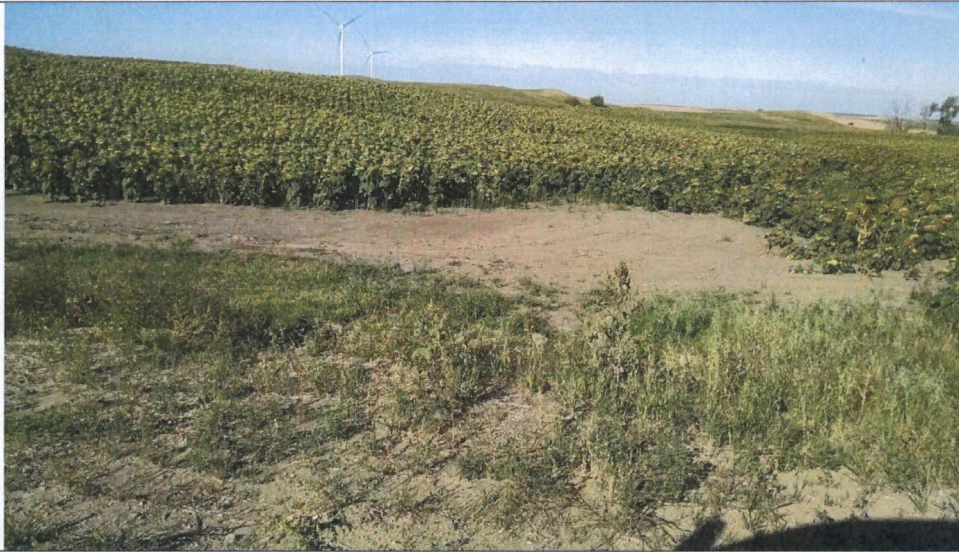
Photo 7: small area of erosion, deposited in the field near Turbine 456.

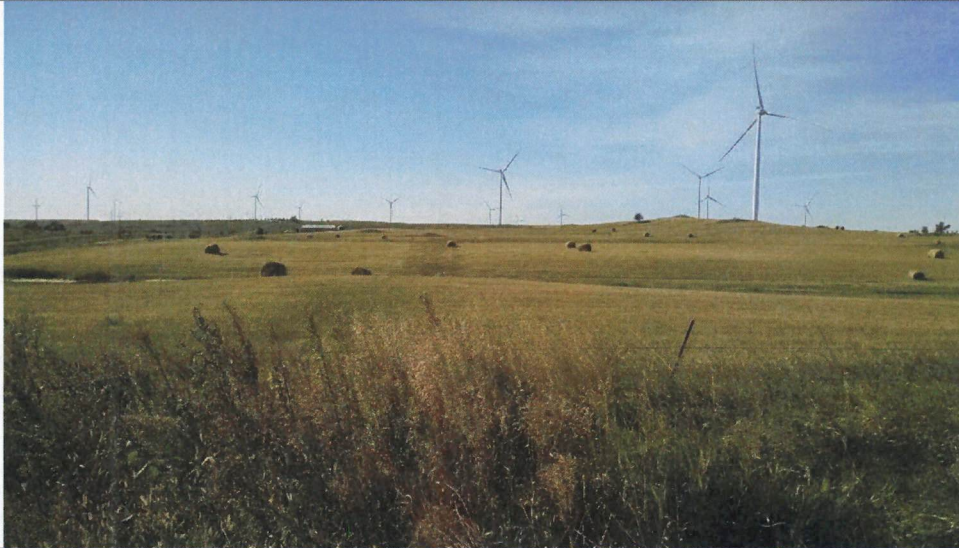
Photo 8: Looking south along revegetated ROW, north of Turbine 464.

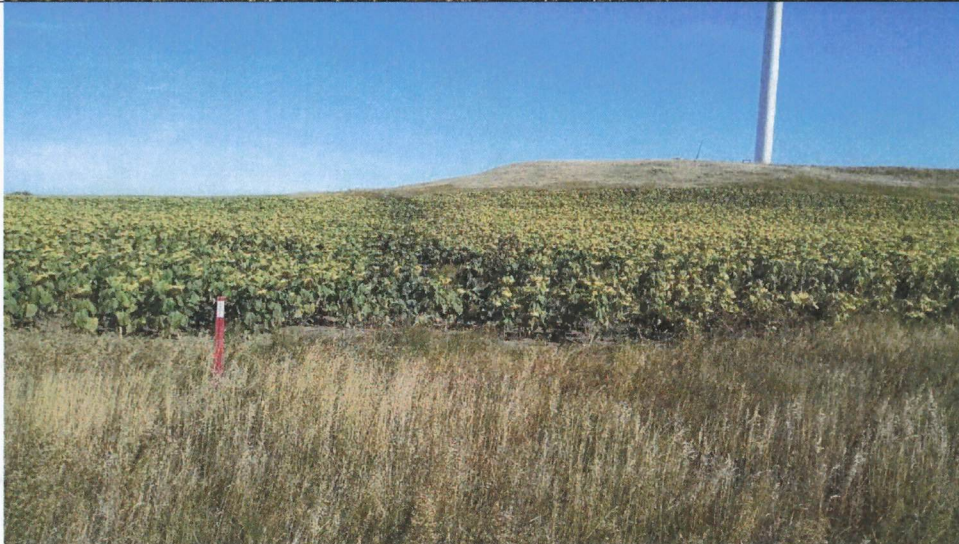
Photo 9: Collector line ROW with 2015 crop of sunflowers planted over it.

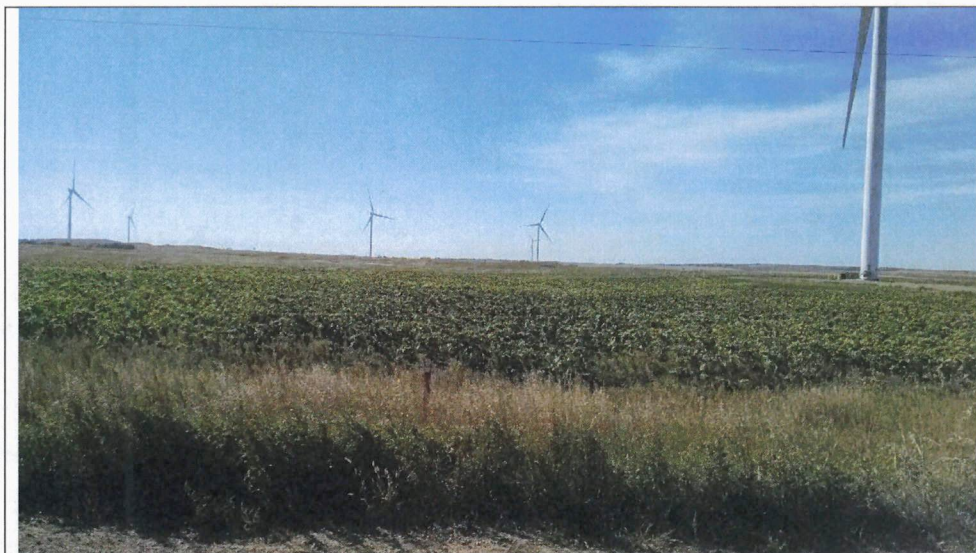
Photo 10:
Collector line
ROW with 2015
crop of
sunflowers
planted over it.
