Technical Memo

From: Luke Toso, Wenck Associates, Inc.

Date: June 14, 2018

Subject: Bison IV Reclamation Investigation, Case PU-13-127 & I-15-0195

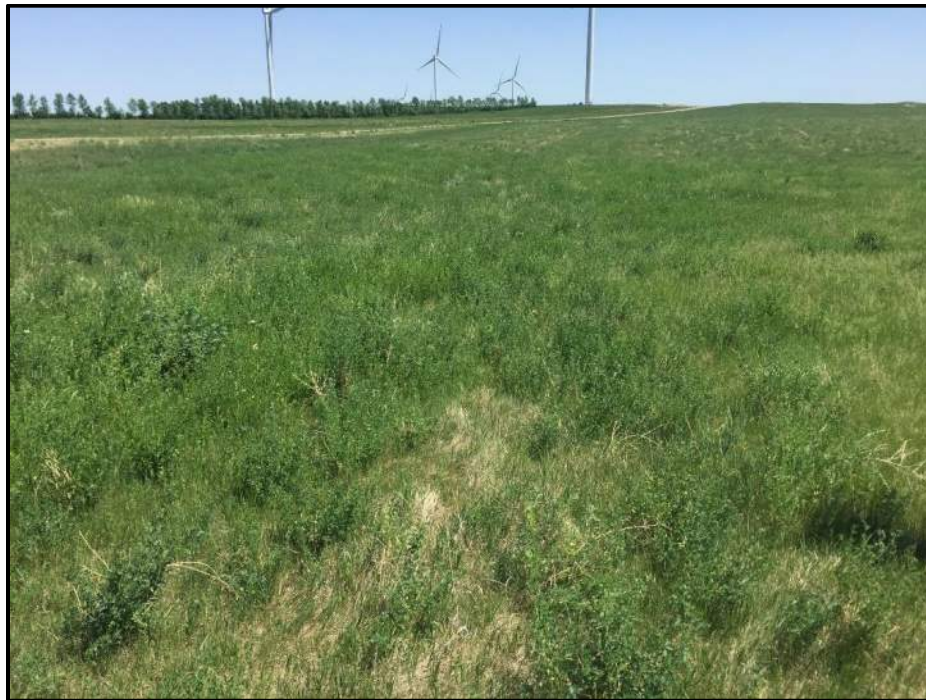
A washout and revegetation concerns were reported along the collector line between T448-T449 (**Photo 2**). The collector line crosses through a gently rolling pasture. Based on the site conditions, the collector line and adjacent areas appeared nearly indistinguishable; there was no evidence of erosion, washouts, or other revegetation concerns (**Photo 3, 4**). Alfalfa (*Medicago sativa*), western wheatgrass (*Pascopyrum smithii*), Kentucky bluegrass (*Poa pratensis*), and fringed sagewort (*Artemisia frigida*) were typical species observed in both the reclaimed collector line and surrounding area. Grasses and forbs had comparable percent cover and distribution to the surrounding areas, with the exception of alfalfa, which was more abundant within the reclaimed area. Soil conditions appeared to be flatter in the reclaimed area as compared to the subtle hummocks in the pasture. This collector line appears to have been restored to as near as is practicable to the condition as it existed prior to the beginning of construction. No further action is recommended.

Photo 2. Facing: Northeast. Location: 47.016456, -101.719680
View of the collector line between T448 and T449. The collector line scar is nearly indistinguishable compared to the surrounding landscape.

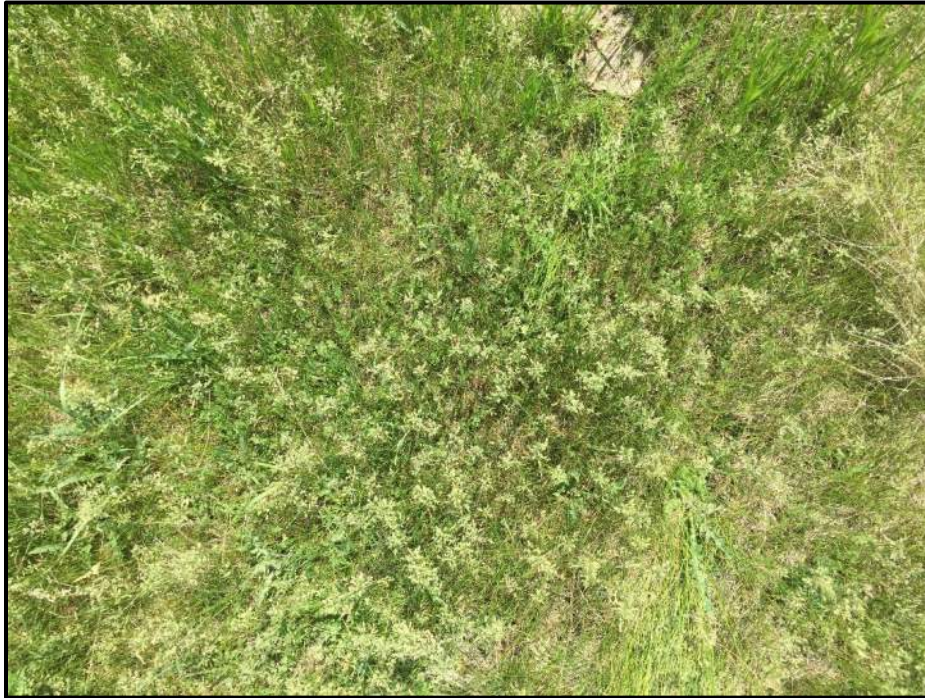
Photo 3. Location: 47.016433, -101.719672

View of the vegetation cover within the pasture undisturbed by construction of the project.

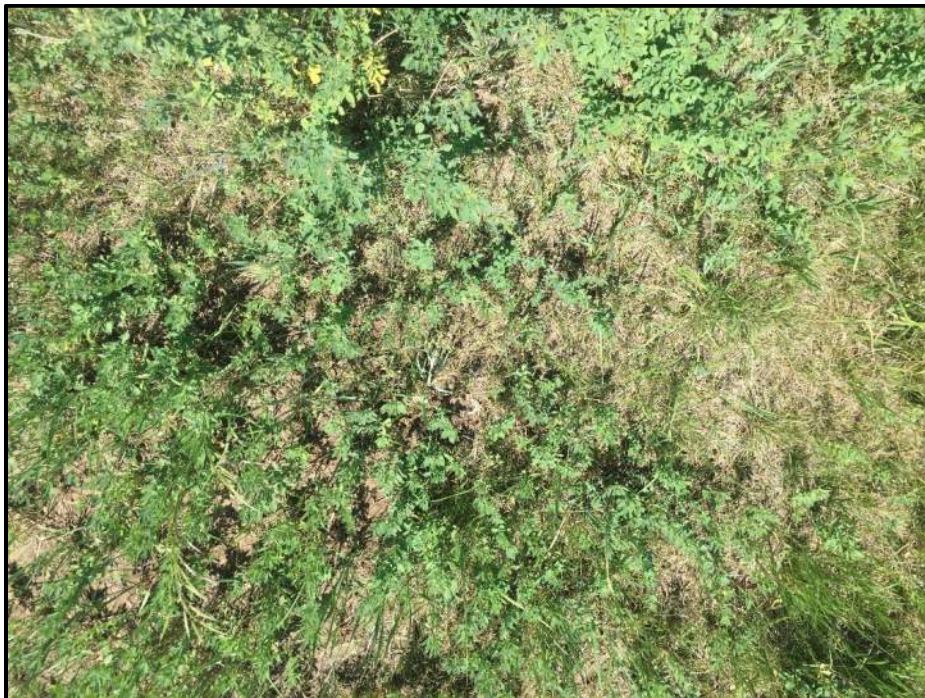
Photo 4. Location: 47.016528, -101.719636

View of the vegetation cover within the collector line corridor. Alfalfa was more abundant in this area compared to the surrounding area. Grasses and other forbs were comparable in composition to the surrounding areas.

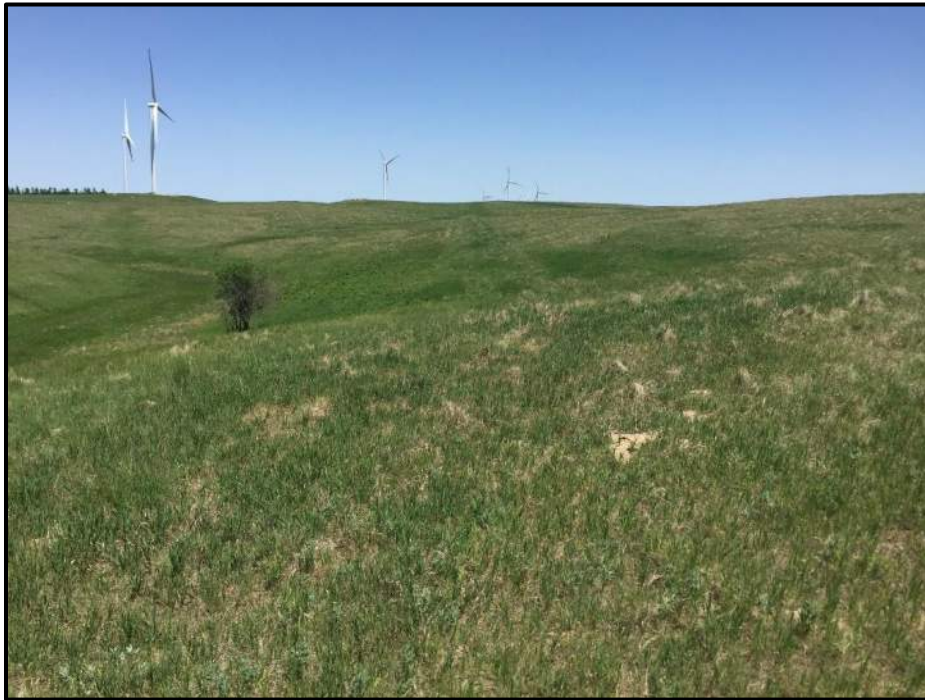
Revegetation and rutting concerns were reported along the collector line route southeast of T449. The line crosses through moderately rolling native pasture and hayland. Vegetation establishment was overall excellent along this route with between 70-80% vegetative cover (**Photo 5-7**). Vegetation was not fully established in some areas; however, the seeded vegetation was in excellent condition and will continue to establish given time (**Photo 7**). Western wheatgrass, yarrow (*Achillea millefolium*), alfalfa, and green needlegrass (*Nassella viridula*) were typical species observed in both the reclaimed area and surroundings. Regarding soil concerns, a subtle ridge was observed along the collector line corridor that spanned approximately 10 feet and was about 1 to 2 inches high (**Photo 8**). The ridge likely formed as soil settled following reclamation. The short length and low height of the ridge should not pose a hazard or impediment to livestock or vehicles and is similar to natural features throughout the pasture. In comparison to the surrounding site, this collector line appears to have been restored to as near as is practicable to the condition as it existed prior to the beginning of construction. No further action is recommended.

Photo 5. Facing: Northeast. Location: 47.010414, -101.717378
View of the southwestern extent of the collector line southeast of T449. The corridor was nearly indistinguishable to the surrounding area.

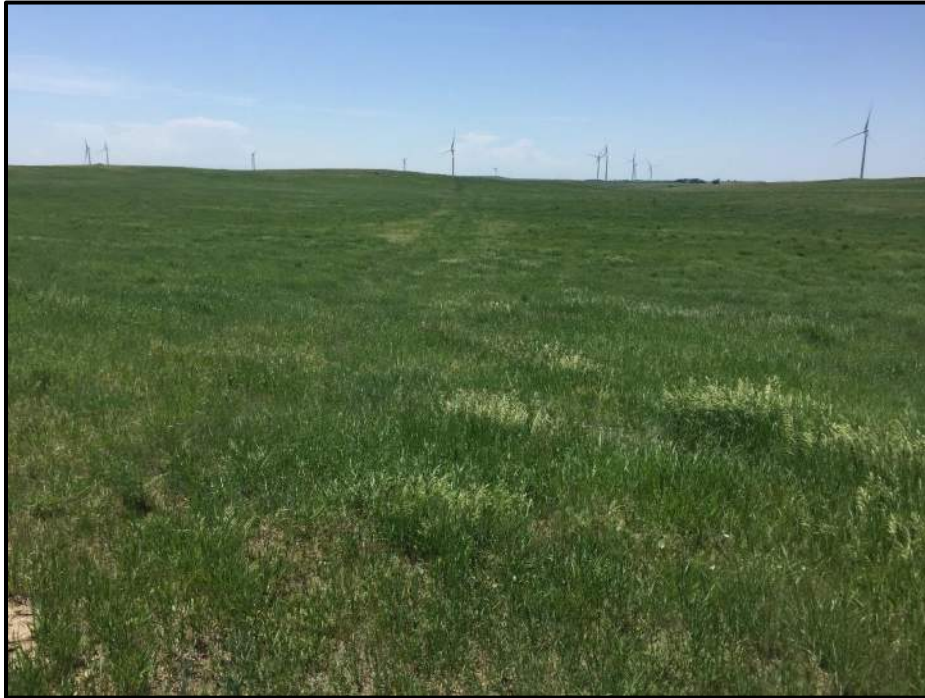
Photo 6. Facing: Southwest. Location: 47.018928, -101.706300
View of the collector line southeast of T449 in the hayed area. Alfalfa and grass cover in this area was comparable to the surrounding areas.

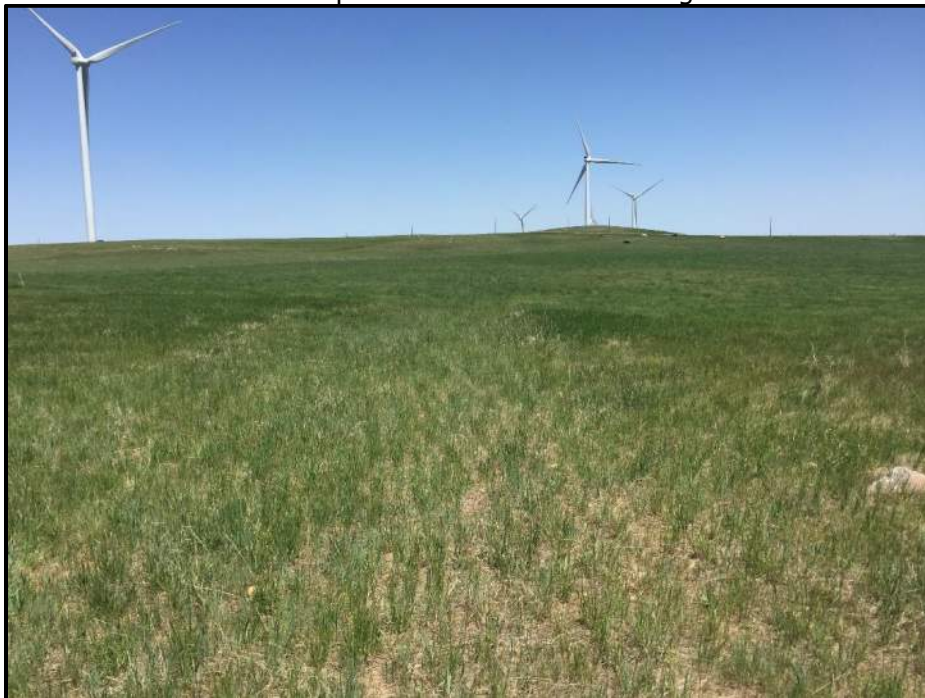
Photo 7. Facing: Northeast. Location: 47.018928, -101.706300
View along the collector line southeast of T449. T451 is visible in the northwest corner of the photo. This area had the least vegetation cover observed along the route, but still had a satisfactory stand of seeded native grasses that will continue to establish over time without intervention.

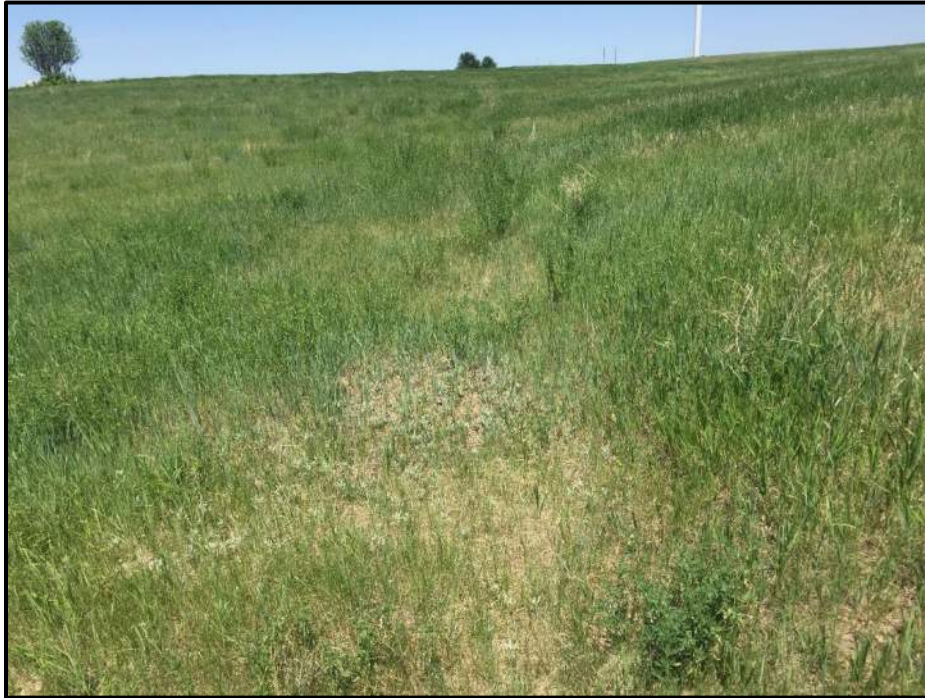
Photo 8. Facing: Northeast. Location: 47.019089, -101.706239
View of a soil ridge along the collector line southwest of T449. This ridge was likely formed from soil settlement after construction.

Regrading or blading these areas would result in disturbance to previously undisturbed areas, which would provide little benefit to the pasture.

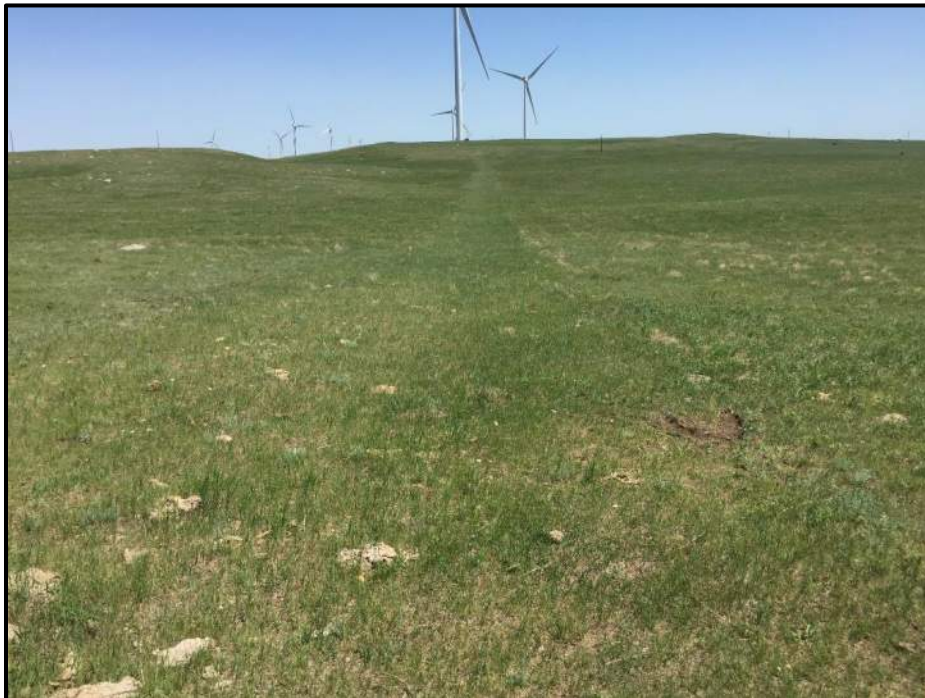
Similar to the other two collector lines discussed in this memo, revegetation concerns were reported along the T450-T451 collector line. The line crosses through a moderately rolling native pasture. Based on current site conditions, vegetation establishment was excellent in this area, with vegetation cover between 70-80% (**Photo 9-11**). Typical species observed included western wheatgrass, green needlegrass, yarrow, fringed sagewort, and Kentucky bluegrass. Vegetation composition in the surrounding area was similar to what had been seeded in the reclaimed corridor. No erosion, rutting, or other soil issues were noted during the inspection. This collector line appears to have been restored to as near as is practicable to the condition as it existed prior to the beginning of construction. No further action is recommended.

Photo 9. Facing: Northeast. Location: 47.021992, -101.710267
Overview of the collector line between T450 and T451 from the southwest end. The route of this line is nearly indistinguishable to the surrounding area.

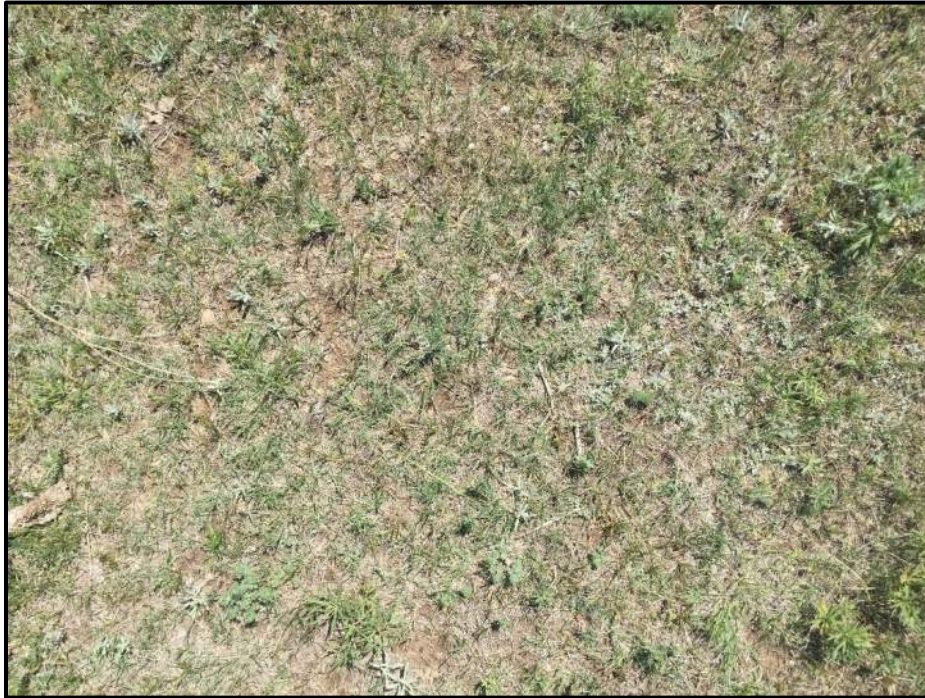
Photo 10. Location: 47.022080, -101.710152

View showing the vegetation cover outside of the disturbed area. Vegetation litter was greater in this area compared to the collector line corridor, but otherwise vegetation cover and composition were similar in both areas.

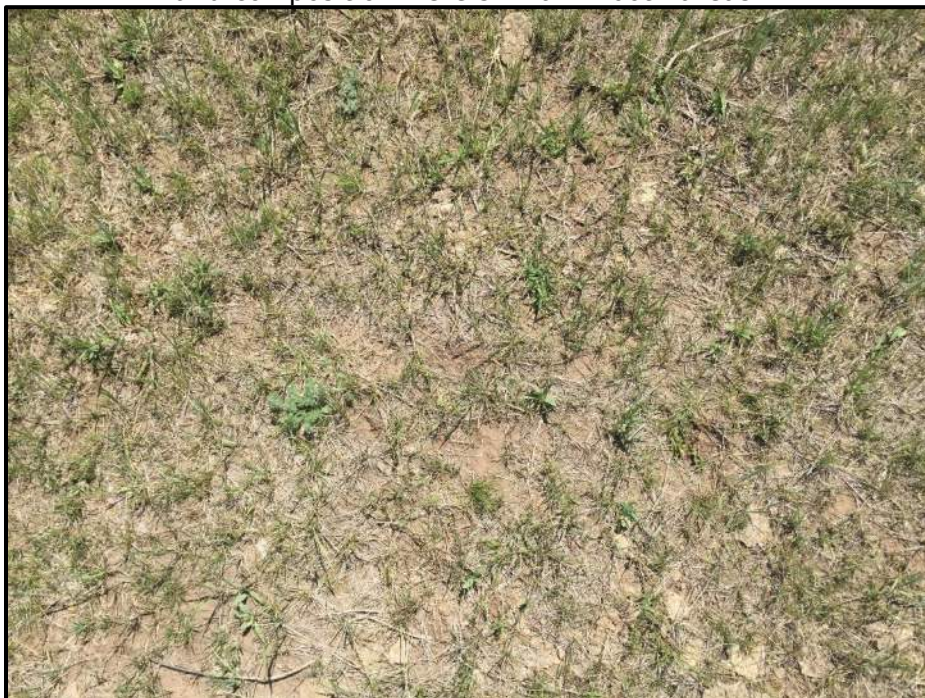
Photo 11. Location: 47.022030, -101.710097

View of the typical vegetation cover within the collector line disturbance corridor.

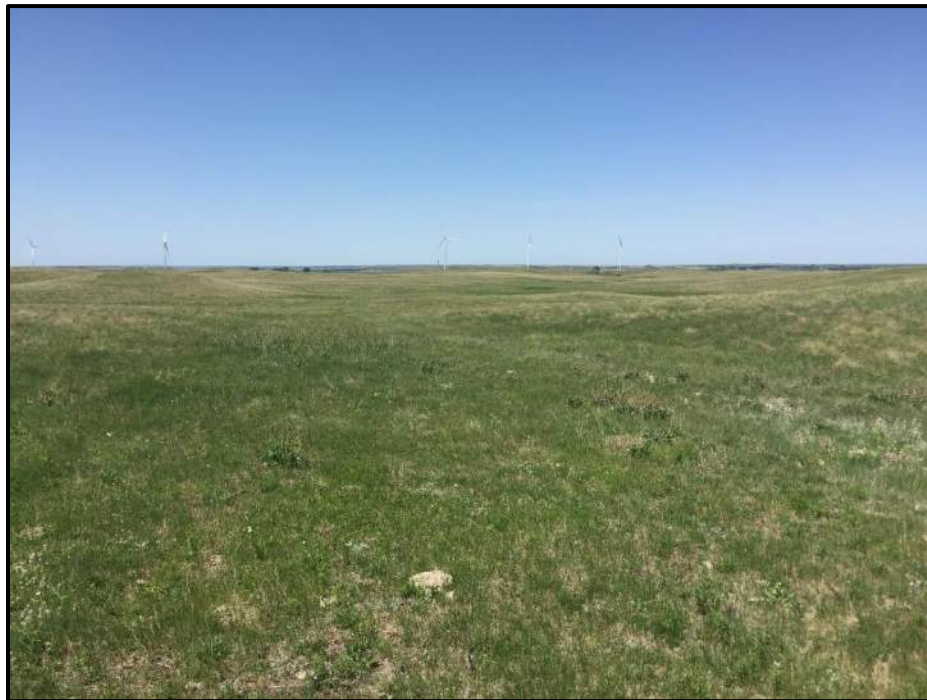
Decompaction and re-seeding along the crane walk path were specifically noted in the NDPSC Reclamation Memo. The crane walk path crosses through rolling native pasture. Based on the site visit, the entire crane walk path had excellent vegetative cover (70-90% absolute cover), with an abundance of the native species western wheatgrass, sun sedge (*Carex inops*), little bluestem (*Schizachyrium scoparium*), field sagewort (*Artemisia ludoviciana*), and green needlegrass (**Photo 11-18**). There was no evidence of extensive or problematic soil compaction along the route, which would have been evident with a lower abundance of native vegetation. One location along the route had a subtle ridge approximately 5 feet long and 2-3 inches high that was formed by the crane compacting the soil (**Photo 15**). The short length and low height of the ridge should not pose a hazard or impediment to livestock or vehicles and is similar to natural features throughout the pasture. In comparison to the surrounding site, the crane walk path appears to have been restored to as near as is practicable to the condition as it existed prior to the beginning of construction. No further action is recommended.

Photo 11. Facing: Northwest. Location: 47.026733, -101.703439
View from the southern extent of the crane walk path, which is nearly indistinguishable from the surrounding area.

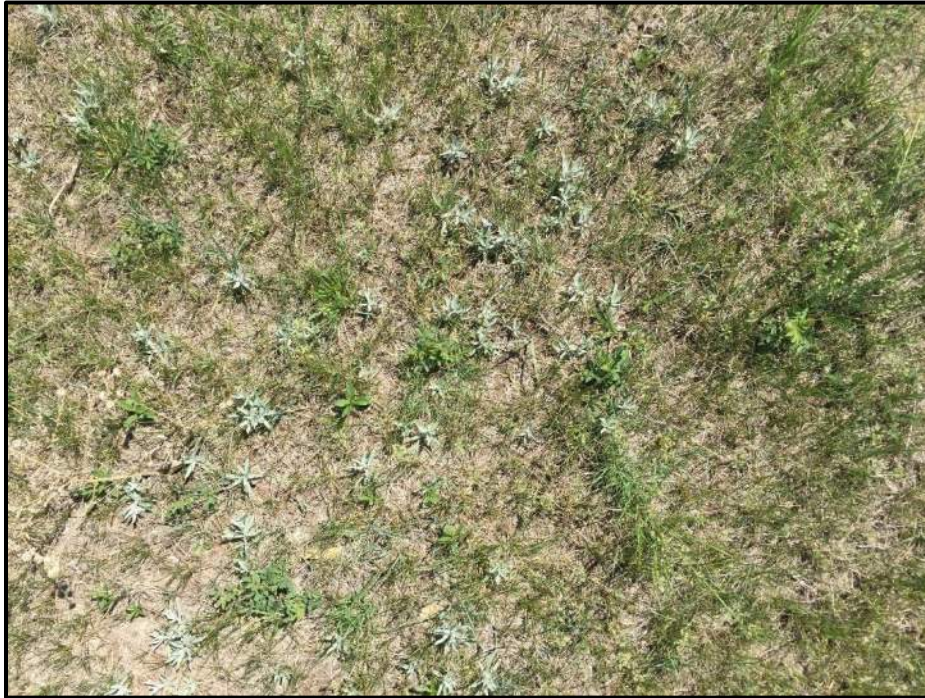
Photo 13. Location: 47.026628, -101.703439
View of the vegetation cover within the crane walk path. The vegetation cover and composition was identical to the surrounding area.

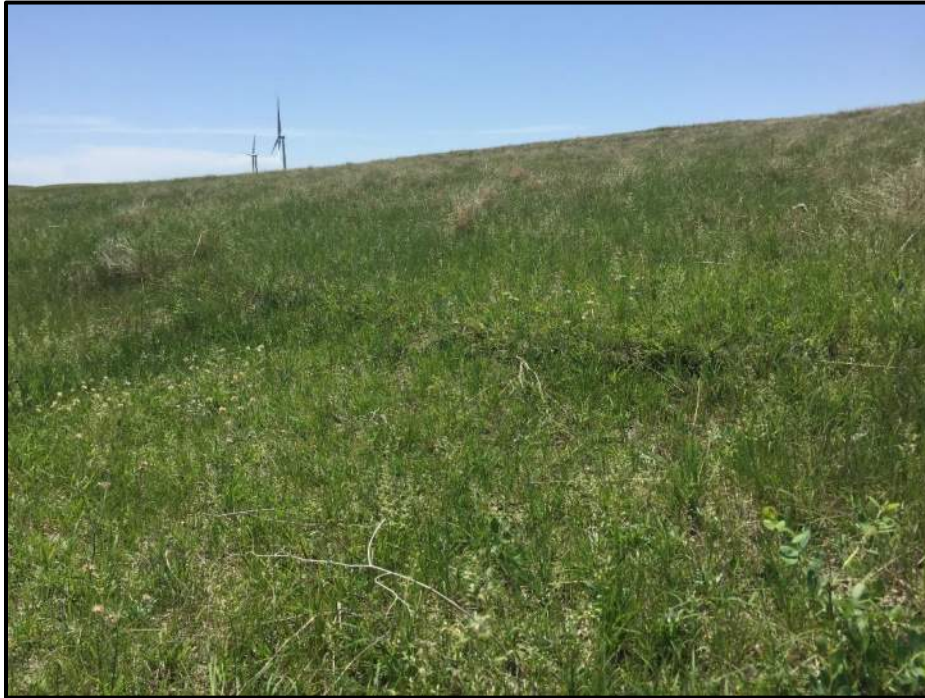
Photo 15. Location: 47.031628, -101.706214

View of a subtle ridge created by the crane along a hillside. No erosion concerns were noted in this area, with vegetation well established throughout.

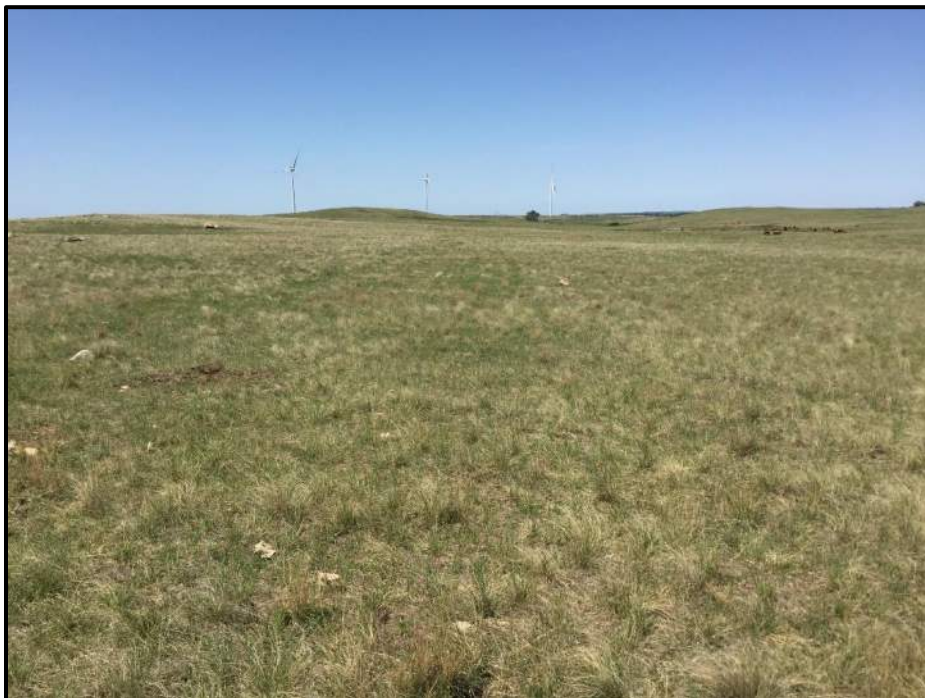
Photo 16. Facing: Northwest. Location: 47.033522, -101.707322

The crane walk path in this pasture was indistinguishable from the surrounding native pasture.

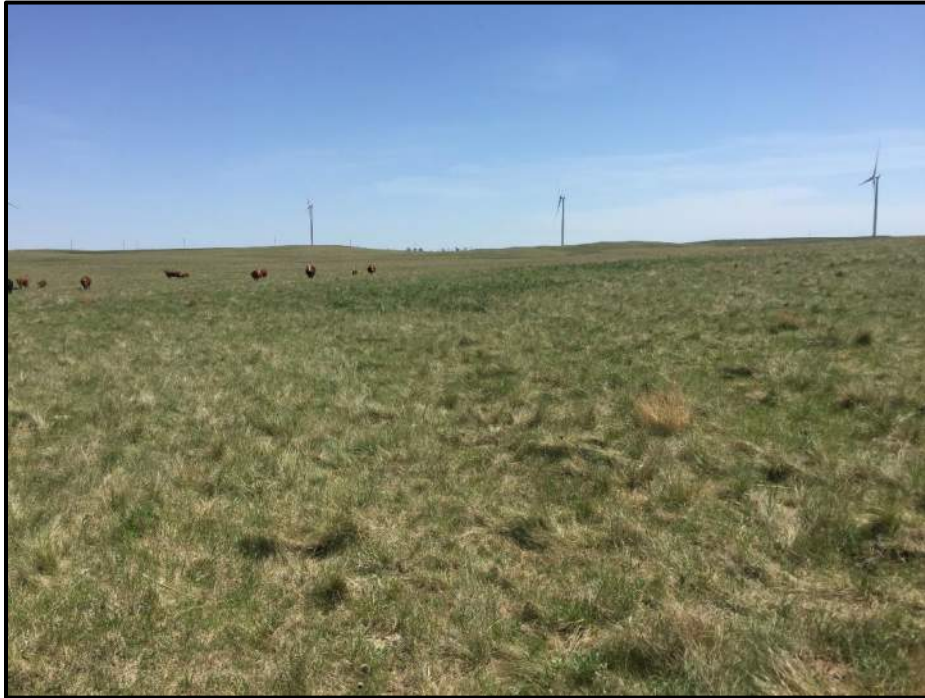
Photo 17. Facing: Southeast. Location: 47.036189, -101.708947
Note the uniformity of vegetation cover in this view of the crane walk path near its northern extent.

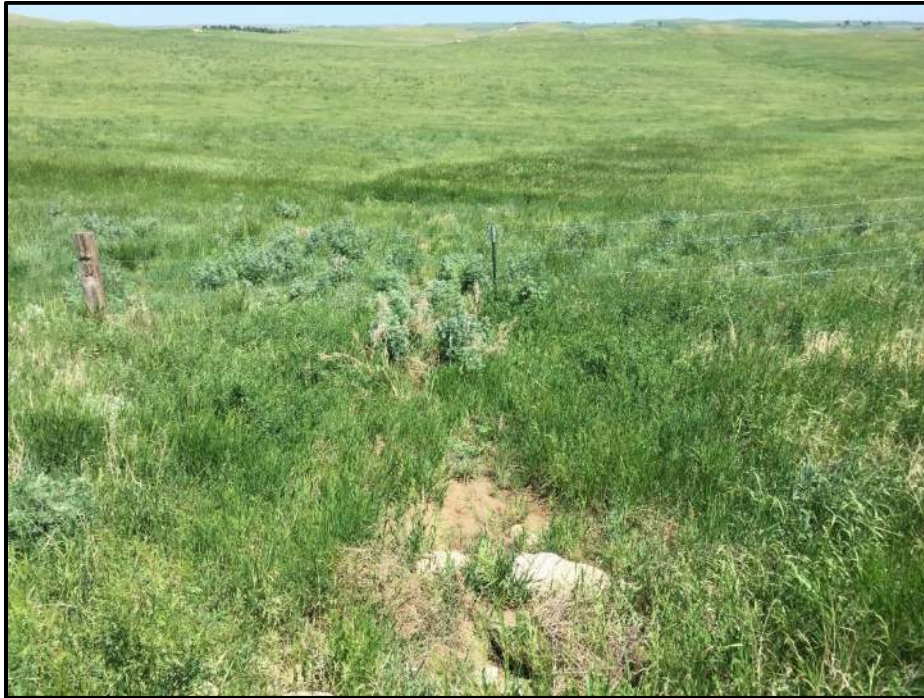
Photo 19. Facing: Southeast. Location: 47.028850, -101.690619

The outlet of the culvert along the T440 access road was noted as having erosion and rills forming. This area did appear to have washed out this spring. Absinthe wormwood was present at the base of the culvert (**Photo 19**). This area should be stabilized to prevent further erosion to the ditch bank and sedimentation to the nearby pasture. The wormwood should be sprayed as a part of annual operation and maintenance to prevent from spreading. A fall spraying is recommended to help control this species.

View east from the access road showing a washout forming at the outlet of a culvert. Note the absinthe wormwood in the background, a weed that should be controlled this season to avoid spreading further into the adjacent pasture.
